CRASH TEST AND EVALUATION OF THE TxDOT T631 BRIDGE RAIL

Test Report 9-1002-12-10

The objective of this research was to evaluate the impact performance of the new TxDOT Type T631 bridge rail. The TxDOT Type T631 bridge rail is intended to serve as a low-cost replacement for the TxDOT Type T6 bridge rail for *MASH* TL-2 applications. The TxDOT T631 bridge rail is intended for new construction. The crash testing was performed in accordance with the requirements of *MASH* TL-2.

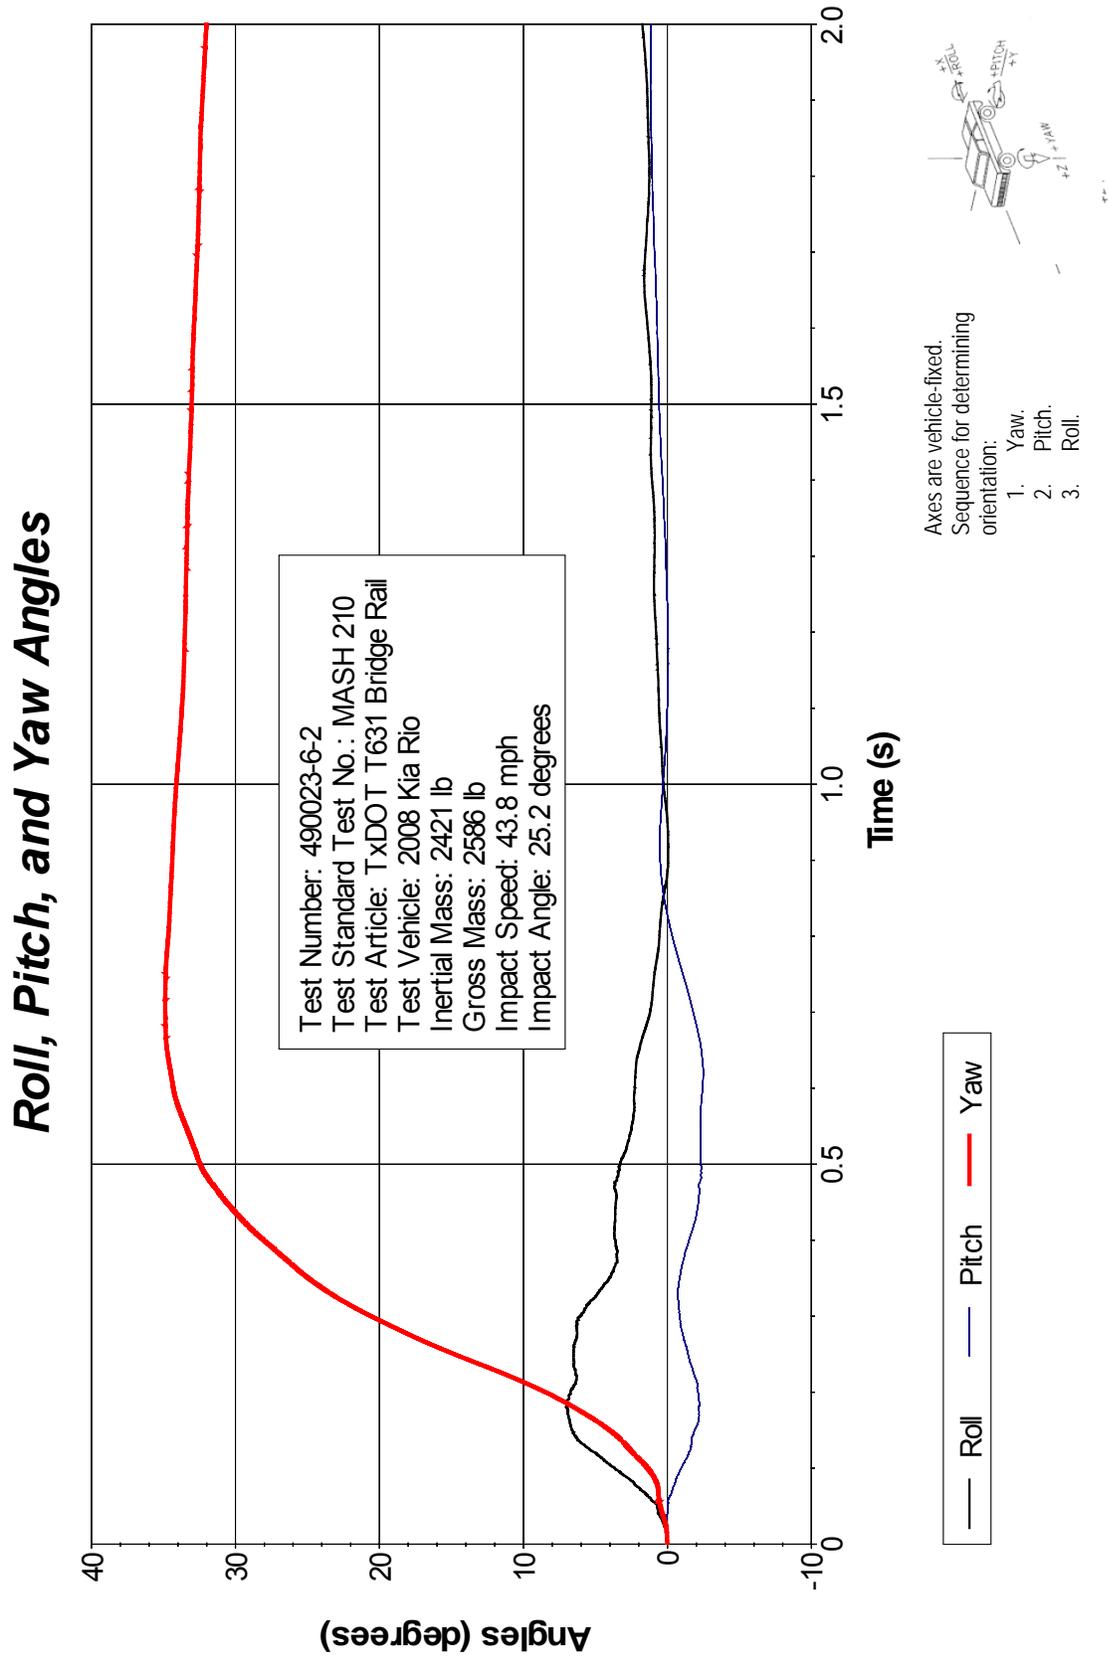
Figure E3. Vehicle Angular Displacements for Test No. 490023-6-2.

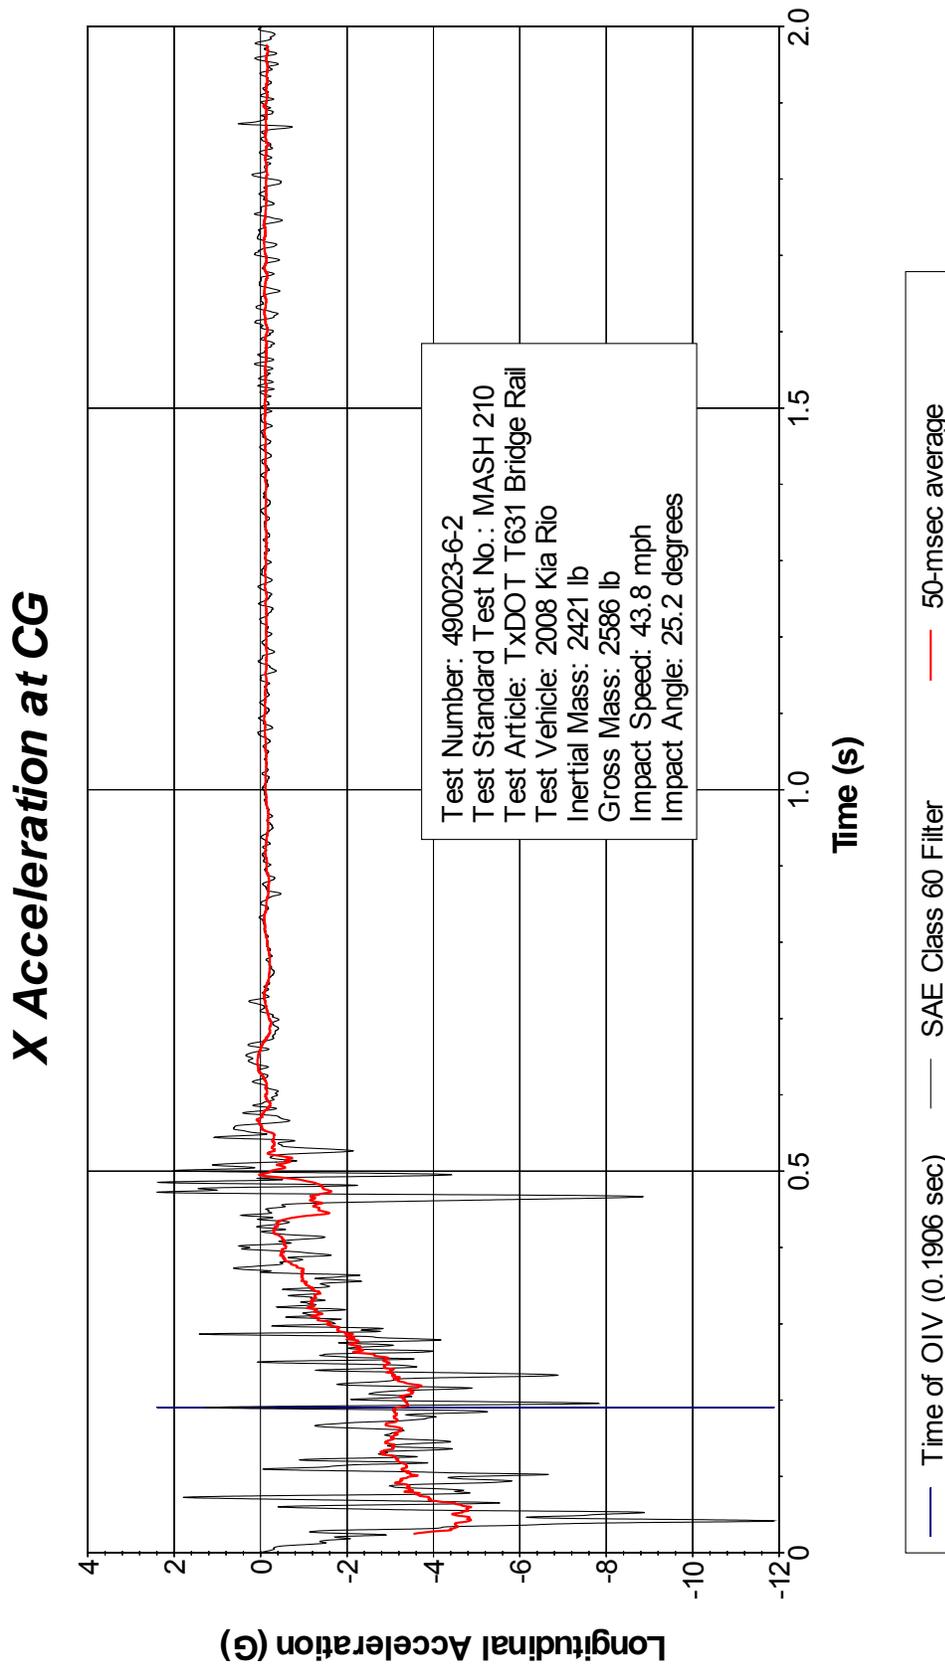
Figure E4. Vehicle Longitudinal Accelerometer Trace for Test No. 490023-6-2 (Accelerometer Located at Center of Gravity).

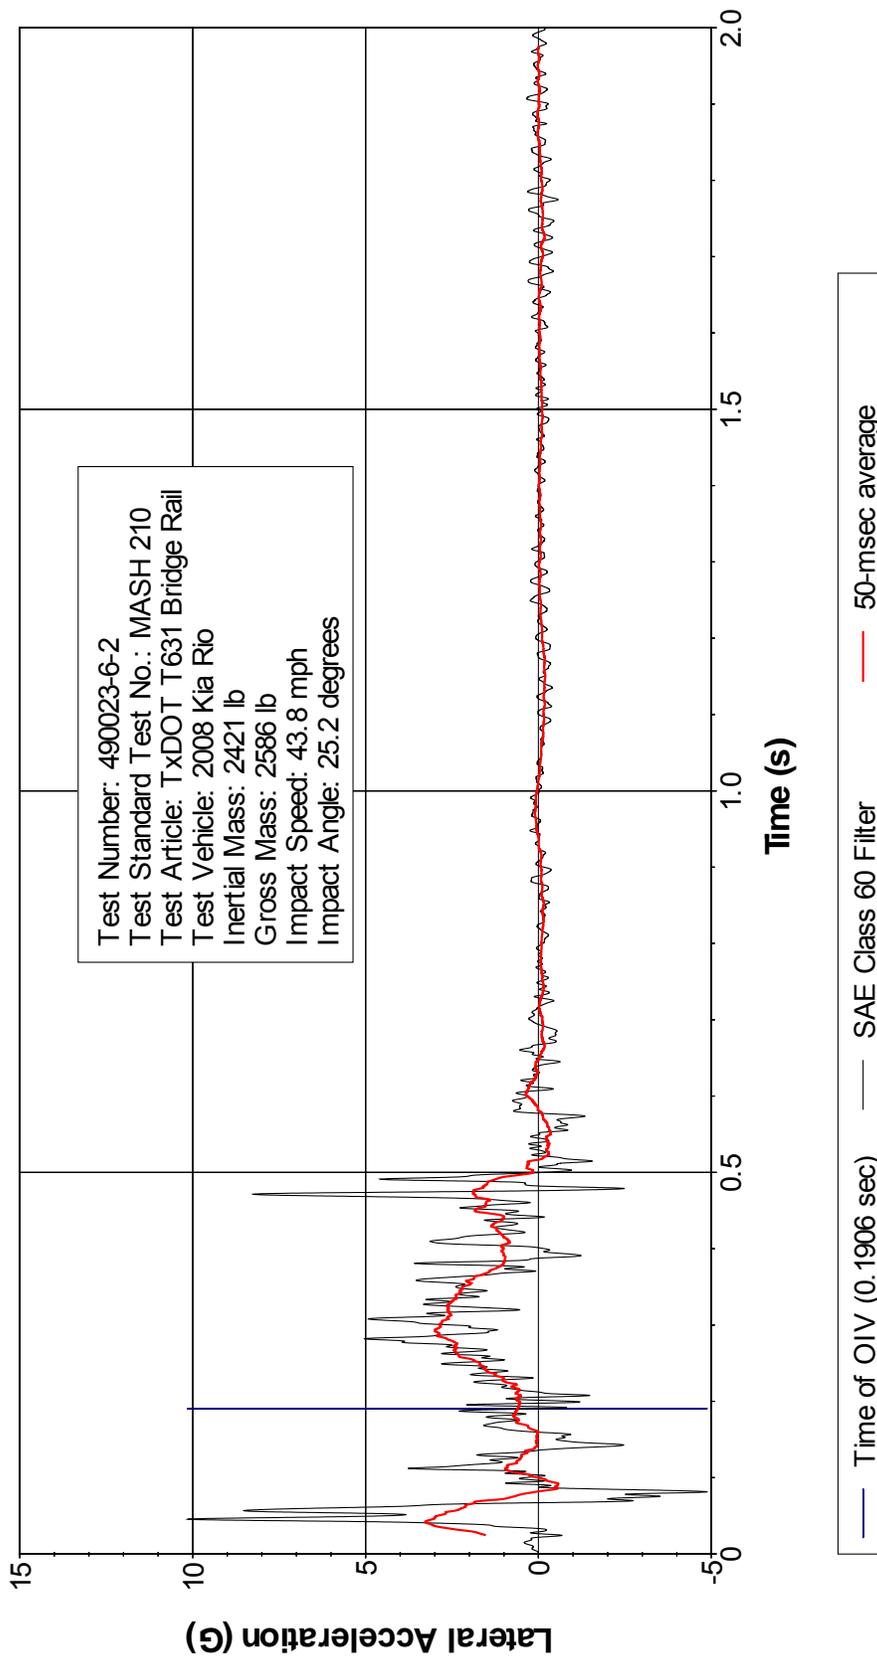
Figure E5. Vehicle Lateral Accelerometer Trace for Test No. 490023-6-2 (Accelerometer Located Rear of Center of Gravity).

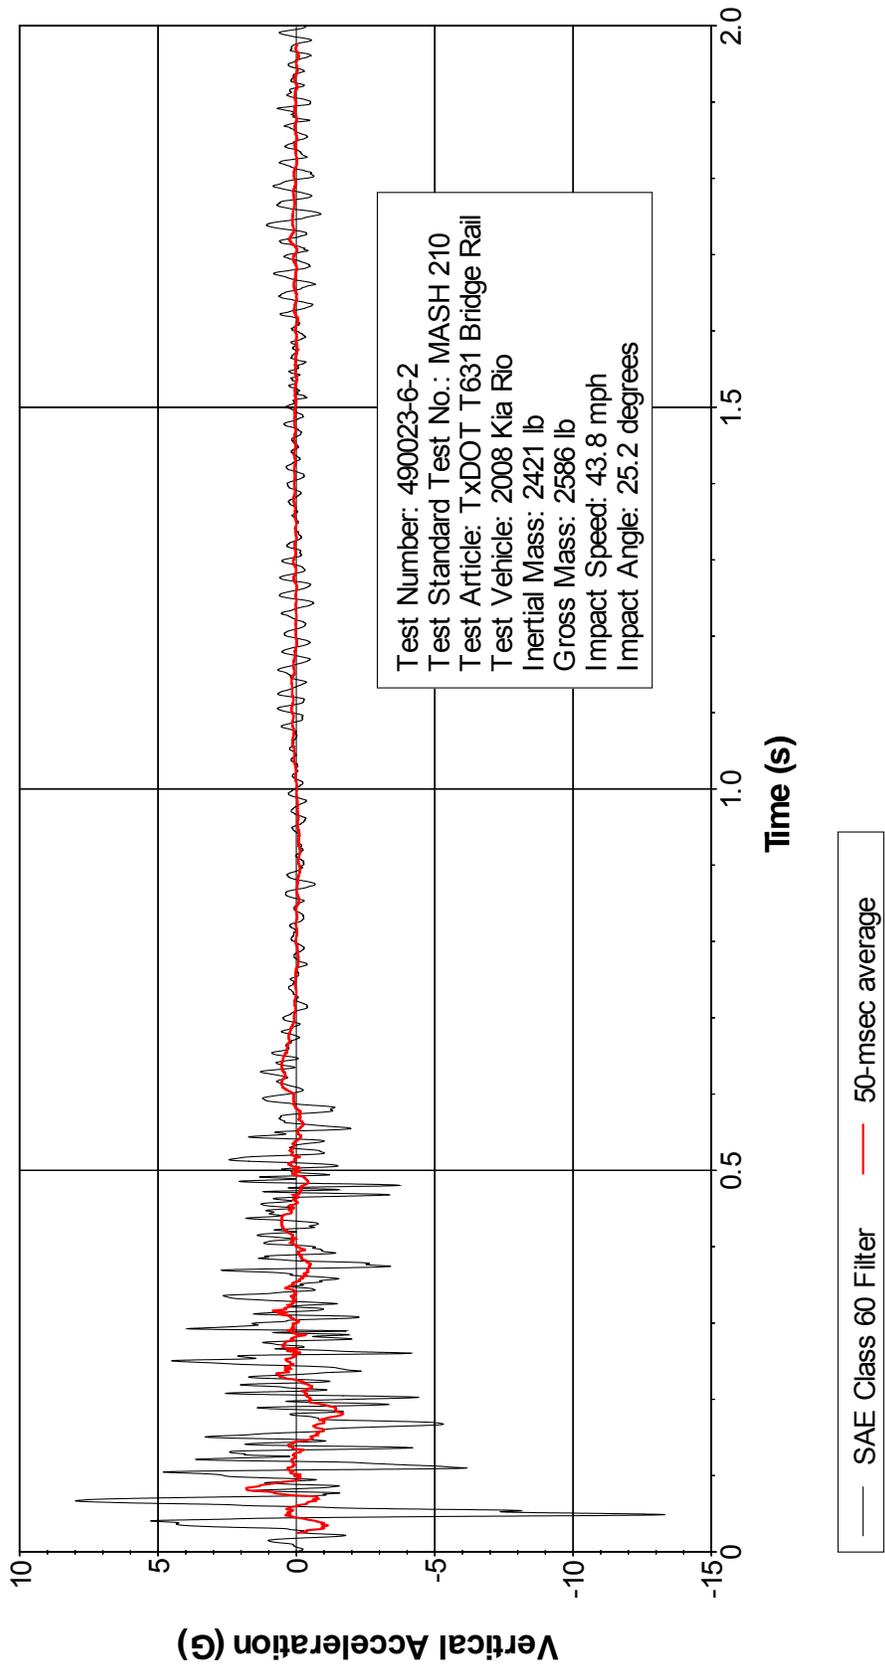
Figure E6. Vehicle Vertical Accelerometer Trace for Test No. 490023-6-2 (Accelerometer Located at Center of Gravity).
