CRASH TEST AND EVALUATION OF 3-FT MOUNTING HEIGHT SIGN SUPPORT SYSTEM

Test Report 9-1002-15-1

TEXAS A&M TRANSPORTATION INSTITUTE
COLLEGE STATION, TEXAS

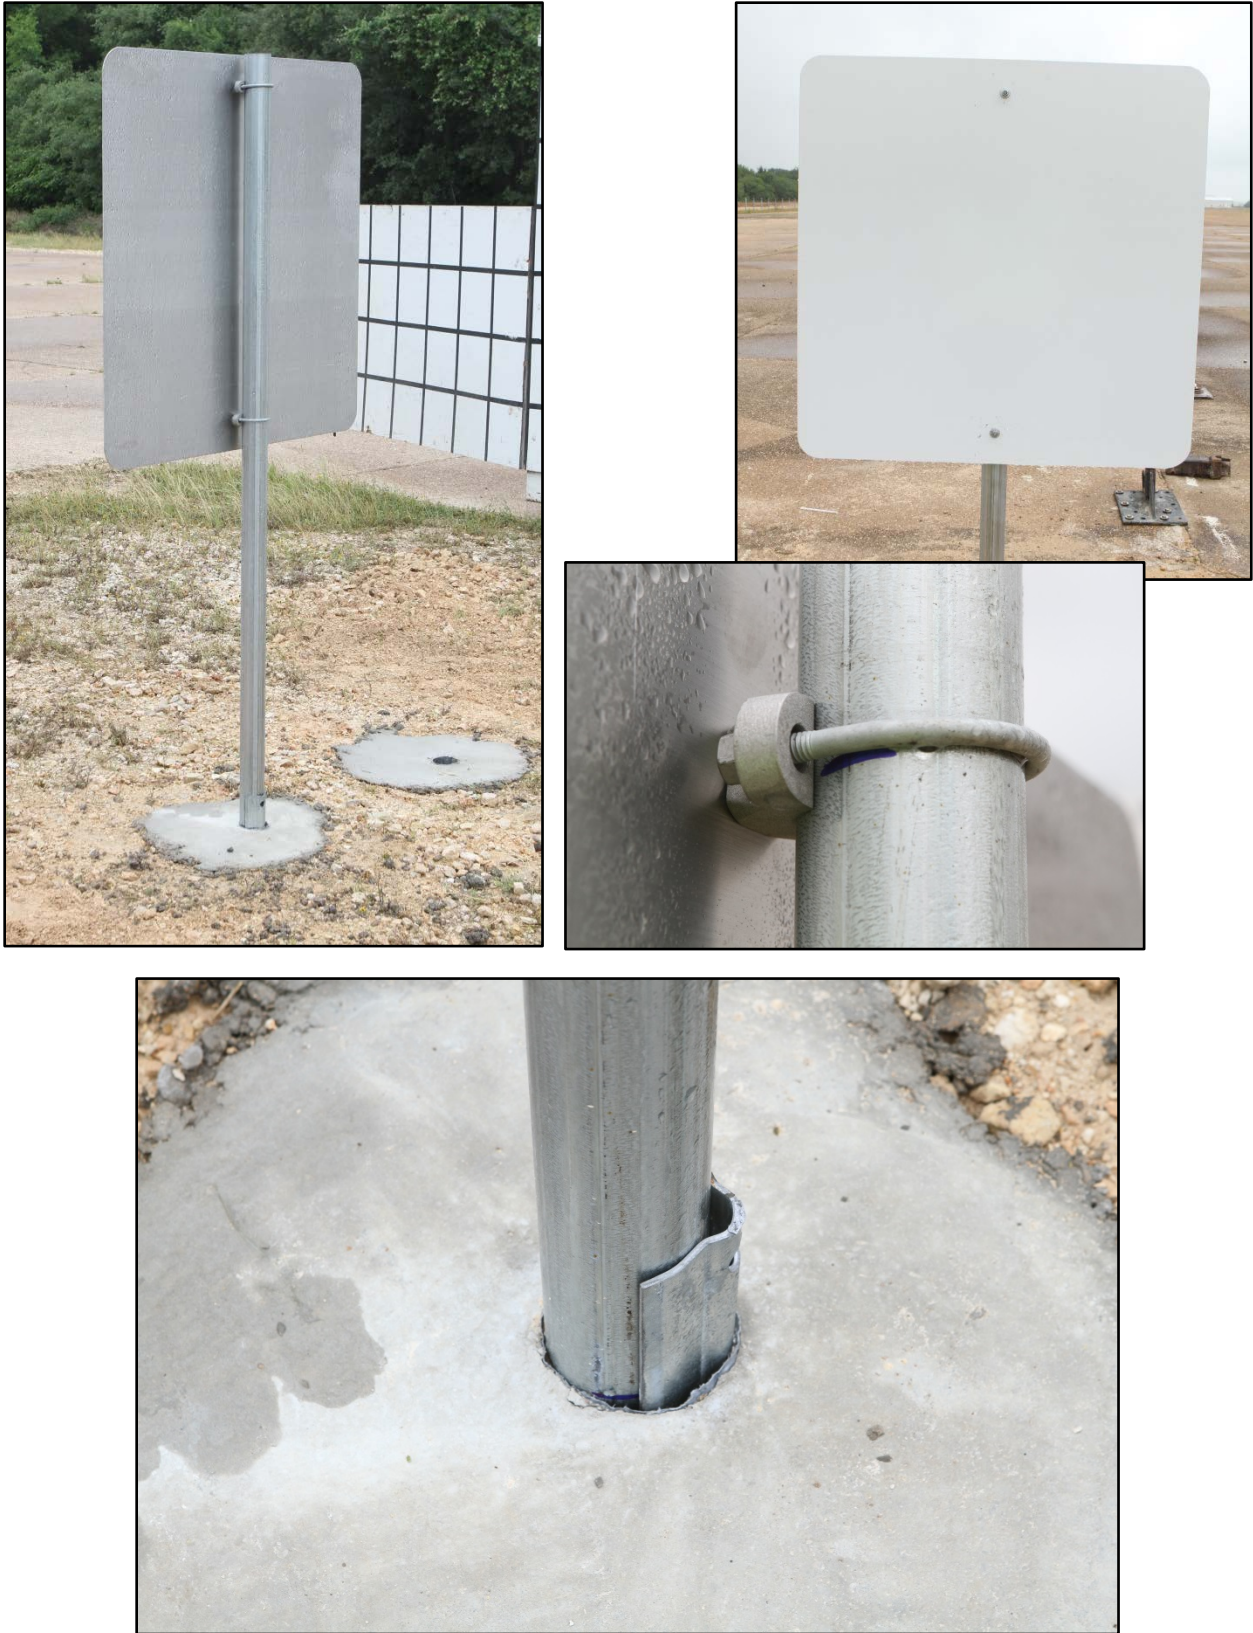
Figure 2.2. 3-ft Mounting Height Sign Support System before Testing.

Figure 2.1 shows details of the sign support test installation. Figure 2.2 provides photographs of the completed installation.

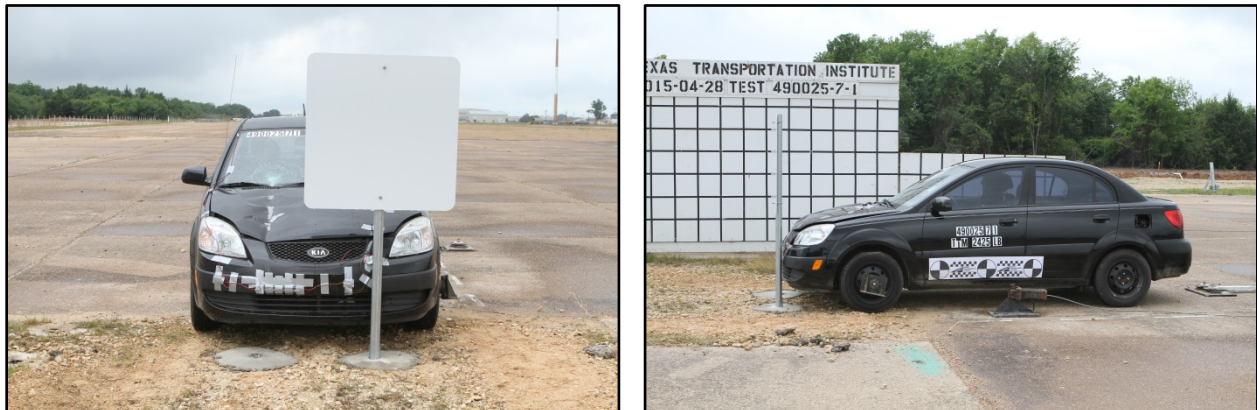
Figure 5.1. Vehicle/Installation Geometrics for Test No. 490025-7-1.

Figures 5.1 and 5.2 show the 2009 Kia Rio used for this crash test. The right quarter point of the vehicle was damaged in the previous high-speed test (Test No. 490025-7-2) conducted that morning. However, this damage was minimal and did not affect independent assessment of the sign panel in this low-speed test. Test inertia weight of the vehicle was 2415 lb, and its gross static weight was 2580 lb. The height to the lower edge of the vehicle front bumper was 9.50 inches, and the height to the upper edge of the front bumper was 21.5 inches. Additional dimensions and information on the vehicle are given in Appendix B1, Table B.1. The vehicle was directed into the installation using a cable reverse tow and guidance system, and was released to be freewheeling and unrestrained just prior to impact.

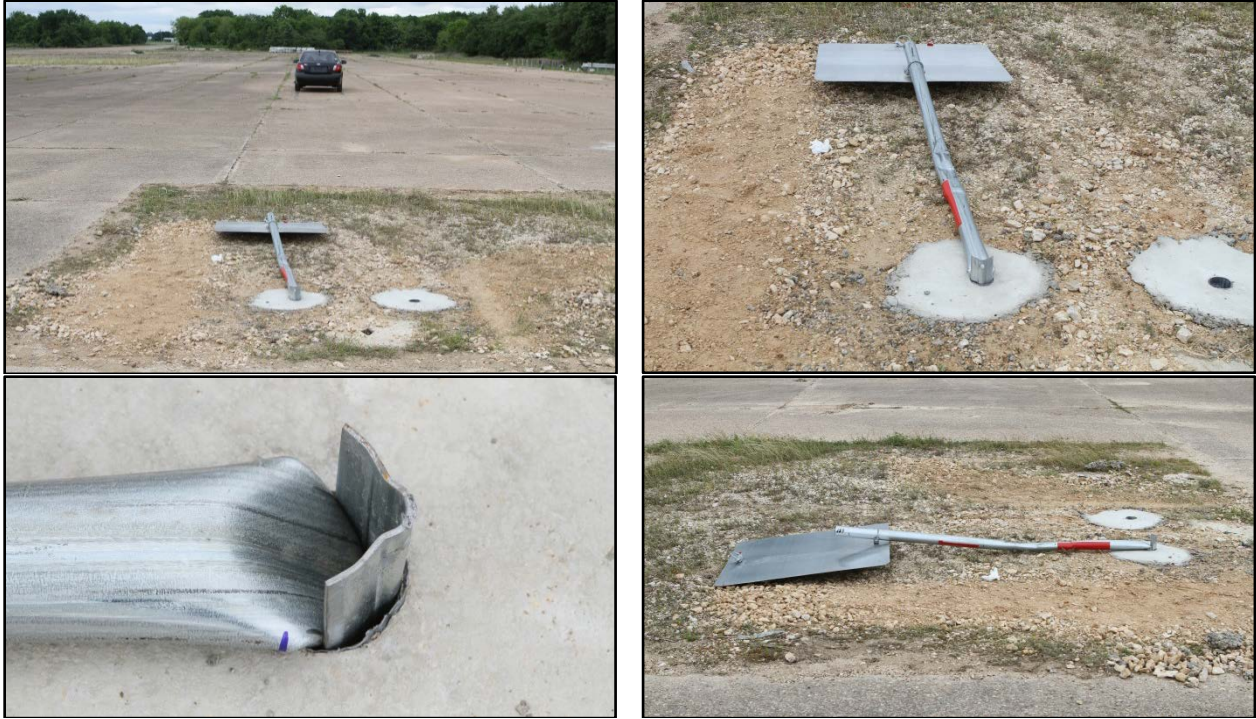
Figure 5.3. 3-ft Mounting Height Sign Support System after Test No. 490025-7-1.

Figure 5.3 shows damage to the sign support structure. The sign support was deformed 90 degrees at ground level. The sign panel slid 20 inches upward on the sign support but remained attached to the support.

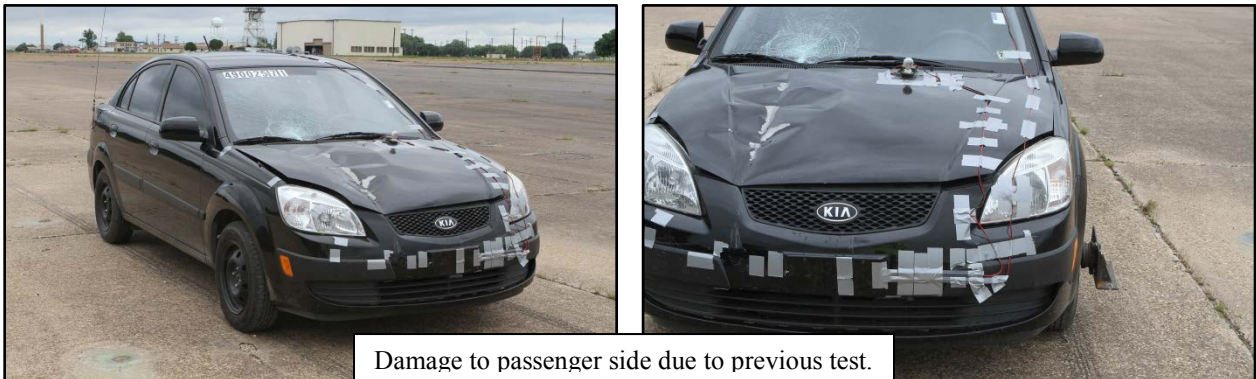
Figure 5.4. Vehicle after Test No. 490025-7-1.

Figure 5.4 shows minimal damage to the driver side of the vehicle after the test. The damage to the passenger side occurred during the previous high-speed test (test no. 490025-7-2), which was performed earlier that morning. Scuff marks were noted on the bumper, but no other damage was obvious. No deformation or intrusion of the occupant compartment was noted. Figure 5.5 shows the interior of the vehicle. Exterior vehicle crush and occupant compartment measurements are shown in Appendix B1, Tables B.2 and B.3, respectively.

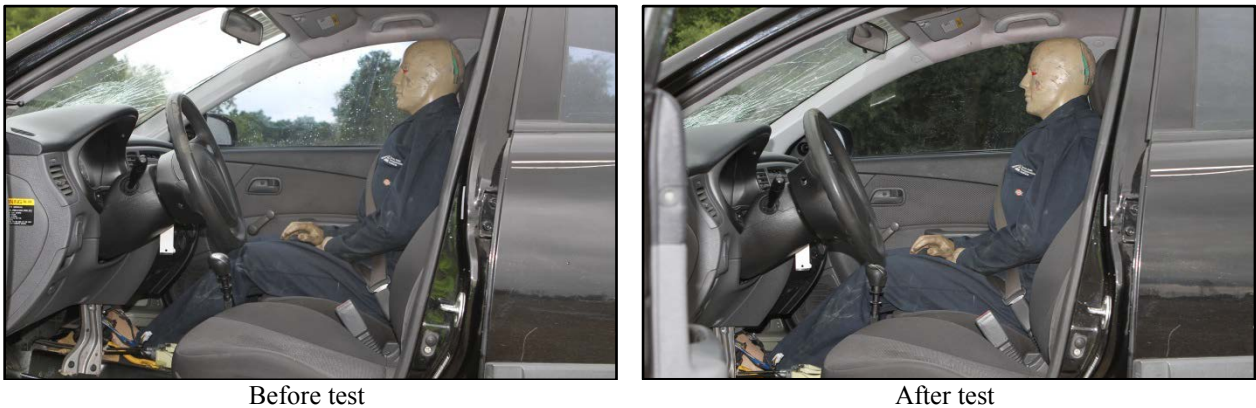
Figure 5.5. Interior of Vehicle for Test No. 490025-7-1.

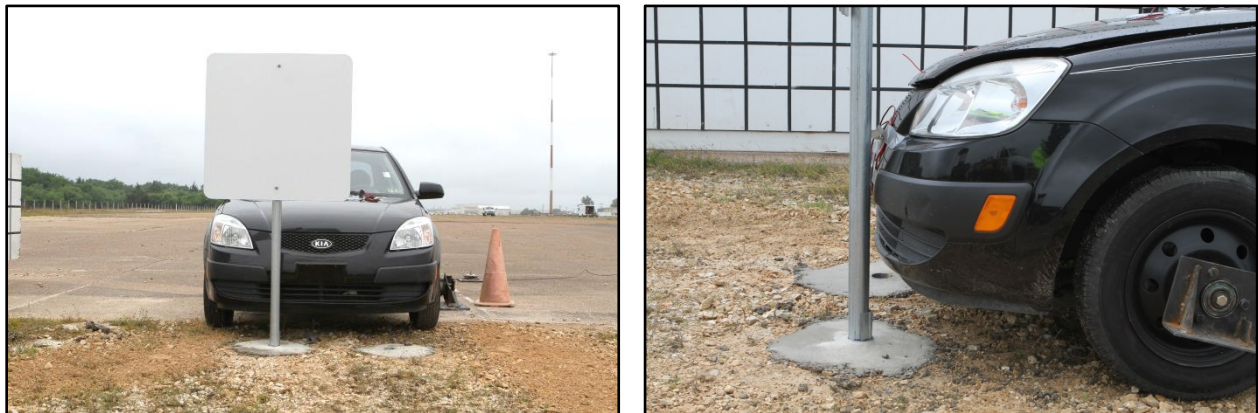
Figure 6.1. Vehicle/Installation Geometrics for Test No. 490025-7-2.

Figures 6.1 and 6.2 show the 2009 Kia Rio used for this crash test. Test inertia weight of the vehicle was 2415 lb, and its gross static weight was 2580 lb. The height to the lower edge of the vehicle front bumper was 9.50 inches, and the height to the upper edge of the front bumper was 21.5 inches. Additional dimensions and information on the vehicle are given in Appendix C1, Table C.1. The vehicle was directed into the installation using a cable reverse tow and guidance system and was released to be freewheeling and unrestrained just prior to impact.

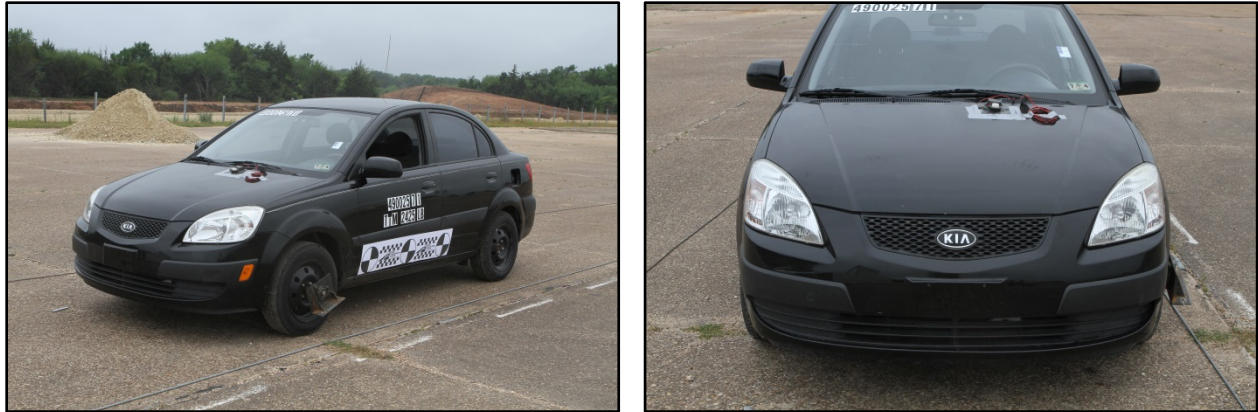
Figure 6.2. Vehicle before Test No. 490025-7-2.

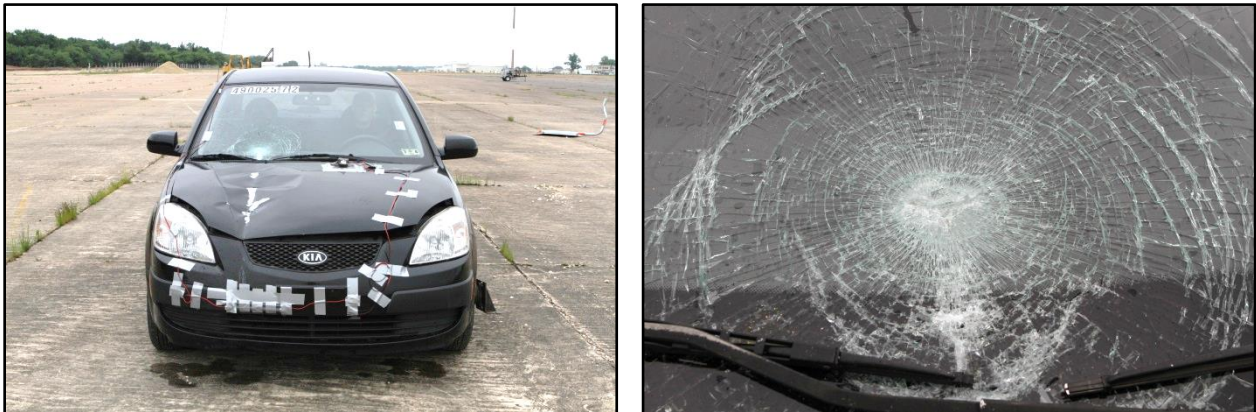
Figure 6.4. Vehicle after Test No. 490025-7-2.

Figure 6.4 shows damage to the vehicle after the test. There was a small indentation in the right side of the hood. The windshield was fractured in the lower right corner but remained intact. No deformation or intrusion of the occupant compartment was noted. Figure 6.5 shows the interior of the vehicle. Exterior vehicle crush and occupant compartment measurements are shown in Appendix C2, Tables C.2 and C.3.

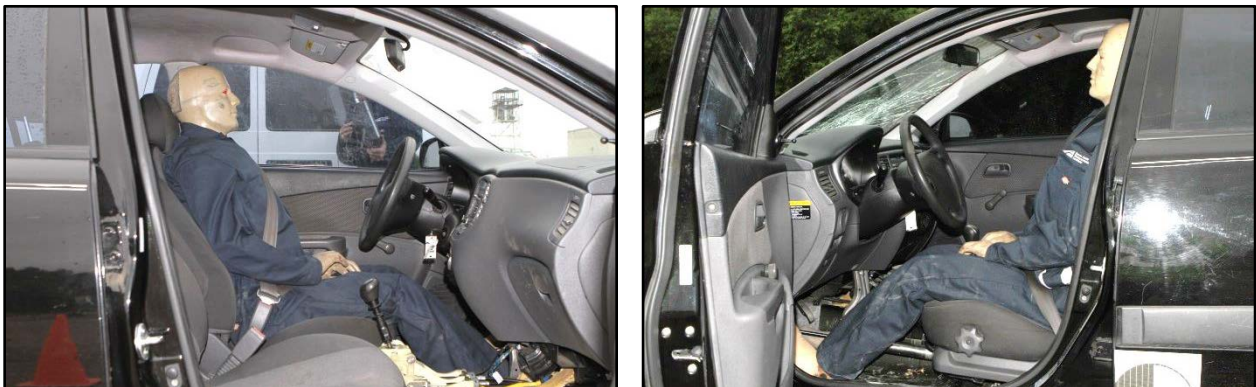
Before test

After test

Figure 6.5. Interior of Vehicle for Test No. 490025-7-2.

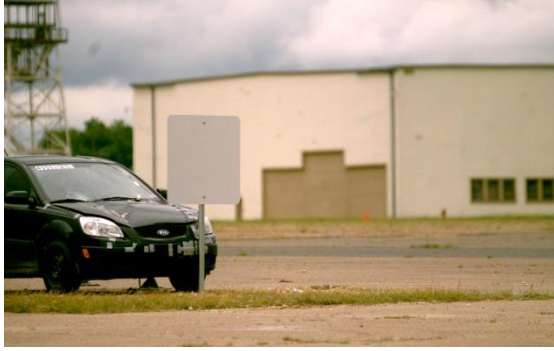
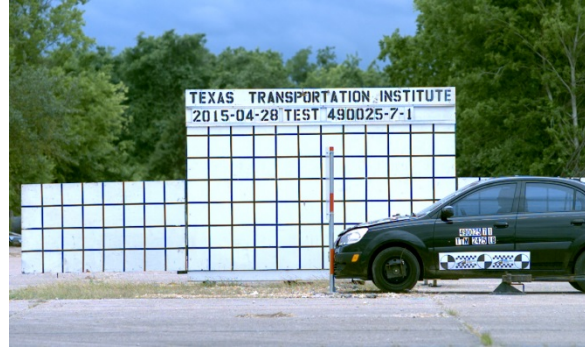
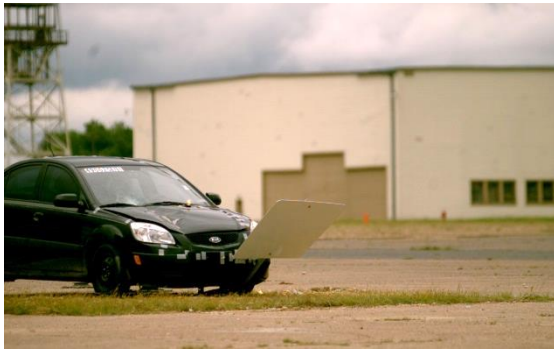
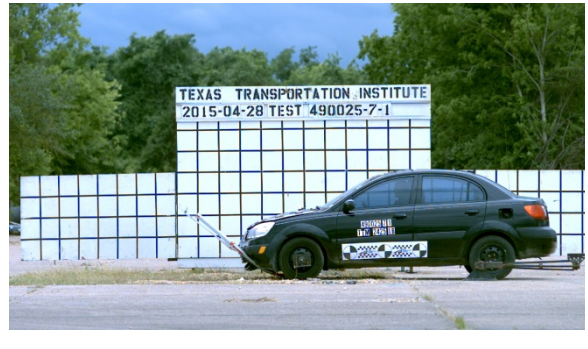
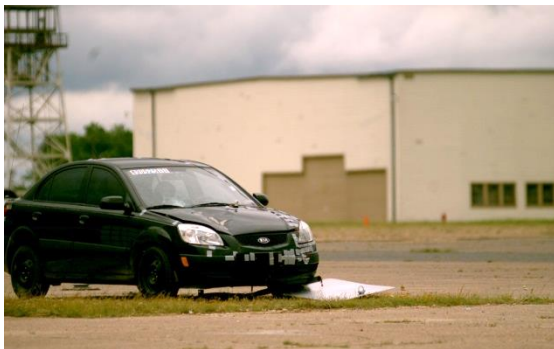
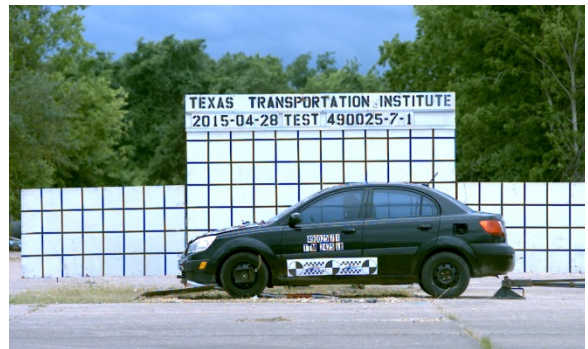
Figure B.1. Sequential Photographs for Test No. 490025-7-1 (Frontal Views).

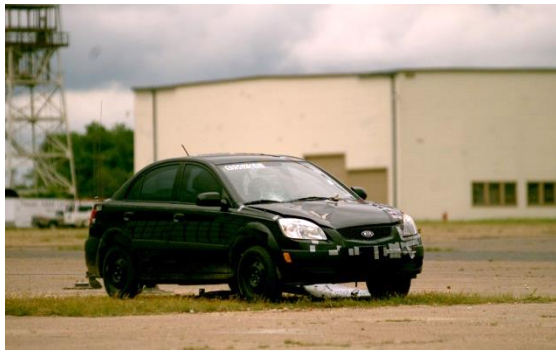
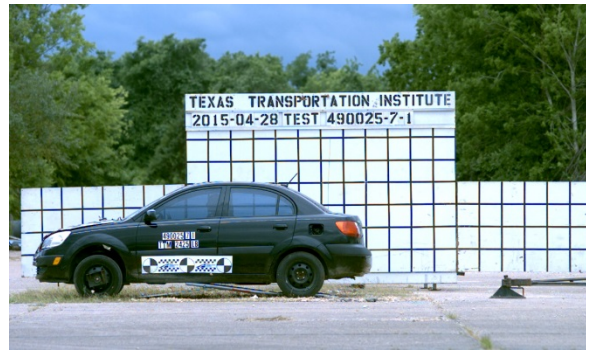
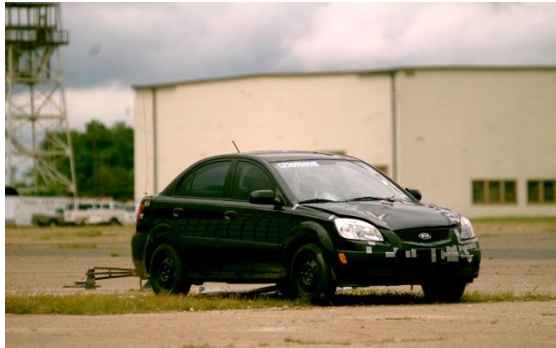
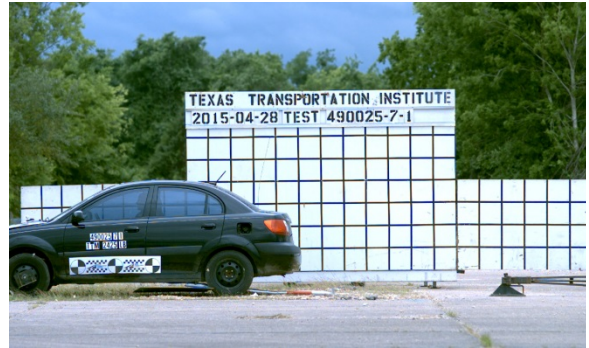
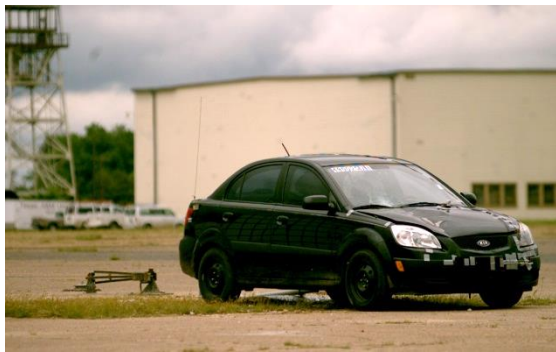
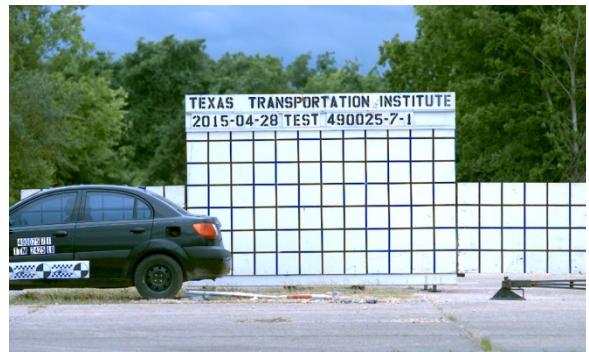
Figure B.1. Sequential Photographs for Test No. 490025-7-1 (Frontal Views) (continued).

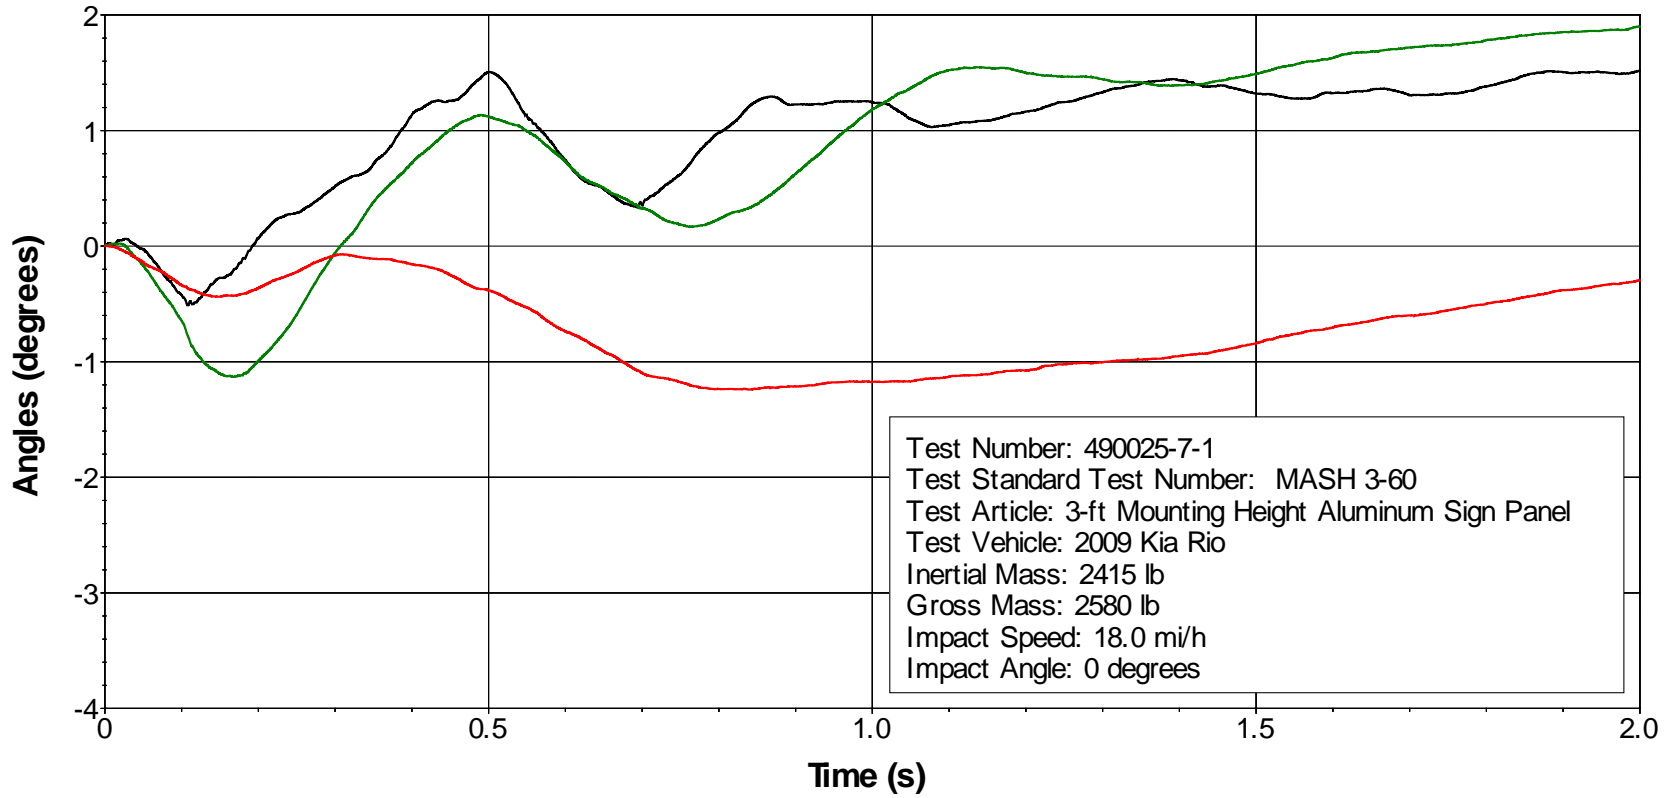
— Roll — Pitch — Yaw

Axes are vehicle-fixed.
Sequence for determining orientation:

Figure B.2. Vehicle Angular Displacements for Test No. 490025-7-1.

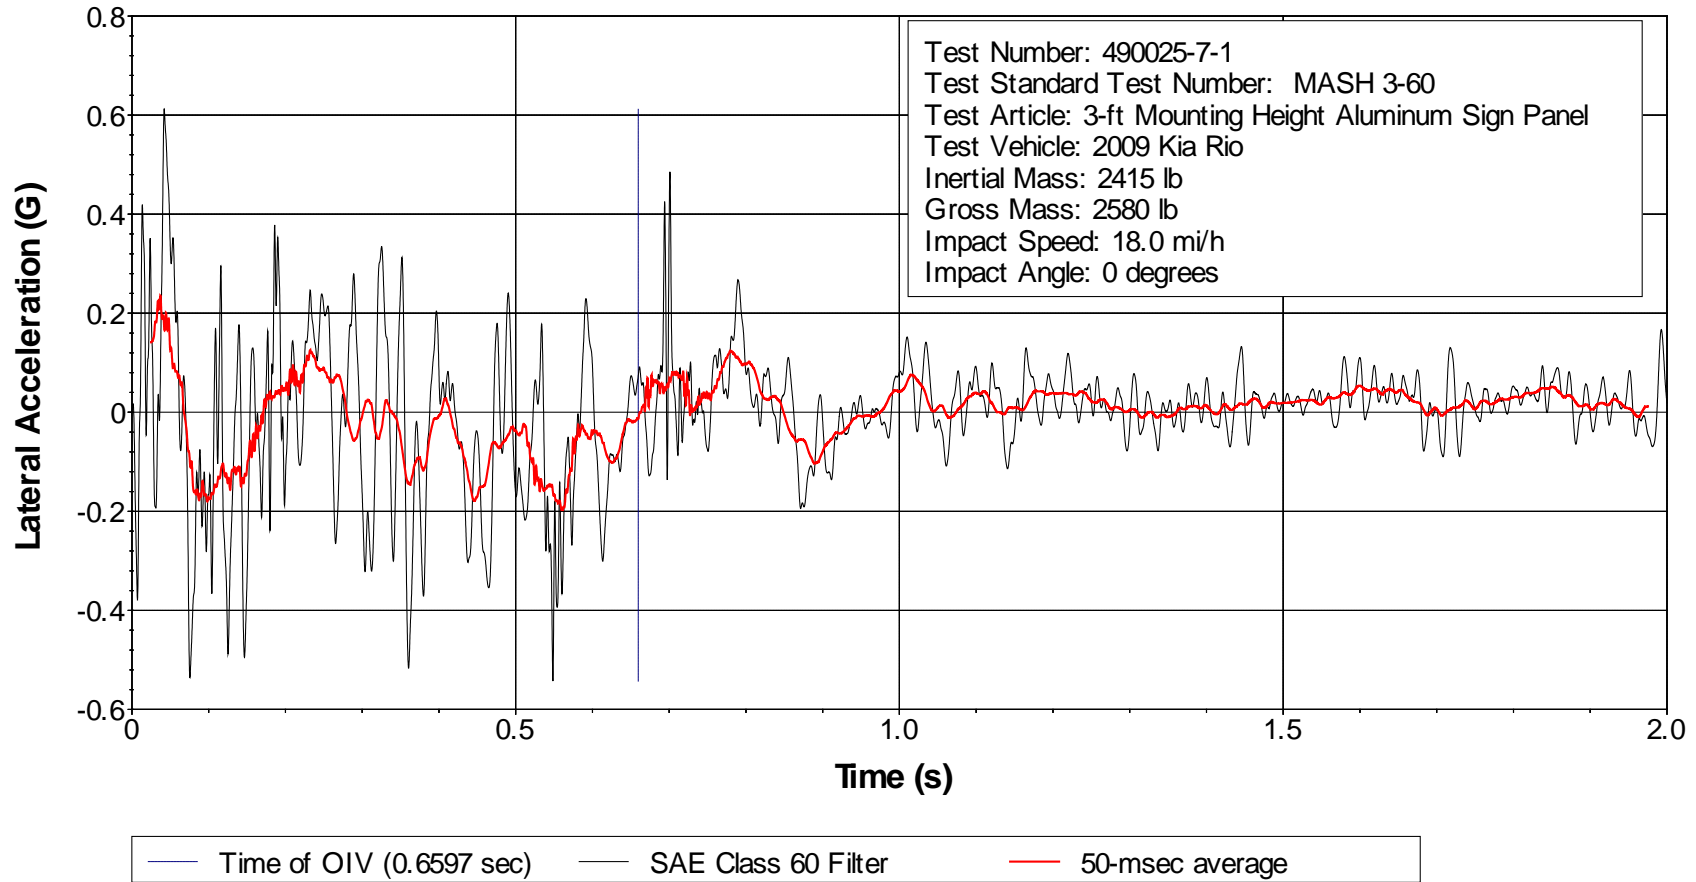
**Figure B.4. Vehicle Lateral Accelerometer Trace for Test No. 490025-7-1
(Accelerometer Located at Center of Gravity).**

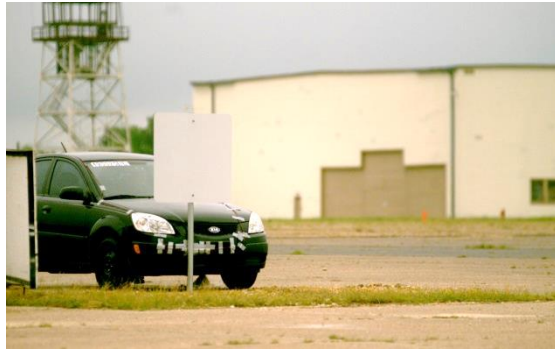
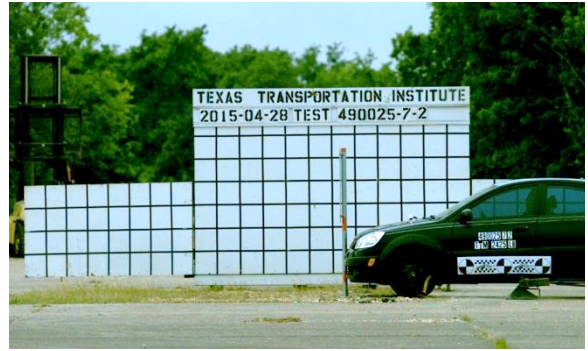
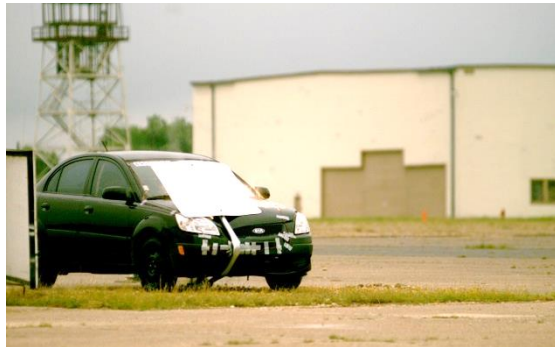
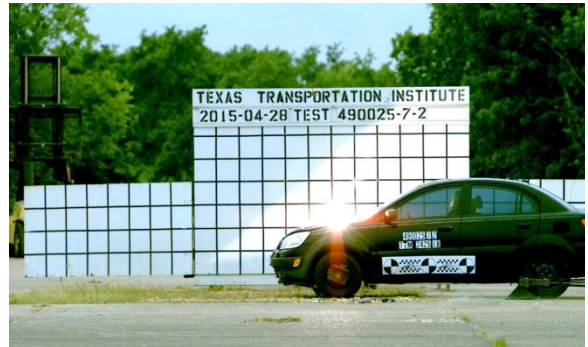
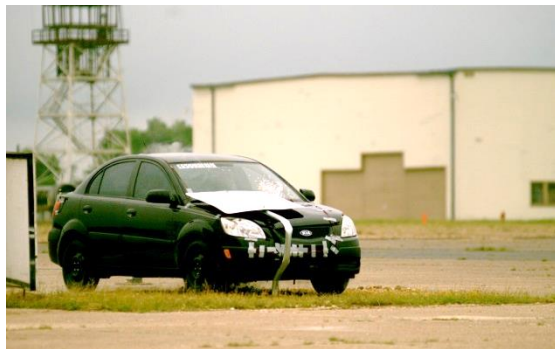
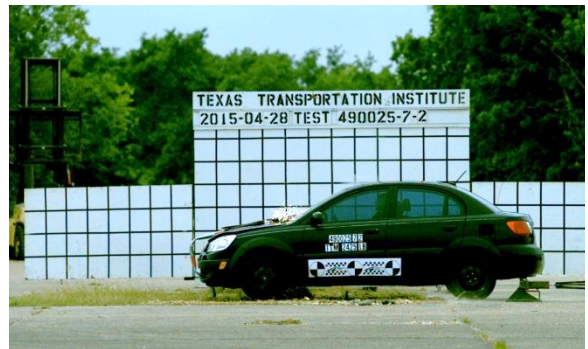
Figure C.1. Sequential Photographs for Test No. 490025-7-2 (Frontal Views).

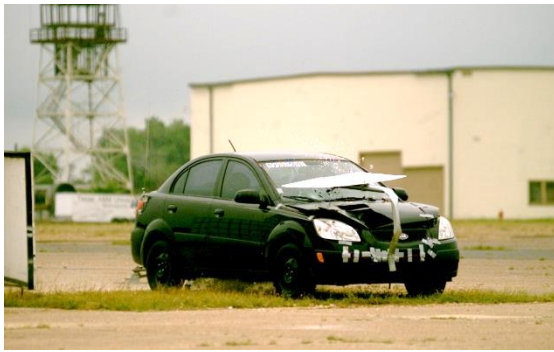
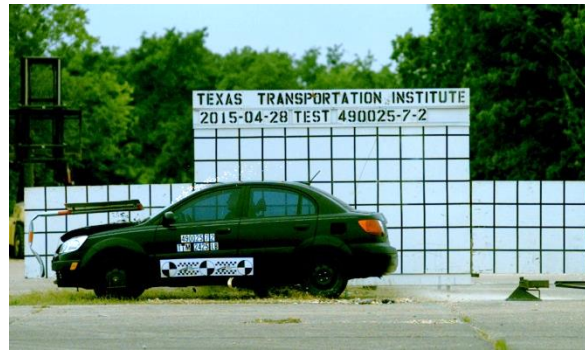
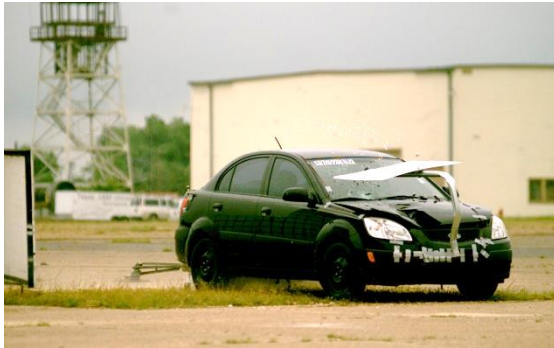
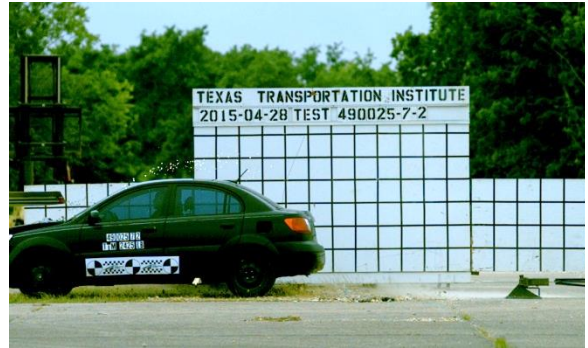
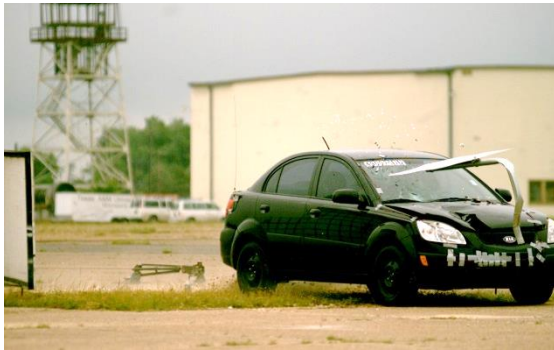
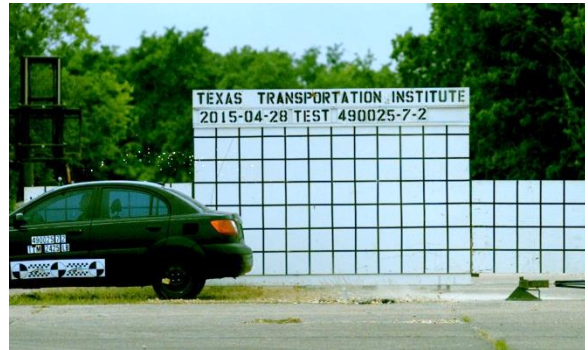
Figure C.1. Sequential Photographs for Test No. 490025-7-2 (Frontal Views) (continued).

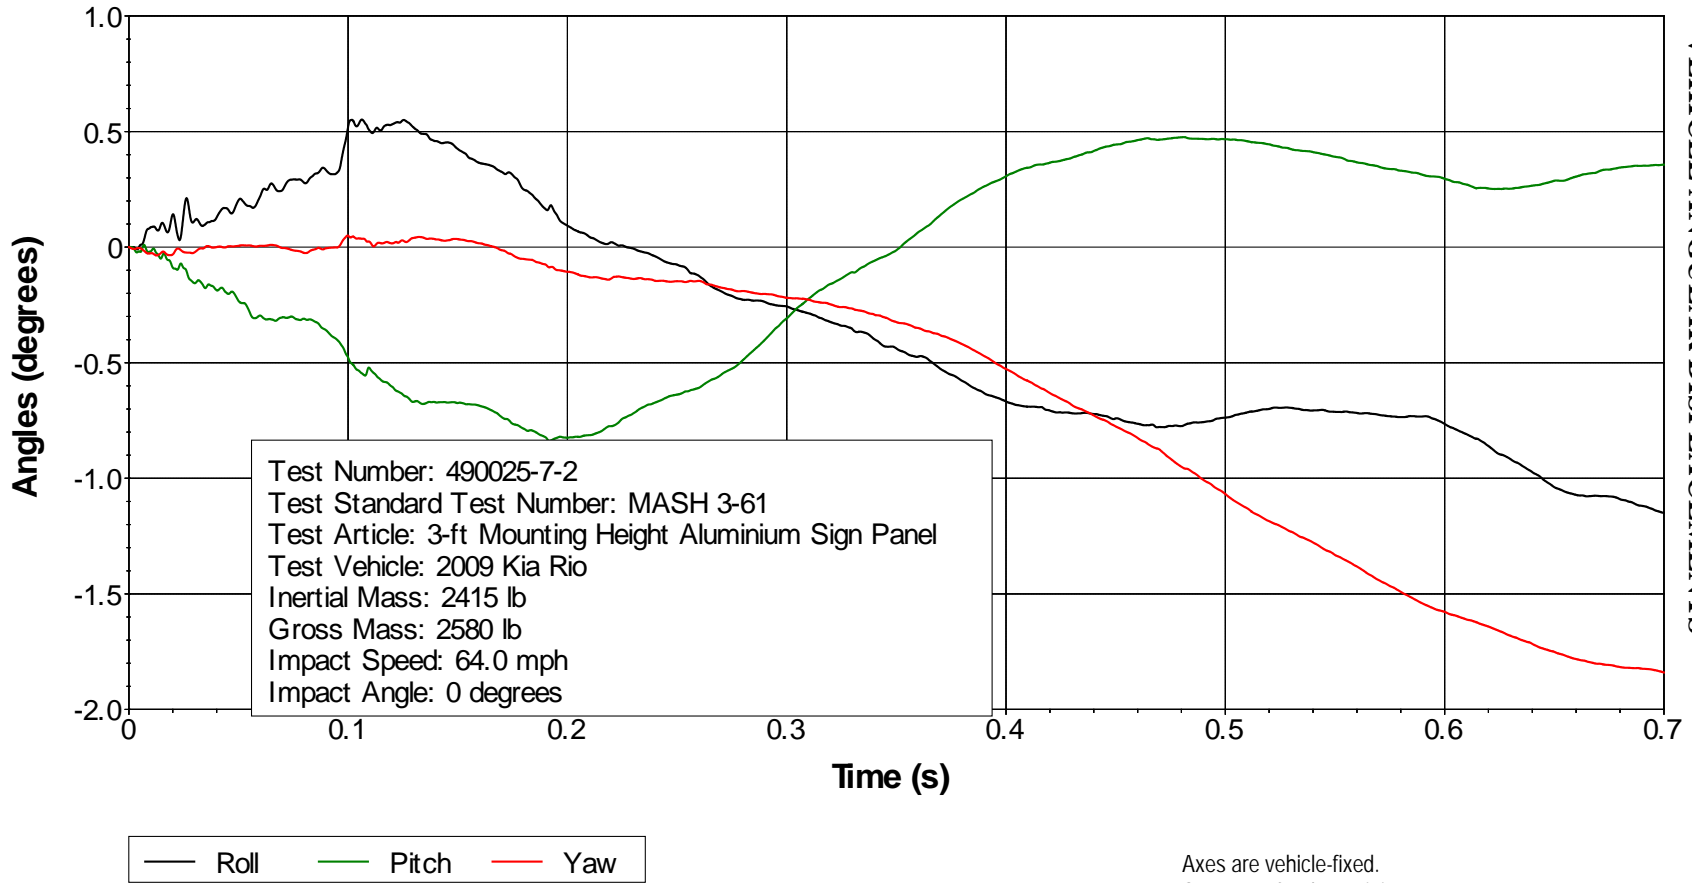
Axes are vehicle-fixed.
 Sequence for determining orientation:

1. Yaw.
2. Pitch.
3. Roll.

Figure C.2. Vehicle Angular Displacements for Test No. 490025-7-2.

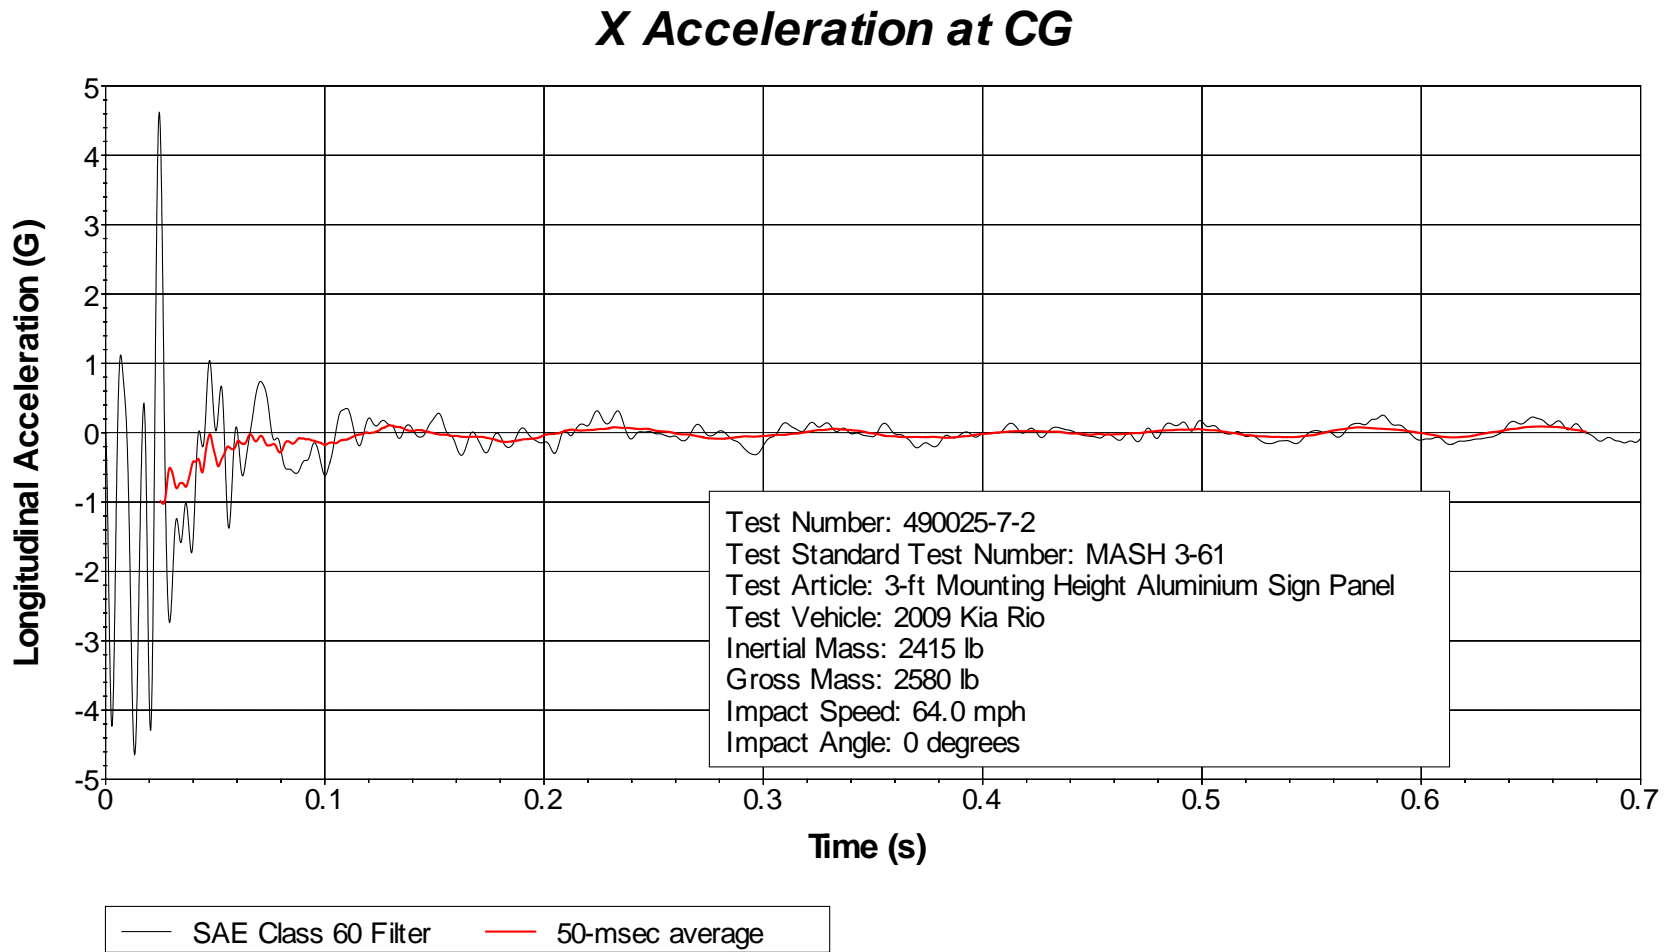
Figure C.3. Vehicle Longitudinal Accelerometer Trace for Test No. 490025-7-2 (Accelerometer Located at Center of Gravity).
