Project Summary Report O-4395-S

Project O-4395: Optimum Spot Base/Subgrade Repair Techniques
for Moderate to High Traffic Highways over Highly Expansive
Subgrade Soils

Development of Guidelines for Maintenance Base Repairs on Expansive Soils

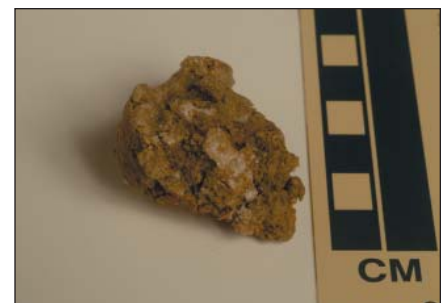
Figure 4. Gypsum Crystals in Soil.

treated, chemical lime reacts better with plastic soils than cement. An application rate of 6 percent is a good general value for lime-treated soils. If considering subgrade treatment, maintenance forces must be aware of organics and sulfates. Soils high in organics will typically be dark in color and have a distinct odor; organic contents in excess of 1 percent can significantly decrease the effectiveness of lime treatment. Likewise sulfates, typically observed in the form of gypsum crystals in the soil as shown in Figure 4, react with lime or cement and cause heaving in the road. Sulfates in excess of 0.3 percent can result in pavement damage. The district pavement engineer can assist with determining the level of organics or sulfates in a soil if excess levels are suspected.
