0-6652: Spliced Texas Girder Bridges

Background

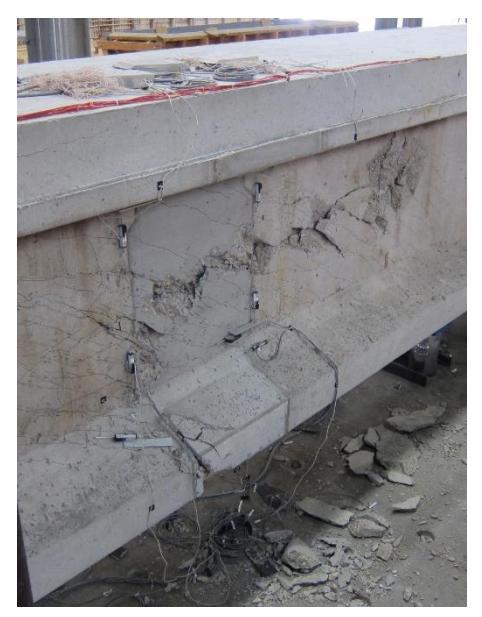
Figure 1. Phase II Spliced Girder Specimen after Failure.

The Phase II specimens exhibited shearcompression failures as expected. The failures were characterized by concrete crushing in the vicinity of the top post-tensioning duct. The girders acted essentially as monolithic members in shear at failure. The web crushing extended across much of the test span and was not localized within the splice regions (see Figure 1). Furthermore, the experimental shear capacities of the specimens were greater than calculated strengths based on AASHTO LRFD¹ expressions and the proposed design procedure of the Phase I program. Lastly, recommended splice region details were selected based on the flexural and shear performance of the test specimens while also minimizing potential constructability issues.
