Project Summary Report 0-1782-S URL: http://tti.tamu.edu/documents/0-1782-S.pdf

Project 0-1782: Development of a Real-Time Transverse Pavement Profile Measurement System

Development of a Real-Time Transverse Pavement Profile Measurement System: Summary Report

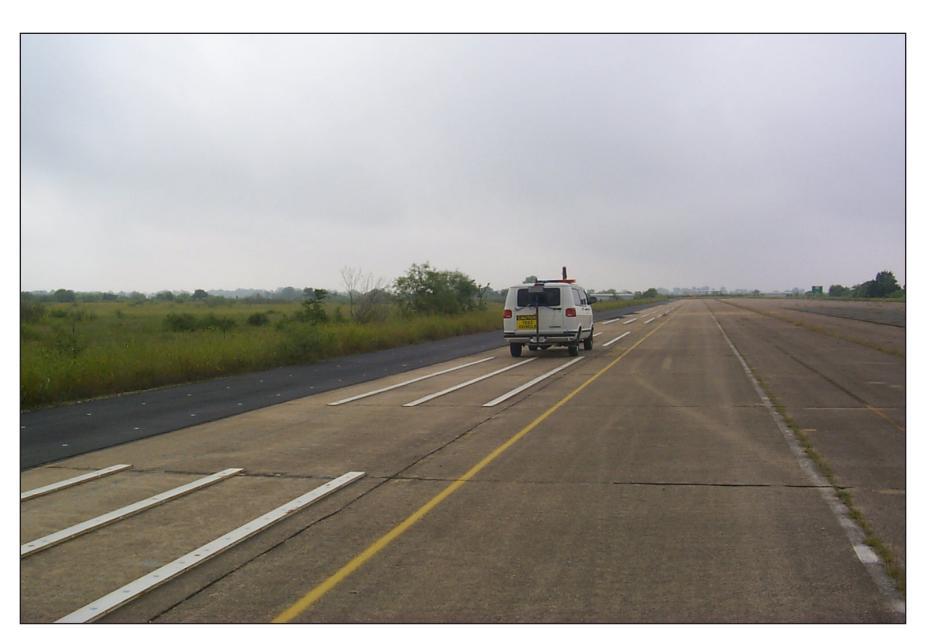
Figure 1. Scanner on Vehicle at the TTI Ride-Rut Facility.

Figure 1 illustrates the laser scanning system (laser and housing shown on the back of the vehicle) being used at the Texas Transportation Institute (TTI) ride-rut facility at the Texas A&M Riverside Campus. Tests were also made on road sections in south Texas and around Austin.

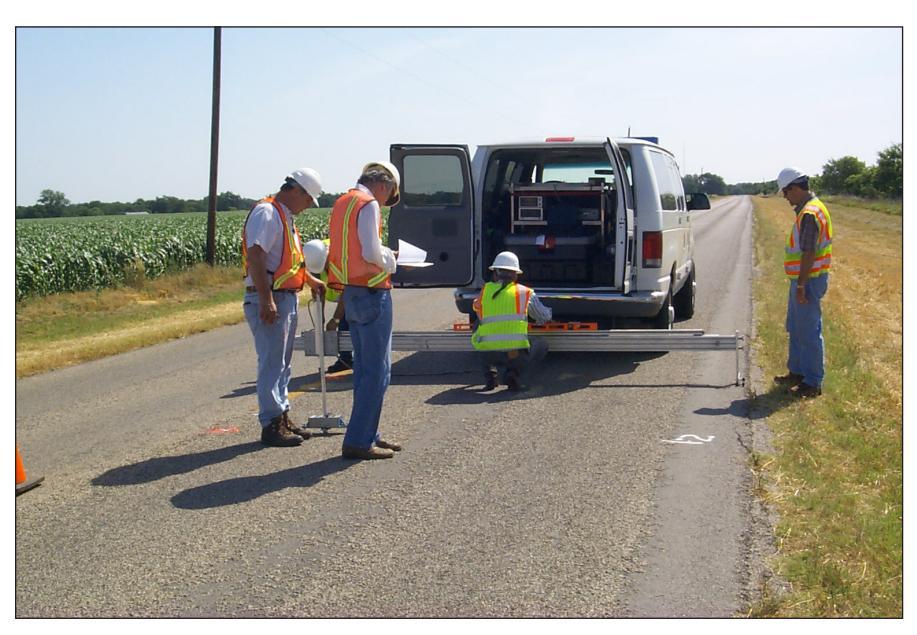
Figure 2. Dip Stick and TMV Profiler in Use at a Test Section near Granger, Texas.

These measurements were all compared to those obtained from the scanning laser rut reports. The tests were conducted on the eastbound lane of FM 971 approximately 2 miles west of Granger. In Figure 2 the dip stick (foreground) and TMV profiler (background) are shown during measurements on one of the Granger sections.

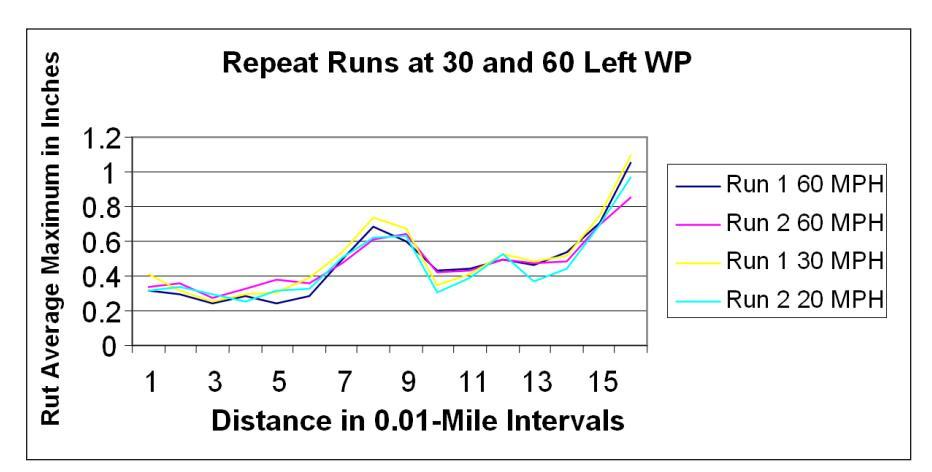
Figure 3. Plots of Left Wheel Path (WP) Rut Measurements Using Scanning Laser System.

scanning laser rut measurement procedures) was applied to the set of profile points from both the TMV and dip stick. Figure 3 illustrates repeat rut measurements at 30 and 60 mph made every 0.01 mile by the Scanning Laser Rut Measurement System over all four test sites.
