Project Summary Report 0-4823-T1-S URL: http://tti.tamu.edu/documents/0-4823-T1-S.pdf

Project 0-4823: Adhesive Anchors for Retrofit/Repair of Bridge Rails

# Adhesive Anchors for Retrofit/Repair of Bridge Rails: Summary Report

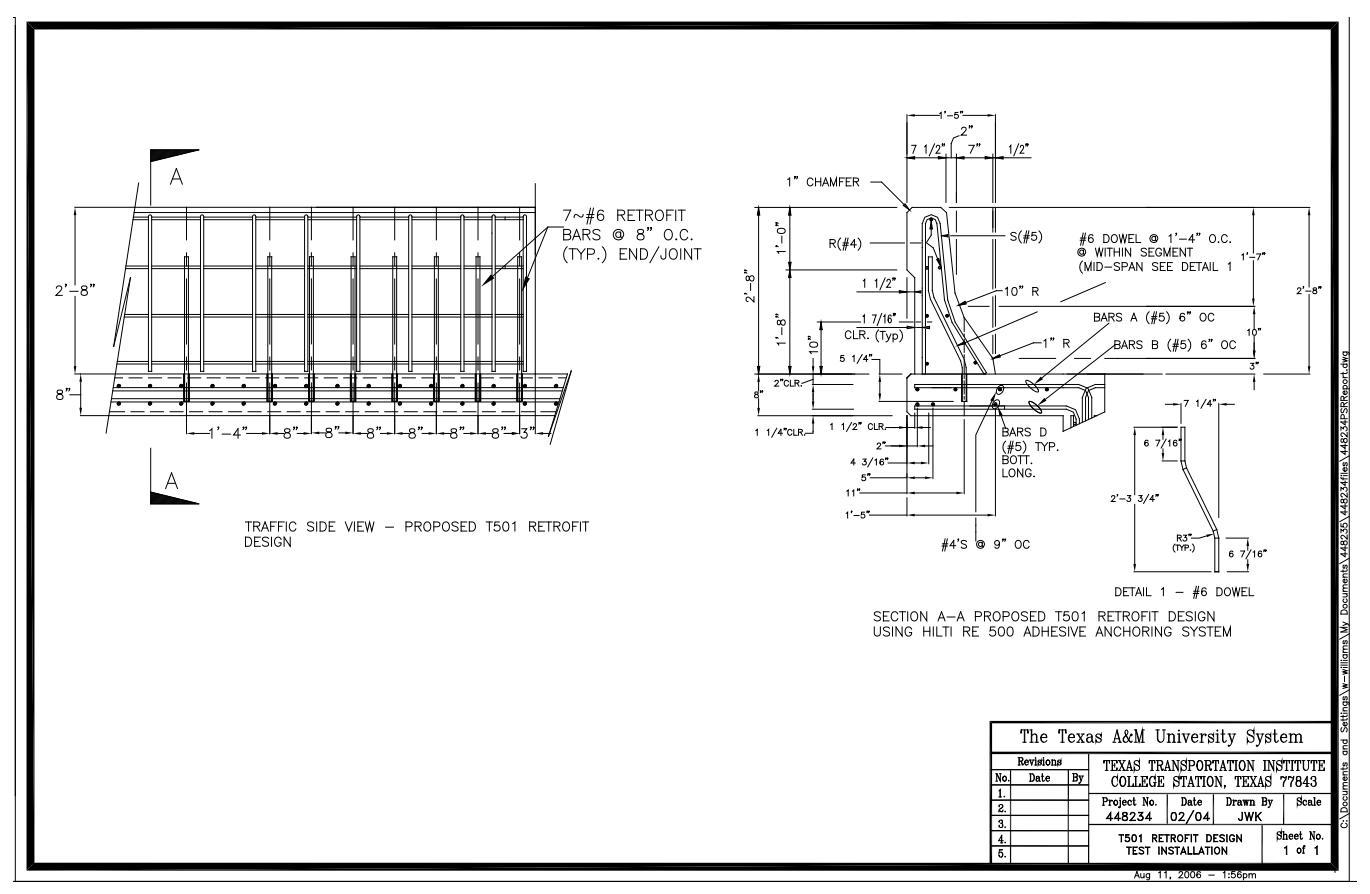
Figure 1. Proposed Retrofit/Repair Design T501 Bridge Rail.

This project provided TxDOT with a repair/retrofit design using adhesive anchors for both the T501 and T203 bridge rails. We found from this research that for severe crash conditions from errant vehicles, the forces transmitted to the conventional cast-in-place reinforcing anchorage for the T501 bridge rail vary from approximately 10 to 12 kips per bar. Based on this information, a retrofit/repair design utilizing a commercial adhesive anchoring system was developed and tested. Details of this retrofit/repair design are provided in Figure 1.

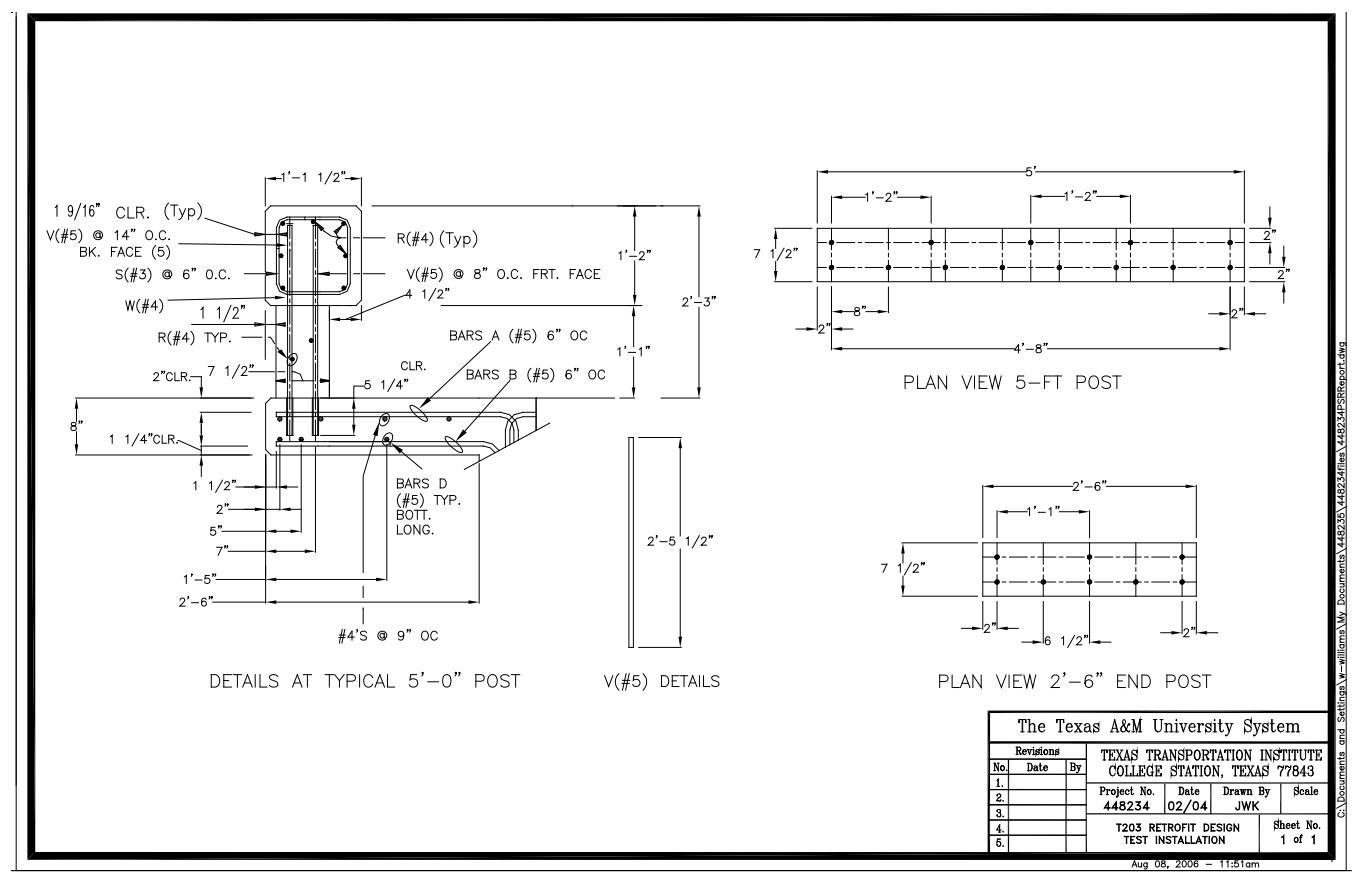
Figure 2. Proposed Retrofit/Repair Design T203 Bridge Rail.

For the T203 bridge rail, we found that for severe crash conditions from errant vehicles, the forces transmitted to the conventional anchorage vary from approximately 8 to 10 kips per bar. Based on this information, a retrofit/repair design utilizing a commercial adhesive anchoring system was developed and tested for the T203. Details of this retrofit/repair design are provided in Figure 2.
