THE UNIVERSITY OF TEXAS AT AUSTIN
CENTER FOR TRANSPORTATION RESEARCH

TECHNICAL REPORT 5-6048-03-1

TXDOT PROJECT NUMBER 5-6048-03

**IMPLEMENTATION OF CENTRIFUGE TESTING OF
EXPANSIVE SOILS FOR PAVEMENT DESIGN**

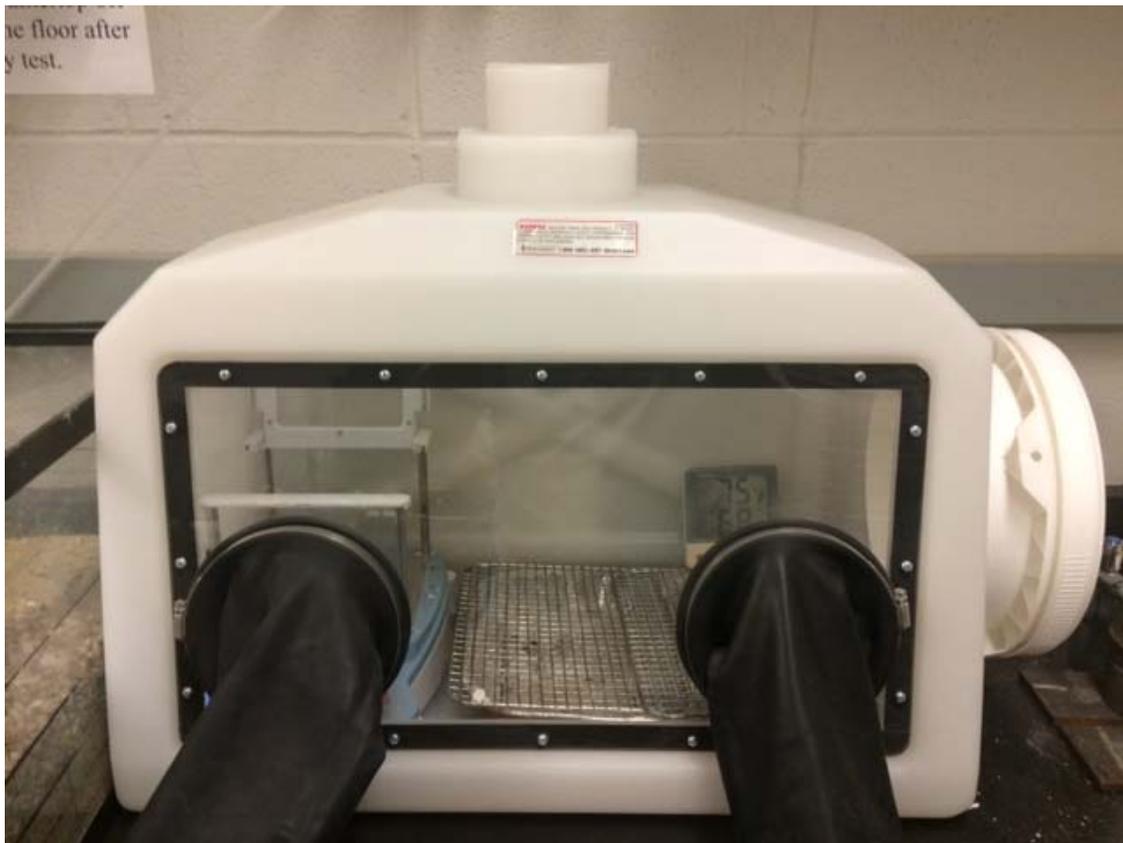
Figure 2.5: Environmental Chamber

To retard the rate of drying, an environmental chamber with a relatively constant, high relative humidity was assembled using a glove box and saturated salt solution. The weights of the specimens were measured using a scale with an accuracy of ± 0.001 g with a Fisher Scientific temperature and humidity monitor. The environmental chamber is shown in Figure 2.5.

The time to reach the targeted moisture content, 3 moisture percentage points dry of optimum, as prescribed by a NAVFAC correlation with the optimum moisture content and the soil’s liquid limit, increased from approximately 12 hours to 36–72 hours using six specimens in the environmental chamber, but the increase in time was met with a decrease in the shrinkage cracking of specimens. Testing of these specimens is further explored in Section 3.1.

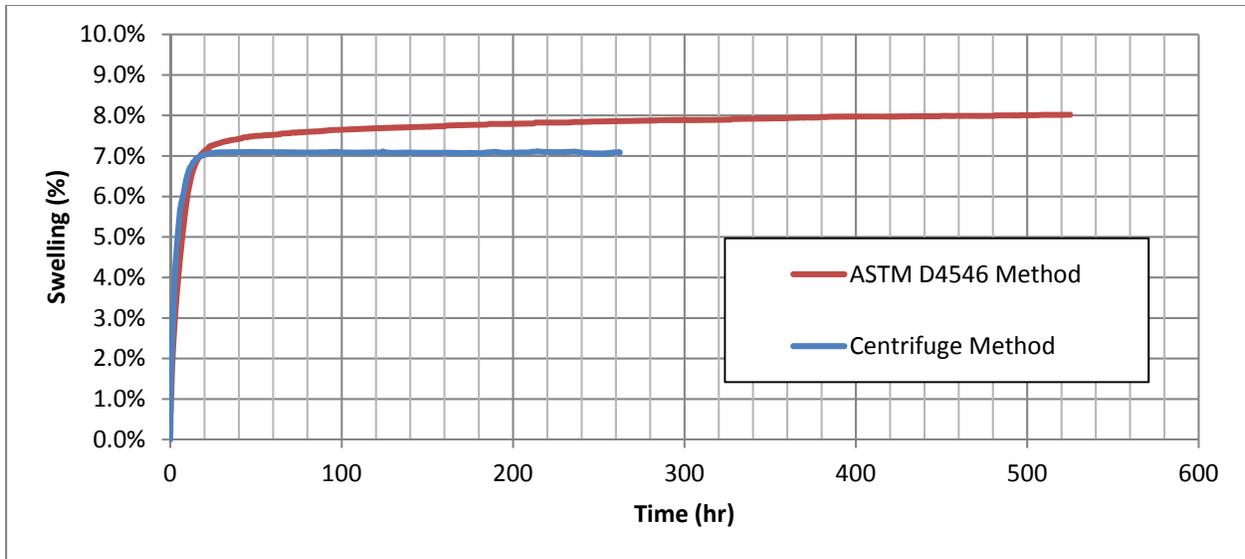
Figure 2.6: Results from Long-Term Tests on Cook Mountain Clay

The results from the long-term Cook Mountain tests are shown below in Figure 2.6 and Table 2.2.

From the results, the tests came to a similar primary swelling value with a slight difference in ultimate swelling. The convergence to a similar primary swelling value is to be expected, as both specimens started at the same initial volumetric moisture content which would give a very similar initial suction. Since the primary swelling is dependent on the gradient in the suction, this initial start would lead to both specimens coming together for primary swelling. The differences in ultimate swelling can be explained by the slight differences in effective stress and initial dry densities, which led to a specimen that would have a smaller ultimate swelling. Overall, however, the trend is that the centrifuge test comes to an ultimate swell at a much quicker time than the ASTM D4546 tests, reducing total testing time by a factor of almost ten.

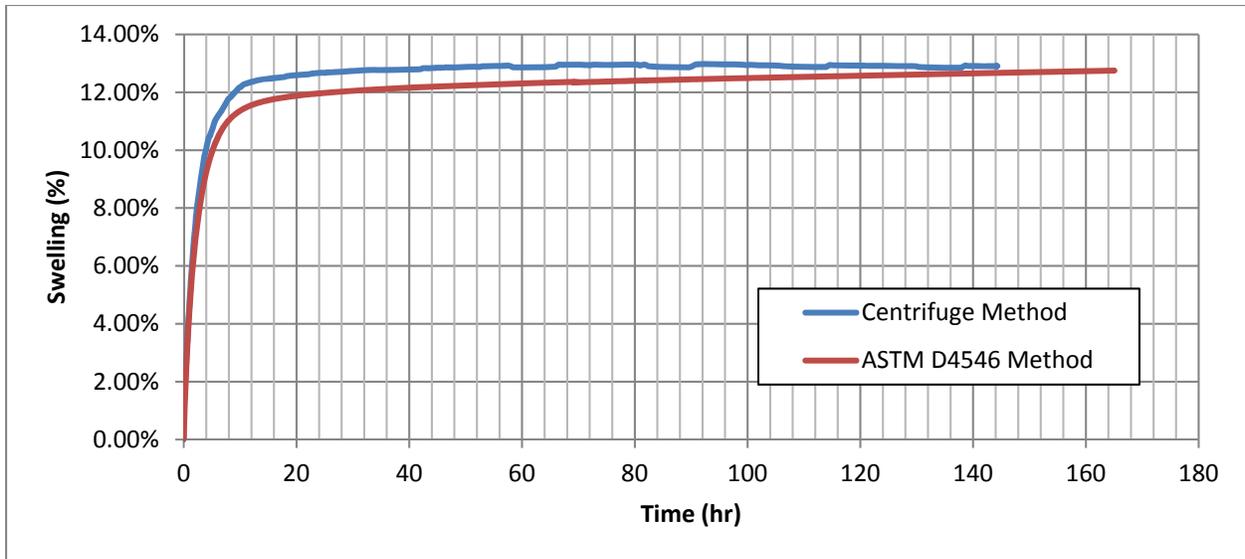
Figure 2.7: Results from Long-Term Tests on Eagle Ford Shale at 500 psf

The results from the long-term tests on the Eagle Ford Shale at an effective overburden stress of 500 psf are shown below in Figure 2.7 and Table 2.3.

From the results, similar trends in Cook Mountain Clay are seen in the Eagle Ford Shale comparison. Starting from similar initial volumetric moisture contents, the tests came to a similar primary swelling value over a similar timeframe. However, ultimate swelling is slightly different again due to a difference in the initial dry density. Note that the trend is reversed in this case, i.e. the ASTM D4546 test has a lower dry density, as compared to Cook Mountain Clay, but a slight effect in ultimate swelling was seen. The differences between the time to ultimate swelling were not as great in this situation, but again, the result indicated that centrifuge testing has a significant impact on the time to primary swelling. Note that while the stresses showed a similar amount of difference as compared to the Cook Mountain test, the difference in the effect of stress was quite different due to the semi-log-linear effect of stress on the swelling of an expansive soil. Thus, a difference of 8 psf closer to 100 psf has a higher effect than that at a stress of 500 psf.

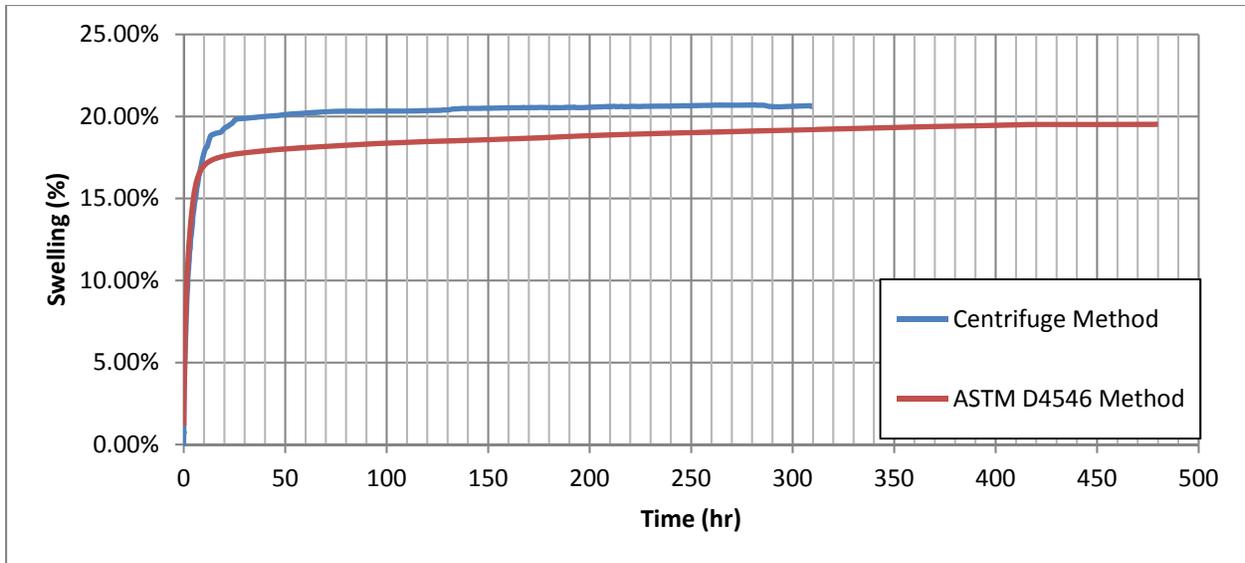
Figure 2.8: Results from Long-term Tests on Eagle Ford Shale at 250 psf

The results from the long-term tests on the Eagle Ford Shale at an effective overburden stress of 250 psf are shown below in Figure 2.8 and Table 2.4.

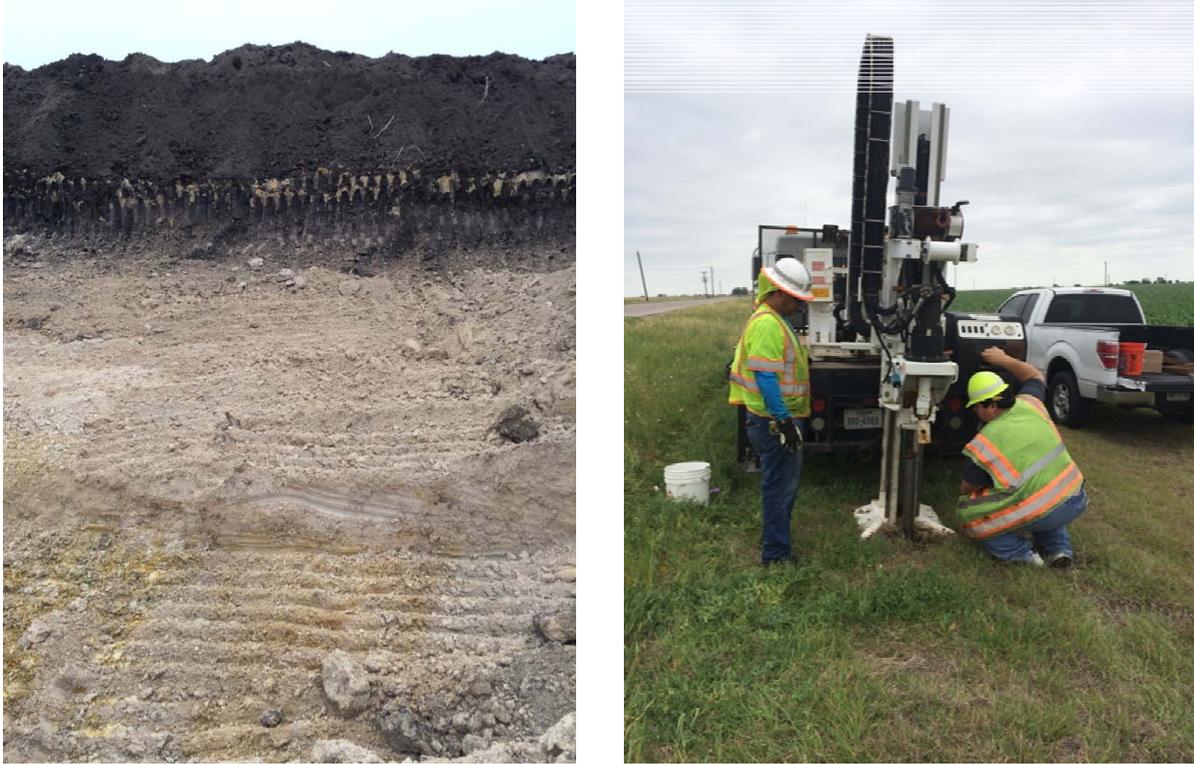
Figure 2.10: Soil Stratigraphy at the Excavation Pit (left, a) and Shelby Tube Sampling at Intersection (right, b)

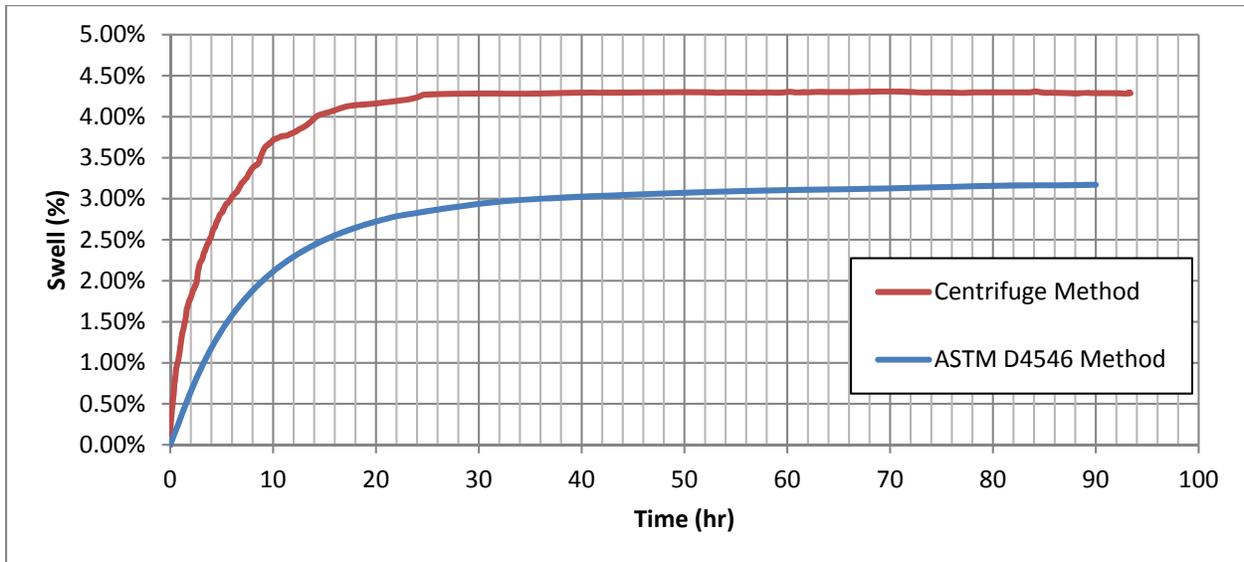
Figure 2.12: Results from Branyon Clay Specimens at their Moisture Adjusted Condition at a Depth of 4 ft.

The results from swelling tests on Branyon Clay samples at their moisture condition are shown below in Figure 2.12 and Table 2.6. The samples were taken from a depth of 4 ft. below the ground surface and tested at an equivalent stress to that which would be experienced in the field.

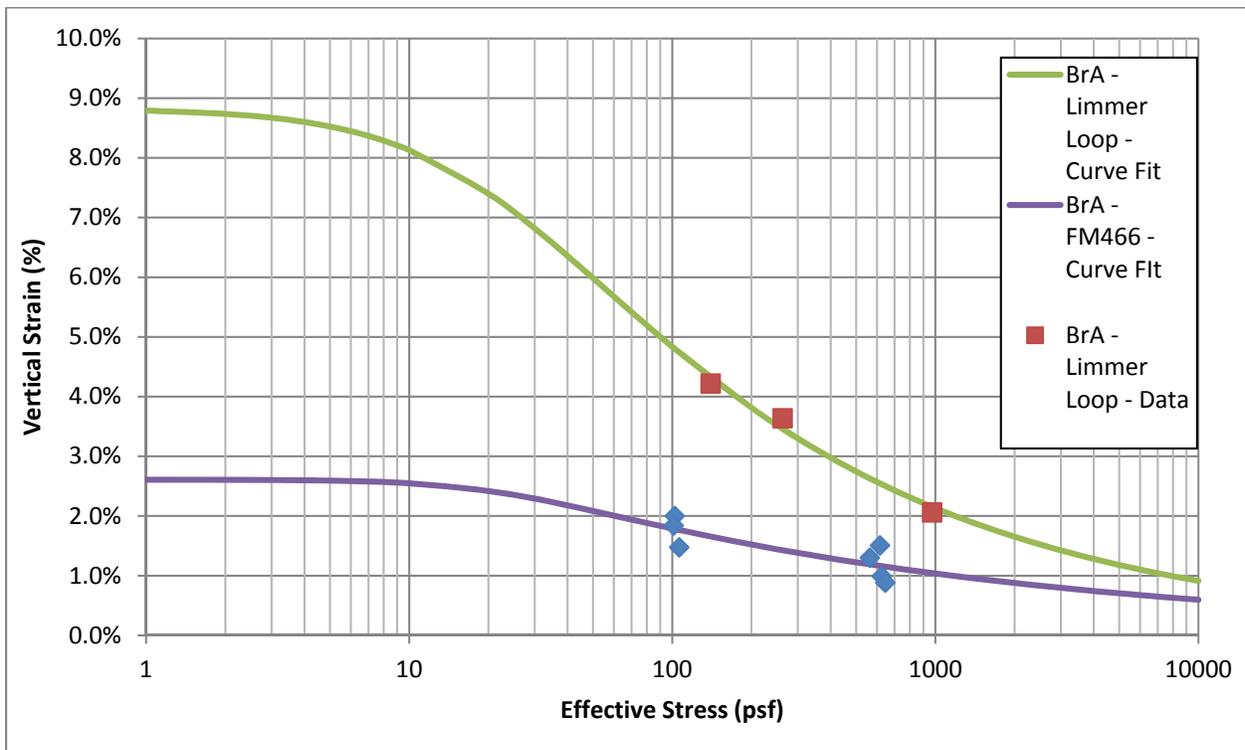
Figure 3.6: Difference in Geologically Similar Soils

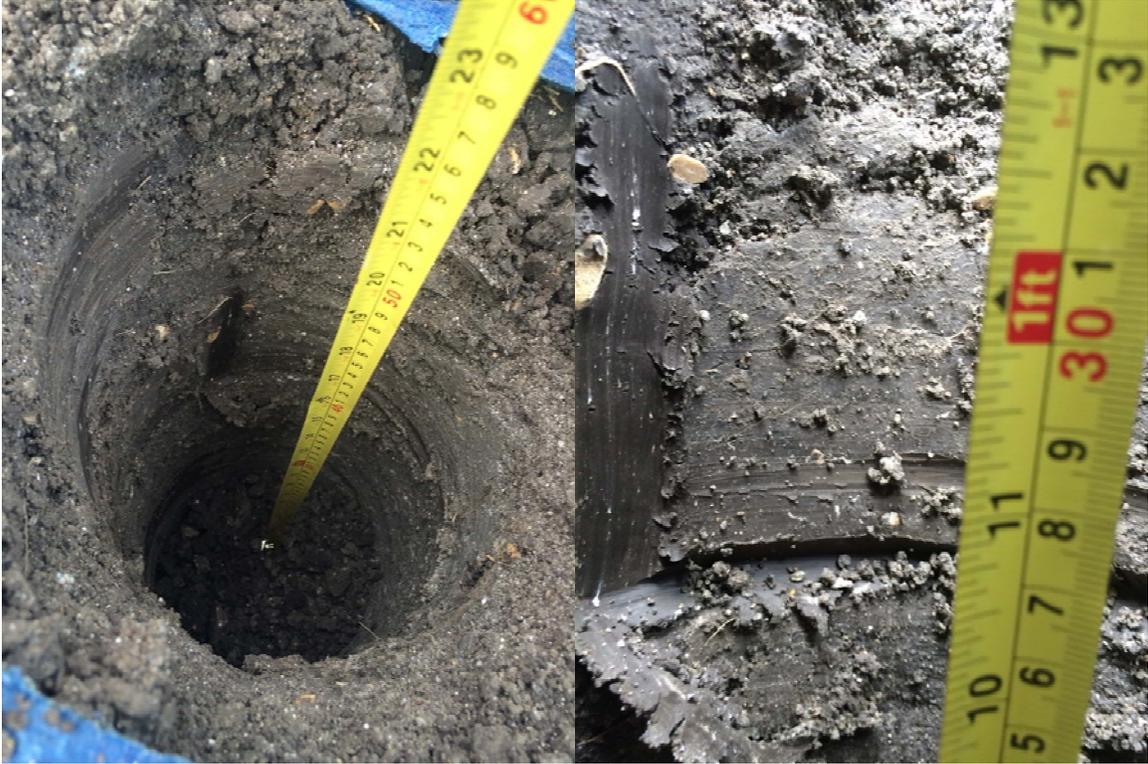
This section summarizes the findings at Site 7. On August 12, 2015, soil samples were collected from the north side of FM 971 just east of Wier, TX in Williamson County (Figure 4.22). The collected soil samples included a large amount of fines, and belong to the Austin Chalk Formation, according to geologic mapping of the area. The side of the roadway showed extensive longitudinal cracking, indicative of an expansive subgrade. The collected soil samples were extensively tested to identify soil characteristics and swelling properties.

Figure 4.22: Augured Hole and Soil Samples from FM 971

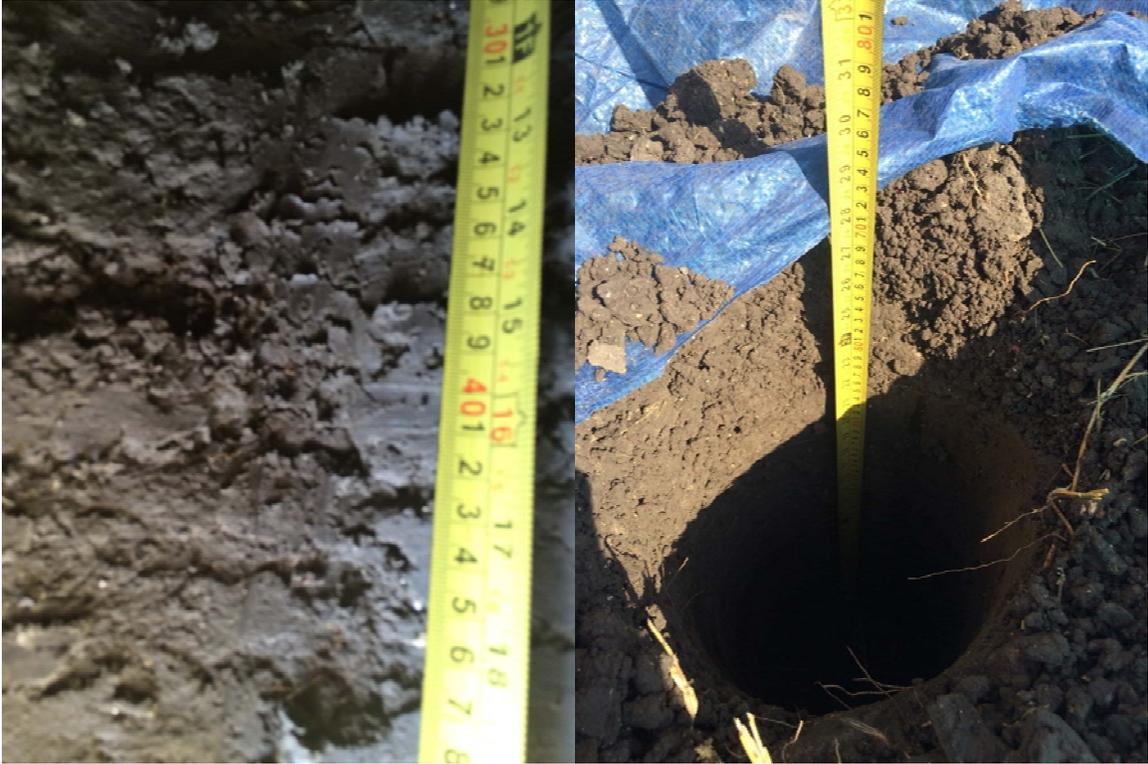
This section summarizes the findings at Site 8. On August 12, 2015, soil samples were collected from the north side of FM 972 just north of Granger, TX in Williamson County (Figure 4.26). The collected soil samples included a large amount of fines, and belong to the Taylor and Navarro group, according to geologic mapping of the area. The side of the roadway showed extensive longitudinal cracking, indicative of an expansive subgrade. The collected soil samples were extensively tested to identify soil characteristics and swelling properties.

Figure 4.26: Augured Hole and Soil Samples from FM 972

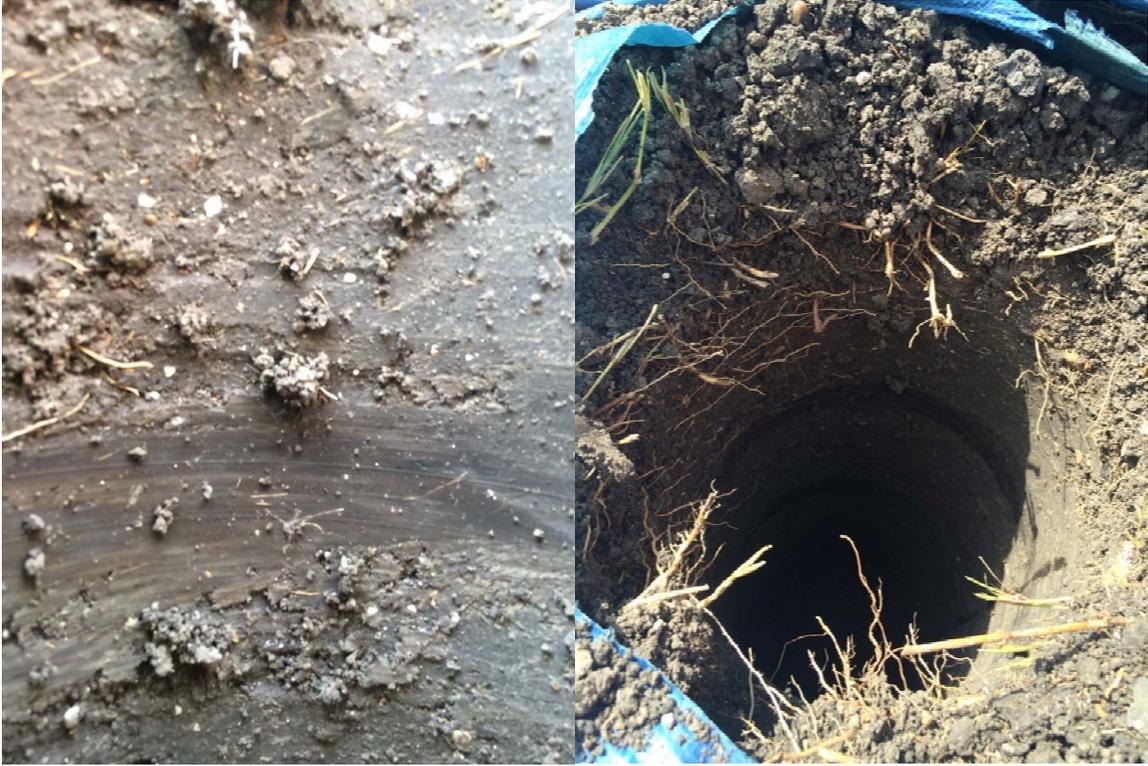
This section summarizes the findings at Site 9. On August 12, 2015, soil samples were collected from the west side of SH 95 just south of Granger, TX in Williamson County (Figure 4.30). The collected soil samples included a large amount of fines, and belong to the Taylor and Navarro group, according to geologic mapping of the area. The side of the roadway showed extensive longitudinal cracking, indicative of an expansive subgrade. The collected soil samples were extensively tested to identify soil characteristics and swelling properties.

Figure 4.30: Augured Hole and Soil Samples from SH 95

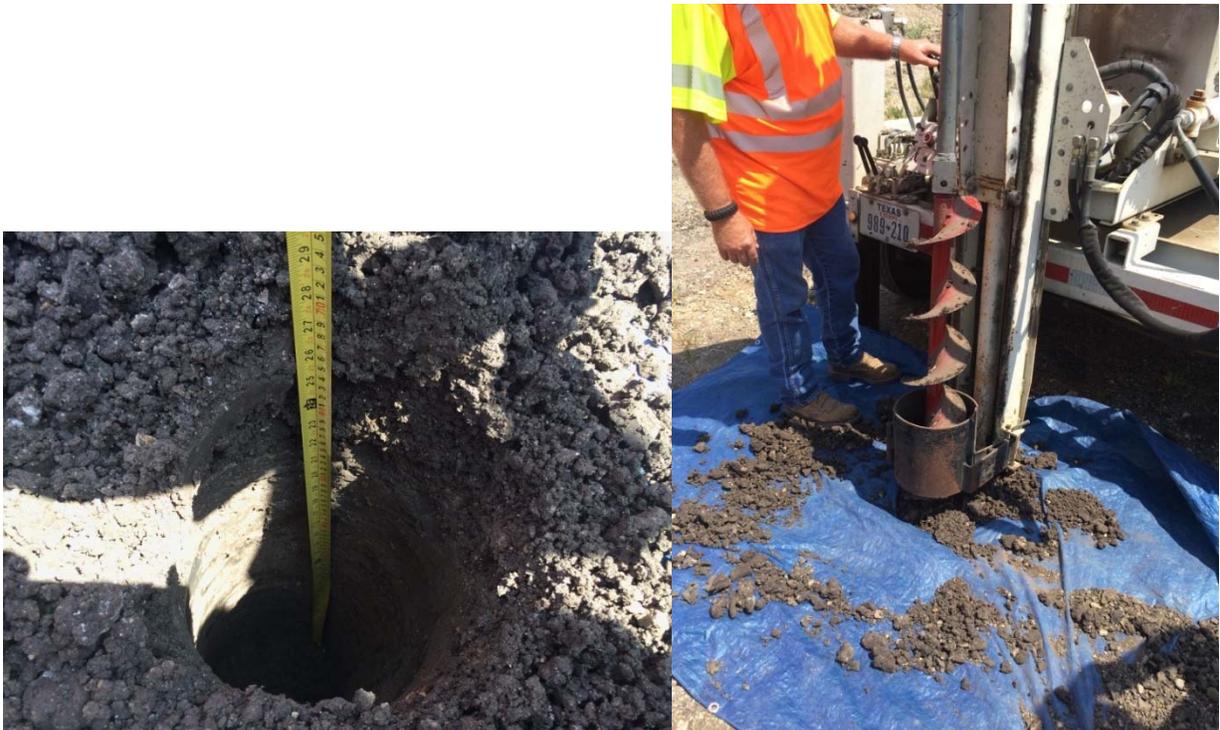
This section summarizes the findings at Site 10. On August 12, 2015, soil samples were collected from the southwest corner of the maintenance yard at the TxDOT office in Taylor, TX in Williamson County, as shown in Figure 4.34. The collected soil samples included a large amount of fines, and belong to the Pecan Gap Chalk, according to geologic mapping of the area. The office was known to sit on an expansive deposit due to cracking in the office floor as well as geologic and soil surveys of the area. The collected soil samples were extensively tested to identify soil characteristics and swelling properties.

Figure 4.34: Augured Hole and Soil Samples from Taylor Maintenance Office

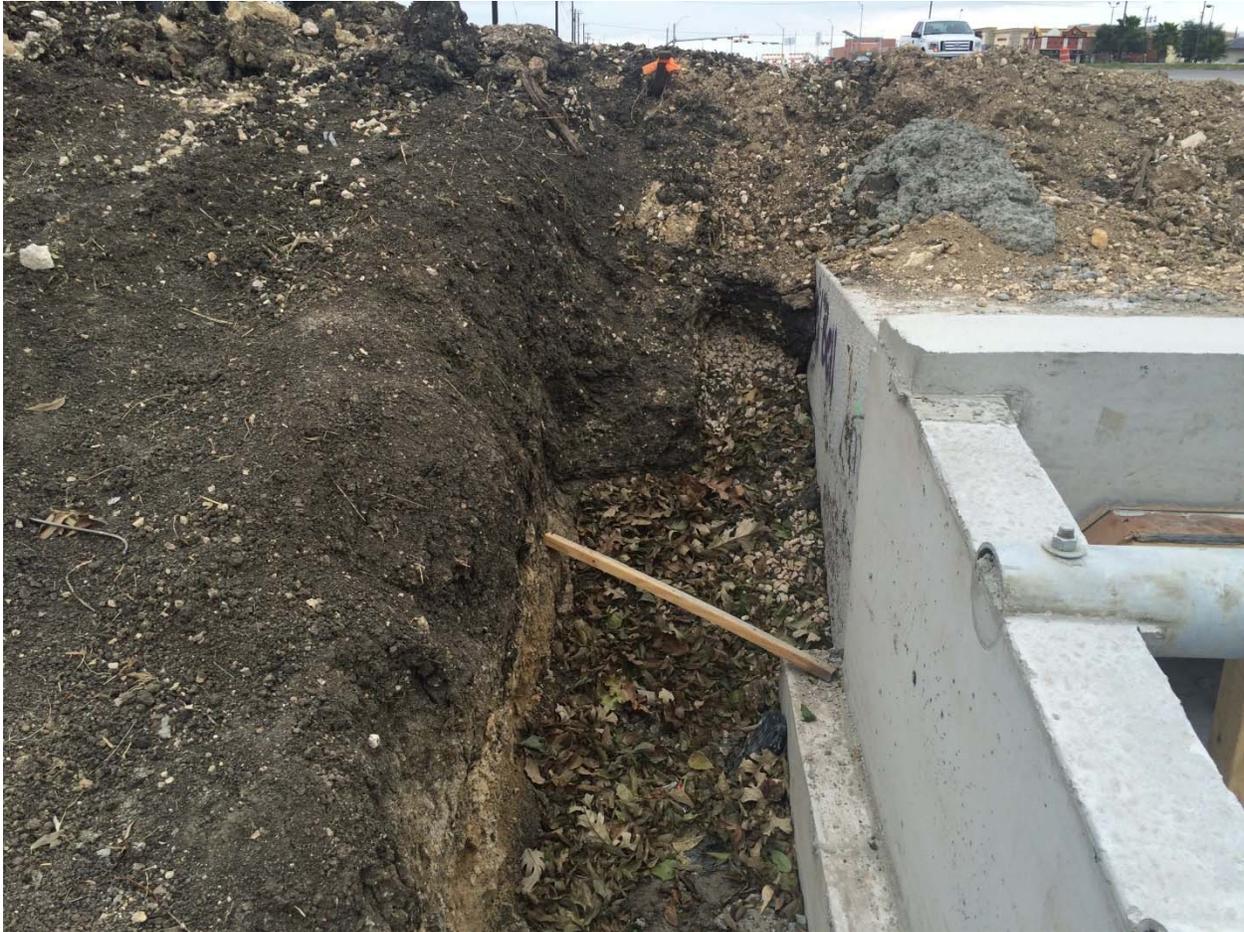
This section summarizes the findings at Site 18, shown in Figure 4.65. In December 2015, soil samples were collected during the installation of moisture and suction sensors used later in Chapter 5. The collected soil samples included a large amount of fines, and belong to the Austin Chalk, according to geologic mapping of the area. The side of the roadway showed extensive longitudinal cracking, indicative of an expansive subgrade. The collected soil samples were extensively tested to identify soil characteristics and swelling properties.

Figure 4.65: Sampled Slope near FM 685

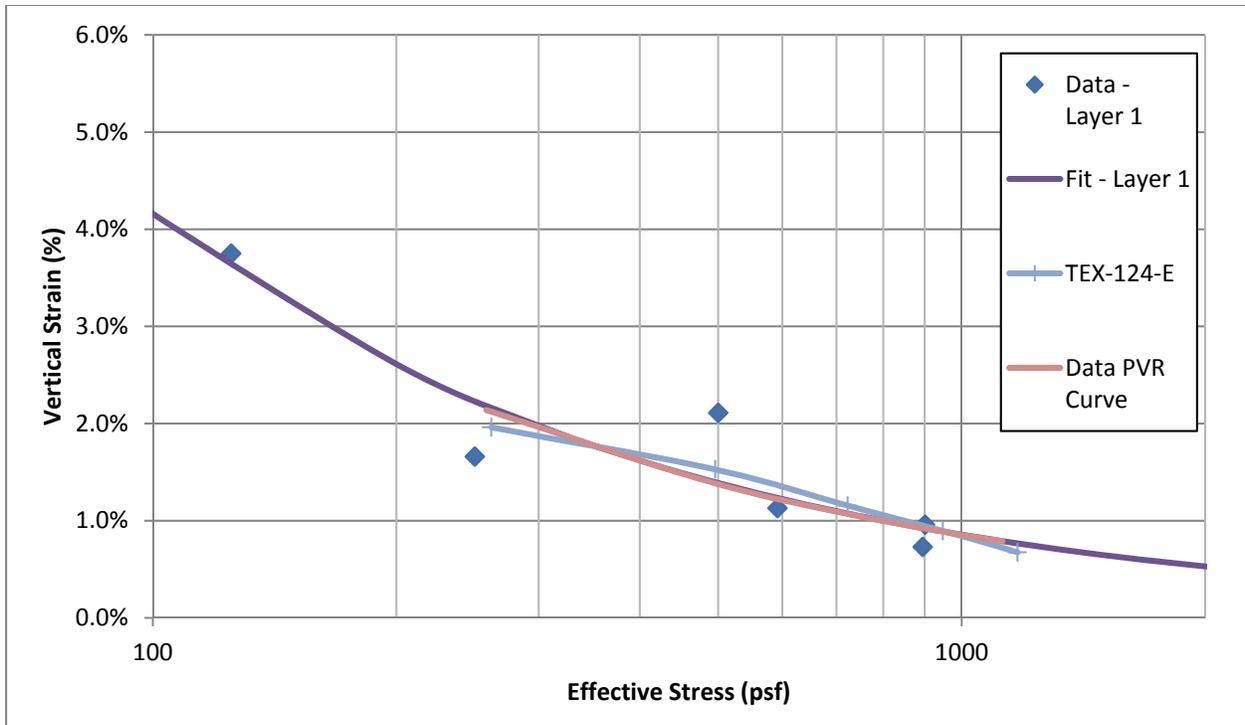
Figure 4.81: Comparison of Swelling Curves from Centrifuge Data and Tex-124-E for Site 1

By integrating the curve fitted function from Figure 3.1 numerically using the trapezoidal rule with 1,000 divisions between the top and bottom stresses of 123 and 1207 psf, the PVR of the subgrade was determined to be 1.53 in. For the Tex-124-E method, an Excel workbook calculated the PVR based upon the input parameters from above and produced a PVR of 1.49 in. The results for both methods, including the PVR curves—i.e., the swelling of each subgrade layer versus the original height of the subgrade layer—are shown in Figure 4.81, and the comparison between the cumulative PVR versus depth is shown in Table 4.24.

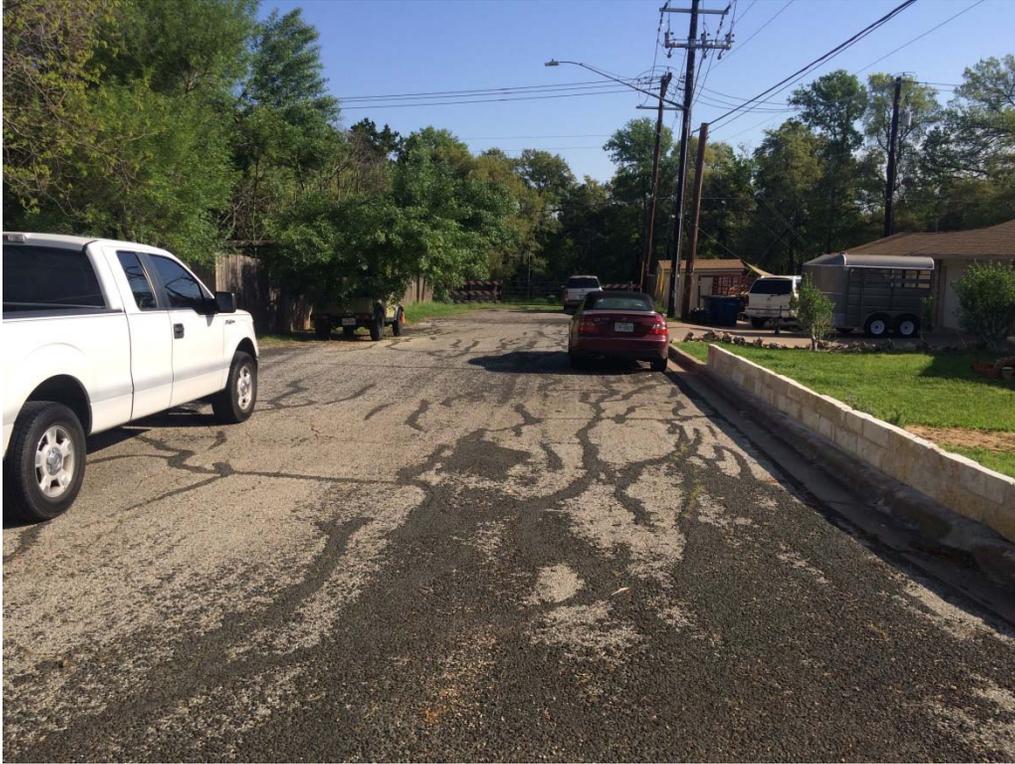
Based upon both the centrifuge testing of the Crawford Clay specimens and the Tex-124-E results, the site is considered to rest on an expansive subgrade with remediation techniques necessary. A site visit was performed in March 2016 near the location sampled in order to determine the amount of longitudinal cracking outside of the outer wheel path. The location that was surveyed for this particular condition is shown in Figure 4.82.

Figure 4.82: Condition Survey Location for Site 1

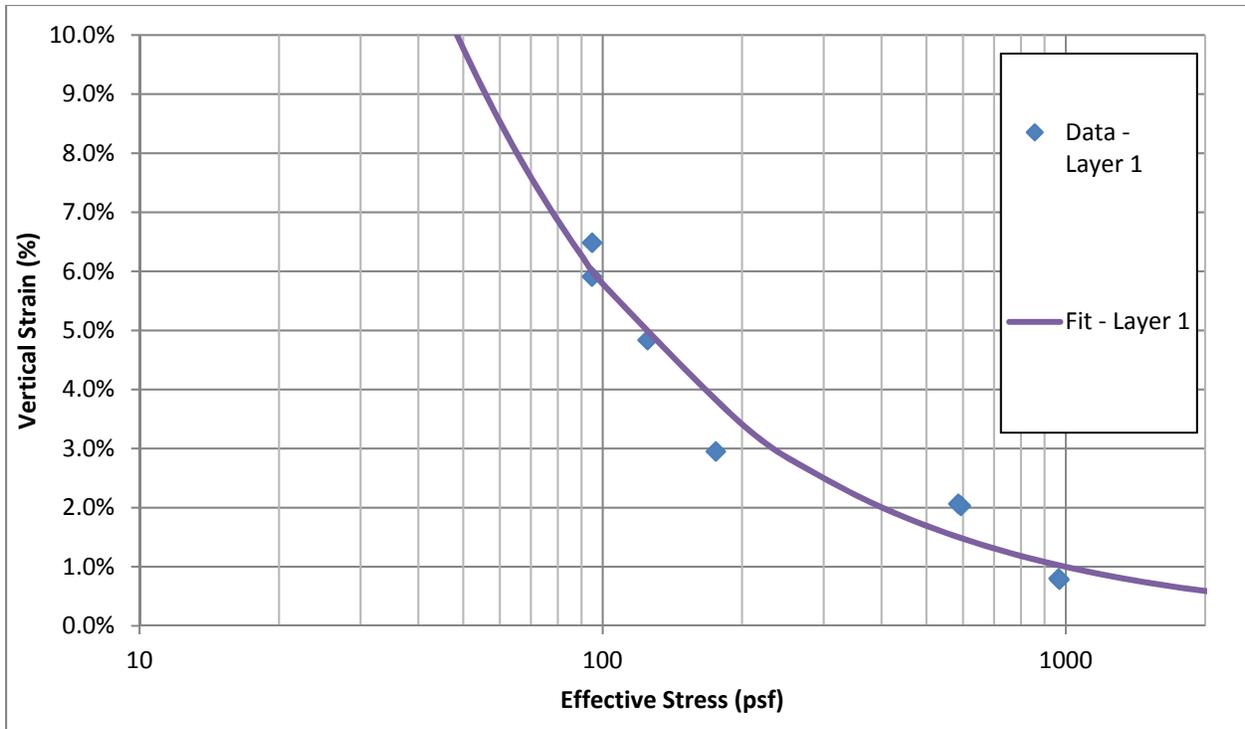
Figure 4.128: Swelling Results and Curve Fitting for Site 18

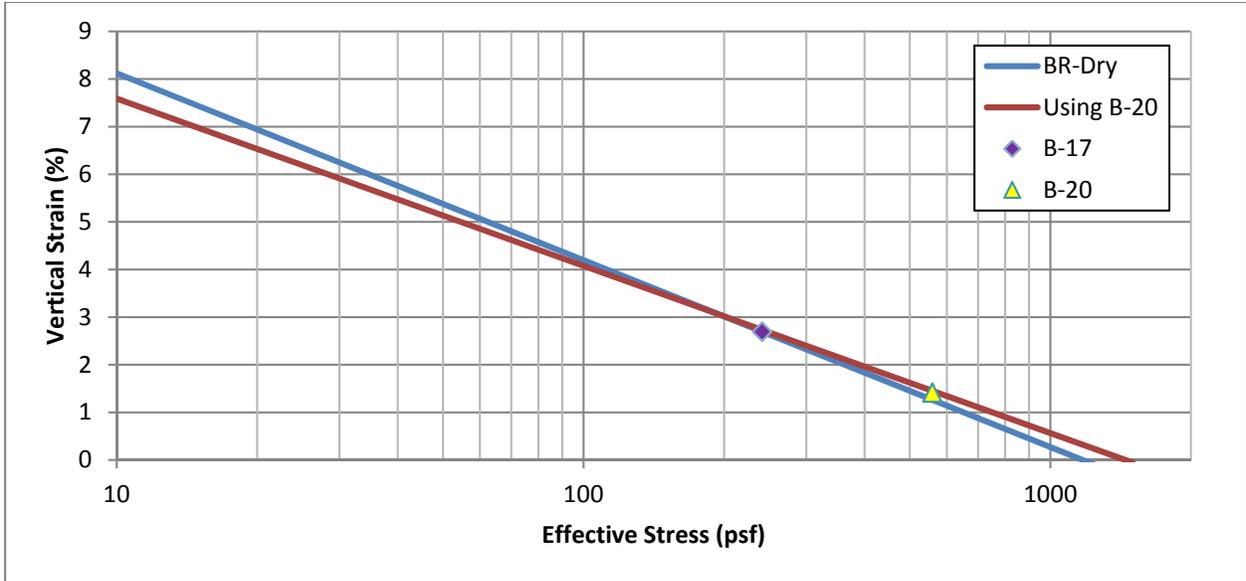
Figure 5.1: Stress-Swell Curves for Moisture Adjusted Conditions

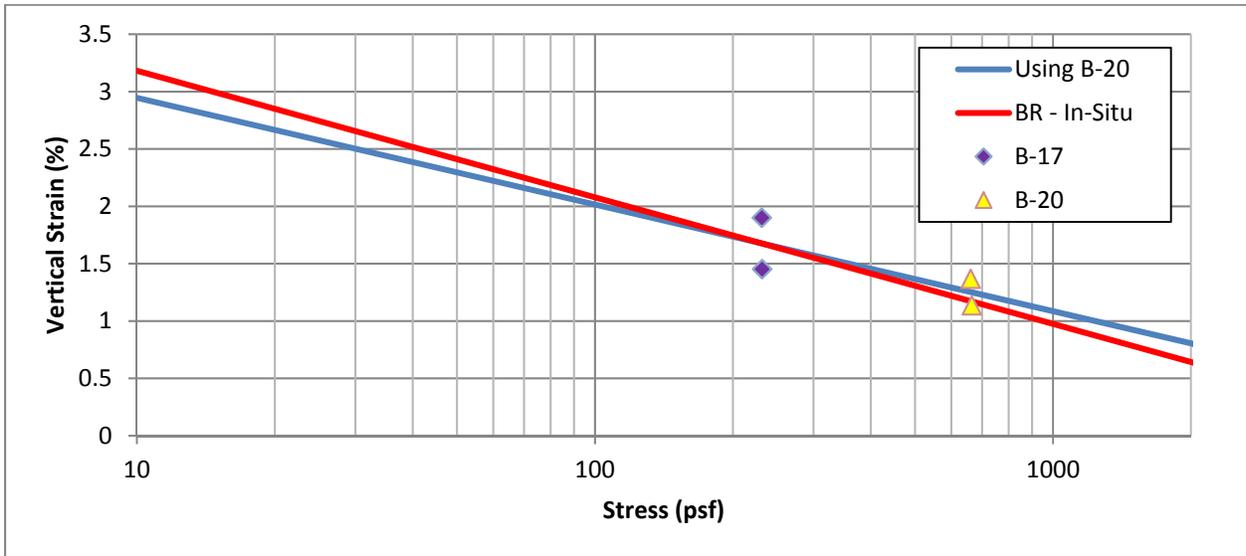
Figure 5.2: Stress-Swell Curves for In-Situ Conditions

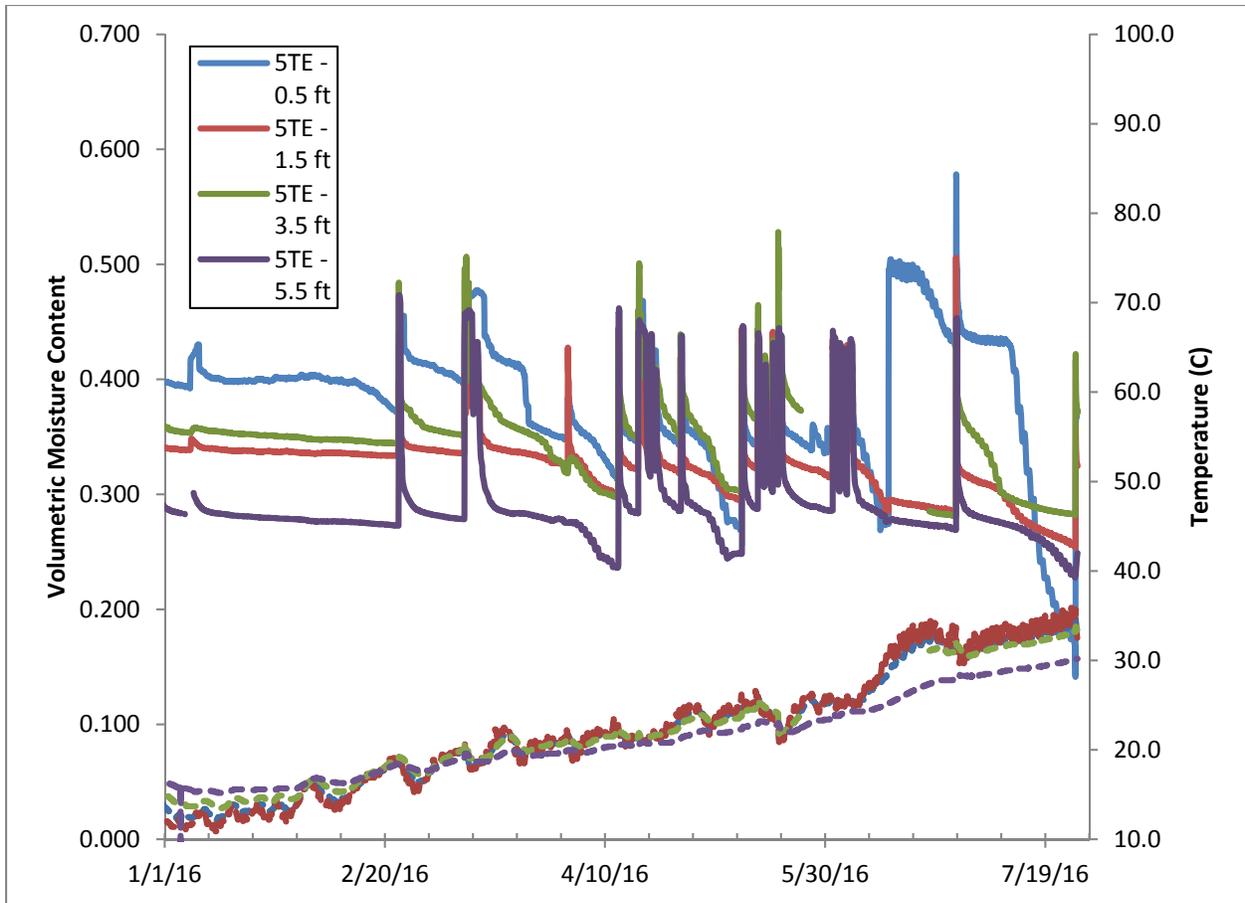
Figure 5.45: VMC and Temperature Data for FM 685 Site

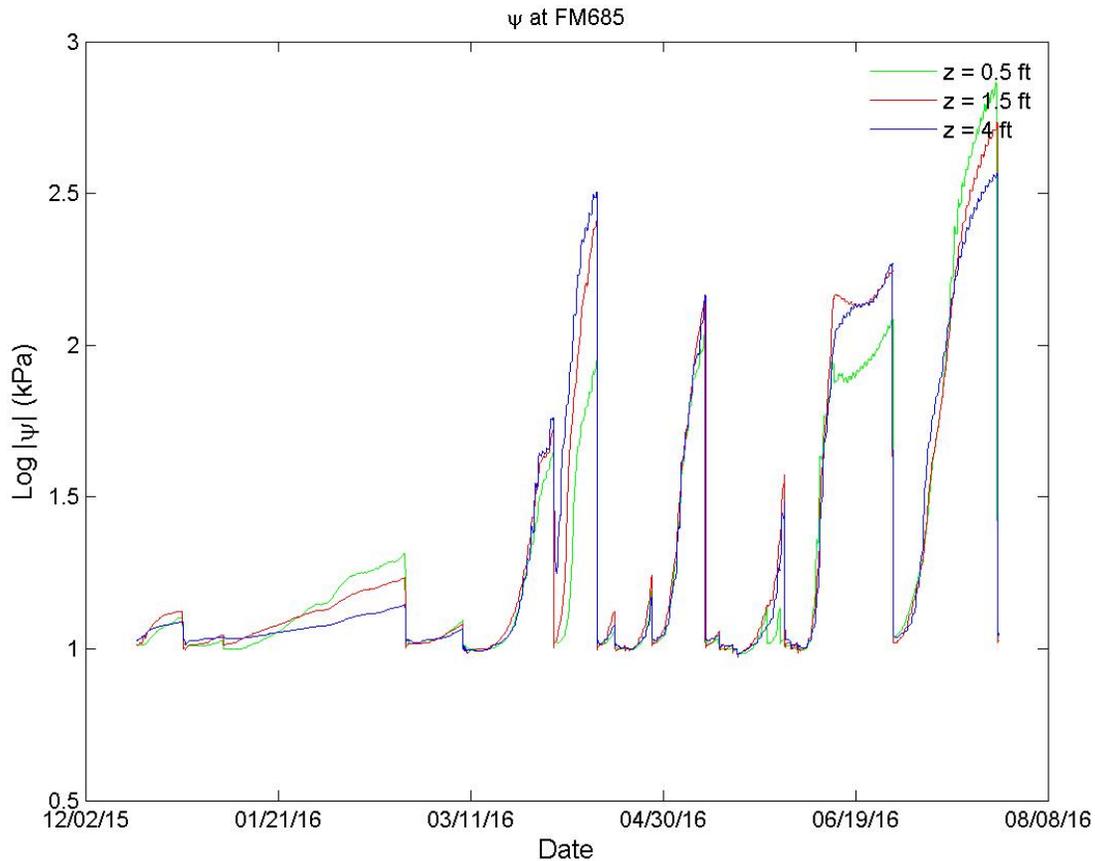
The data from the MPS-2 sensors is shown in Figure 5.46.

Figure 5.46: Suction Data for FM 685 Site

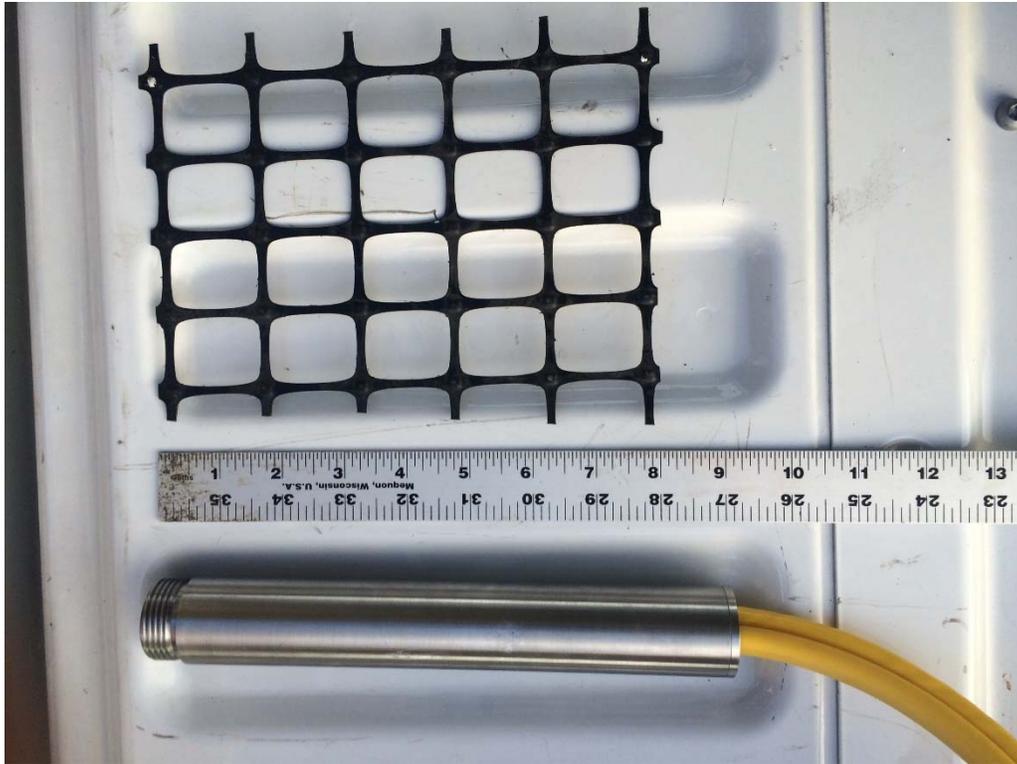
Figure 5.49: Geokon Settlement Sensor and Geogrid for Inundation Project

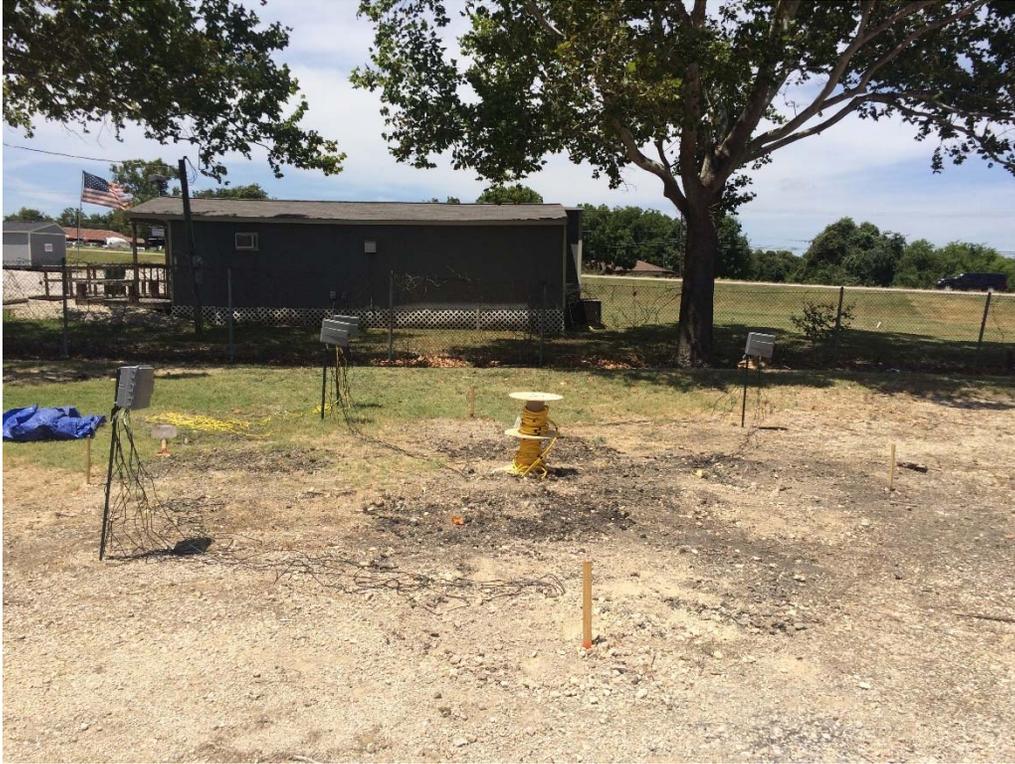
Figure 5.52: Instrumented Inundation Site
