TEXAS DEPARTMENT OF
TRANSPORTATION

MAINTENANCE SOLUTIONS FOR BLEEDING AND FLUSHED PAVEMENTS

RESEARCH PRODUCT 0-5230-P1
RESEARCH STUDY NO. 0-5230

study title
Short Term Solutions to “Bleeding” Asphalt Pavements

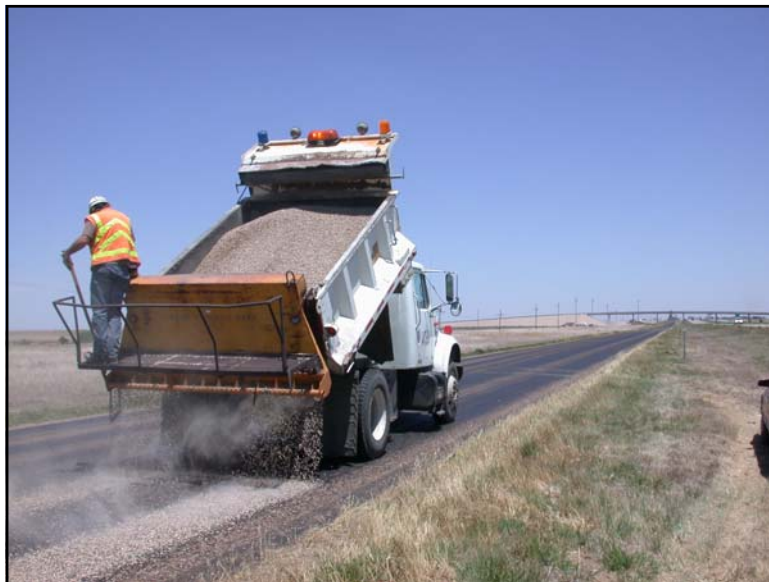
Effectiveness varies with this method. This can be a short-term solution (1 to 3 days) or mid-term solution (several weeks), with suc-

cess dependent upon a variety of factors including the severity of bleeding, temperature and humidity, traffic volume and type, pavement construction type and history (materials and methods), location (urban, rural, intersections, etc.), and others.

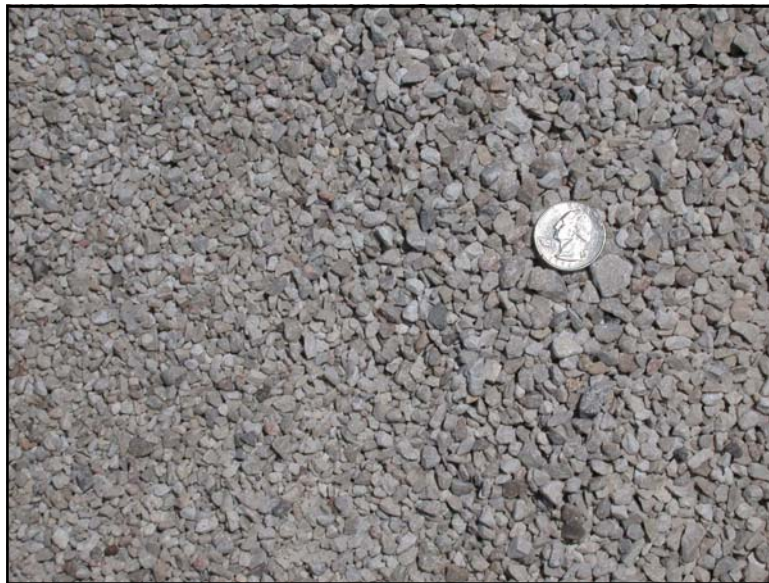
Maintenance personnel have used rotary brooms to sweep excess rock across a bleeding pavement (lane) in lieu of another application of rock. The swept rock sticks to the bleeding asphalt and traffic rolls it in. A shadow vehicle is used for this operation.

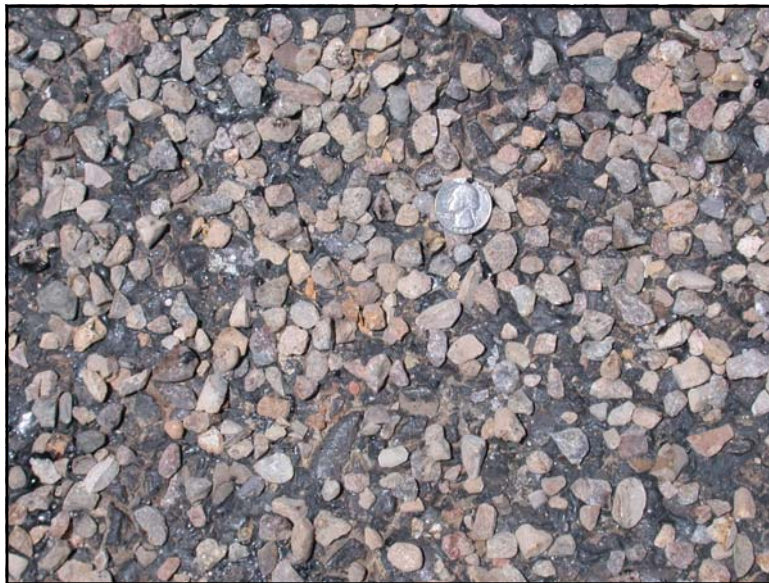
TxDOT standard specification Item 302 defines Grade 4 rock as having a nominal size of 1/4 inch. The particle size is generally smaller than 3/8 inch, but larger than 0.19 inch (number 4 sieve).

TxDOT standard specification Item 302 defines Grade 3 rock as having a nominal size of 3/8 inch. The particle size is generally smaller than 1/2 inch, but larger than 1/4 inch.

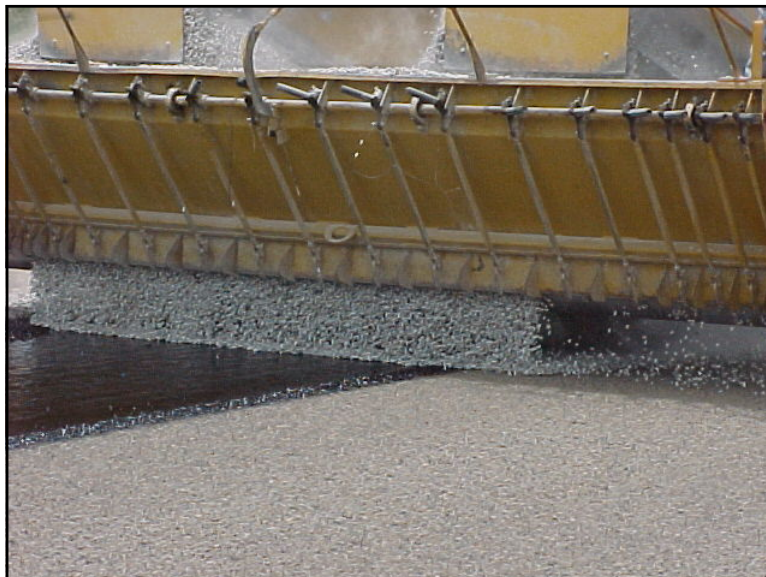
**APPLY LAYER OF LARGER SIZE
(GRADE 4 OR 3) AGGREGATE, CONT'D.**

The key to success for this treatment option is getting the larger aggregate to stick to the bleeding asphalt pavement surface. Even when the bleeding problem is severe, the amount of hot liquid asphalt on the roadway may be insufficient. This is because the pavement temperature for bleeding asphalt

is typically around 140°F to 165°F whereas the original application temperatures for hot asphalts range from 300°F to 350°F.

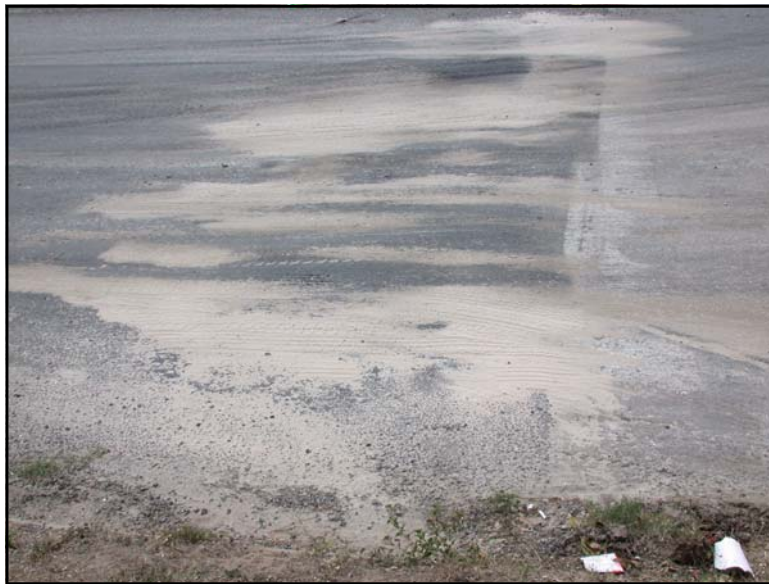
Under the best of circumstances blotter materials are employed to treat light bleeding – that is, between a flushed and bleeding pavement condition. As bleeding becomes more severe, the finer-grained materials become increasingly problematic.

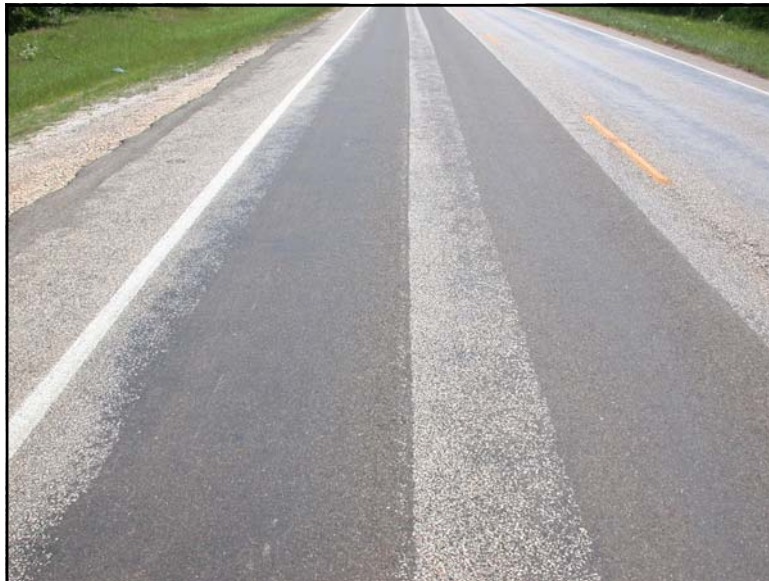
This treatment method seals the roadway surface and improves skid resistance. It is considered to be a long term solution to bleeding.

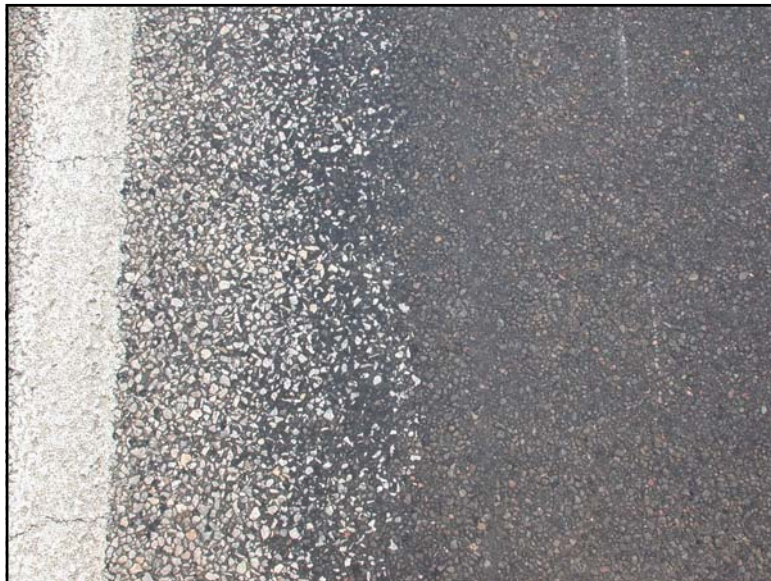
SANDWICH SEAL, CONT'D.

The sandwich seal is a relatively complicated remediation method for bleeding pavements that involves three separate materials including two sizes of rock and an asphalt binder. This might be somewhat awkward for a maintenance section crew, the main challenge being equipment availability.

This method might fit into one of the more expensive remediation categories that would be better suited for contractor applications in larger areas.

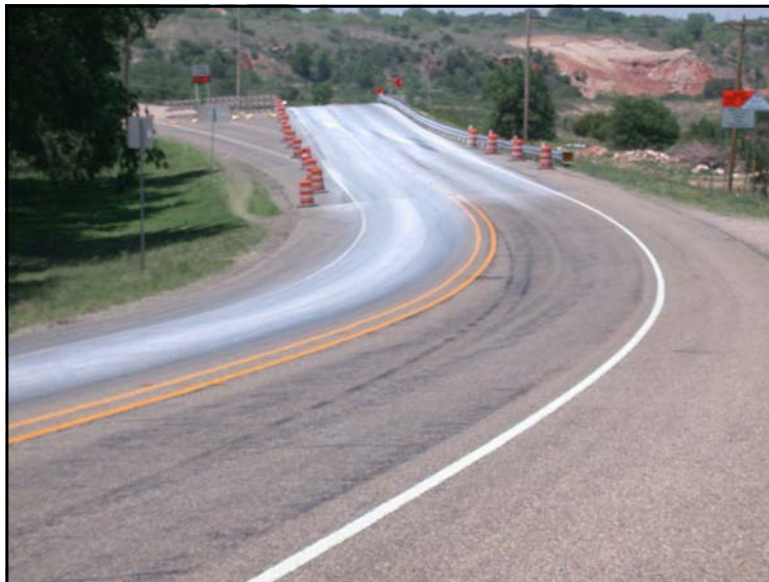
This method is typically used to treat light to moderate bleeding on roadways that do not experience extremely high volumes of traffic. Both construction contractors and maintenance crews use this method, and they like it because it is quick and inexpensive and because it is a moving operation. A typical application is on freshly placed seal coats to control bleeding and to minimize the chances of the seal coat being picked up.

The application of lime water is generally viewed as a short term solution to bleeding asphalt pavements – it “buys some time.” Maintenance crews indicate that treatment effectiveness can range from as little as 2 to 4 hours to as much as 3 to 5 days. Multiple applications of lime water are normally required to achieve the desired result.

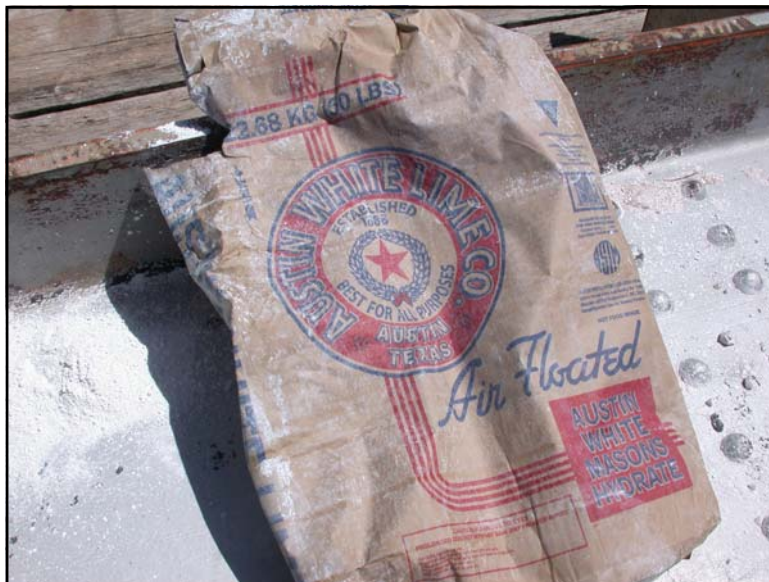
- Apply lime water when pavement is hot for fast drying.

- If dust is excessive or cars are getting a white residue on them, cut back lime in mixture (reduce concentration).
- Never apply faster than 45 MPH.
- Pour lime in tank prior to adding water or while adding water.
- Use goggles, gloves and dust mask.
- Every other nozzle can be plugged and still get an effective coverage.
- Tanks will need a method to circulate the mixture. This will keep the lime suspended in the water.
- Empty tank at the end of each day. The tank may need to be rinsed out if there is a heavy build-up of lime in the bottom of the tank.

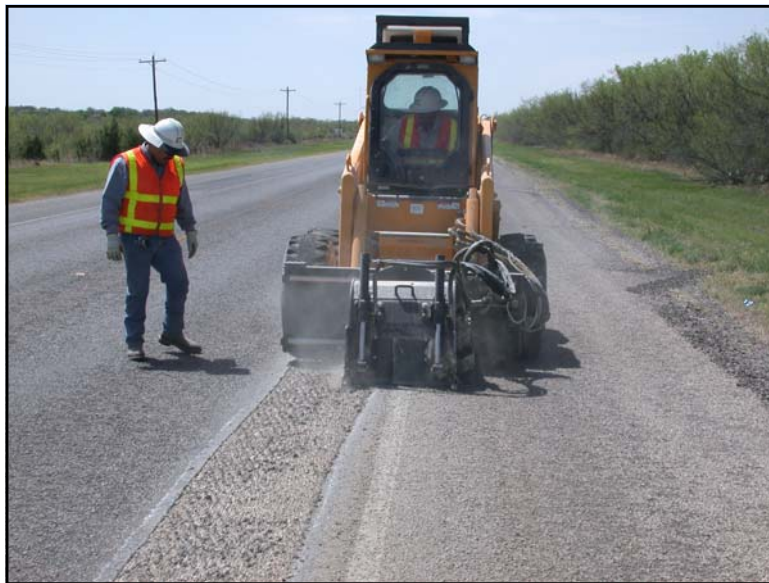
The typical application is where rutting has occurred in the wheel paths, causing water to accumulate during rains, and skid resistance

and hydroplaning are a concern.

Milling is also used quite often at intersections where heavy starting and stopping movements have caused rippled, bumped and otherwise rough pavement surfaces.

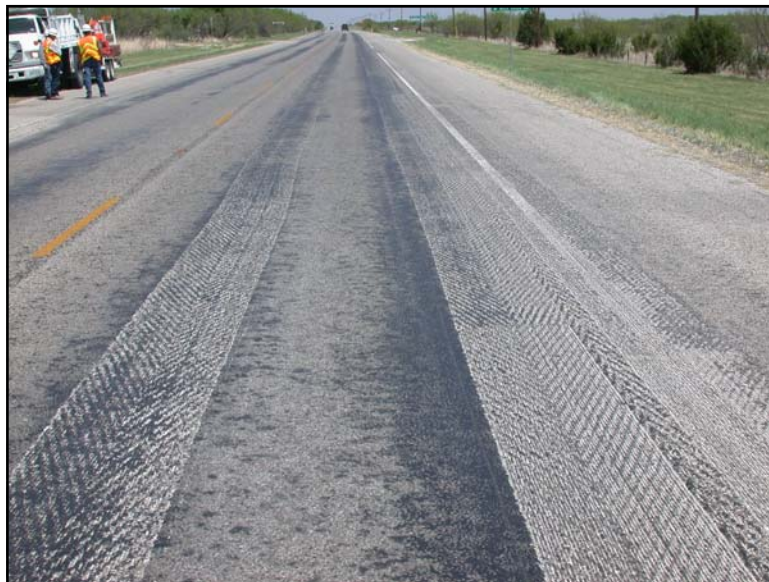
Milling can sometimes make a rutting situation worse.

Certain seal coat materials have a tendency to gum up the milling machine in hot weather, especially the crumb rubber seal.

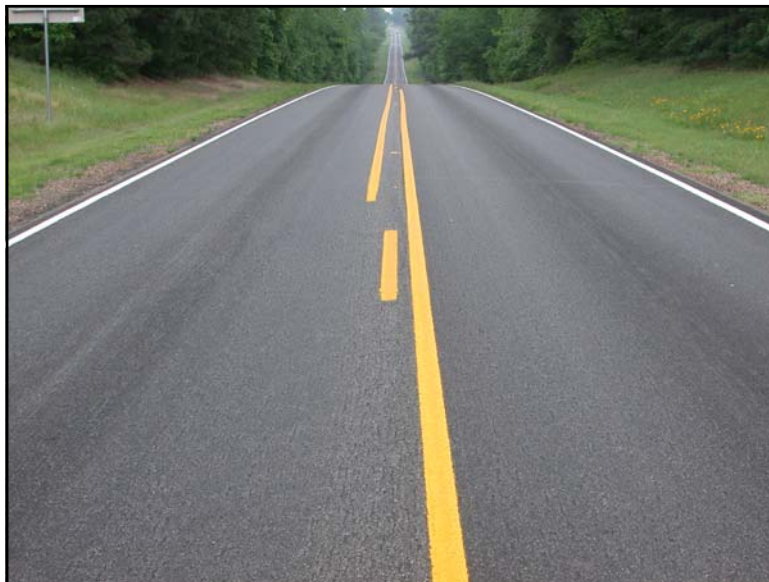
Selection of the microsurfacing method typically focuses on correcting problems associated with rutting in the wheel paths and providing improved macrotexture and skid resistance on a roadway. Flushing problems are often addressed as a by product of this treatment. Microsurfacing is not typically used in and of itself to correct a flushed pavement problem. It is also not used to mitigate bleed-

ing.

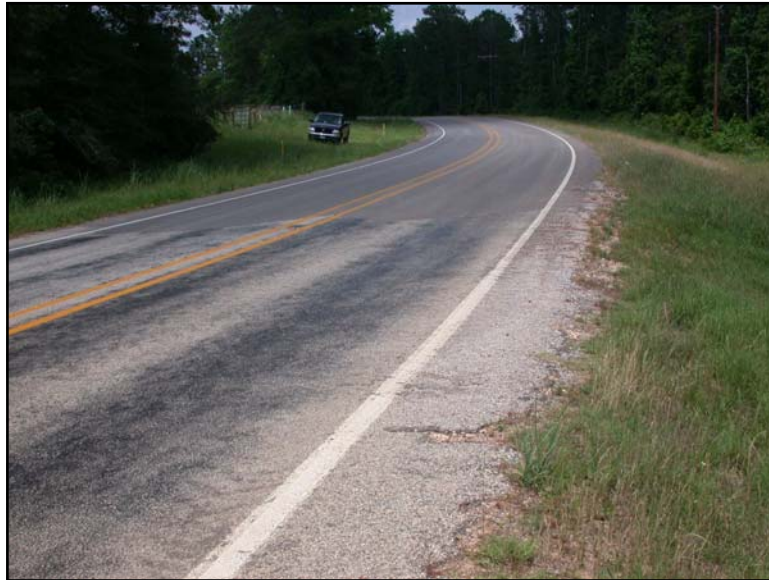
Older (dry) LRA premix material has been used successfully to soak up excess asphalt on bleeding pavements. Water may be added to the LRA if it is too dry.

For reasons of cost and mobilization effort, overlays are typically used to treat larger areas of pavement.

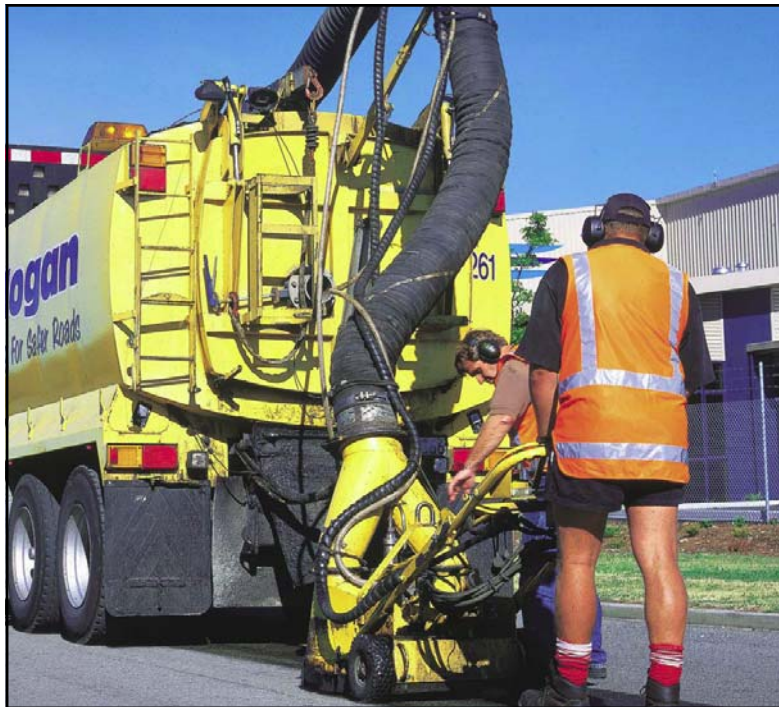
The UHP watercutter equipment consists of very high pressure pumps, usually truck mounted and self contained, and applicators, which may vary from the hydro-mower (umbilical) type for treating smaller areas, to large tractor or truck mounted units. Both machine types include tanks for the supply of fresh water and storage of collected water and debris. Machines currently are in use in Australia and New Zealand.

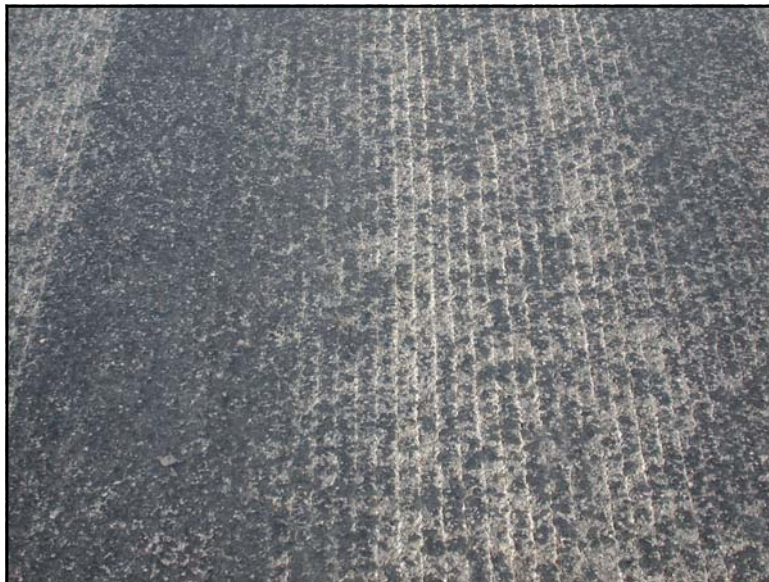
In this method, the flushed pavement surface is pre-heated and new aggregate is applied, the idea being to get the asphalt hot and soft enough to stick the aggregate to the pavement surface. Maintenance forces can use a weed-burner, either hand-wand or tractor-mounted, or a more sophisticated heater-planer, to preheat the pavement surface. Preheating is followed by the application of a hot aggregate (typically, Grade 4) which may be obtained from a hot mix plant or may be preheated in the drier of a portable patching ma-

chine. The hot aggregate is rolled in using a steel wheel roller.

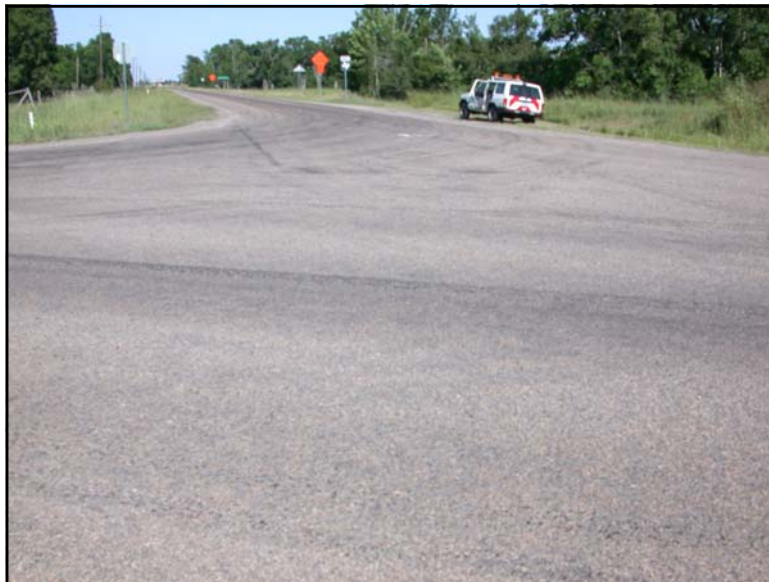
The purpose behind the racked-in seal is to provide a stronger seal coat treatment. The scatter coat aggregate (rack rock) is intended to prevent the seal coat rock from sliding, rolling over or scrubbing off of the underlying pavement. The analogy is to billiards, where a

rack holds cue balls in a tight pattern.
