1. Report No. FHWA/TX-09/0-6568-1		2. Government Accession No.		3. Recipient's Catalog No.	
4. Title and Subtitle Use of Flashing Yellow Operations to Improve Safety at Signals with Protected-Permissive Left Turn (PPLT) Operations				5. Report Date Published: October 2012

**USE OF FLASHING YELLOW OPERATIONS TO IMPROVE SAFETY AT
SIGNALS WITH PROTECTED-PERMISSIVE LEFT TURN (PPLT)
OPERATIONS**

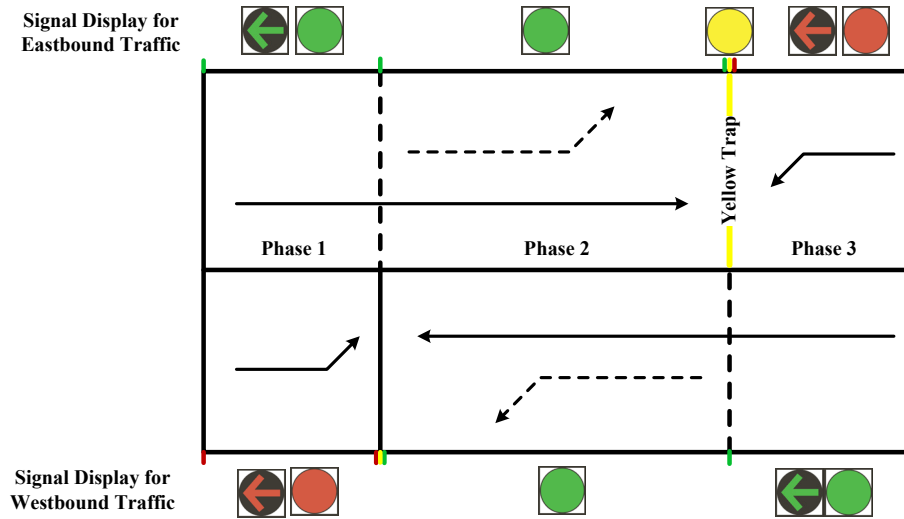
Figure 1-1: Yellow Trap Illustration in Phasing Graph

signal for the adjacent through traffic turns yellow at this moment. Actually, the signal display for the opposing through movement is still green, and the opposing through vehicles will not stop or slow down. In this case, the vehicle that makes a left turn during the yellow phase may crash into the opposing through traffic.

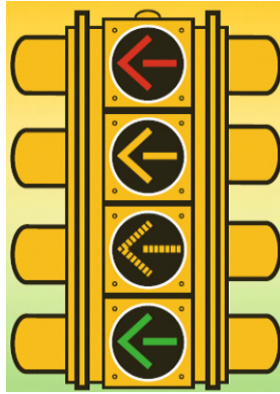
A typical signal head for the FYA signal indication includes an FYA, as well as a steady green arrow, a steady yellow arrow, and a steady red arrow, as is shown in Figure 1-2.

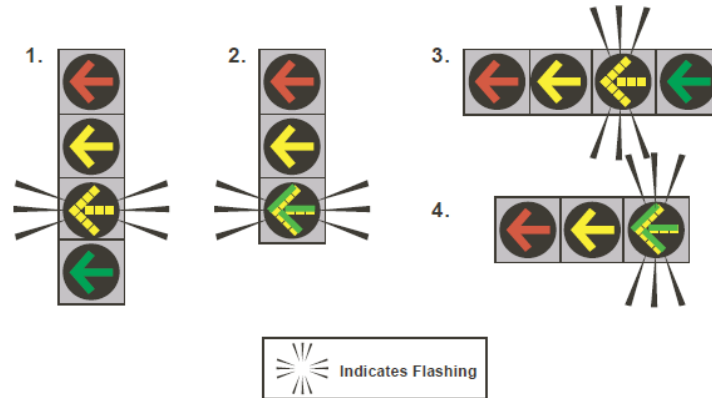
NCHRP Report 493 recommended four types of signal face arrangements to incorporate the FYA indication at locations where there is an exclusive left-turn lane, and the display is exclusive for left turns, not shared by the adjacent through movements. These signal face arrangements are shown in Figure 1-4 with different configurations in terms of section (three-section or four-section) and/or alignment (vertically or horizontally). Generally, the four-section

display face is more widely used for FYA PPLT display as opposing to the three-section signal face with a bi-modal section enabling steady green arrow and FYA indications.

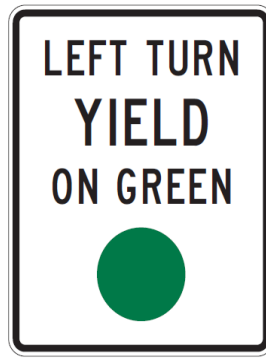
Figure 2-7: Supplemental Sign (R10-21): LEFT TURN YIELD ON GREEN

This study was to identify driver comprehension of permissive left-turn indications. The survey consisted of several visualized survey questions, which presented respondents with various driving situations. The results of the survey showed that CG indications with “LEFT TURN YIELD ON GREEN’ supplemental sign” (R10-12, see Figure 2-7) is better understood than FYA indications. The average correct response rate to FYA indications was 72.4%, while the average correct response rate to CG indications with the sign was 94%.

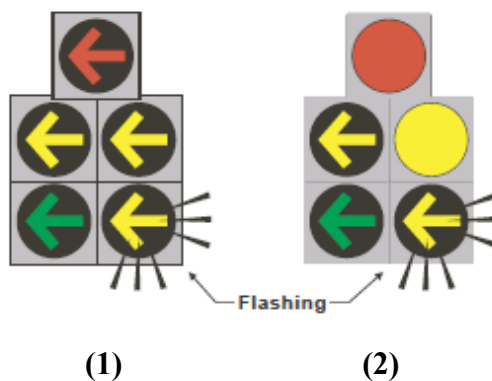
- A three-section display with bi-modal lenses is justified as exception because it operates in the same way as the four-section display face does by incorporating FYA and green arrow into one section. Only one indication shall be illuminated at any time.
- A five-section display may only be allowed under the condition when it is used as the left-turn signal and must be shielded from the adjacent through movement. NCHRP Report 493 (2003) demonstrated two potential options for converting a five-section signal face to the FYA signal faces as shown in Figure 2-8.

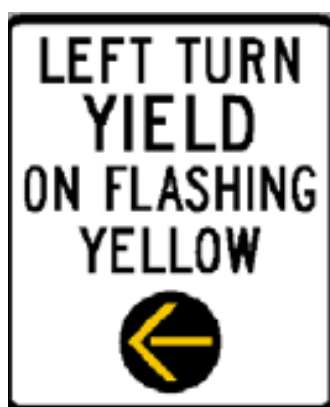
In this study, it was found that drivers who saw FYA permissive left-turn indications for the first time might not be able to understand FYA very well, which resulted in left-turn accidents at some of the FYA implementation sites. The potential solution to this problem was to use the supplemental sign “LEFT-TURN YIELD ON FLASHING YELLOW” with a symbolic arrow, as shown in the Figure 2-10.

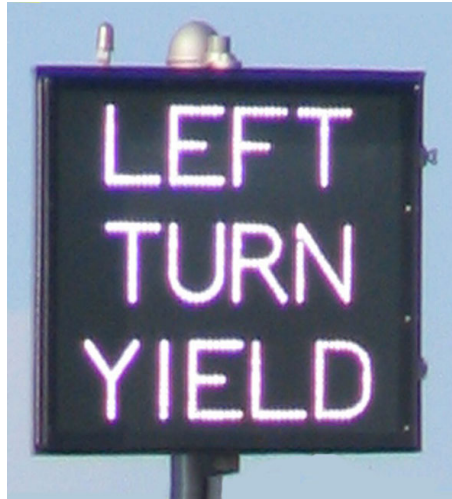
Figure 2-11: "LEFT TURN YIELD" EMS Sign

above the signal heads directing the left-turn movement, and was synchronized with the signal indications. The EMS would illuminate when the yellow arrow or green ball indications were illuminated on the signal head. Figure 2-12 shows the use of the EMS during the green arrow, yellow arrow, and CG signal indications.

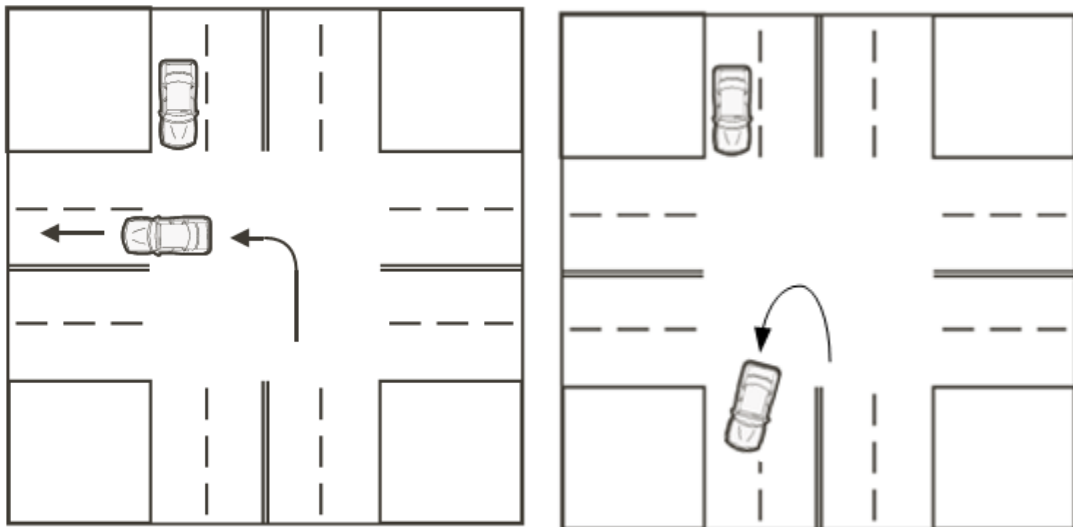
Type 1: Conflict with opposing through

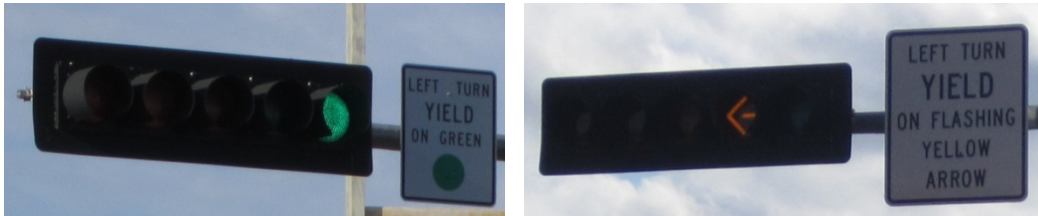
Figure 4-10: Before and After Arrangement of Left-Turn Signal Lens and Sign (Bellmead)

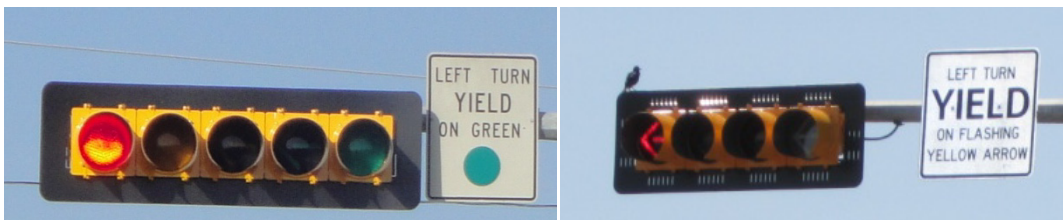
Figure 4-12: Before and After Arrangement of Left-Turn Signal Lens and Sign (Austin)

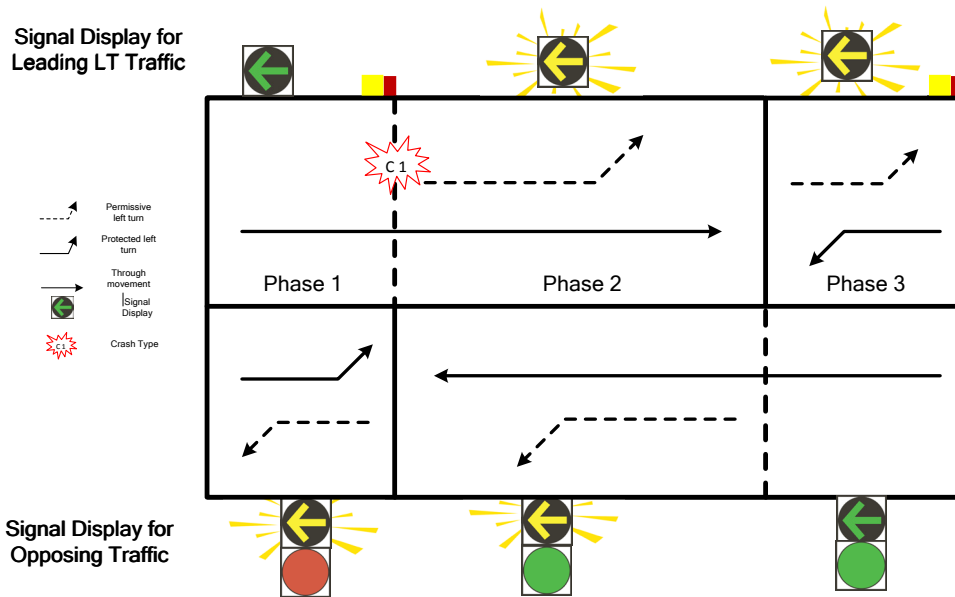
Figure 5-2: Signal Phase of Lead-Lag PPLT Operation

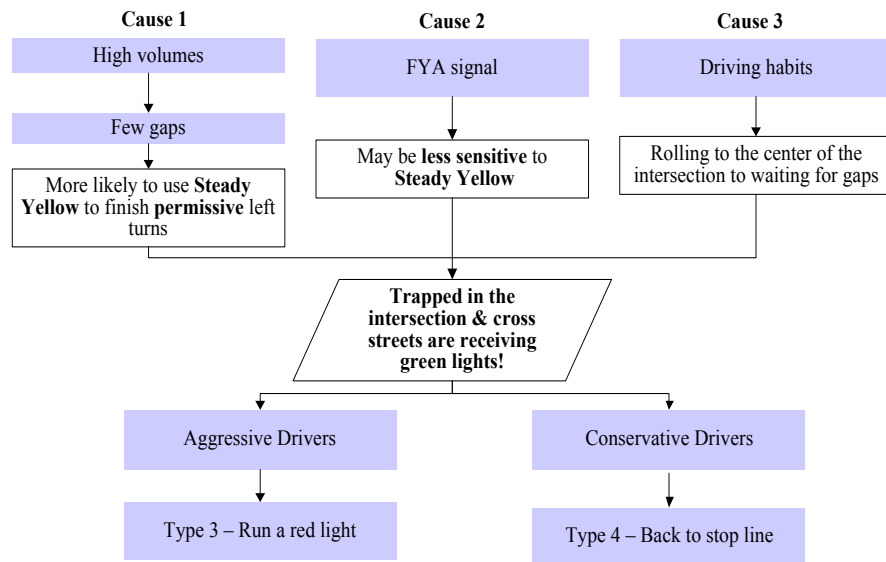
Figure 5-3: Explanation on the Increased Rates of Type 3 and Type 4 Traffic Events after the Use of FYA
