## Performance Evaluation of the Modified T77 Bridge Rail

Report 0-4852-1, *Crash Testing and Evaluation of the Modified T77 Bridge Rail*

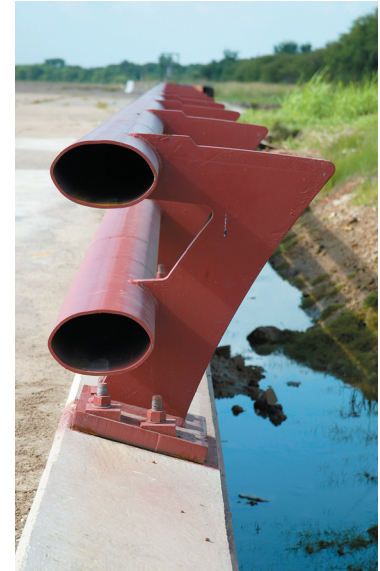
Post Profile on T77 Bridge Rail. Local rail deformation near the rail splice and the sleeve splice itself caused the truck to experience snagging and excessive occupant compartment deformation. As part of the current project, TTI and TxDOT revised the T77 design to make it perform acceptably and in accordance with *NCHRP Report 350*.

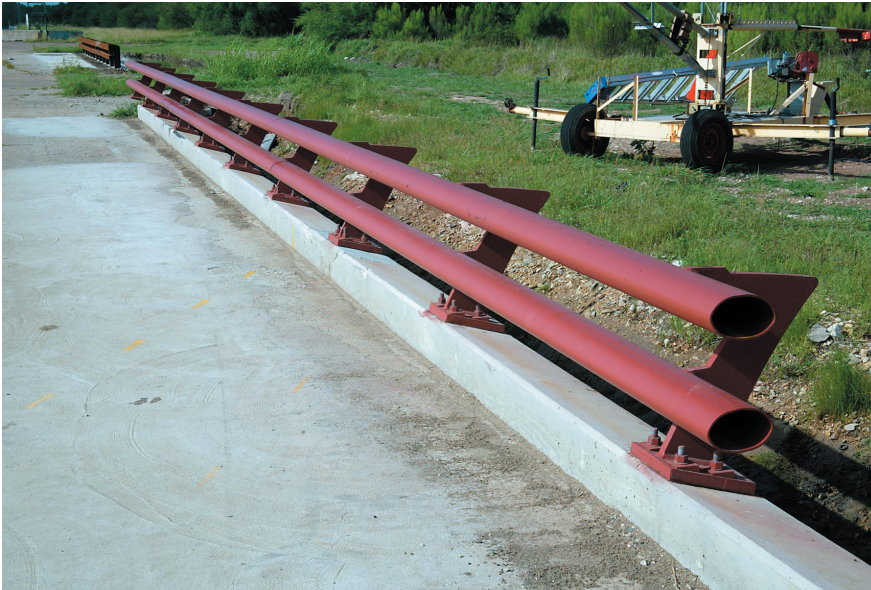
T77 Bridge Rail Prototype Installation.

consisting of two tubular steel rail elements mounted on 1-1/4 inch thick steel plate posts spaced 8 ft apart. The elliptical-shaped rails are 8 inch x 4-7/8 inch and are manufactured from 6 inch diameter API-5LX52 pipe with a wall thickness of 0.188 inch. The center of the lower rail and the top of the upper rail measure 1 ft-6 inches and 2 ft-9 inches, respectively, from the pavement surface. The rails are welded to the posts. The 1-1/4 inch thick posts are fabricated in the shape of the numeral “7” and are welded to 11-1/2 inch x 12 inch x 1-1/2 inch thick baseplates.

For the tests, each post was anchored to the curb using four 7/8 inch diameter A325 anchor bolts with a 7 inch x 11 inch x 1/4 inch thick anchor plate used for additional anchorage. The bridge railing system was supported by a cast-in-place concrete deck and curb. The curb was 14 inches wide and 9 inches high on the traffic side and 5-1/2 inches high on the field side. The top of the curb sloped downward approximately 14 degrees from horizontal toward the field side. The post plates were sloped in a similar fashion so that the two rail elements were flush with the traffic-side face of the curb. The post plates and base plates were manufactured from A572 grade 50 steel. A simulated concrete bridge deck cantilever and curb was constructed immediately adjacent to an existing concrete runway located at the TTI test facility. The bridge deck cantilever was 2 ft-5 inches in width and 8 inches thick and was rigidly

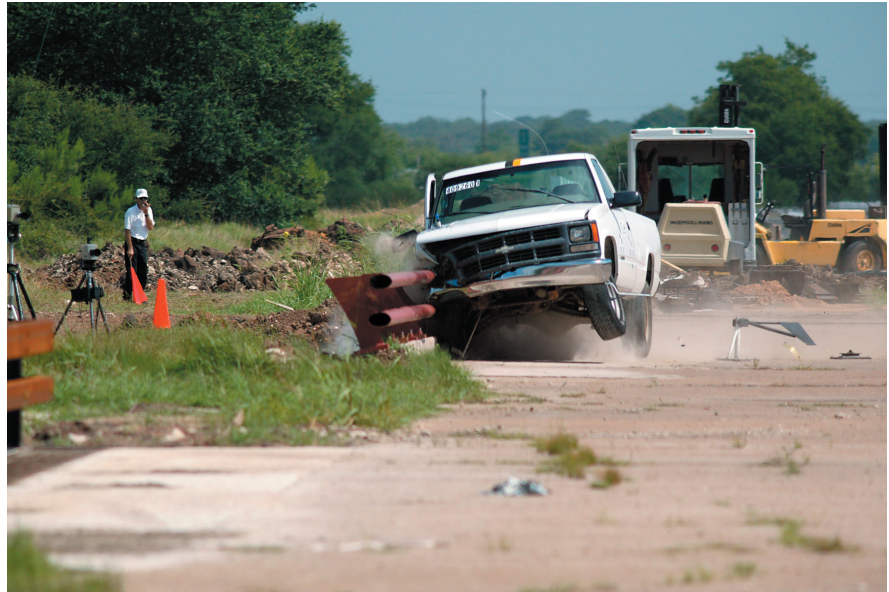
Successful Pickup Truck Test with T77 Bridge Rail.

Due to excessive occupant compartment deformation in test 448523-1, the T77 bridge rail did not meet the occupant risk criteria for *NCHRP Report 350* test 3-11. However, after increasing the wall thickness of the rail member and using the newly designed rail sleeve splice connection, the T77 bridge rail performed acceptably in test 409260-1 (repeat of test
