1. Report No. FHWA/TX-13/0-6132-2		2. Government Accession No.		3. Recipient's Catalog No.	
4. Title and Subtitle NEW GENERATION HMA MIX DESIGNS: ACCELERATED PAVEMENT TESTING OF A TYPE C MIX WITH THE ALF MACHINE				5. Report Date September 2012 Published: July 2013

**NEW GENERATION HMA MIX DESIGNS: ACCELERATED PAVEMENT
TESTING OF A TYPE C MIX WITH THE ALF MACHINE**

Report 0-6132-2

Project 0-6132

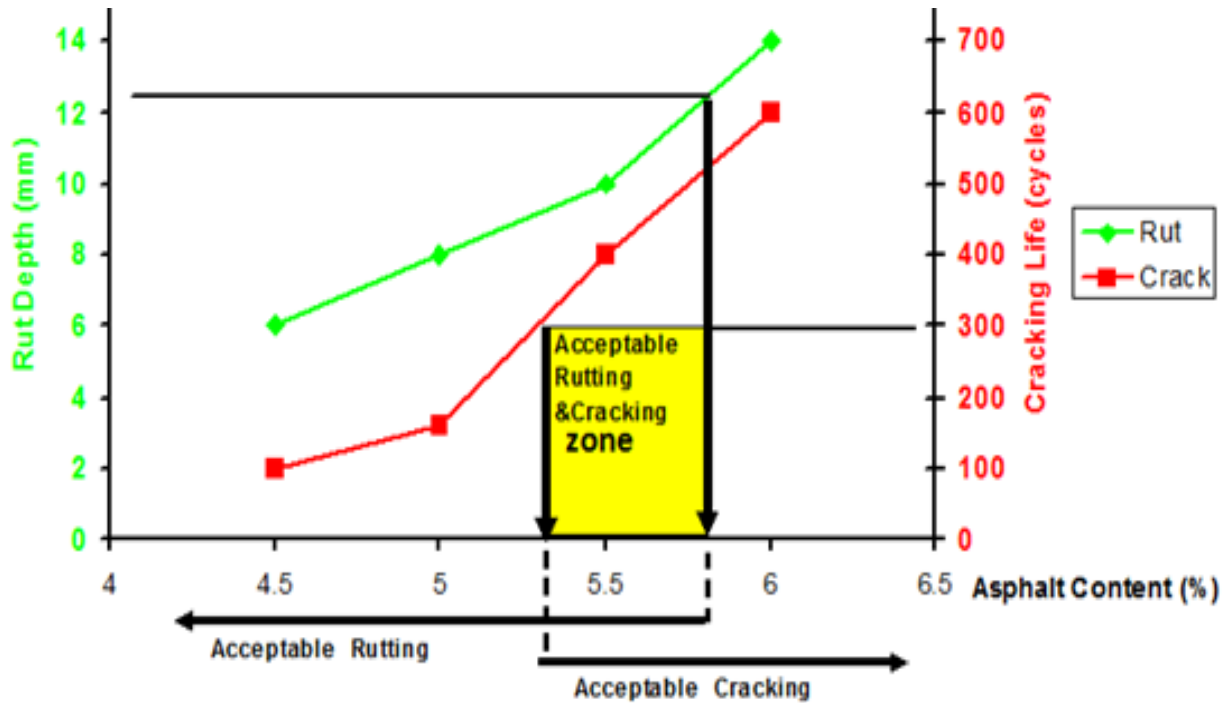
Figure 2-2. Graphical Illustration of the Balanced Mix-Design Concept.

The concept of the proposed balanced mix design method is fundamentally centered on designing HMA mixes that are both rutting and cracking resistant (Zhou et al., 2006). As shown in Figure 2-2, the mix-design philosophy is based on designing and selecting an OAC that simultaneously meets certain prescribed laboratory rutting and cracking requirements based on the HWTT and Overlay Tester (OT) tests, respectively, with a minimum of three trial asphalt-binder contents at 93 ± 1 percent lab density.

Figure 2-2 clearly shows that as the asphalt-binder content increases, the rutting resistance decreases, and vice versa for the cracking resistance. Conversely, the opposite result would be expected if the asphalt-binder content were decreased. A balanced OAC design

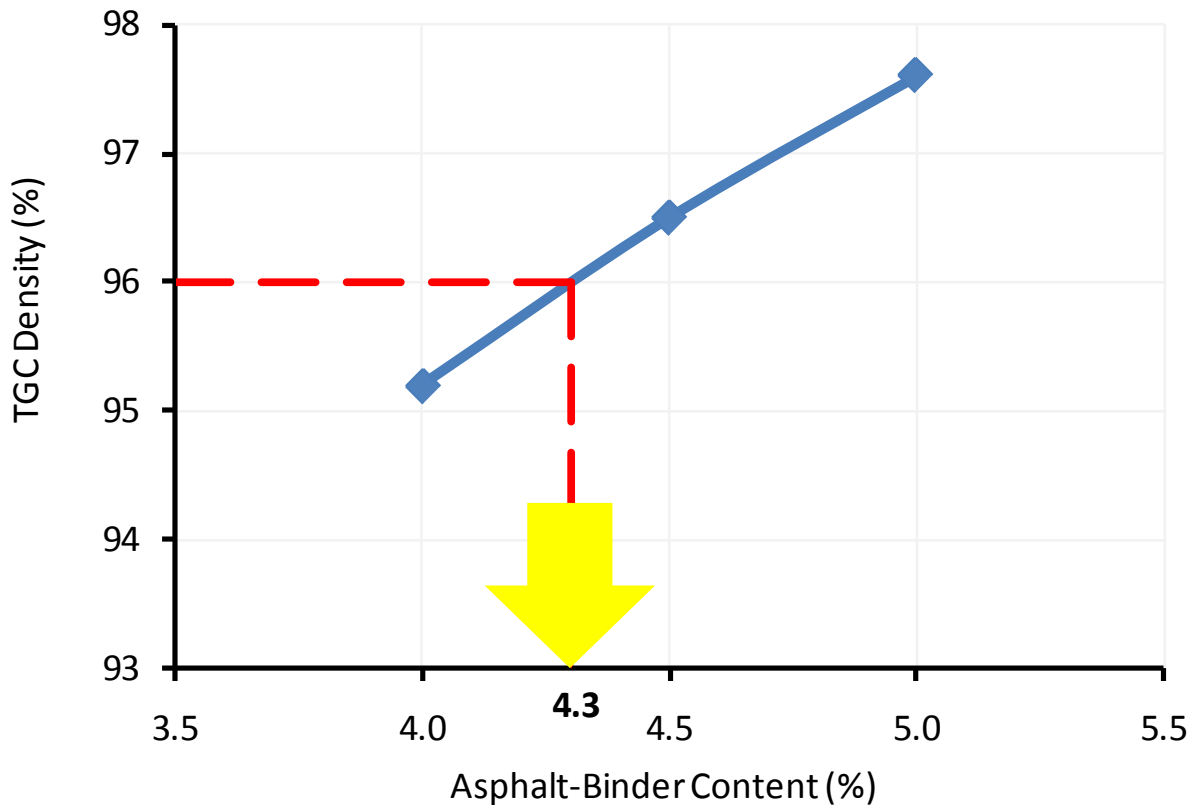
Figure 2-6. TGC Density and Asphalt-Binder Content Results.

With the TG method, the criterion for selecting the design OAC for this particular mix was 96 percent TGC lab density (TxDOT, 2004, 2011). As shown in Figure 2-6, the asphalt-binder content corresponding to this density level (96 percent) was 4.3 percent; thus, this content was selected as the design OAC based on this method.

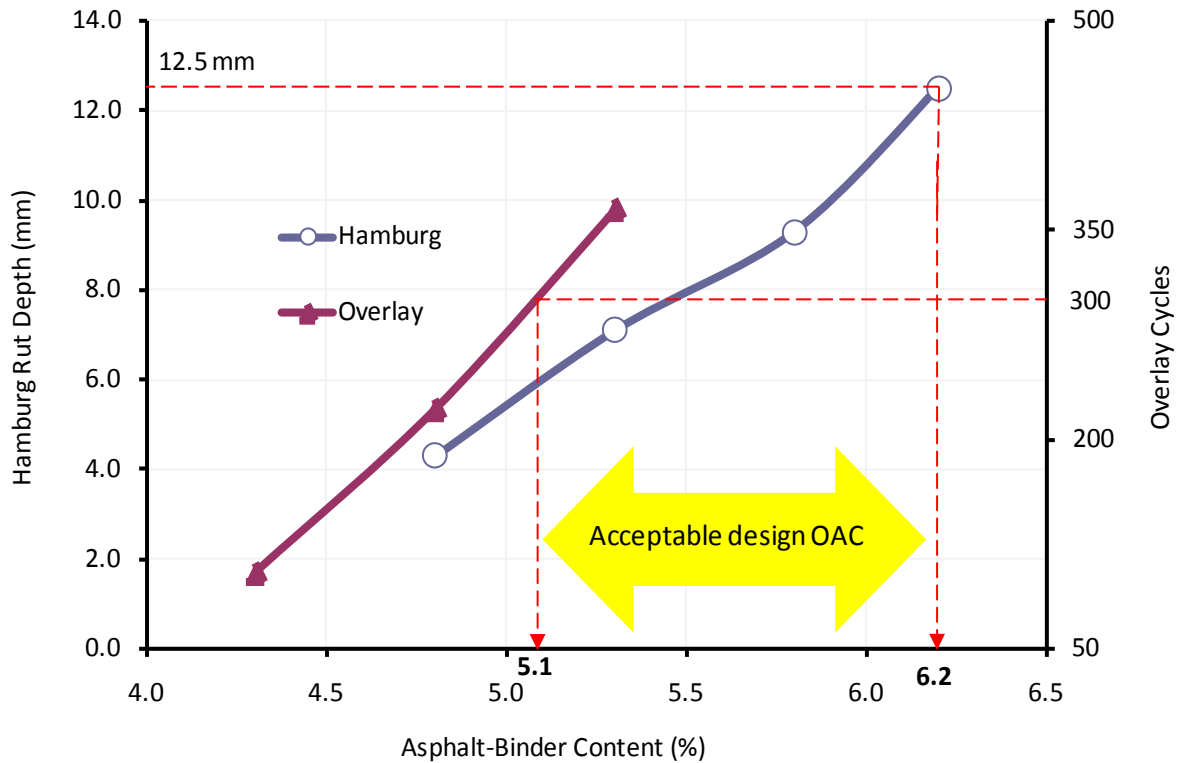
Figure 2-7. Hamburg-Overlay and Asphalt-Binder Content Results.

Figure 2-7 shows the Hamburg and Overlay test results for a trial asphalt-binder content range of 4.3 to 6.2 percent.

According to Figure 2-7, the selectable asphalt-binder content range that meets both the Hamburg rutting (i.e., rut depth ≤ 12.5 mm rut depth after 20,000 HWTT load passes for PG 76-22 mixes) and the Overlay cracking (i.e., crack cycles ≥ 300) requirements is from 5.1 to 6.2 percent. To accommodate the field density requirements (i.e., ≤ 98 percent), and for the purposes of practicality, 5.2 percent was selected as the balanced design OAC meeting both the laboratory rutting and cracking requirements; see Table 2-2.

As Figure 2-7 illustrates, the Overlay crack test is the determinant of the lower limit (i.e., ≥ 5.1 percent) for the selectable design OAC. The Hamburg rutting test, on the other hand, is the determinant of upper limit (i.e., ≤ 6.2 percent) of the selectable design OAC.

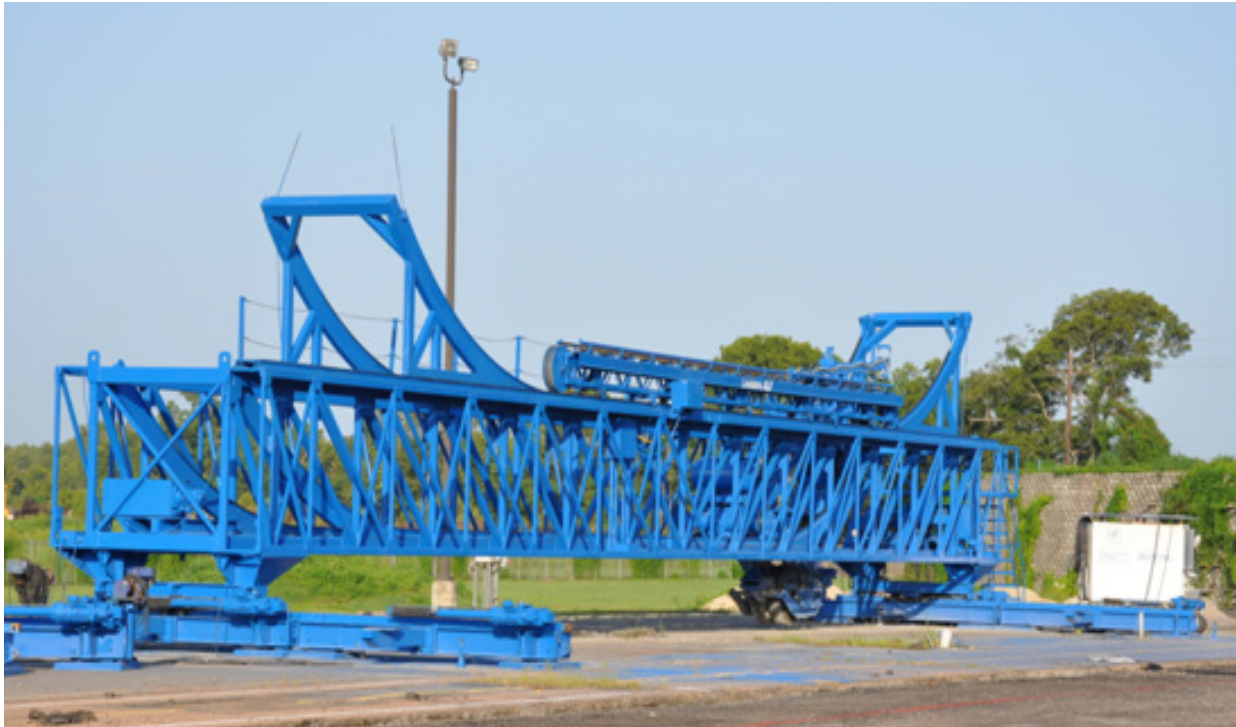
Figure 3-1. LTRC's ALF Machine.

The ALF device is a 100-ft-long, 55-ton accelerated loading device used to simulate truck loading for pavement testing. When running, the weight and traffic movement is simulated repetitively in one direction via a computer-controlled trolley. The LTRC-ALF is a uni-directional APT device with dual wheels that are 9 inches wide, with a 6-inch separation between the tires. The ALF loading is adjustable, ranging from 5 to 10.5 kips per tire, with a maximum operable tire pressure of up to 150 psi. The test area under the ALF is approximately 40 ft long, with a tire contact area of 445 inch² at 100 psi. The maximum operable ALF speed is 120 mph.

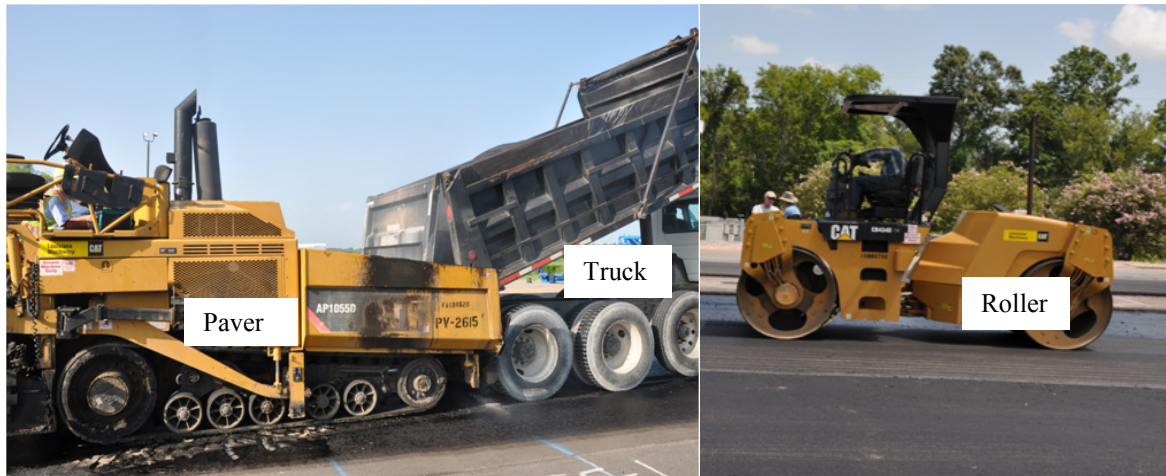
Figure 3-5. HMA Placement and Compaction Operations.

HMA (Type C) placement was consistent with the Texas construction specifications (TxDOT, 2004). No material transfer device was engaged in this construction operation. As Figure 3-5 shows, the trucks dumped the hot mix directly into the paver.

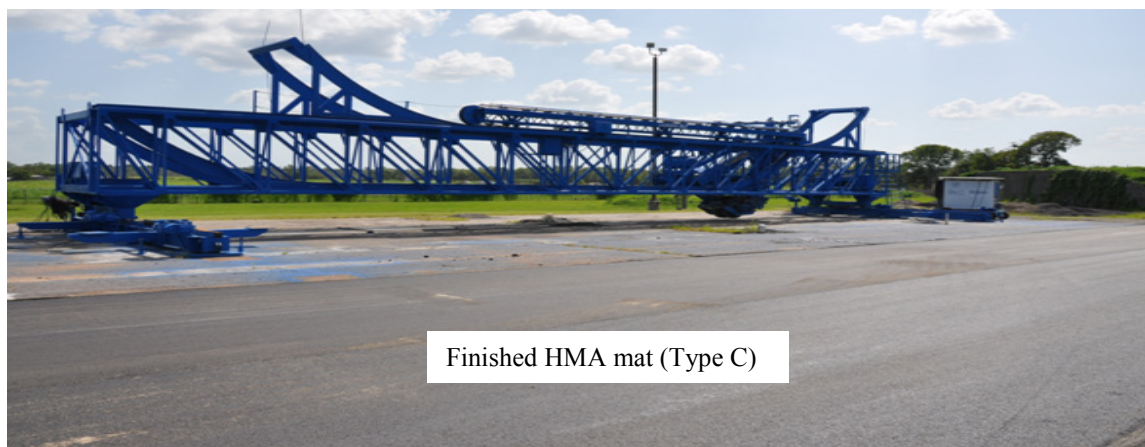
Figure 3-6. Finished HMA Mat at the LTRC-APT Test Site (August 2009).

The air and surface temperatures at the time of HMA placement were 82 and 105 °F, respectively, which satisfied the Texas construction specification requirements (TxDOT, 2004). To meet the 143 to 145 pcf density requirements, the compaction rolling pattern consisted of two vibrating passes and two static passes of an 18-ton steel wheel roller; see Figure 3-5. An example of the finished HMA mat at the LTRC-APT test site is shown in Figure 3-6.

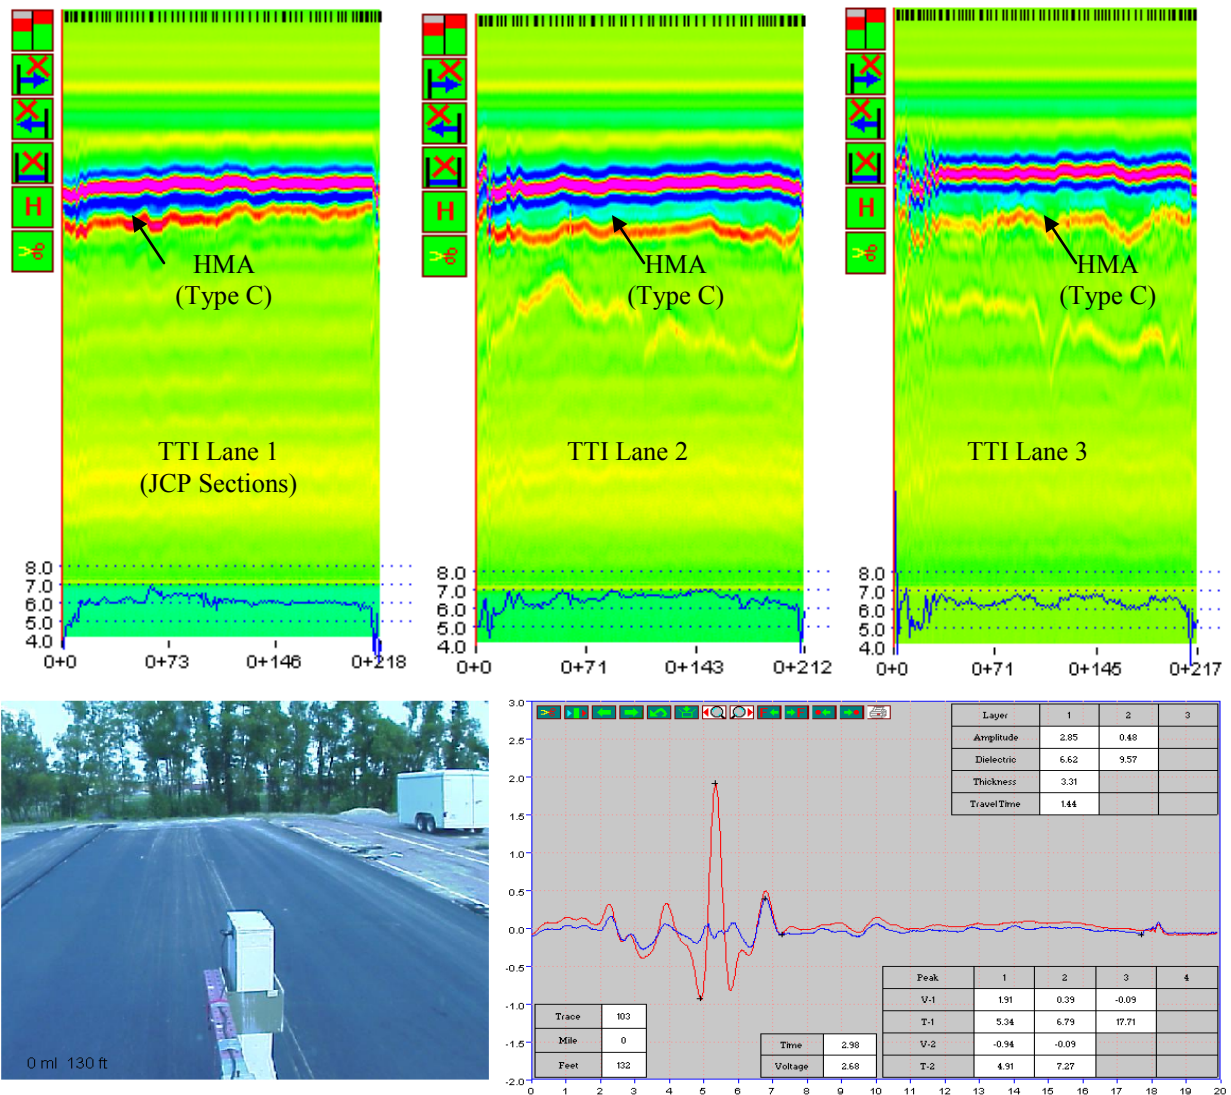
Figure 3-8. GPR Measurements.

Figure 3-8 shows GPR readings taken just after placement of the HMA mat. The GPR readings for Lanes 2 and 3 with some blue coloring suggest density variations within the HMA mat, which may be critical for the rutting performance of the HMA mixes. Density measurements of cores taken from these locations are discussed in the subsequent chapters of this report.

As [Figure 3-8](#) shows, both the HMA and the base exhibited inconsistent thickness. This was a construction quality issue that could impact the APT performance of the test sections under ALF loading.

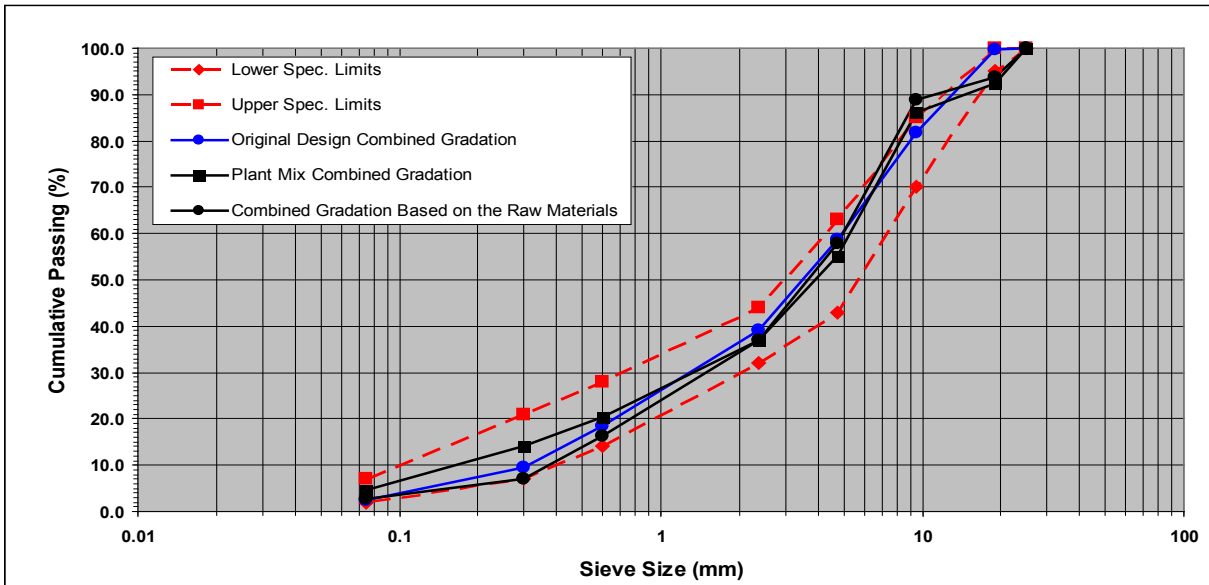
Figure 4-1. Comparison of Combined Aggregate Gradations.

Texas ± 0.3 percent specification tolerance (TxDOT, 2004, 2011). As shown in Figure 4-1, however, the aggregate extraction tests indicated that the combined gradation of the plant mix was out of the design specification on the $\frac{3}{4}$ -inch (19 mm) and $\frac{3}{8}$ -inch (9.5 mm) sieve sizes. This was primarily attributed to the gradation of the coarse C-rock that was slightly different from the design gradation on these particular sieve sizes; see Appendices A and B.

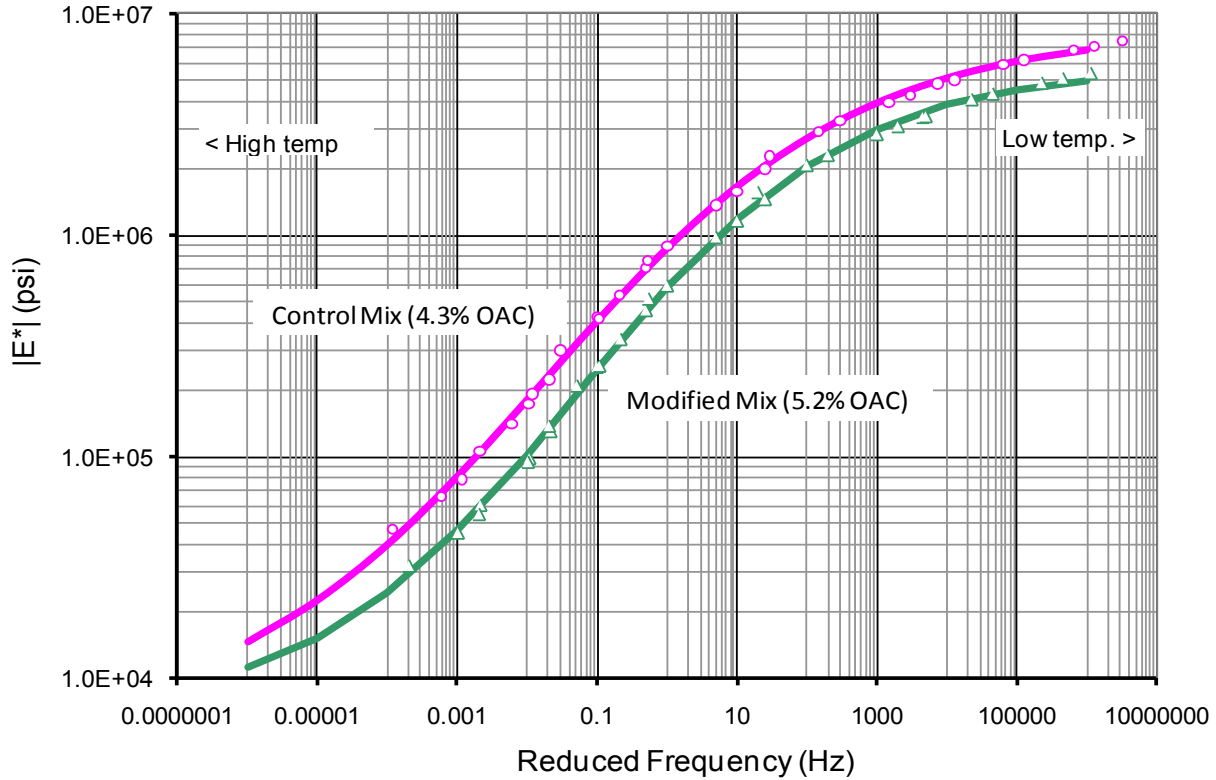
Figure 4-3. $|E^*|$ Master Curves at a Reference Temperature of 77 °F.

Officials [AASHTO], 2001; Walubita et al., 2012). These $|E^*|$ master curves, at a reference temperature of 77 °F, are shown in Figure 4-3.

As expected, Figure 4-3 shows that the Control mix with 4.3 percent OAC was comparatively stiffer (and, theoretically, more rut resistant) than the Modified mix with 5.2 percent OAC. At 77 °F and 10 Hz frequency, the modulus of the Control mix was approximately 33 percent higher than the modulus of the Modified mix in magnitude. Based on Figure 4-3, the HMA moduli at 10 Hz (and 77 °F) were approximately:

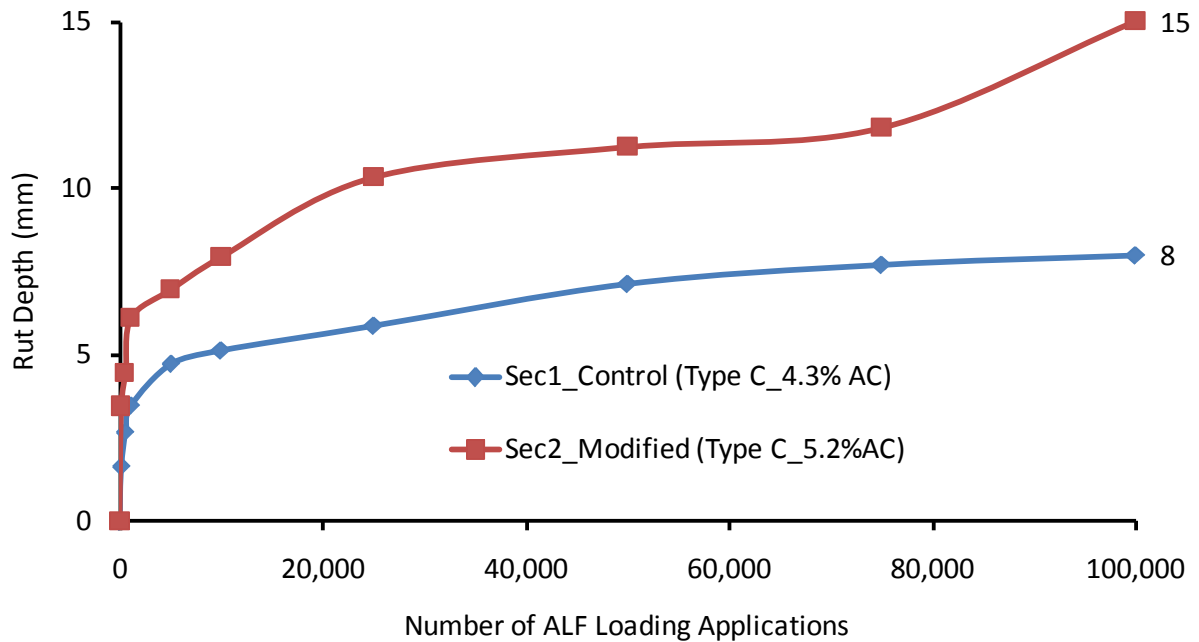
Figure 5-1. Rutting under ALF Load Trafficking.

Consistent with the laboratory test predictions based on the BMD method and as theoretically expected, the Modified mix with more asphalt-binder rutted more than the Control mix under ALF trafficking. After 100,000 ALF load passes under equivalent test temperatures, the rut depth on Section 2 with the Modified mix (at 5.2 percent AC) was almost 50 percent more than that accumulated on Section 1 with the Control mix (at 4.3 percent AC), i.e., 15 versus 8 mm. These results are shown graphically and pictorially in [Figures 5-1](#) and [5-2](#), respectively.

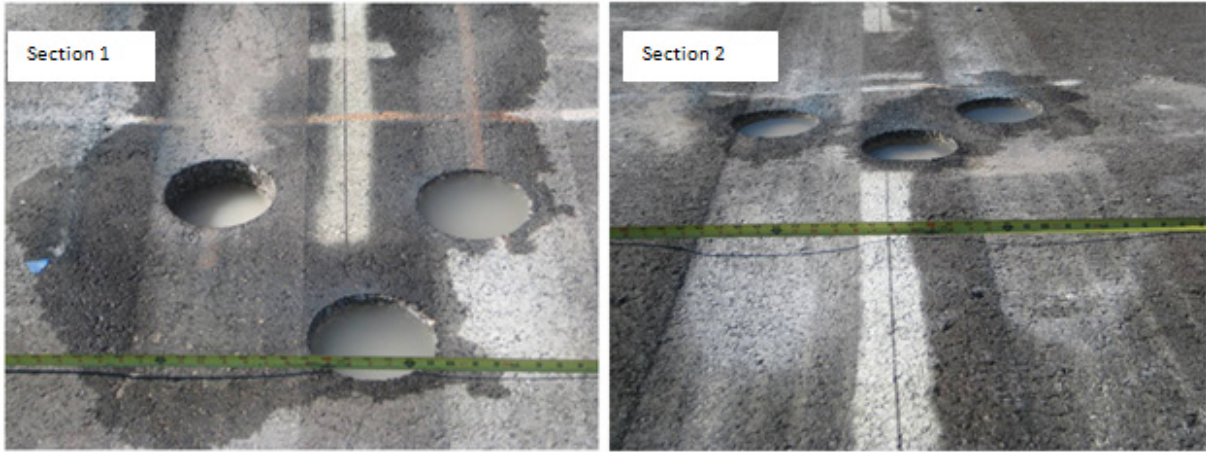
Figure 5-2. Surface Rutting on Sections 1 (Control) and 2 (Modified).

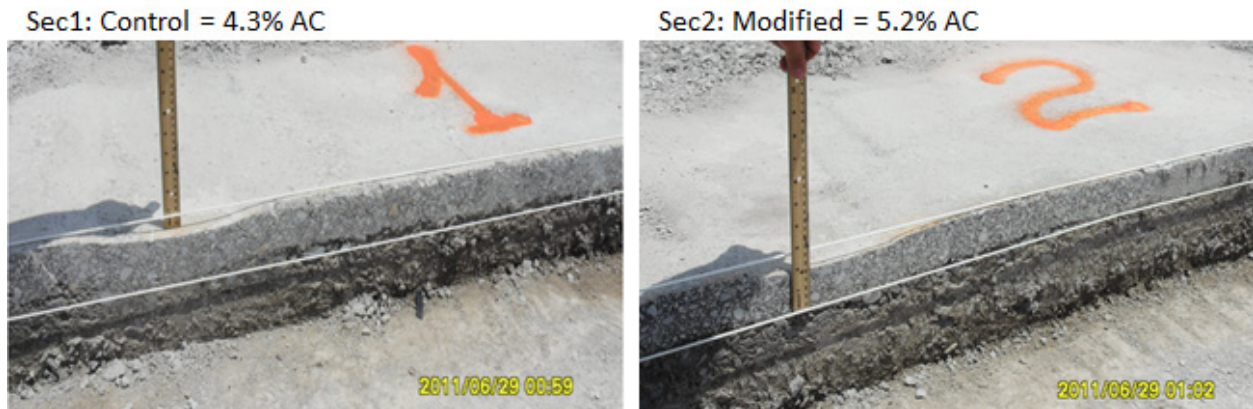
Figure 5-3. Trenching and Pictorial Comparison of Rutting on Sections 1 and 2.

As shown in [Figure 5-3](#), subsequent trenching of the test sections indicated that all the rutting was coming from the top HMA layer. Deformation in the base and subgrade was marginal.

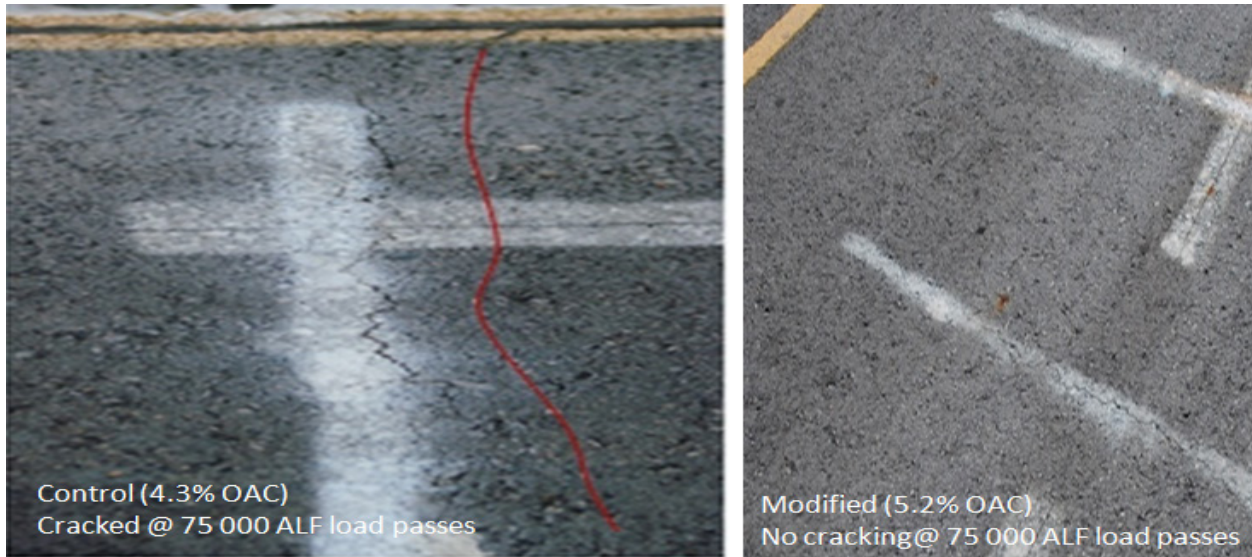
Figure 5-5. Reflective Cracking Comparison of Section 4 (Control, LTE = 50 Percent) and Section 6 (Modified, LTE = 50 Percent) after 75,000 ALF Load Passes.

By contrast however, no cracking was observed on the Modified Section 6 (with LTE = 50 percent) even after applying 100,000 ALF load passes and increasing the tire load; see [Table 5-1](#) and [Figure 5-5](#). For the Modified Section 5 with good LTE (i.e., LTE > 90 percent),

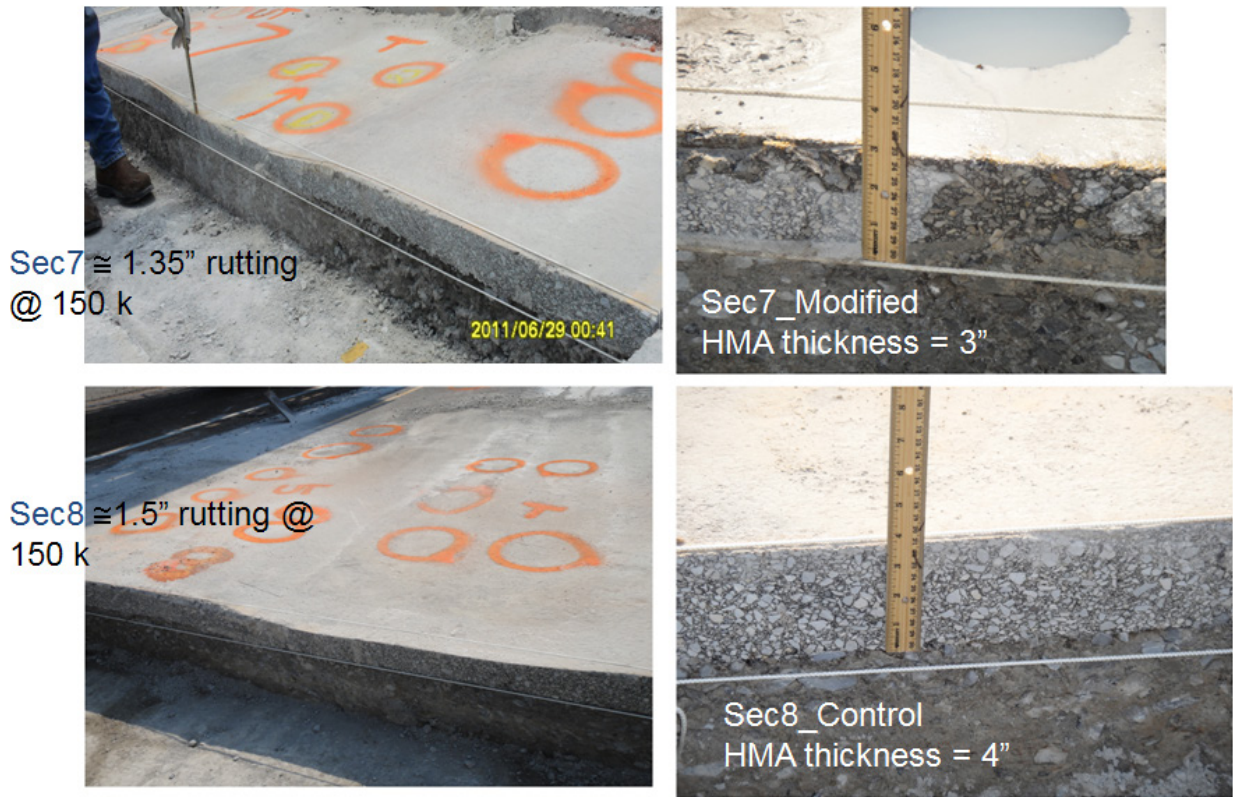
Figure 5-8. Base-Subgrade-Related Rut Failure on the Fatigue Crack Sections 7 and 8.

- The Control Section 8 (4 inches) was thicker than the Modified Section 7 (3 inches) in terms of the surfacing HMA layer; see [Figure 5-8](#). This was considered to be due to construction-related issues; see [Chapter 3](#).
- The distresses (particularly rutting) were found to be related to the base and construction problems; see [Figure 5-8](#).
- Coring indicated micro-damage and micro-cracking on the Modified Section 7.
- As can be inferred from [Table 5-1](#), ALF trafficking on these sections was done around summertime during high temperatures, hence the high rutting, particularly on the Control Section 8.

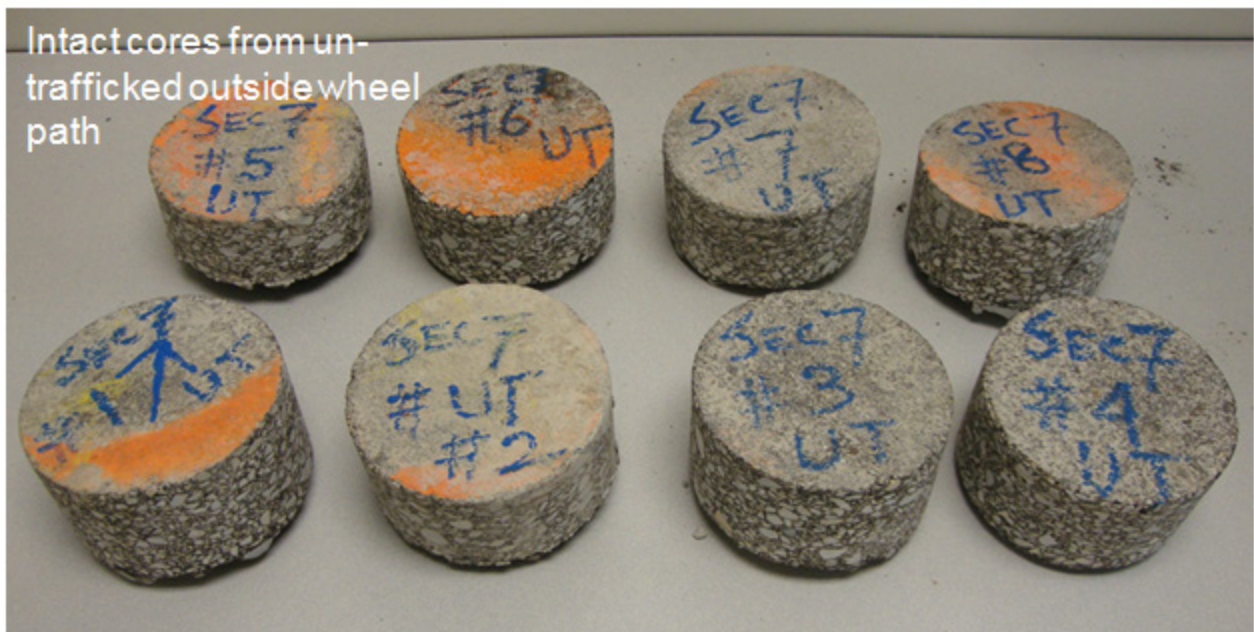
Figure 5-10. Cracked and Uncracked Cores from Modified Section 7.

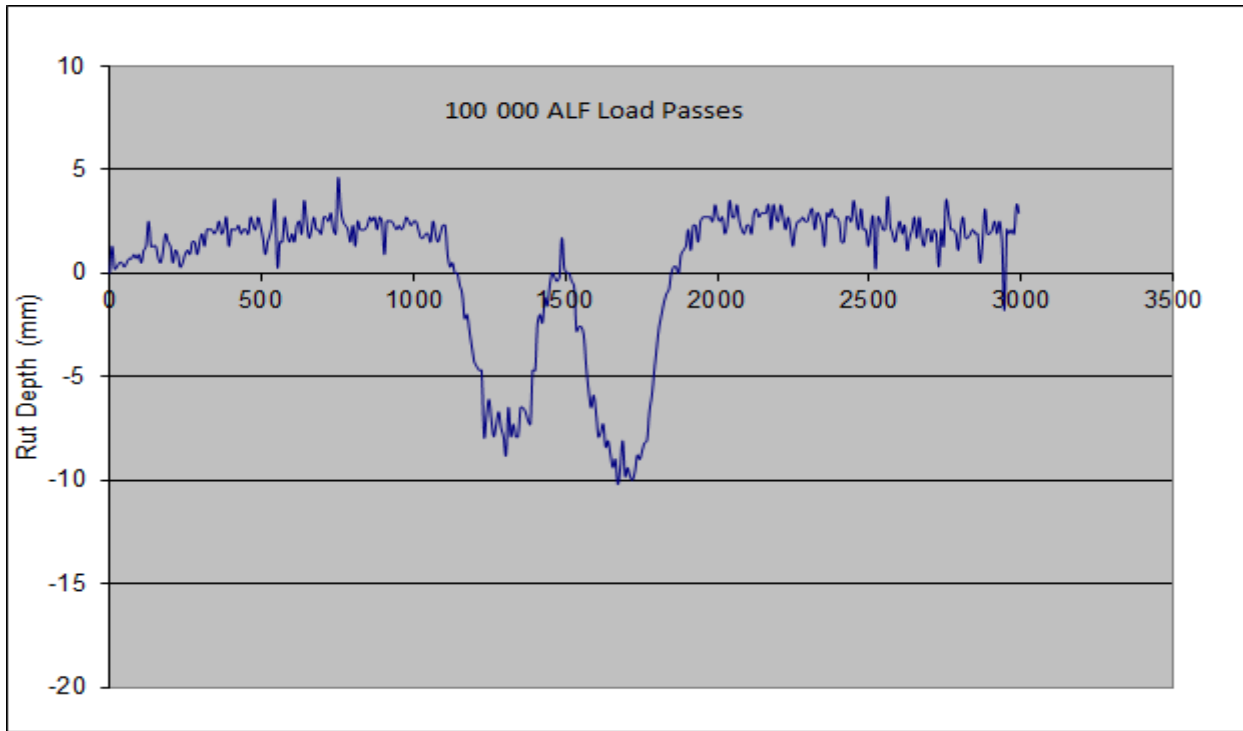
Figure E-1. Transverse Rut Measurements on Control Section 1.

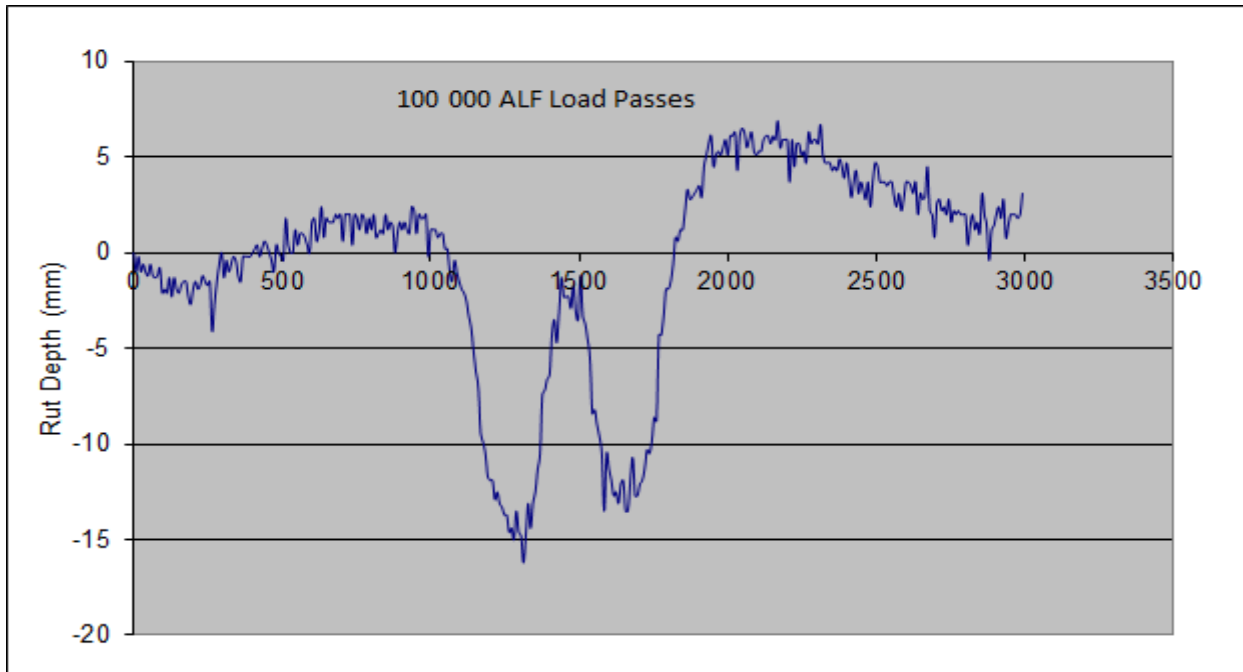
Figure E-2. Transverse Rut Measurements on Modified Section 2.

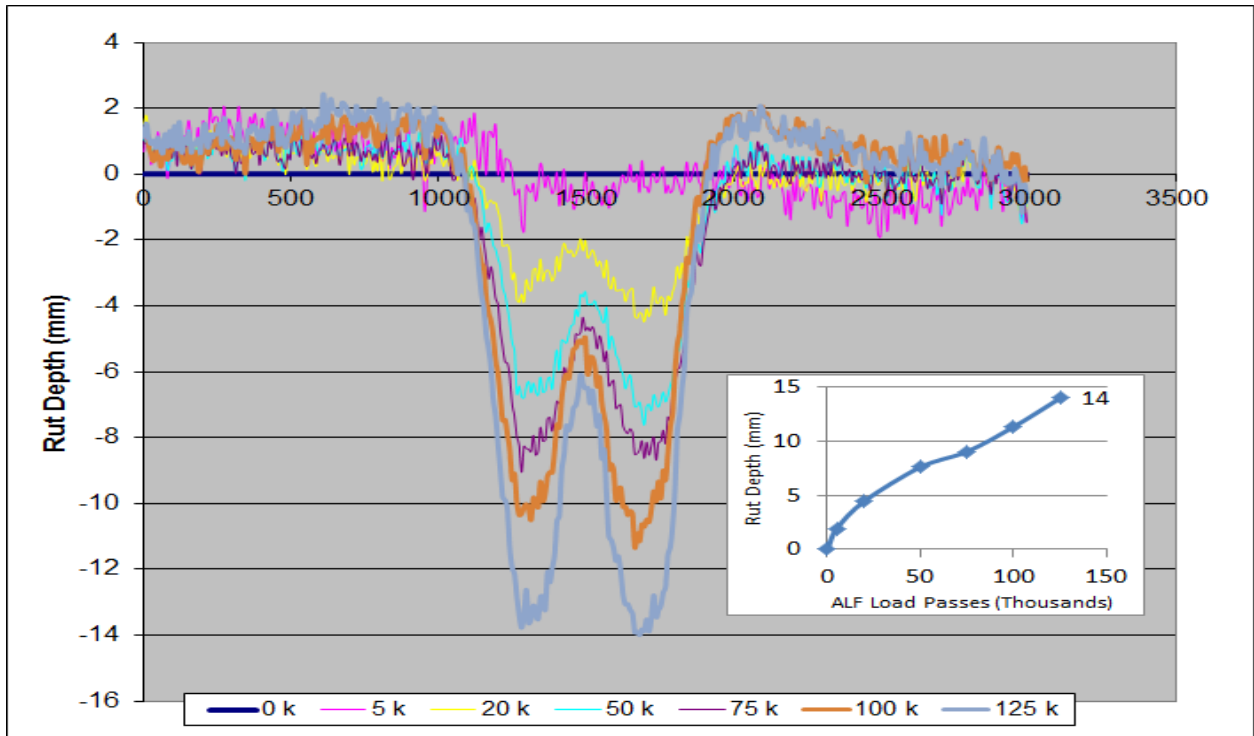
Figure E-3. Transverse Rut Measurements on Control Section 7.

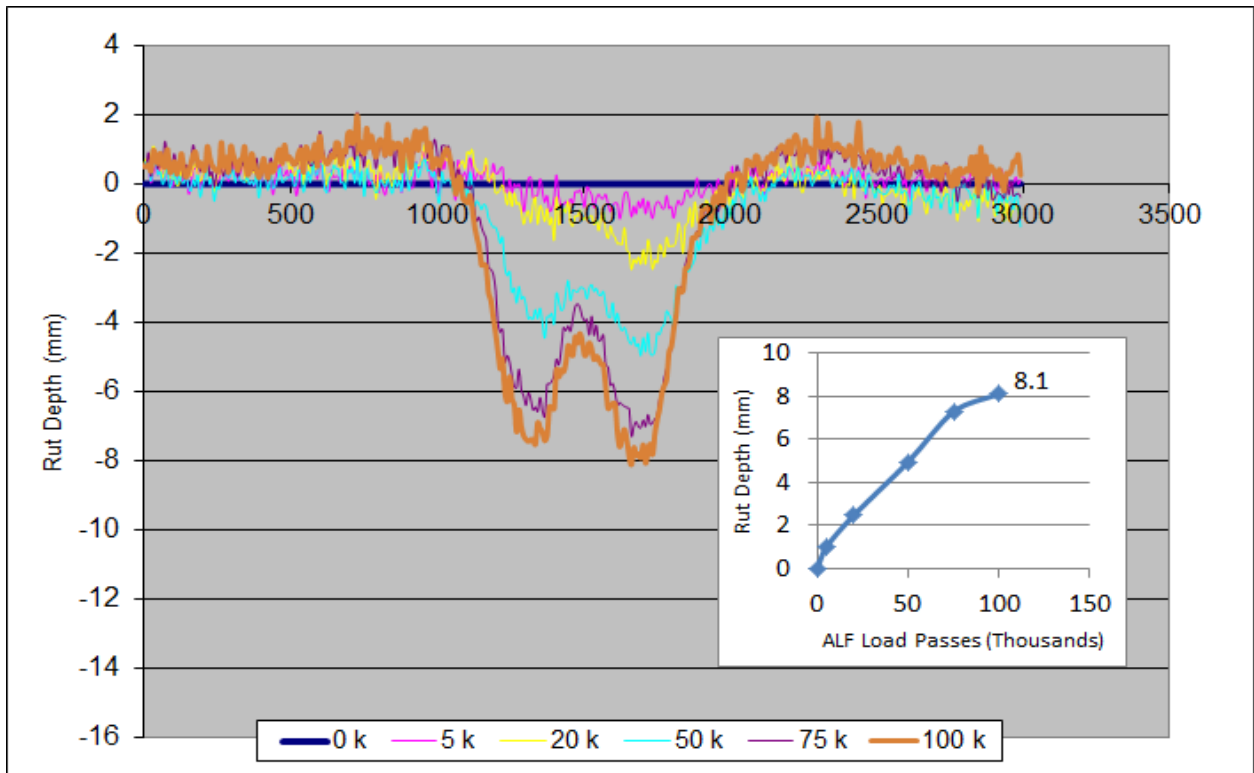
Figure E-4. Transverse Rut Measurements on Modified Section 8.
