1. Report No. FHWA/TX-13/0-6132-3		2. Government Accession No.		3. Recipient's Catalog No.	
4. Title and Subtitle NEW GENERATION MIX-DESIGNS: LABORATORY-FIELD TESTING AND MODIFICATIONS TO TEXAS HMA MIX-DESIGN PROCEDURES				5. Report Date October 2012 Published: July 2013

**NEW GENERATION MIX-DESIGNS: LABORATORY-FIELD TESTING  
AND MODIFICATIONS TO TEXAS HMA MIX-DESIGN PROCEDURES**

Report 0-6132-3

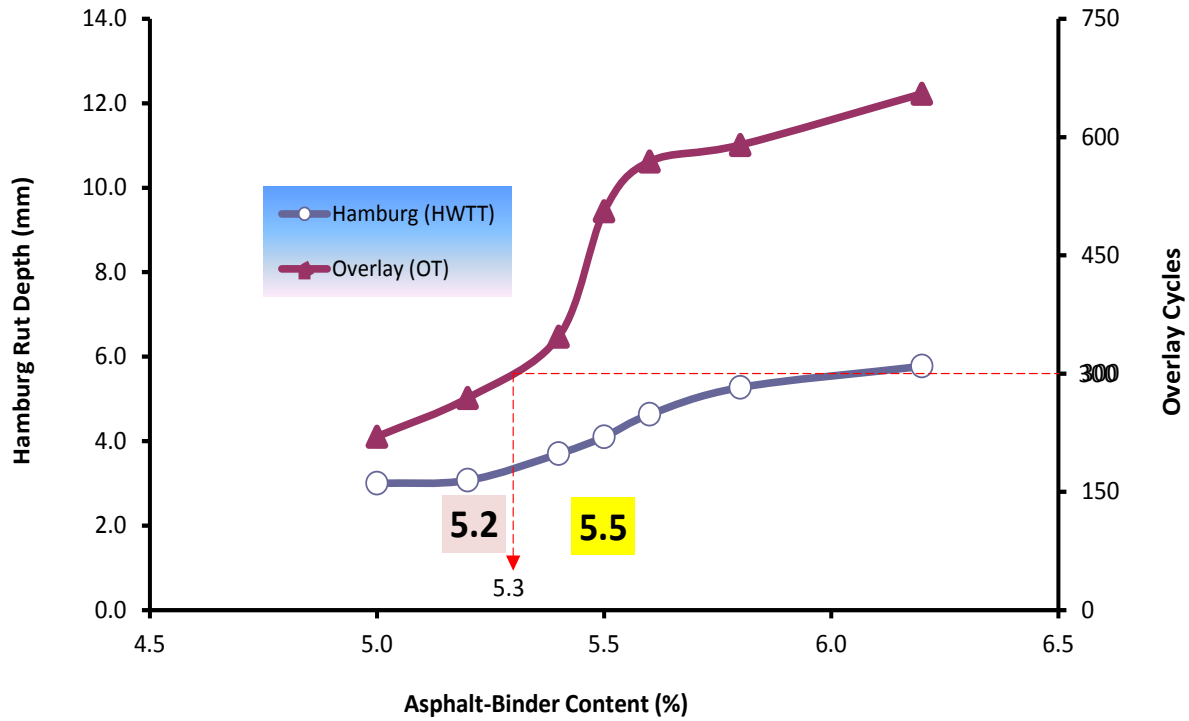
**Figure 4-2. HWTT-OT Lab Results for Type D Mix (ATL).**  
**Table 4-2. TGC Lab Density and VMA Results (ATL).**

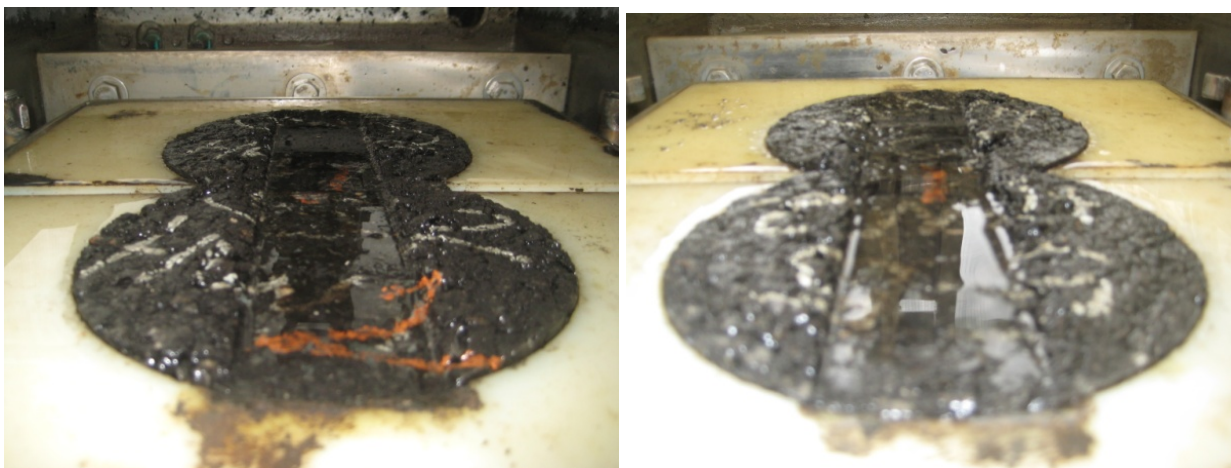
**Figure 4-3. Type D 5.2% AC (3.1 mm) and 5.5% AC (4.1 mm) HWTT Specimens (ATL).**

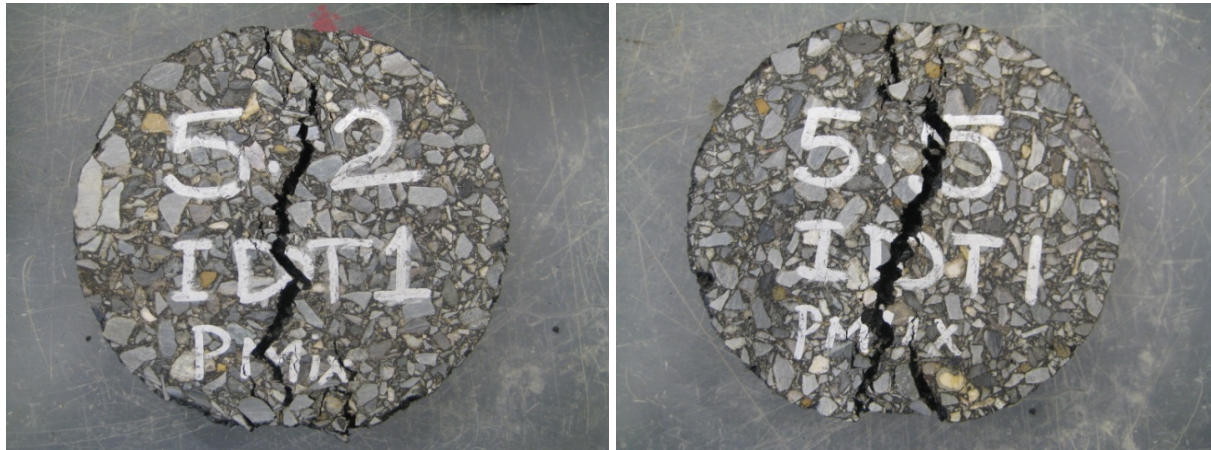
Figure 4-5. Type D 5.2% AC (126 psi) and 5.5% AC (104 psi) IDT Specimens (ATL).

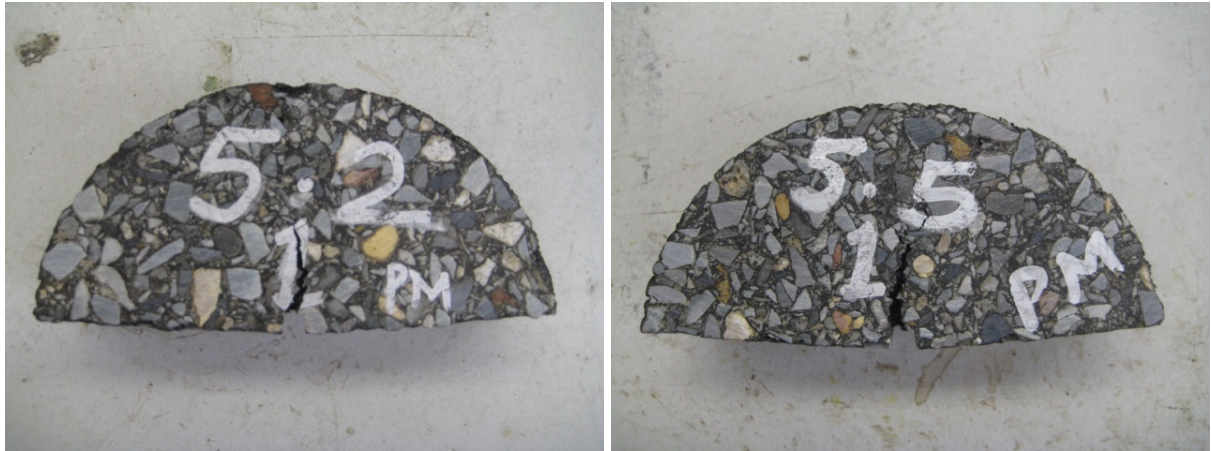
Figure 4-6. Type D 5.2% AC (124 psi) and 5.5% AC (100 psi) SCB Specimens (ATL).

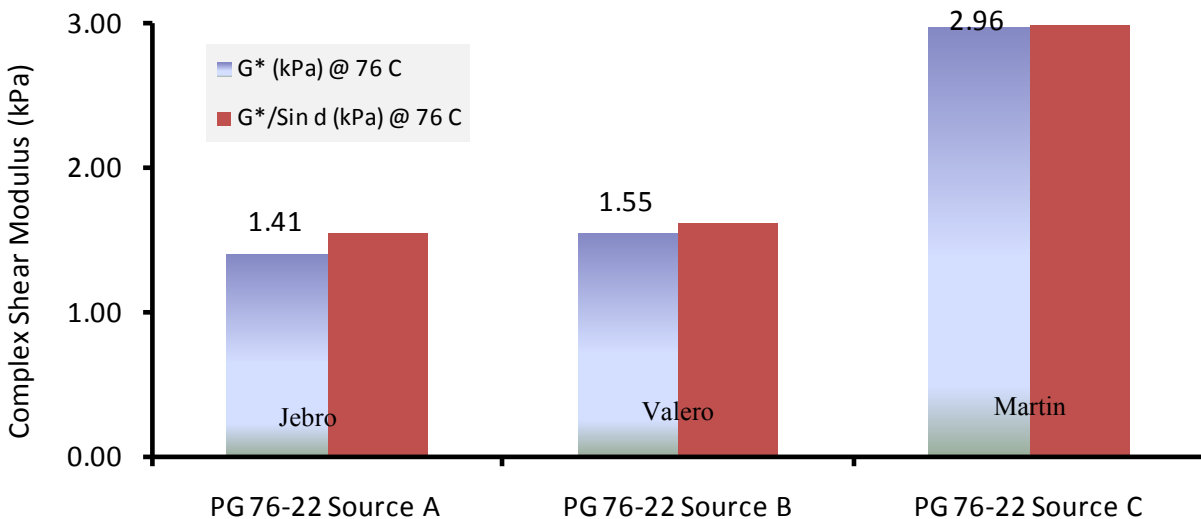
**Figure 4-7. Comparison of Asphalt-Binder Shear Modulus at 76°C.**

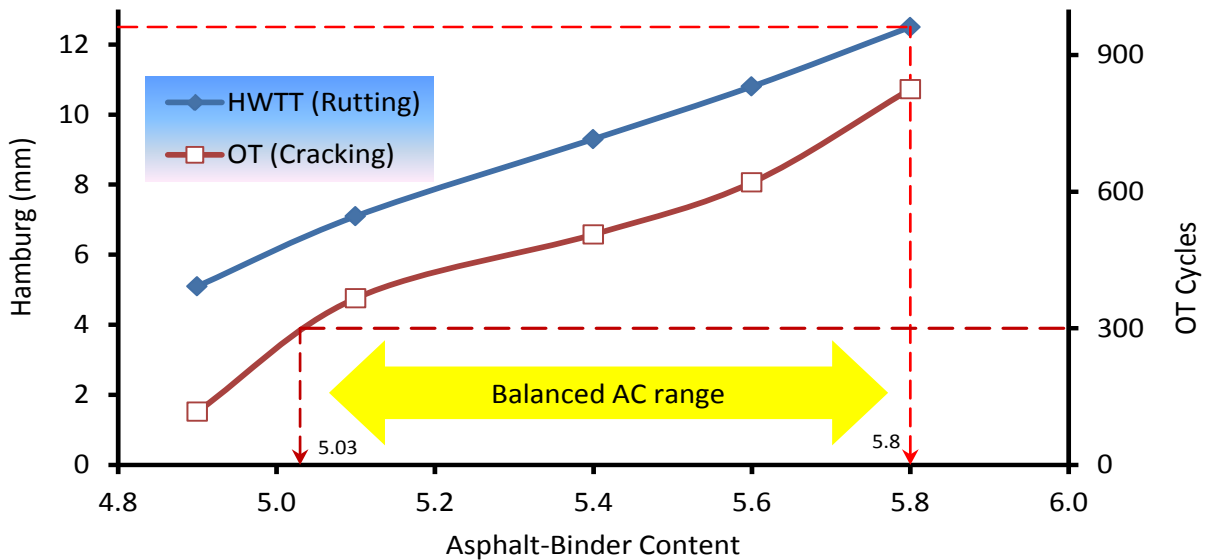
**Figure 4-8. Type D HWTT-OT Lab Test Results (CHS).**

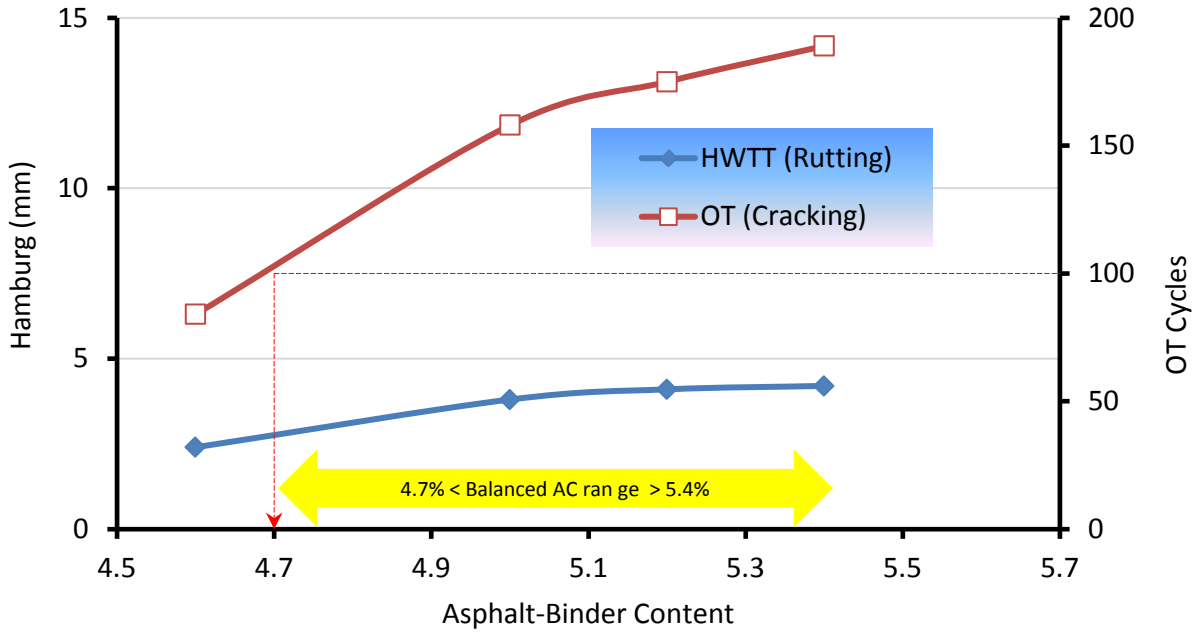
**Figure 4-9. Type D HWTT-OT Lab Test Results (FTW).**

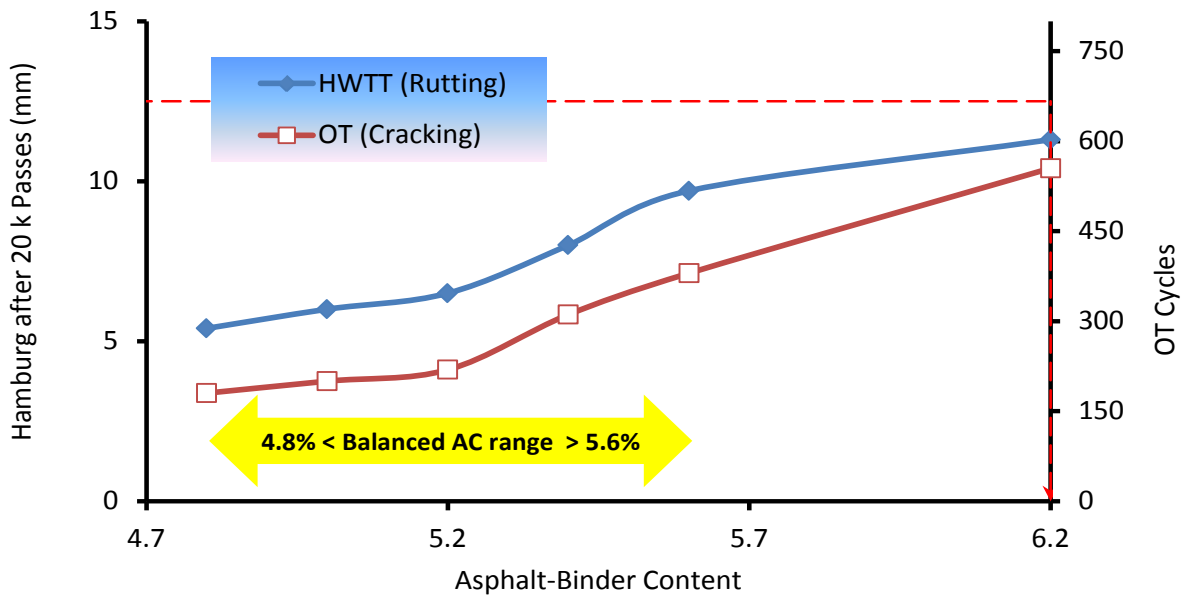
**Figure 4-11. Type C HWTT-OT Lab Test Results (LRD).**

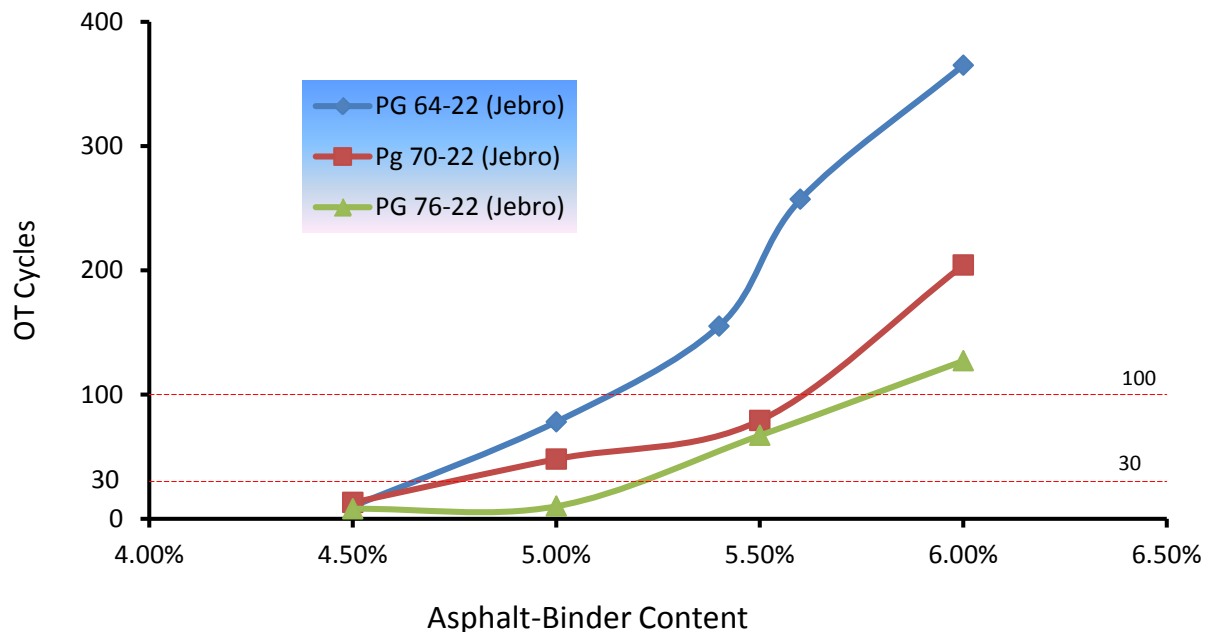
**Figure 4-13. Type C OT Lab Test Results (WAC).**

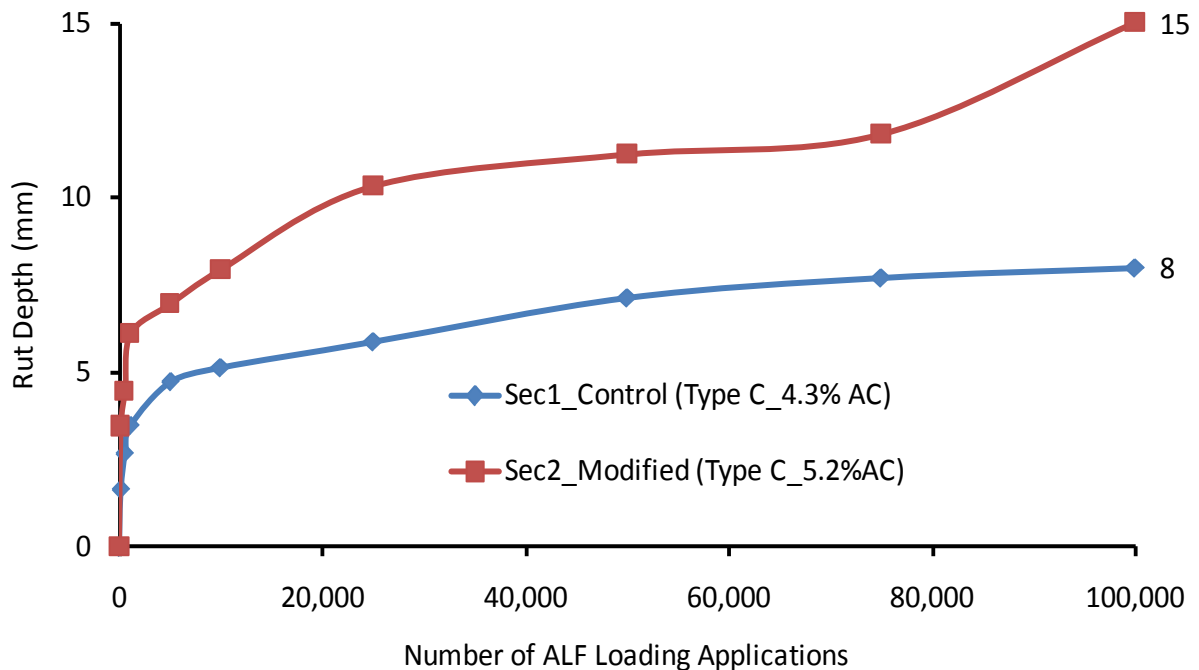
**Figure 5-2. Rutting under ALF Load Trafficking.**

Consistent with the laboratory test predictions based on the BMD method and as theoretically expected, the Modified mix with more asphalt-binder rutted more than the Control mix under ALF trafficking. After 100,000 ALF load passes under equivalent test temperatures, the rut depth measured on Section 2 with the Modified mix (at 5.2 percent AC) was almost 50 percent more than that accumulated on Section 1 with the Control mix (at 4.3 percent AC), i.e., 15 mm versus 8 mm. These results are shown graphically and pictorially in Figures 5-2 and 5-3, respectively.

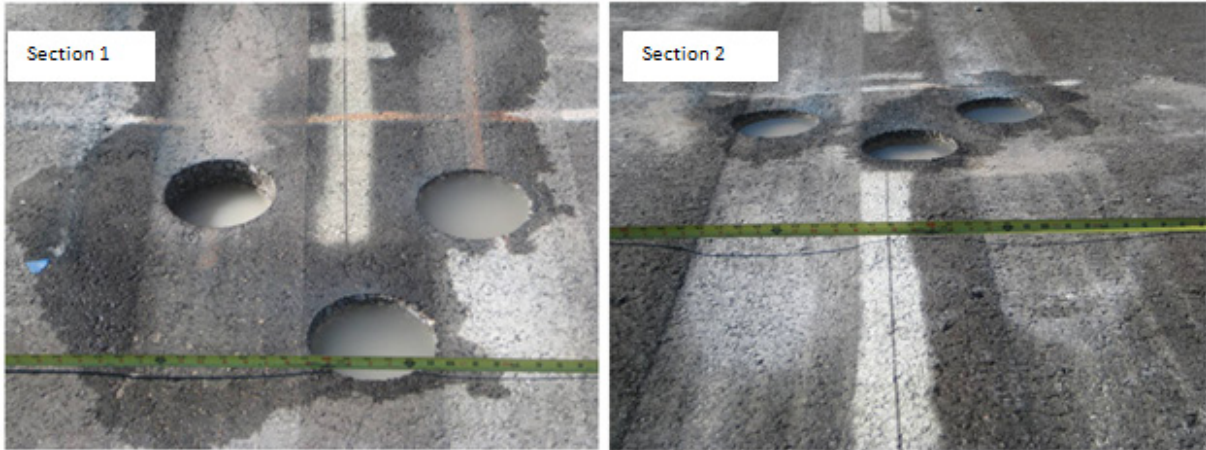
**Figure 5-3. Surface Rutting on Sections 1 (Control) and 2 (Modified).**

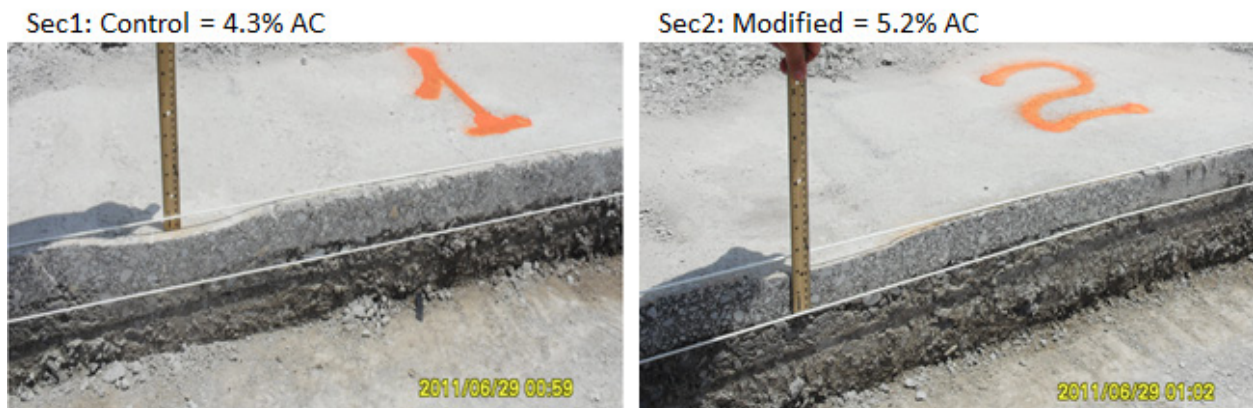
**Figure 5-4. Trenching and Pictorial Comparison of Rutting on Test Sections 1 and 2.**

As shown in [Figure 5-4](#), subsequent trenching of the test sections indicated that all of the deformation was coming from the top HMA layer. Deformation in the base and subgrade was marginal.

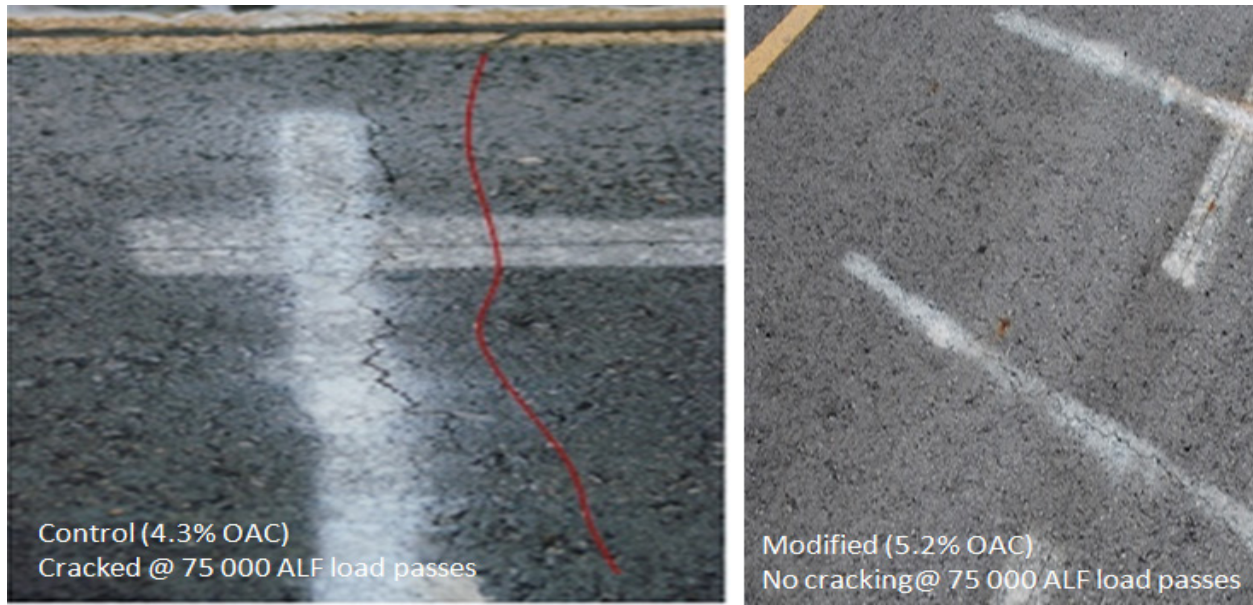
**Figure 5-6. Reflective Cracking Comparison of Section 4 (Control, LTE = 50 Percent) and Section 6 (Modified, LTE = 50 Percent) after 75,000 ALF Load Passes.**

By contrast and in line with the BMD mix-design expectations, no cracking was observed on the Modified Section 6 (poor LTE = 50 percent) even after applying 100,000 ALF load passes and increasing the tire load (from 9.8 kips to 14.6 kips); see [Figure 5-6](#) and [Appendix C](#). For the Modified Section 5 with good LTE (i.e., LTE > 90 percent), no cracking was observed within the trafficked test sections. Cracking manifested only around the joints after 143,000 ALF load passes.

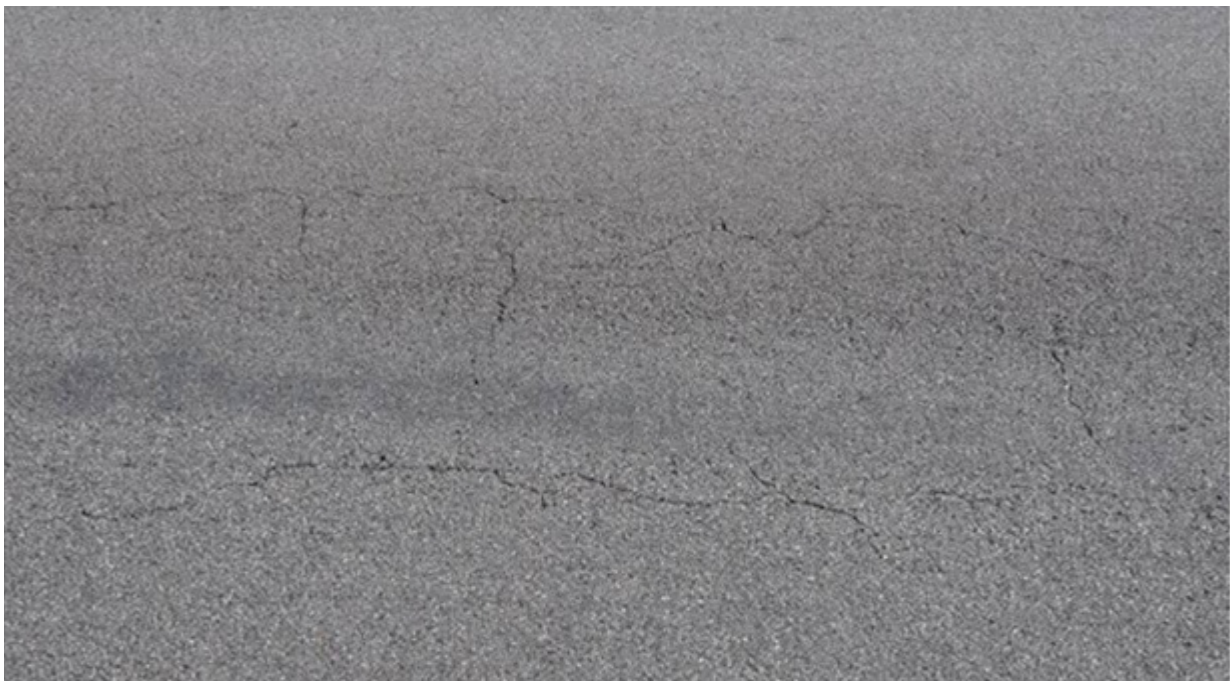
**Figure 6-2. Example of Pre-Existing Cracks on Control Section 01 (ATL).**

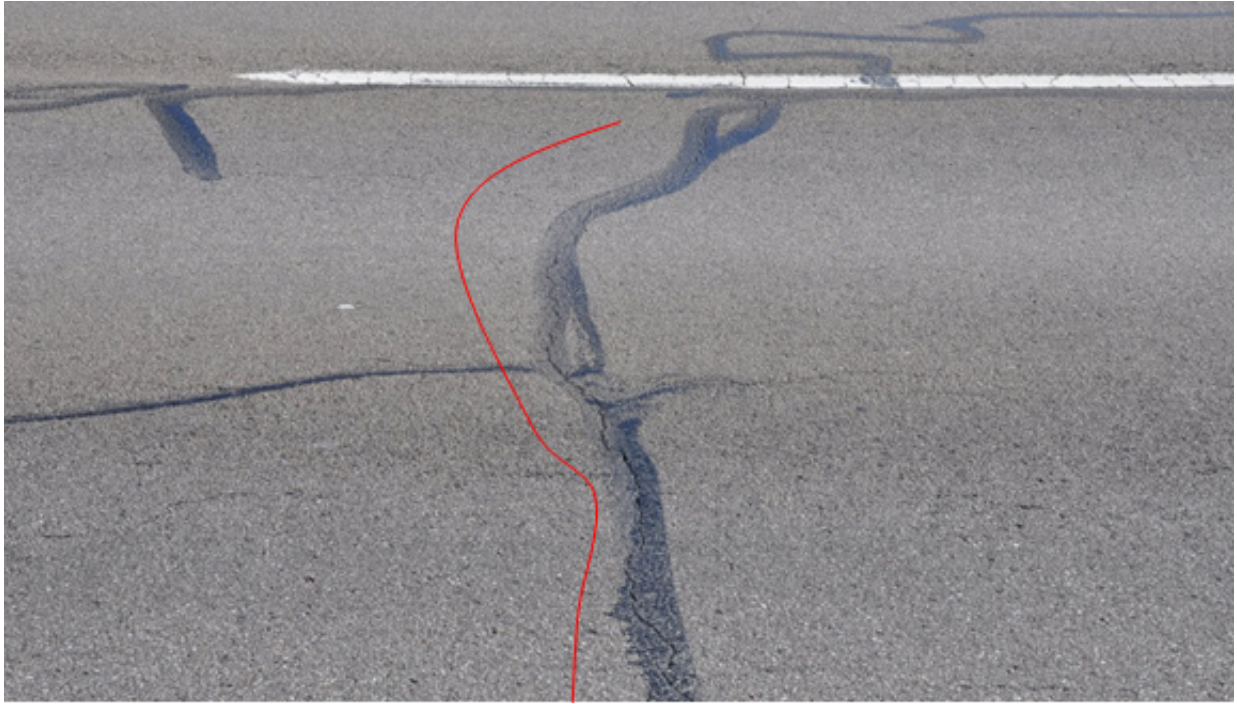
**Figure 6-3. Example of Pre-Existing Cracks on the Modified Section (ATL).**

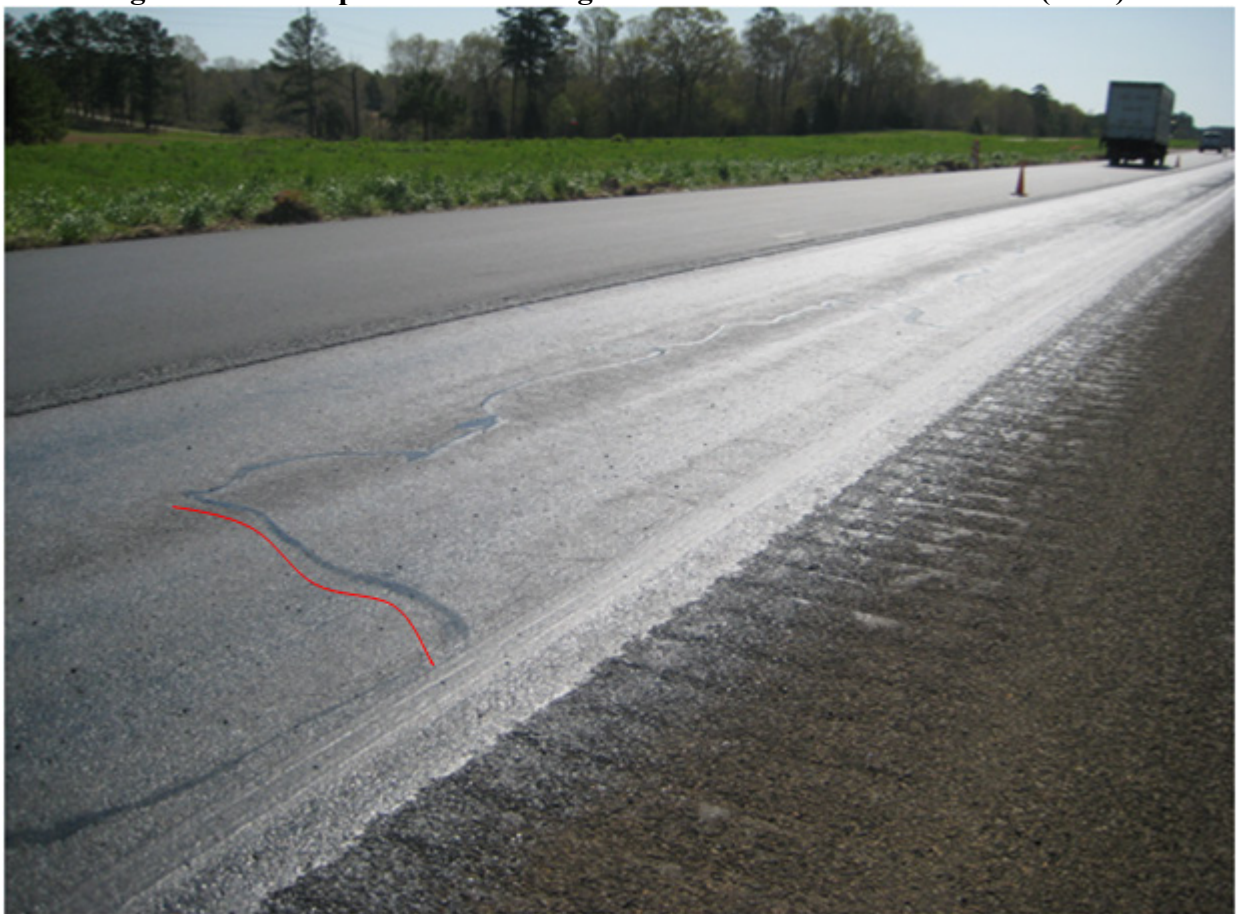
**Figure 6-4. Example of Pre-Existing Cracks on Control Section 02 (ATL).**

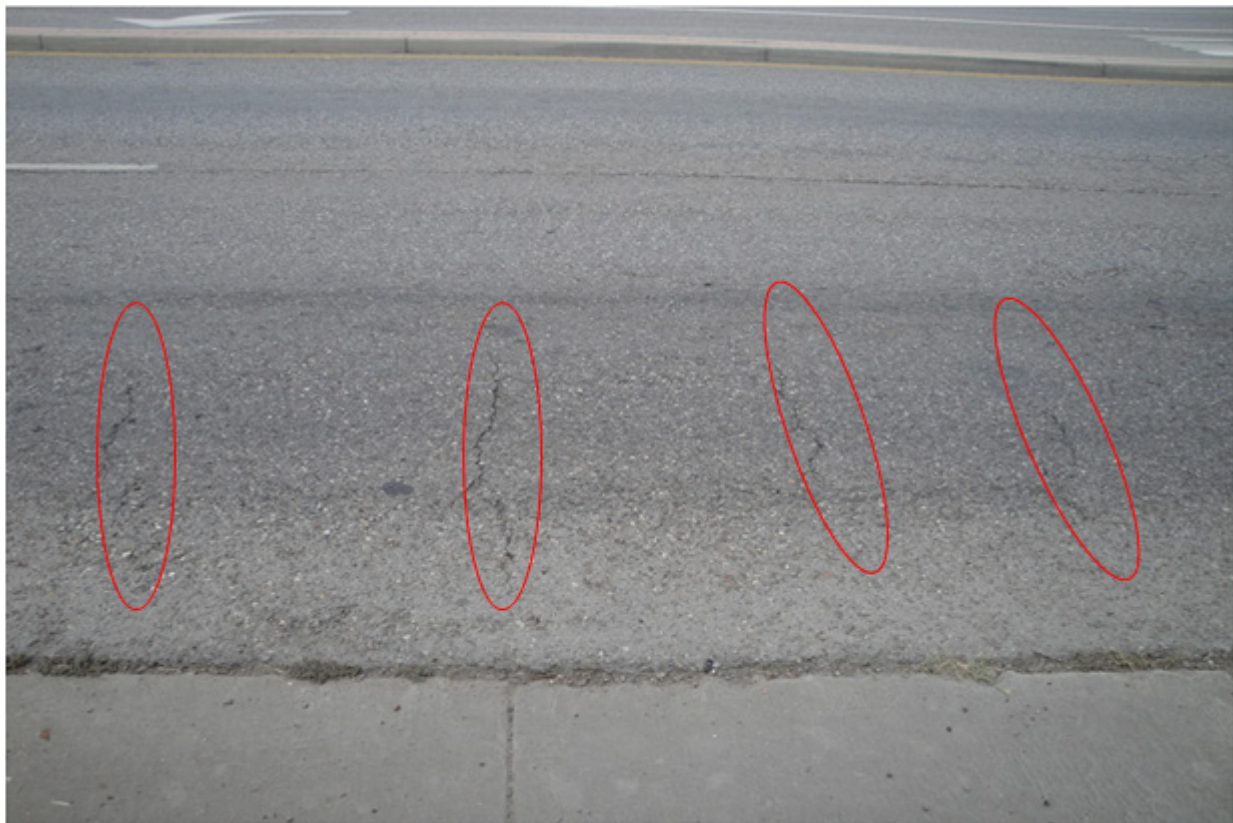
**Figure 6-12. Example of Cracking on US 59 prior to 2 inch HMA Overlay.**

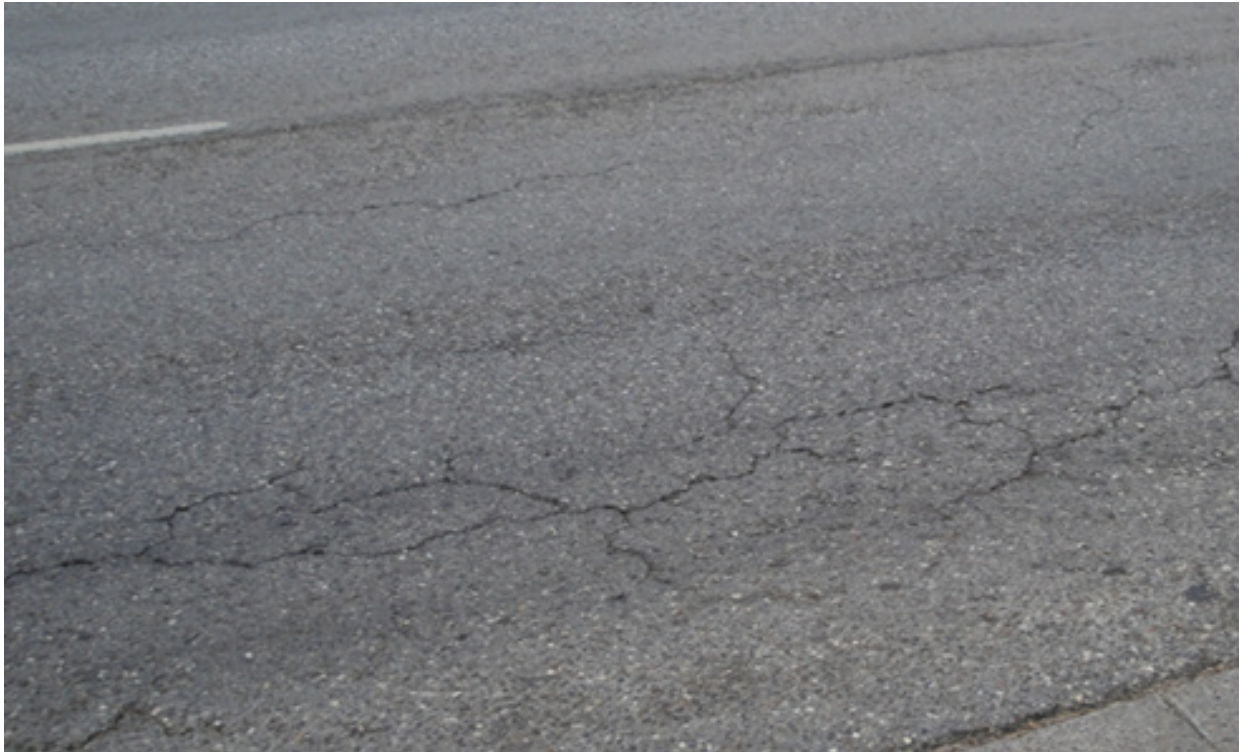
**Figure 6-13. Example of Cracking on Spur 400 prior to 2 inch HMA Overlay.**

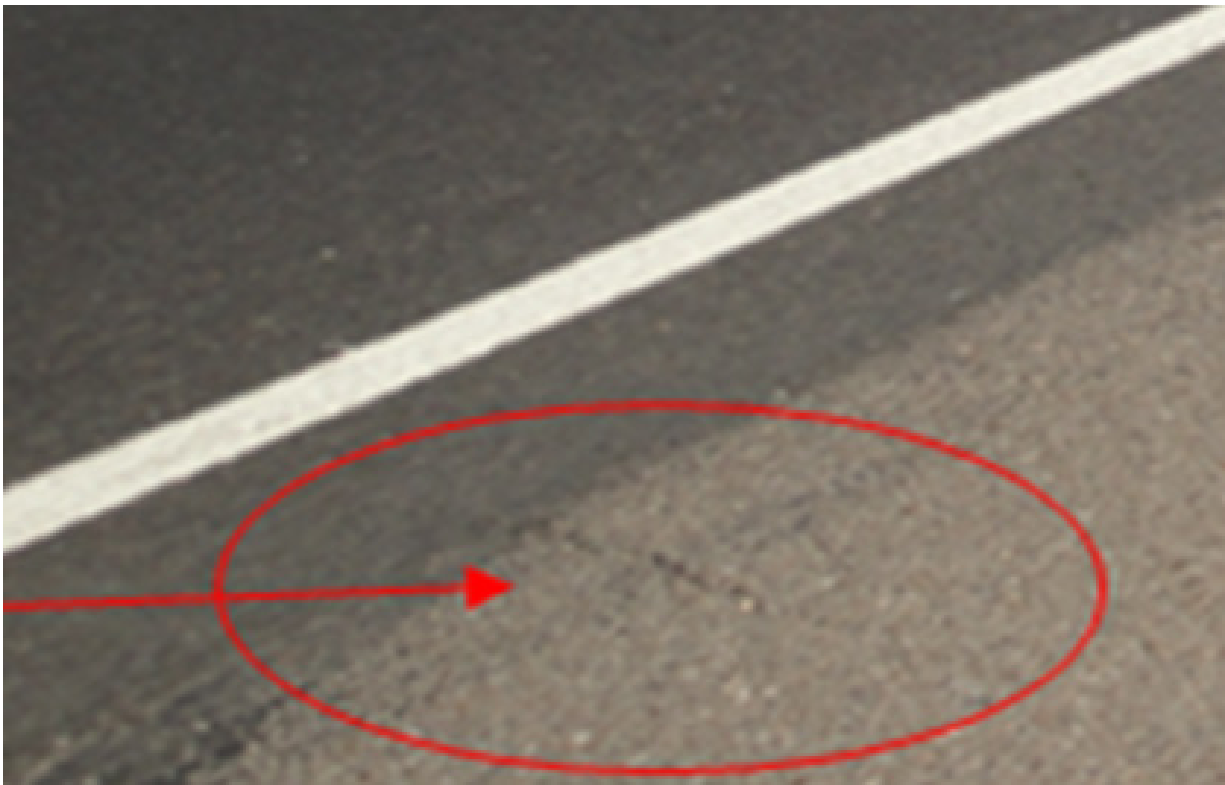
**Figure 6-14. Example of Cracking on Loop 20 prior to 2 inch HMA Overlay.**  
**Construction Monitoring – HMA Placement**

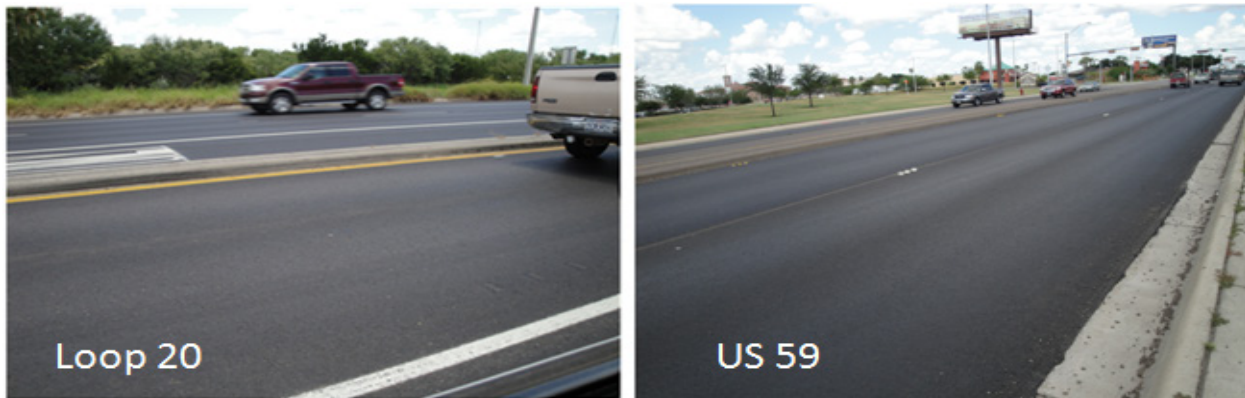
**Figure 6-16. Example Completed 2 inch Thick HMA Mats on Loop 20 and US 59.**  
(5.0%PG 64-22 + Crushed Gravel + 20% RAP + 1% Lime)

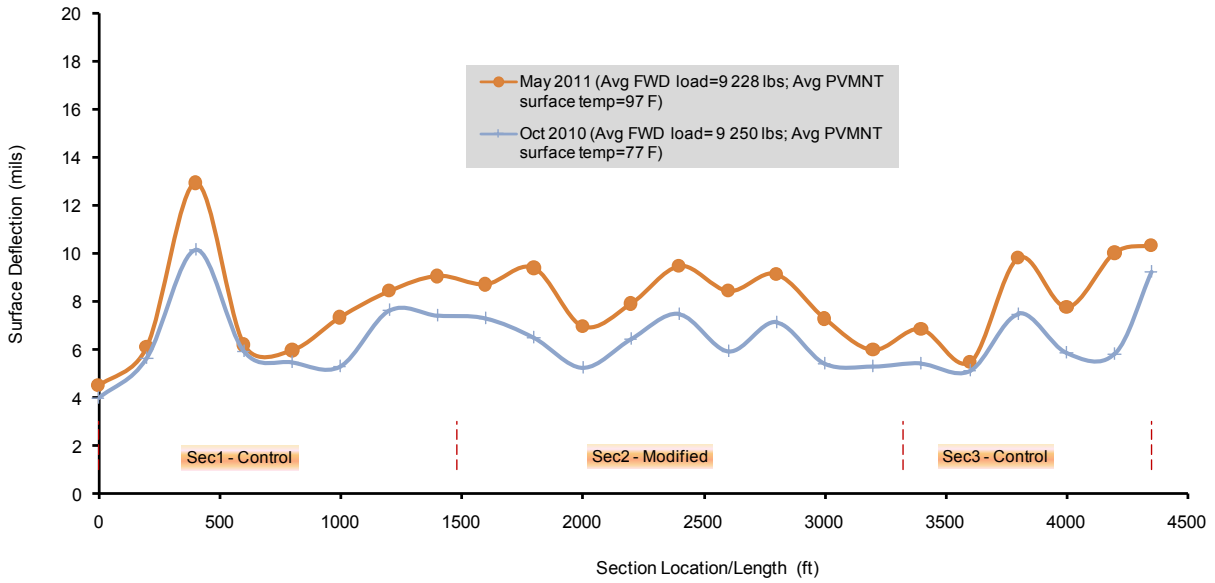
**Figure G-3. Plot of FWD Surface Deflections - ATL.**

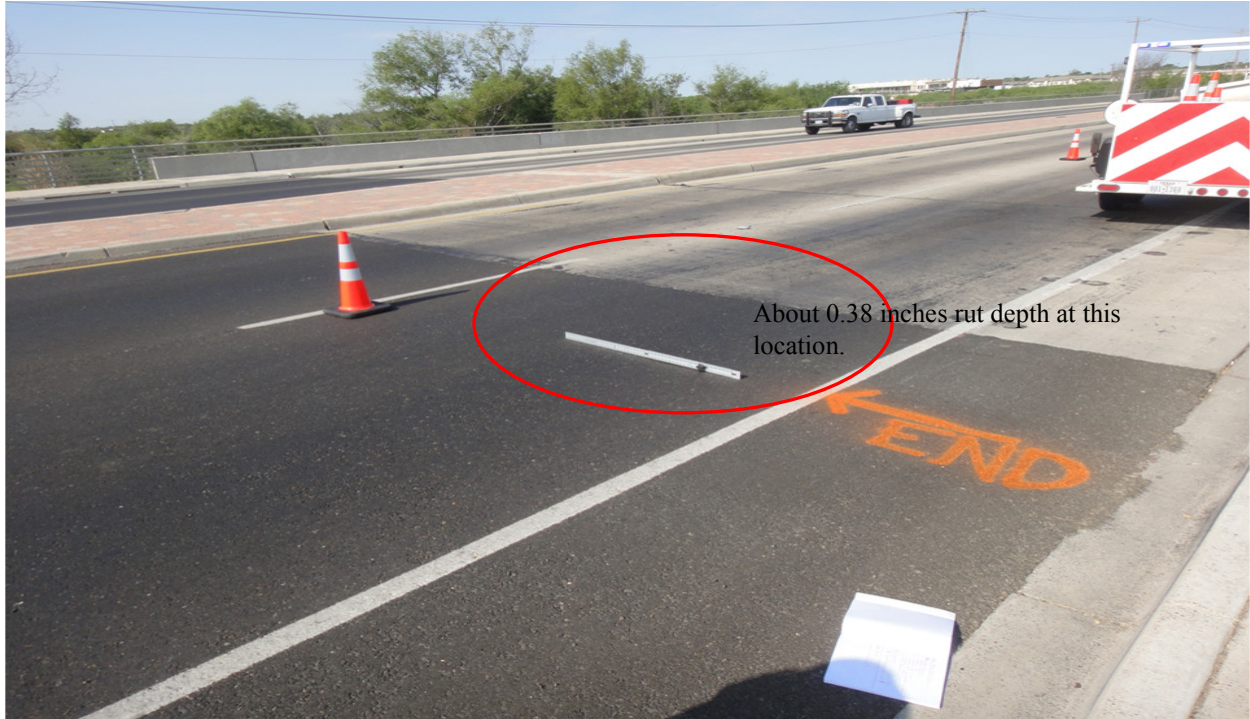
**Figure G-9. HMA to Bridge Concrete Deck Transition  $\cong$  0.38 Inches Rut Depth (Spur 400) - LRD.**
