1. Report No. FHWA/TX-11/0-6271-2	2. Government Accession No.	3. Recipient's Catalog No.	
4. Title and Subtitle FULL-DEPTH RECLAMATION: NEW TEST PROCEDURES AND RECOMMENDED UPDATES TO SPECIFICATIONS		5. Report Date July 2011 Resubmitted May 2012 Published: July 2012

**FULL-DEPTH RECLAMATION:
NEW TEST PROCEDURES AND RECOMMENDED UPDATES
TO SPECIFICATIONS**

The objectives of this final report are to present the work conducted in the final year of Project 0-6271, to address key issues identified, and to make suggested changes to both test protocols and specifications. This report is broken down as follows:

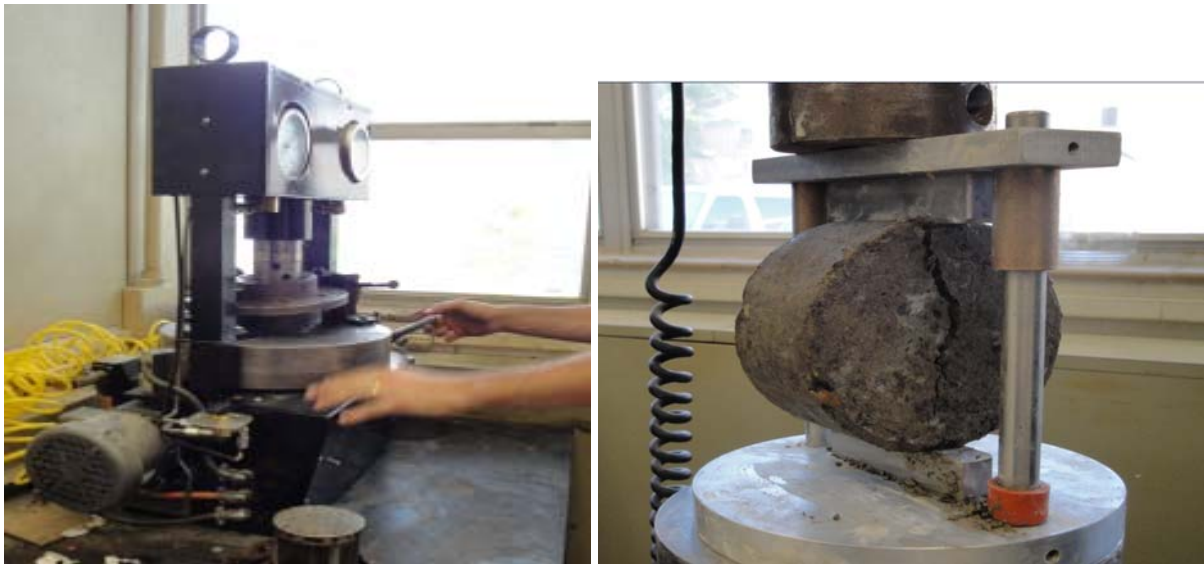
Figure 1.2. Use of the Texas Gyrotory Compactor and IDT Test for FDR Design.

This chapter explores preliminary ideas to use much smaller samples and accelerated moisture conditioning. These concepts are based on the procedures that Wirtgen, Inc. (Marshall 2010) had recommended. [Figure 1.2](#) below shows the basic concept, where the current Texas Gyrotory press is used to mold 4-in. diameter by 2-in. high samples to a required density. These samplers then cure for seven days (in the case of cement) and are then tested in the indirect tension test. For a typical test sequence, six samples are prepared and cured for seven days and three samples are submerged in water for four hours prior to testing so a wet versus dry indirect tension (IDT) strength can be measured. [Appendix A](#) contains complete details of the sample preparation procedures and a draft test procedure for running the IDT test on these samples.

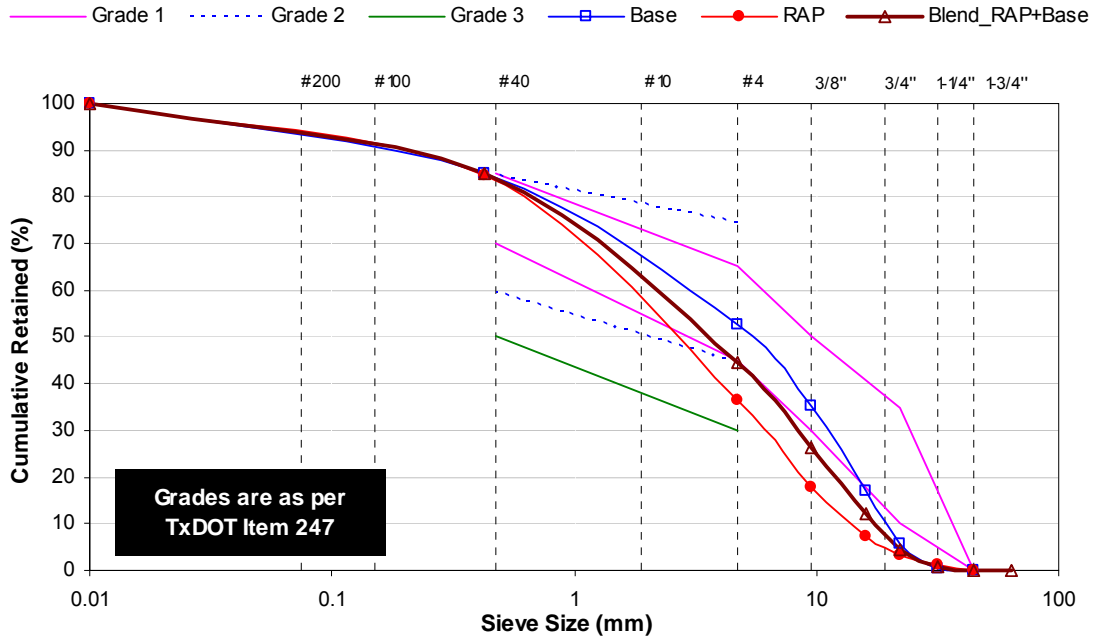
Figure 1.4. Gradation Analysis of US 60.

Figures 1.4 through 1.6 show material gradation analyses of RAP, existing flexible base materials, and blend of these materials for US 60 (Lubbock), US 70/84 (Lubbock), and FM 552 (Dallas) roadways. For US 60, flexible base material belongs to Grade 1, while the RAP material is affiliated with Grade 3, as TxDOT Item 247 specified. A gradation analysis of US 70/84 is the complete opposite of US 60. The flexible base material of FM 552 is not affiliated with any categories of Grade 1 though Grade 3 because the material retained 90 percent on the No. 40 sieve; the specification maximum is 85 percent cumulative retained on the No. 40 sieve. However, the RAP material complies with the Grade 2 gradation band.

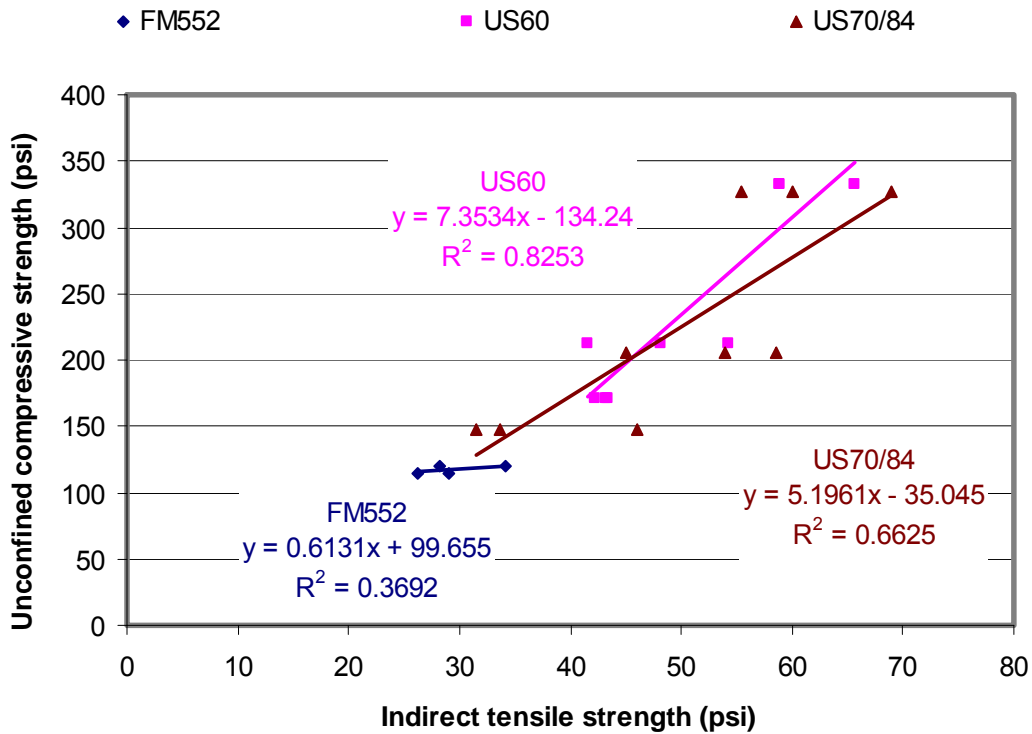
Figure 1.8. Comparison of UCS and IDT for Each Road Mixture.

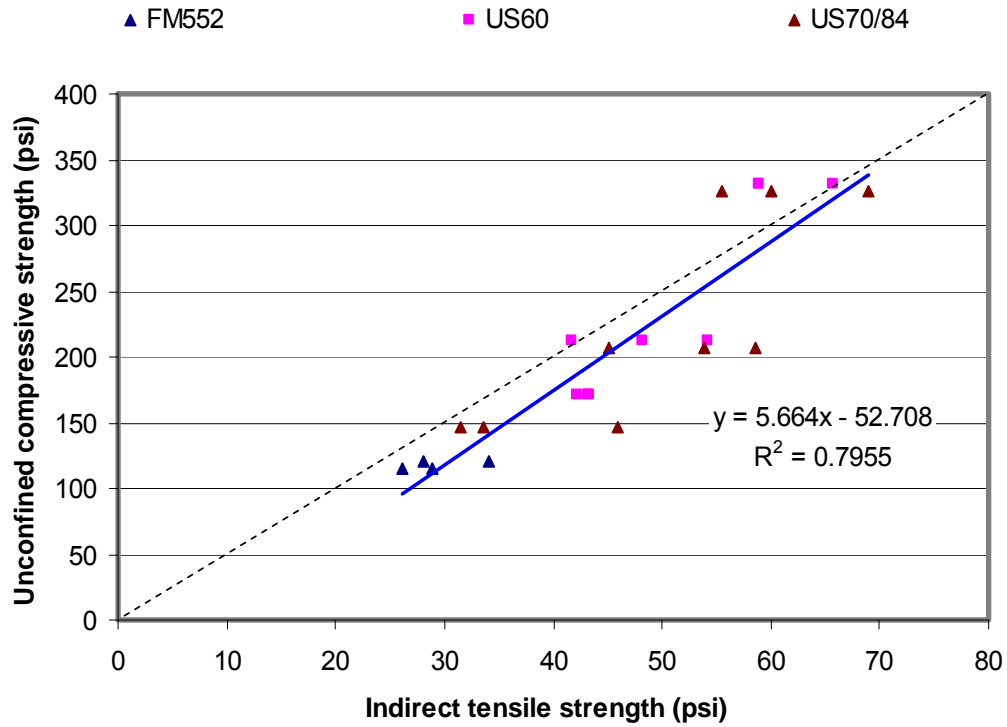
Figure 1.9. Relationship between UCS and IDT through All Points.

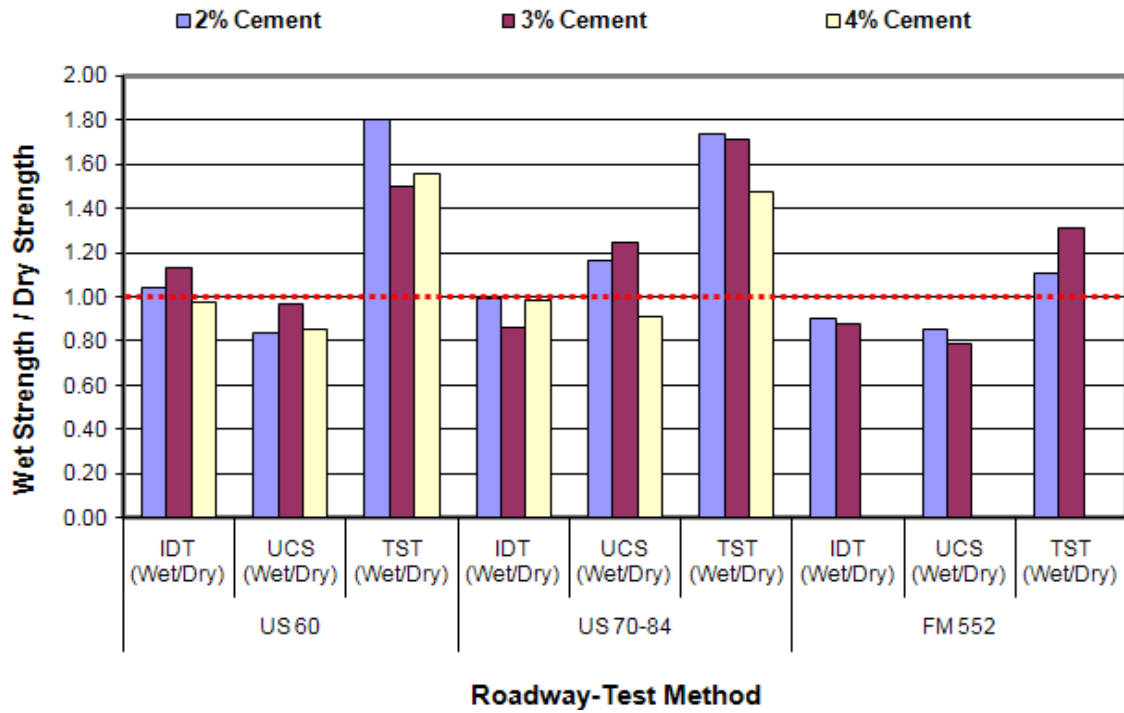
Figure 1.10. Relationship between UCS and IDT through All Points after Dunk Test.

Figure 1.10 shows the comparison between wet/dry strengths for a range of moisture conditioning. TxDOT procedures currently use the TST wet/dry, where the wet strength is the UCS measured after the 10-day capillary rise in the Tube Suction Test. The IDT and UCS wet strengths are measured after the samples were submerged for four hours. For all of the TST results, the wet strengths are always substantially higher than the dry strengths (this is the TTI researchers' experience from other work; this criteria very rarely fails with cement). The 4-hr dunk test appears to give similar results, and seems more severe from this data set. No criteria are currently established for the 4-hr dunk and more data should be collected, but a retained strength of 80 percent of dry strength seems reasonable.

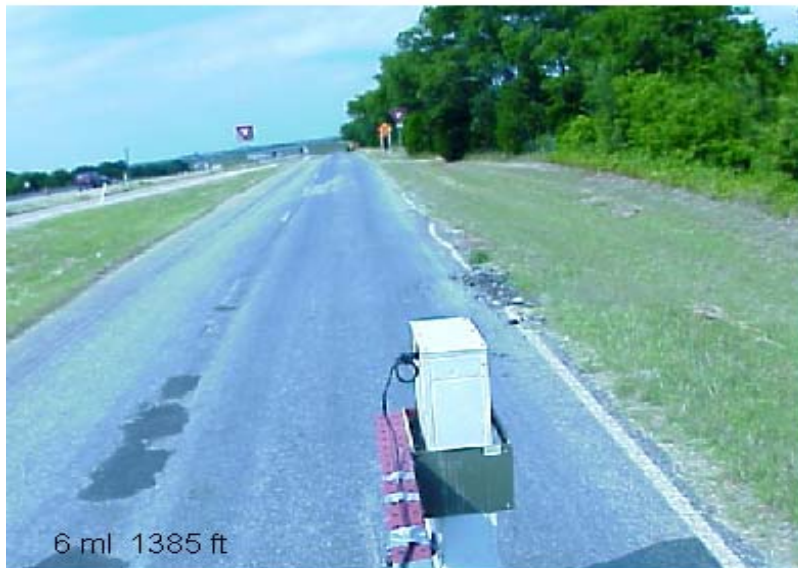
Figure 1.11. Distressed Condition of IH 35 Frontage Road in Dallas District.

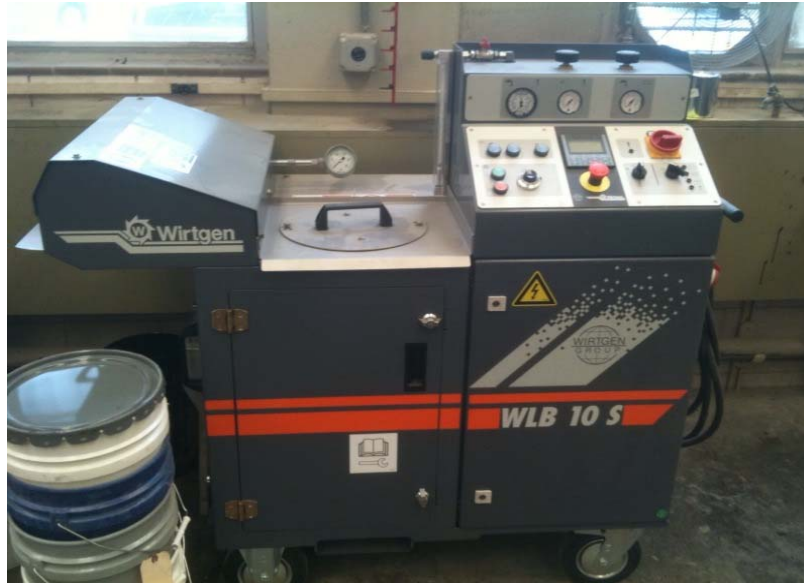
Figure 1.12. TTI’s Foaming Equipment.

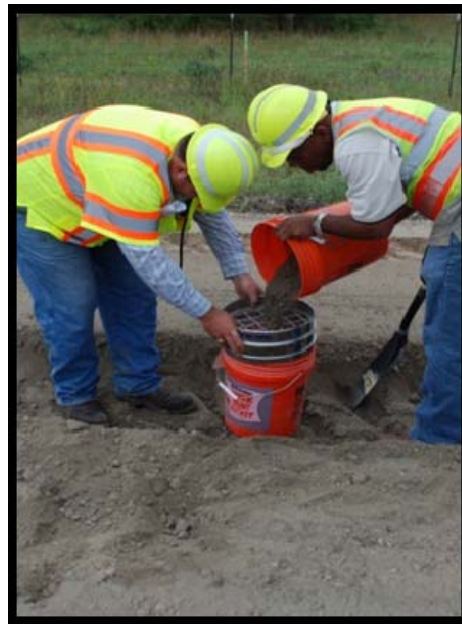
Figure 2.2. Checking Field Pulverization by Sieving.

By performing thorough up-front testing and planning the project in a manner to produce a relatively homogenous pavement structure as described in Product 0-6271-P2, the thickness and variability of the pavement structure can be controlled. Once in the field, attainment of the proper pulverization can be checked simply by sieving as [Figure 2.2](#) shows.

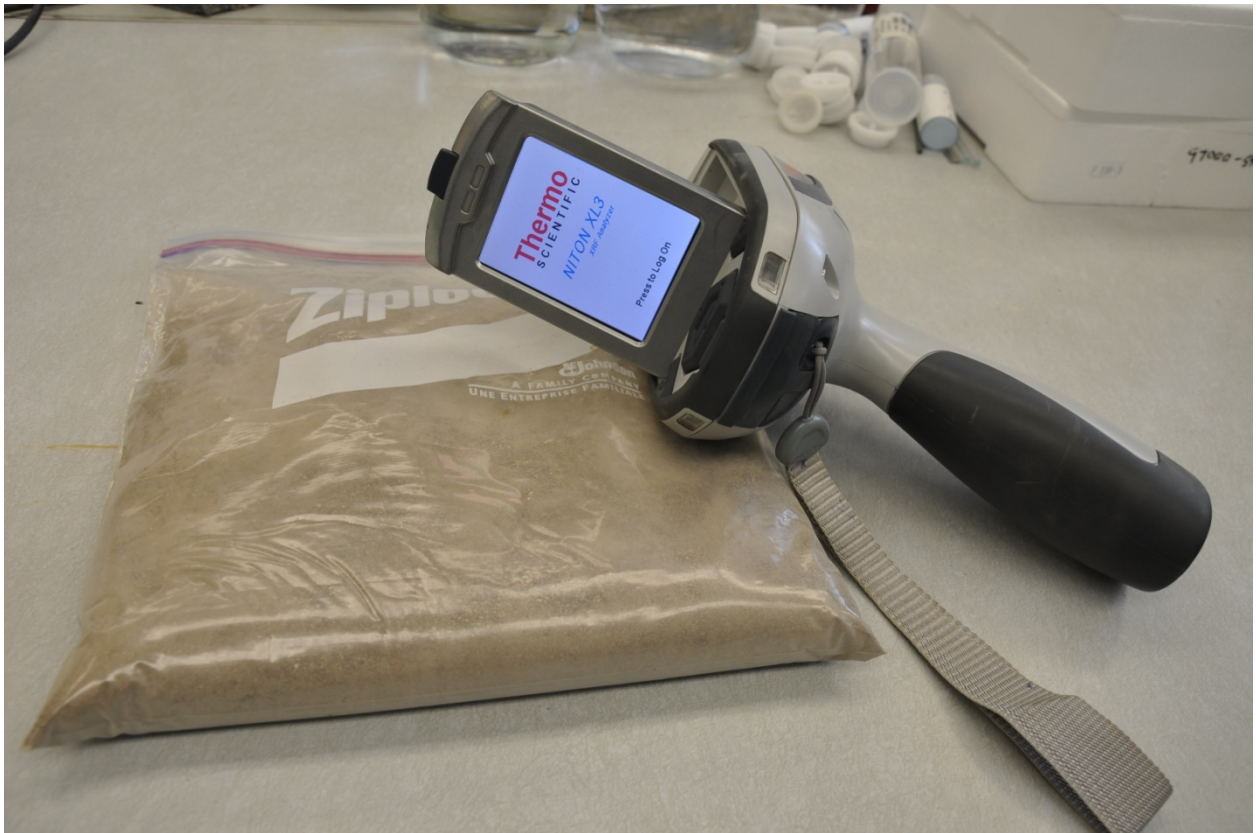
Figure 2.4. Portable Handheld XRF Analyzer and a Soil Sample Used in Study.

The first phase of the study evaluated the instrument's response to calcium from different sources. Instrument response to two Ca-based stabilizers (lime and cement) and two sources of soil calcium (Gypsum- $\text{CaSO}_4 \cdot 2\text{H}_2\text{O}$ and Calcite- CaCO_3) were evaluated. Samples were prepared by mixing each Ca-based material with bentonite clay (in a 1L Ziploc® bag) to produce mixtures containing 1–8 percent lime, cement, gypsum, or calcite. After thorough mixing, samples were analyzed for calcium (Soils mode) at five random locations across each Ziploc bag (Figure 2.5). Analysis time was 2 min per location for a total of 10 min per sample.

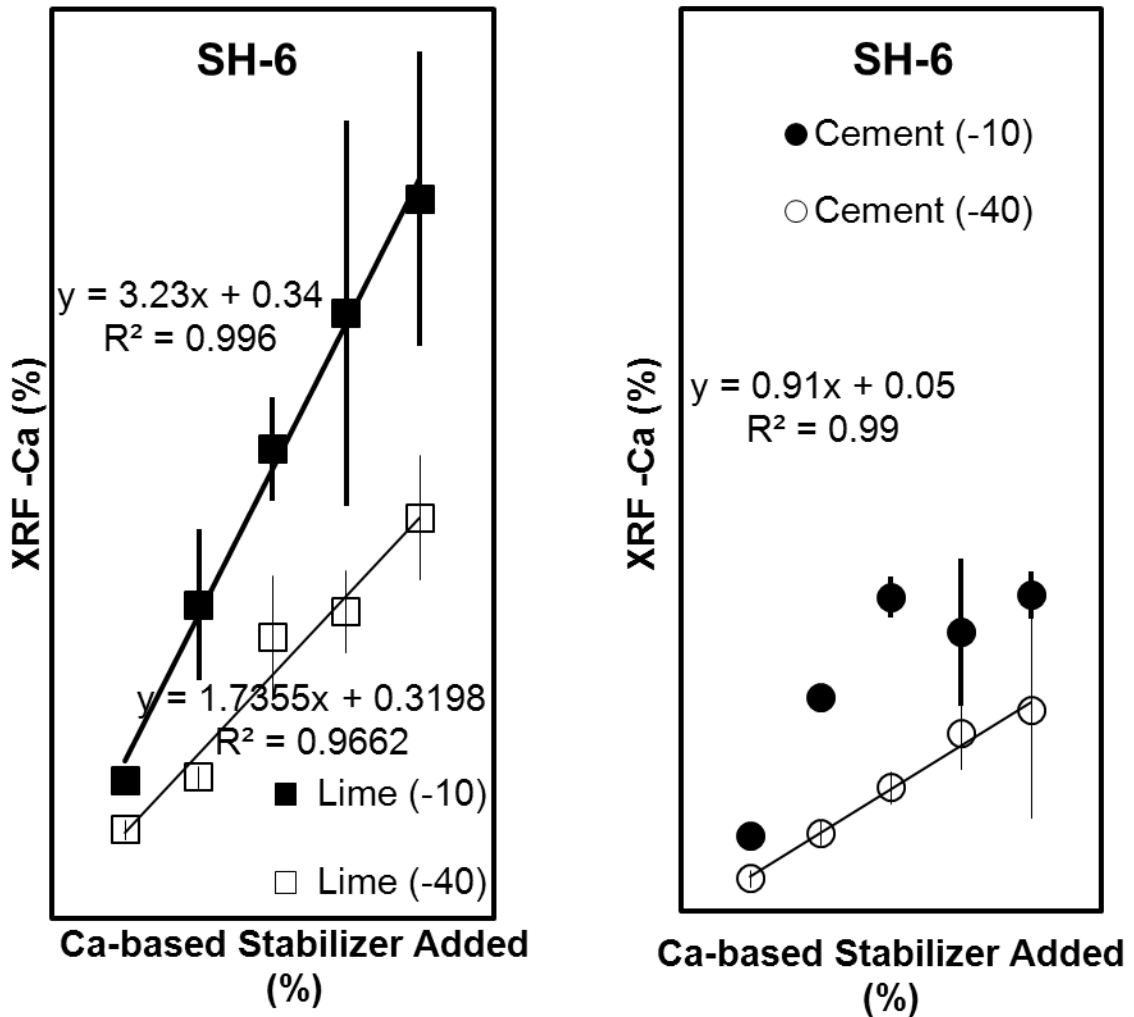
Figure 2.10. Relationship between XRF-Ca and Stabilizer Content for -10 and -40 Fractions of SH 6 Study Soil.

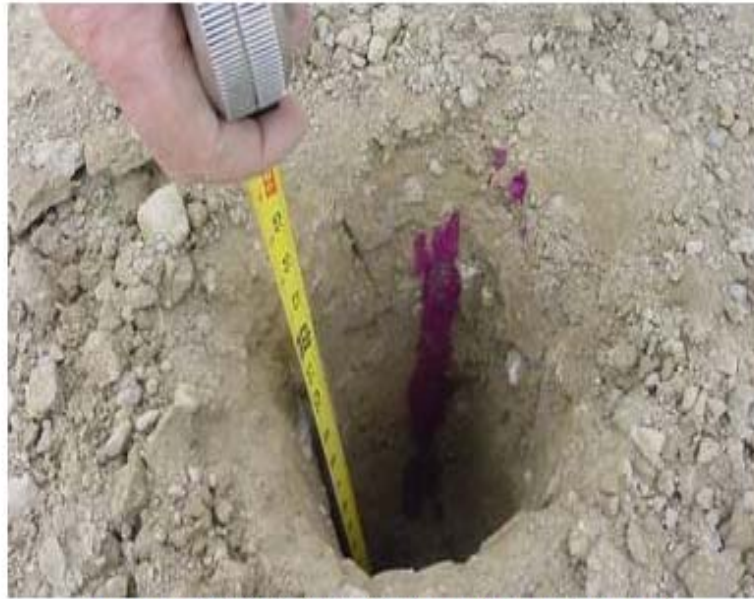
Checking depth of soil stabilization with phenolphthalein

The work presented above found that the phenolphthalein test was not feasible to be a definite indicator of the amount of stabilizer used in an FDR project. Phenolphthalein remains a useful go/no-go indicator (see [Figure 2.14](#)). The best use is in auger holes to determine if the stabilizer is mixed to the depth required in the pavement design.

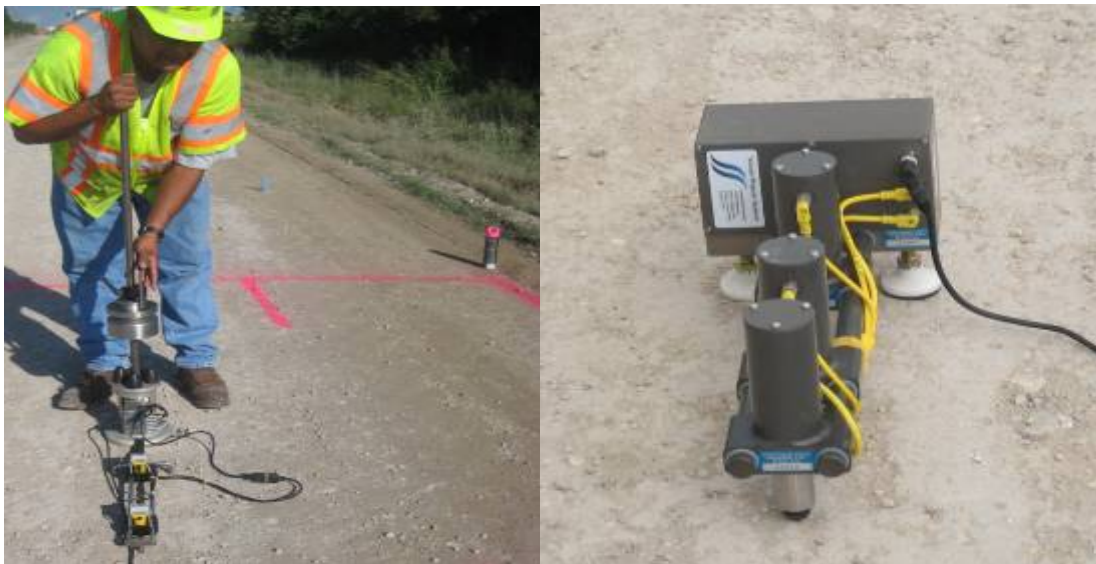
Figure 2.19. Portable FWD and Seismic Test Equipment.

While TxDOT uses field density measurements for compaction testing and acceptance, limited work in this project was conducted employing a PFWD and PSPA for tests on FDR layers after compaction. Since the stiffness and modulus values of stabilized layers are constantly changing during the curing period, the research team concluded that identifying target values for compaction of stabilized layers was impractical. Additionally, even if the “true” target could be identified, few practical options exist for reworking stabilized layers. Also, under normal curing operations the surface is kept moist during the first three days. Stiffness needs to be checked during this time. Other concerns were also raised about the poor repeatability of measurements with the coarse textured surface. [Figure 2.18](#) shows the grid arrangement used on FM 2502 to check the different NDT devices shown in [Figure 2.19](#).

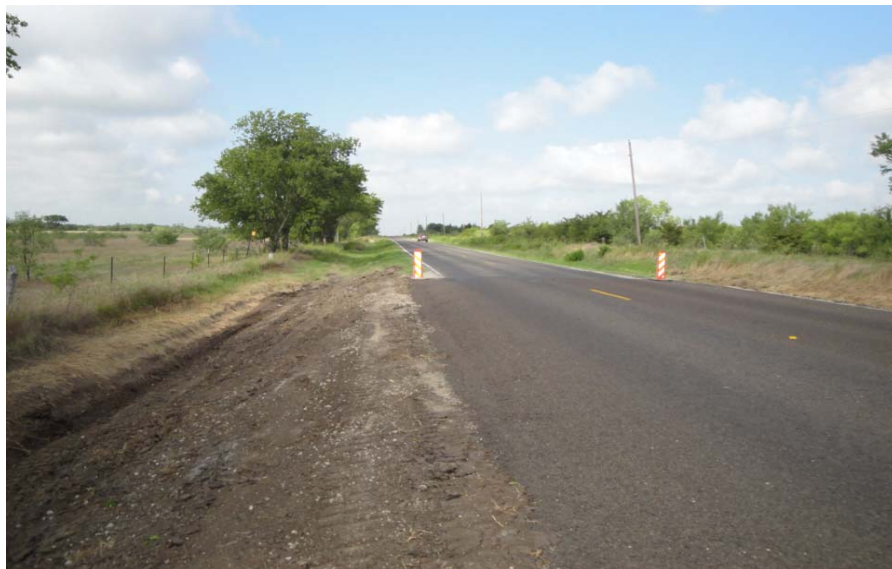
Figure 2.21. Partially Completed FM 148 Verification Testing of First 1.1 Mile.

Figure 2.21 shows the prediction for the FDR project completed in Dallas on FM 148. The FWD testing was to be completed on top of the flexible base layer on the underseal, but before the final HMA surfacing was placed. In the graph shown in Figure 2.20 the maximum deflection allowable should be 31 mils. The FWD data can be collected and compared with this value.

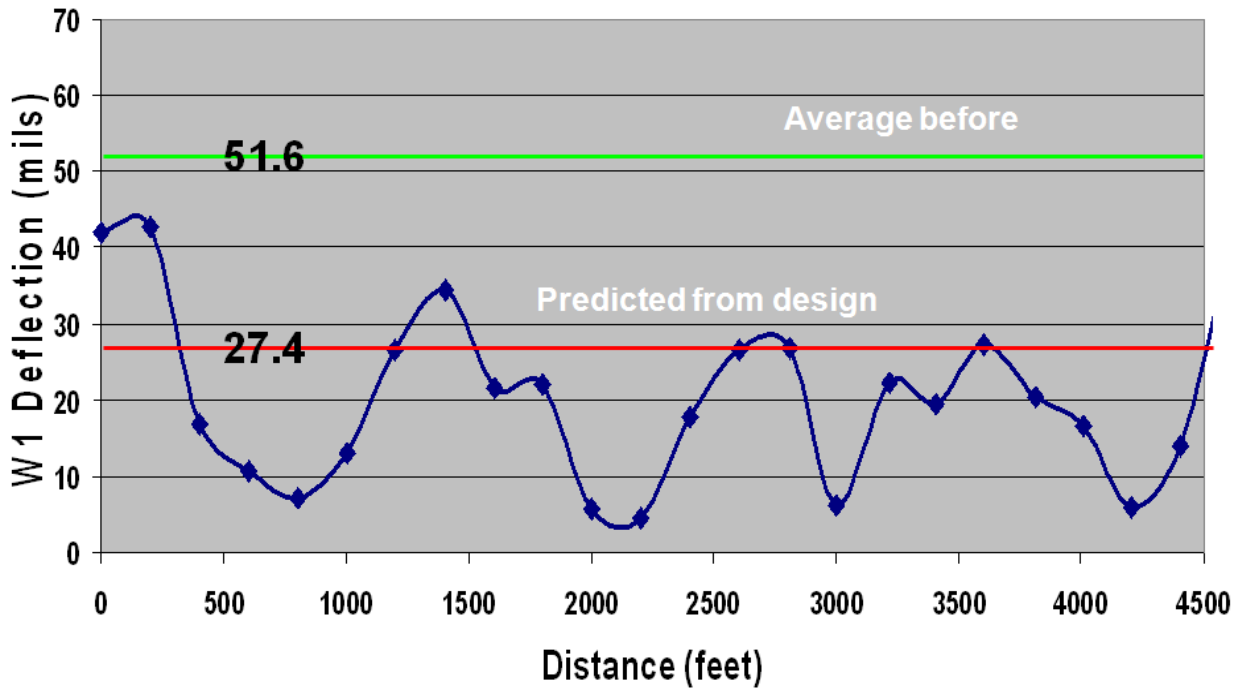
Figure 2.23. Validation Test Results from a Marginal Project (Equipment Problems).

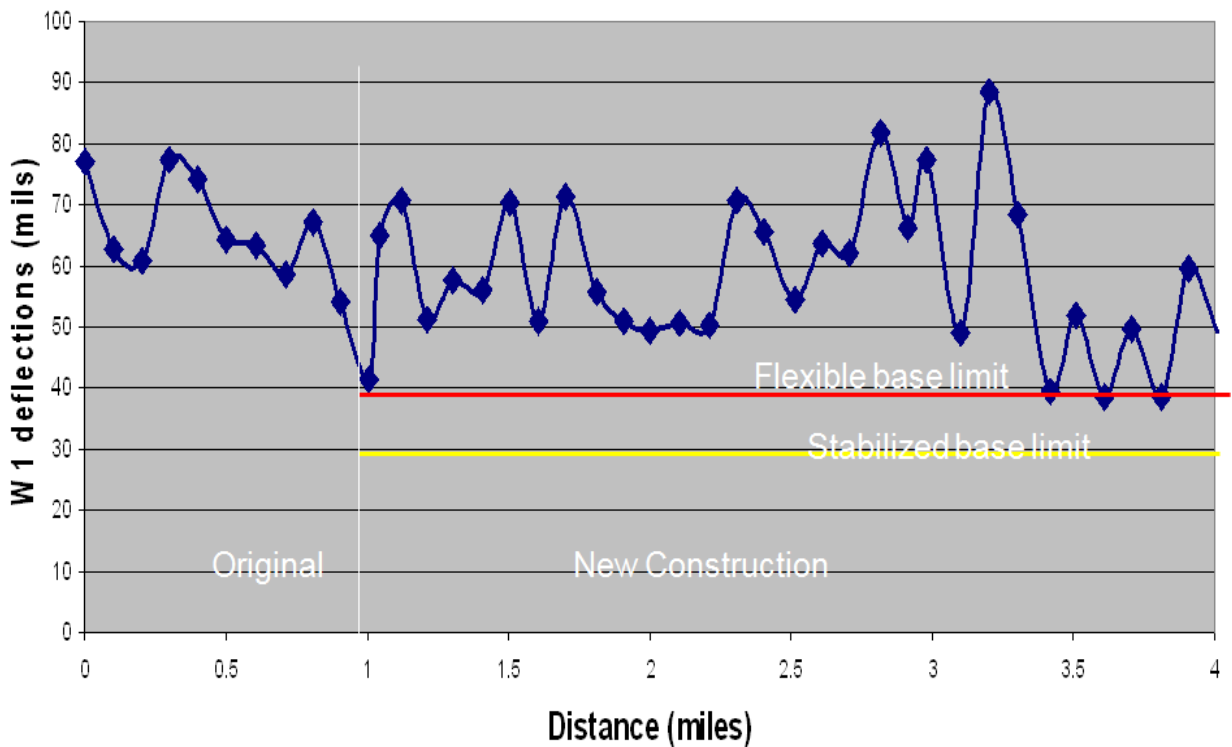
Figure 2.24. Validation Results from a Section that Failed Two Months after Completion.

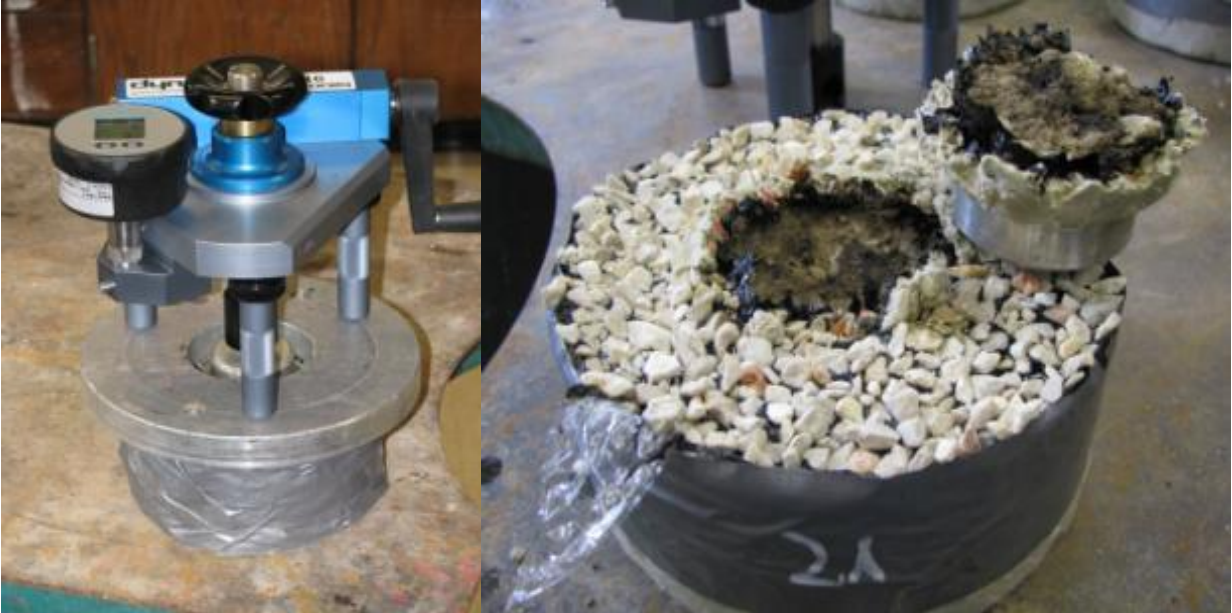
Figure 3.1. Surface Treatment Bond Test Equipment and Tested Lab Specimen.

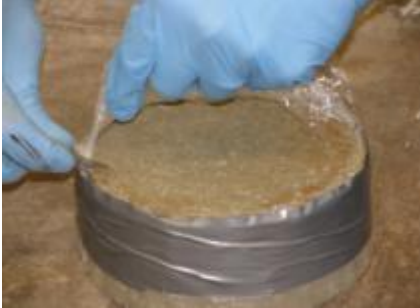
<p>Apply prime material at predetermined application rate to specimen surface. Place sample in 110°F oven to cure for three days.</p>

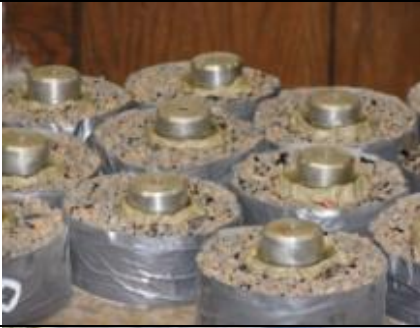
<p>Test sample in Direct Tension Bond Test apparatus and record the ultimate breaking strength in lb and identify the plane where the failure occurred:</p> <ul style="list-style-type: none"> • In the surface treatment. • Interface between prime and surface treatment. • Within the penetrated portion of the prime. • Beneath the prime. • Into the base.

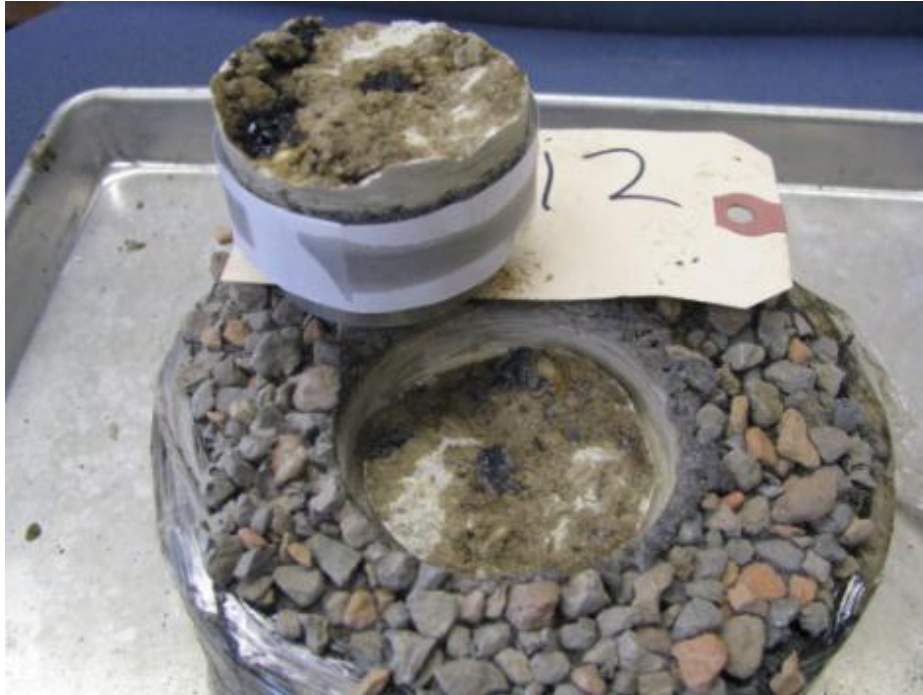
Figure 3.5. Failure Plane of Surface Treatment Bond Test when Prime Coat A Material Was Used (Good Penetration of the Prime, Failure in Base Course).

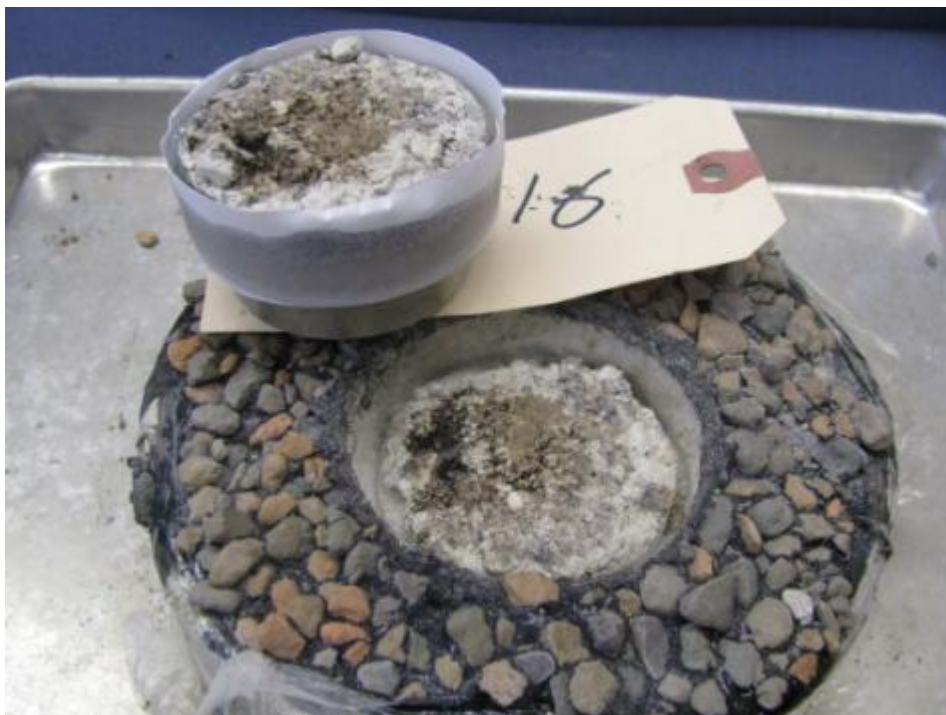
Figure 3.6. Failure Plane of Surface Treatment Bond Test when Prime Coat C Material Was Used (Poor Penetration of the Prime, Failure at Surface Treatment/Base Interface).

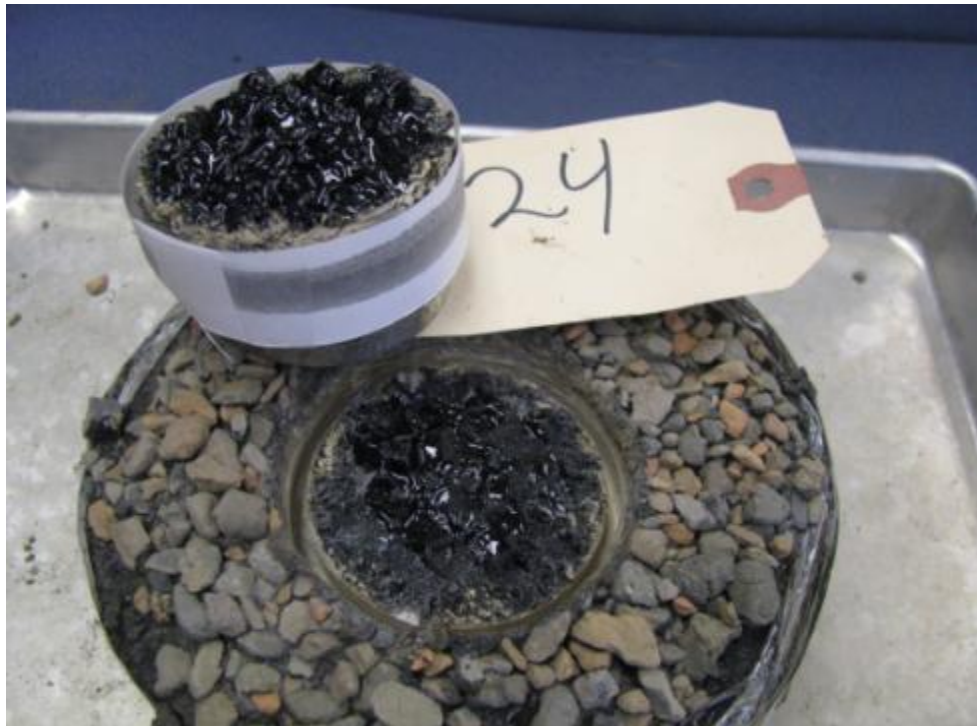
Figure 3.7. Failure Plane of Surface Treatment Bond Test when Covered Prime Was Used (Failure within Surface Treatment Binder Indicating Good Bond to Base Course).

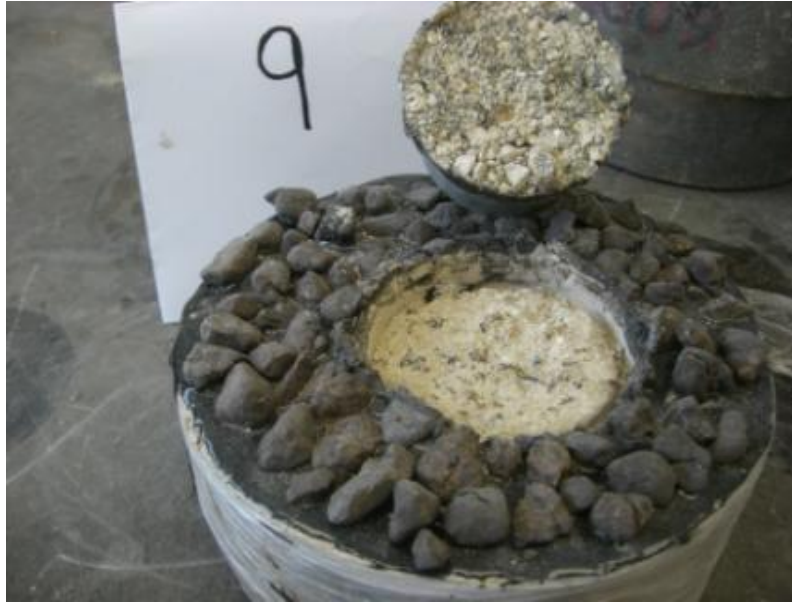
Figure 3.9. Failure Plane of Surface Treatment Bond Test when No Prime Was Used (Failure at Surface Treatment/Base Interface).

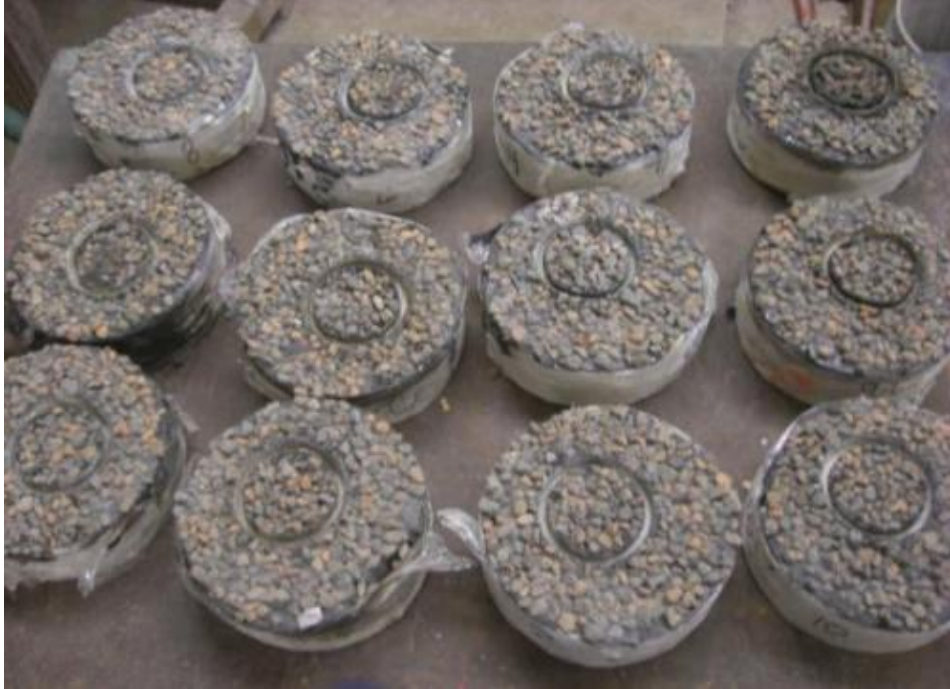
Figure 3.12. Laboratory Specimens Cut Using 2-In. Core Barrel prior to Bond Strength Testing.

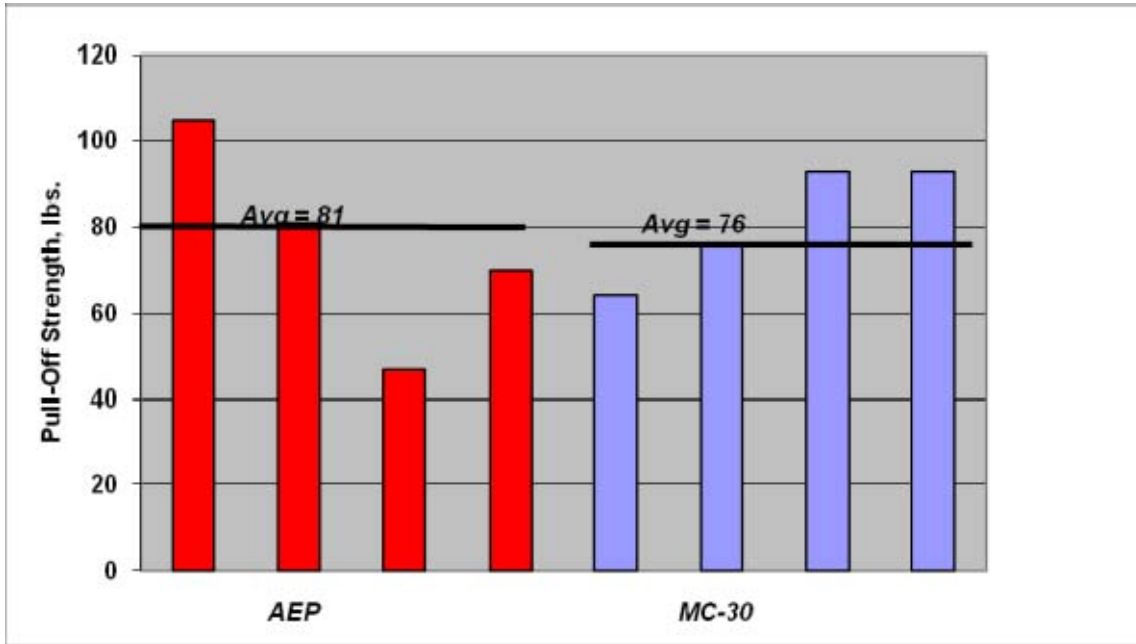
Figure 3.15. Pull-Off Strength Results for Fly-Ash Stabilized Base Specimens.

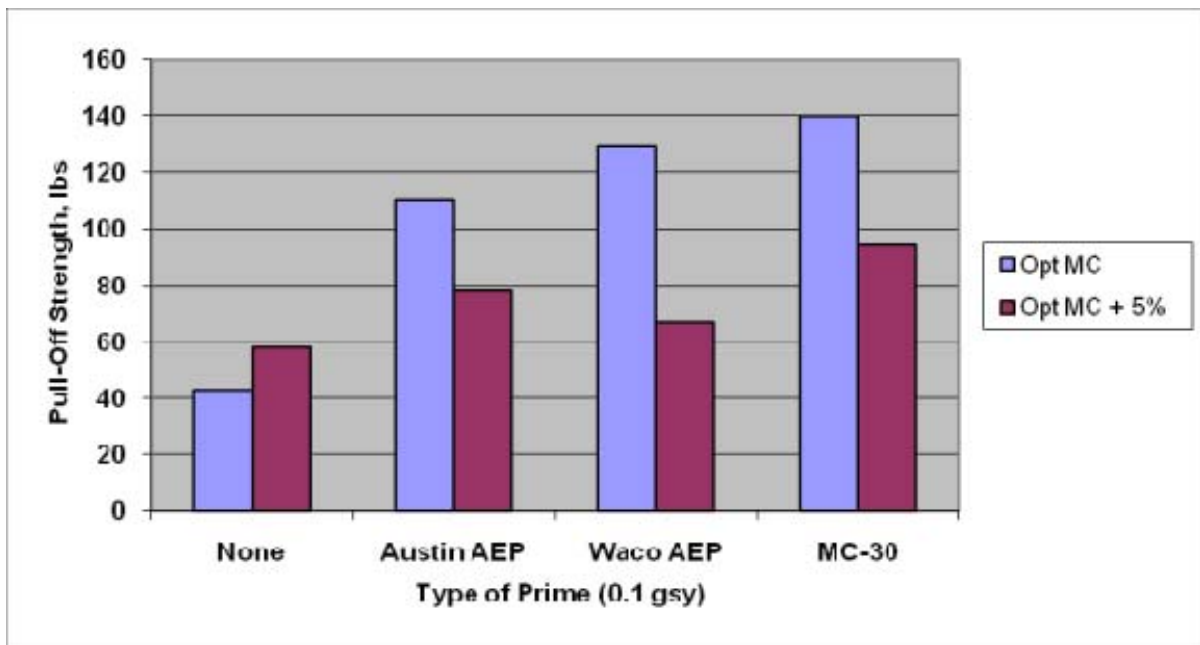
Figure 3.17. Effect of Base Moisture Content (MC) on Pull-Off Strength.

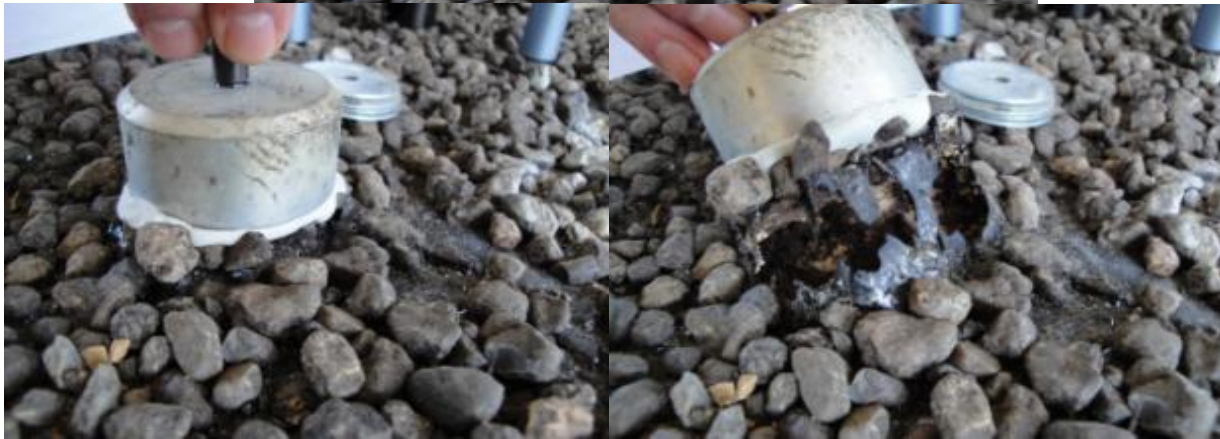
Figure 3.18. Surface Treatment Bond Testing on SH 6.

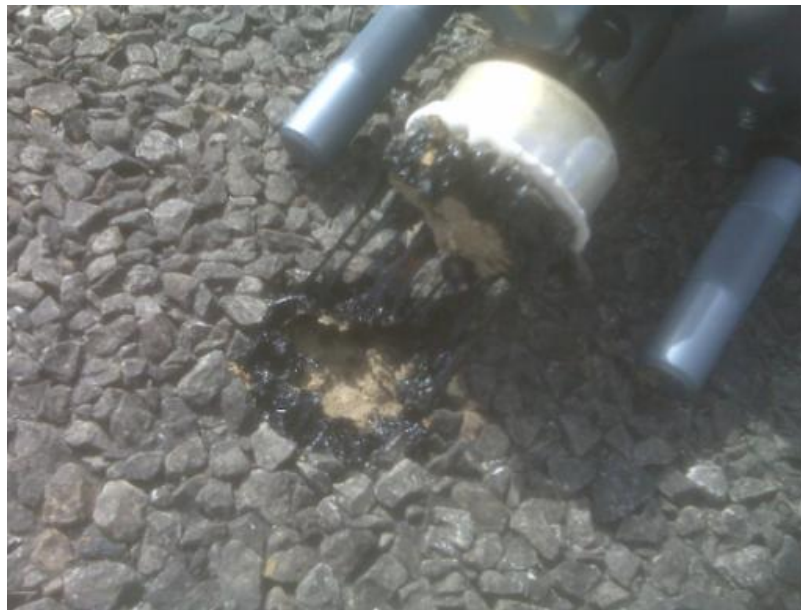
Figure 3.19. Surface Treatment Bond Testing on FM 2502.

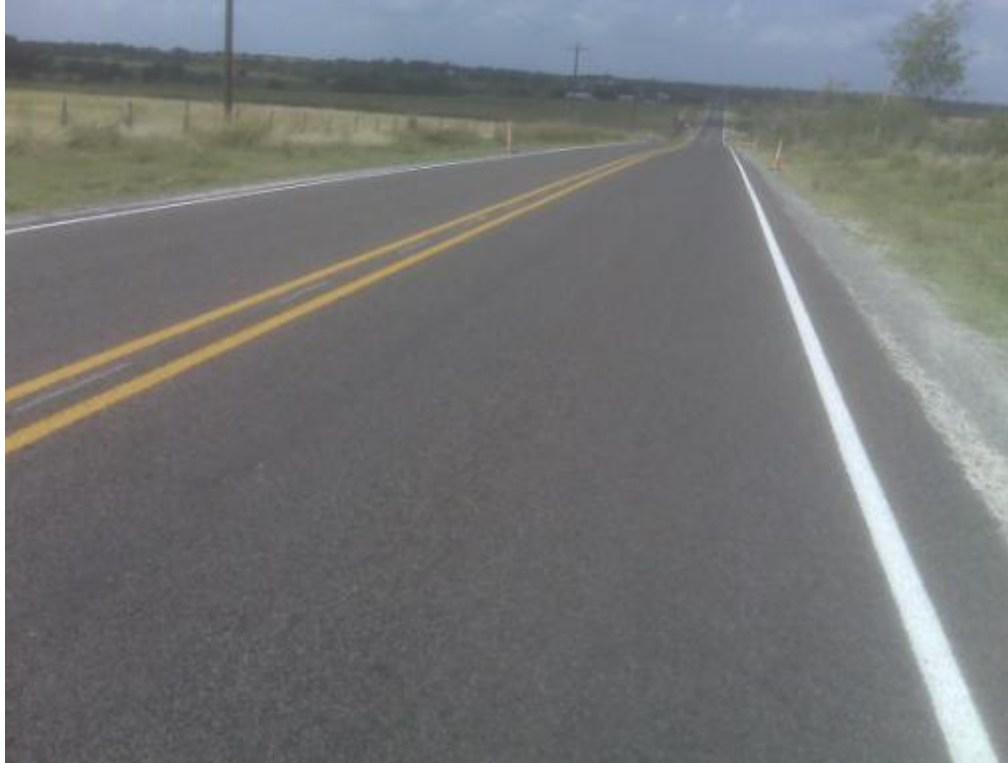
Figure 3.20. FM 2502 after 3 Months of Service.

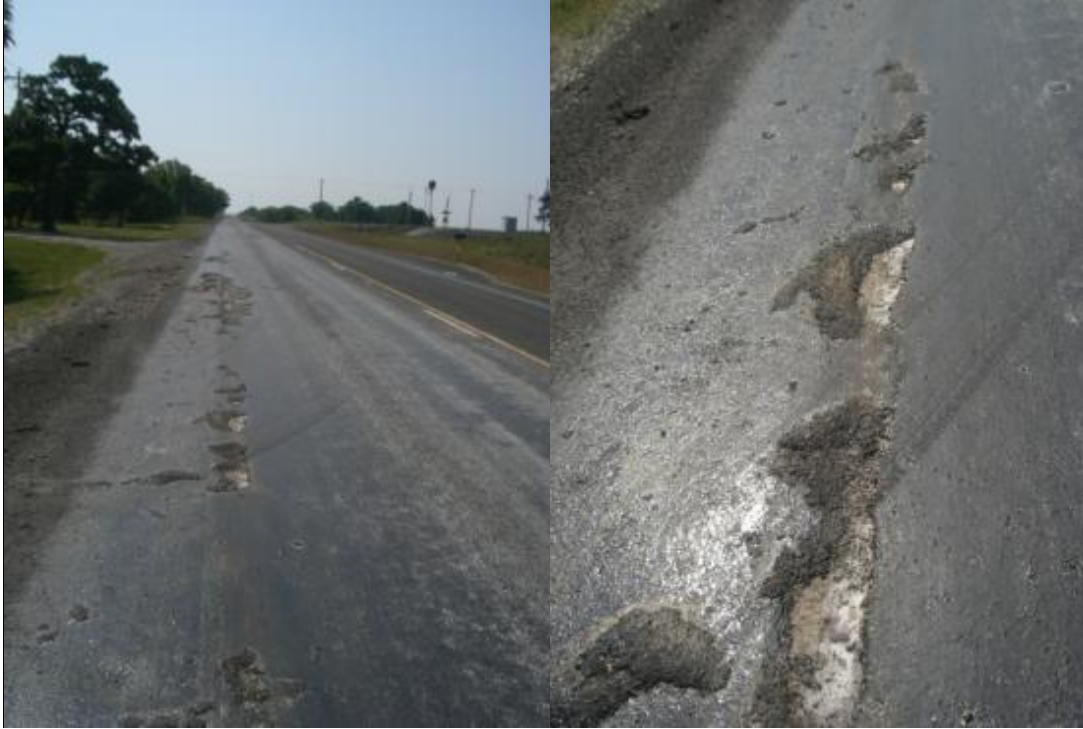
Figure 3.21. Debonded Surface Treatment (FM 2154).

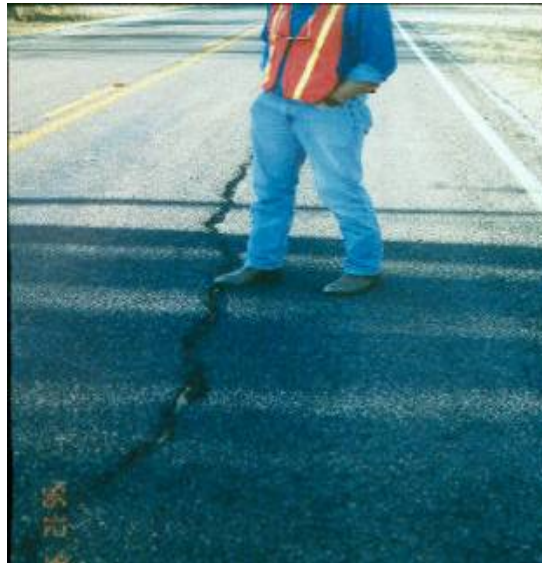
Figure 4.1. Longitudinal Cracking on FDR Projects.

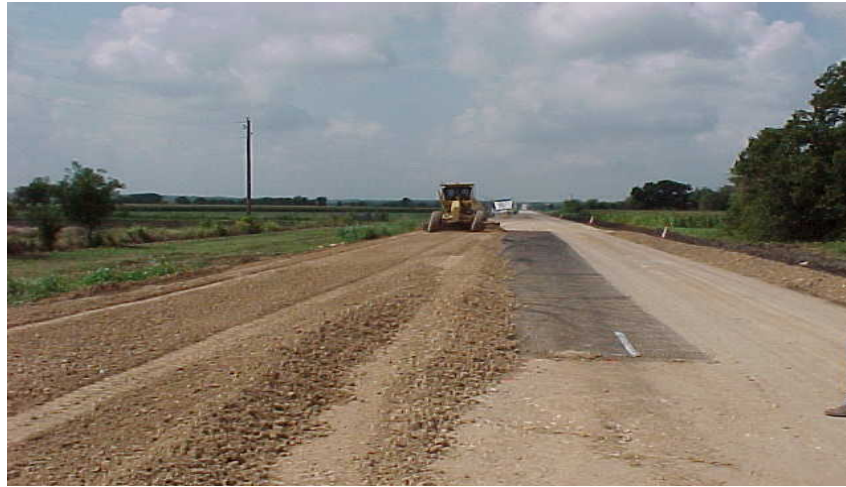
Figure 4.2. Localized Geo-Grid in Potential Problem Location.

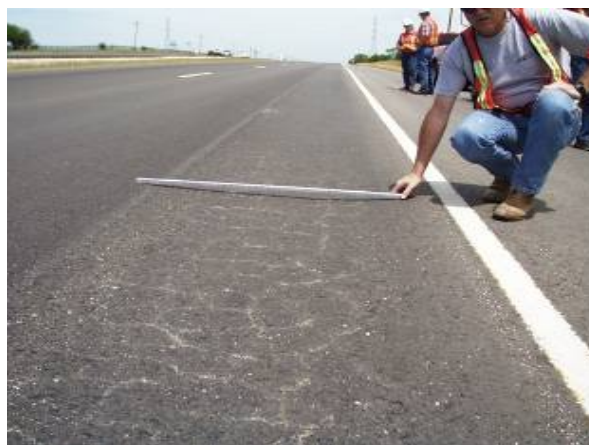
Figure 4.3. Under-Stabilization.

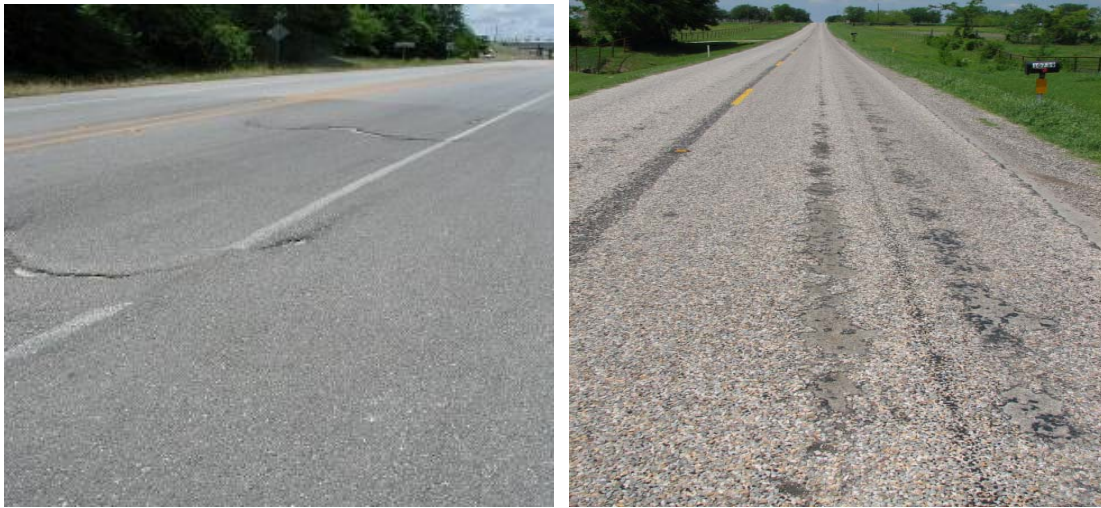
Figure 4.4. HMA Bonding Problems and Seal Coat Pop-Outs over Stabilizer Base.

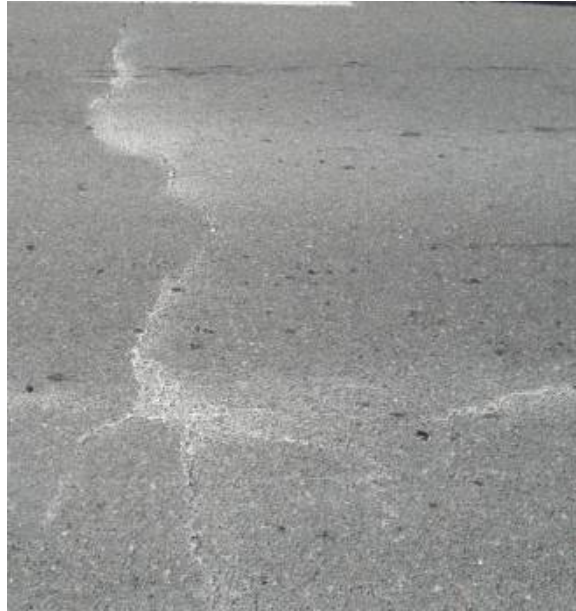
Figure 4.5. Block Cracking.
