1. Report No. FHWA/TX-11/0-6271-2	2. Government Accession No.	3. Recipient's Catalog No.	
4. Title and Subtitle FULL-DEPTH RECLAMATION: NEW TEST PROCEDURES AND RECOMMENDED UPDATES TO SPECIFICATIONS		5. Report Date July 2011 Resubmitted May 2012 Published: July 2012

**FULL-DEPTH RECLAMATION:
NEW TEST PROCEDURES AND RECOMMENDED UPDATES
TO SPECIFICATIONS**

The objectives of this final report are to present the work conducted in the final year of Project 0-6271, to address key issues identified, and to make suggested changes to both test protocols and specifications. This report is broken down as follows:

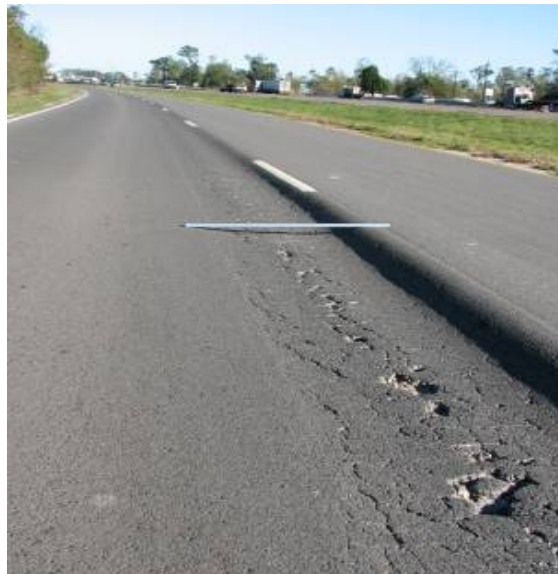
Figure 4.6. Failure in One Wheel-Path Only.

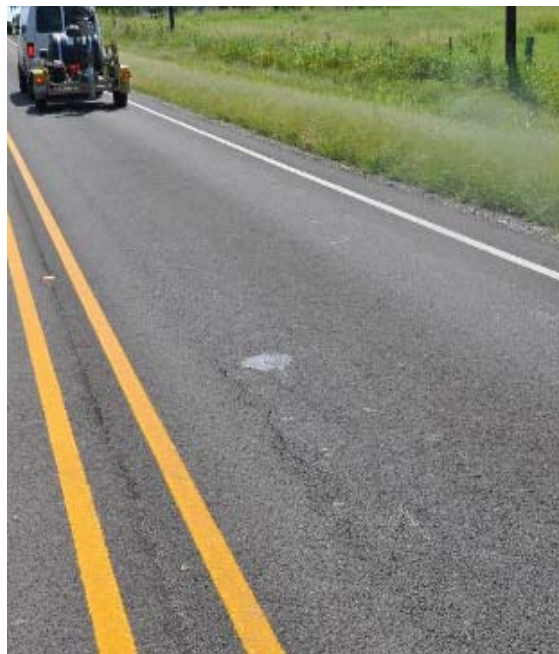
**Figure 4.7. Alligator Cracking and Rutting
a Few Months after Construction.**

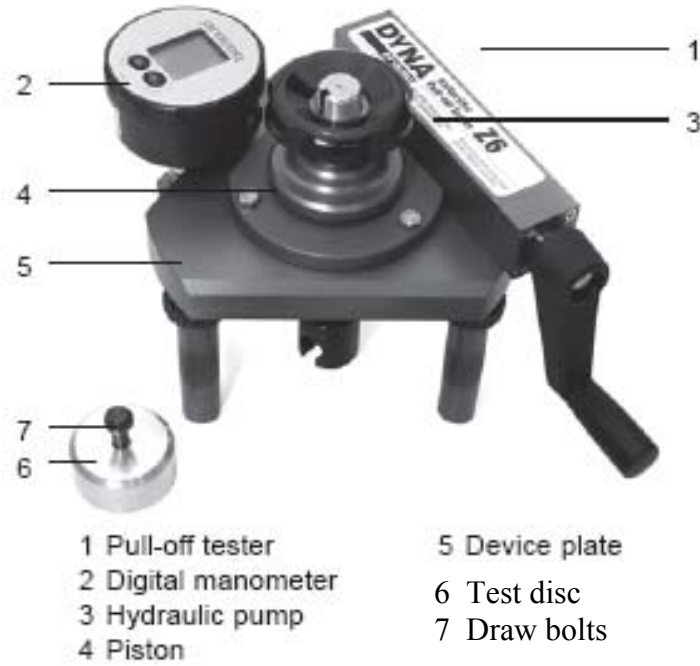
Figure 1. DYNA Z Pull-Off Tester and Digital Manometer.

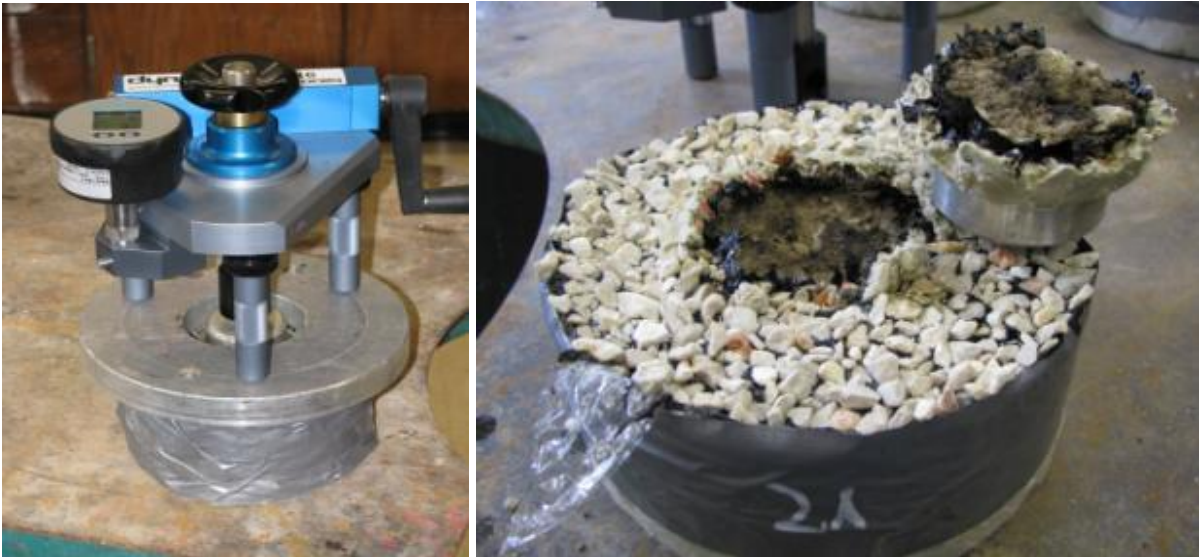
Figure 3. Surface Treatment Bond Test Equipment Set-Up and Tested Lab Specimen.
