Traffic Control Device Analysis, Testing, and Evaluation Program: FY2020 Activities

Technical Report 0-6969-R3

TEXAS A&M TRANSPORTATION INSTITUTE
COLLEGE STATION, TEXAS

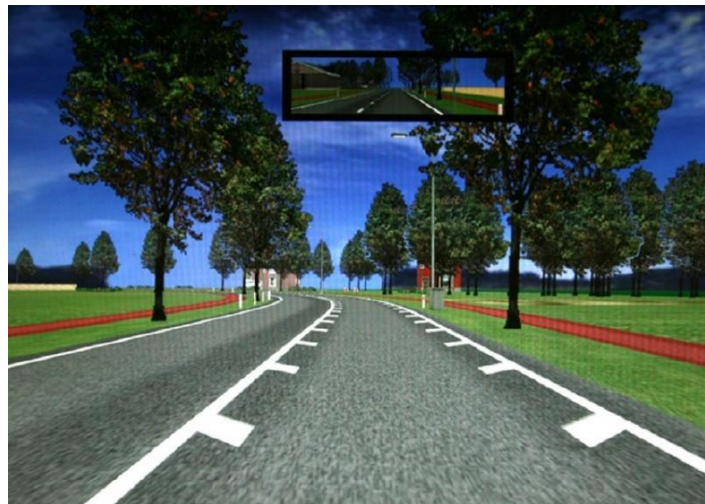
Figure 20. Herringbone-Pattern Optical Speed Bars (23).

- Both transverse rumble strips and herringbone-pattern markings were associated with lower speeds at the curve PC and ahead of it, compared to the no-treatment condition. The greater change in speed was observed for transverse rumble strips.
- Both transverse rumble strips and herringbone-pattern markings were associated with lower deceleration rates at the curve PC compared to the no-treatment condition. The greater change in deceleration rate was observed for transverse rumble strips.
- Transverse rumble strips induced drivers to begin decelerating sooner in advance of the curve, and more gradually, resulting in a more uniform deceleration profile.

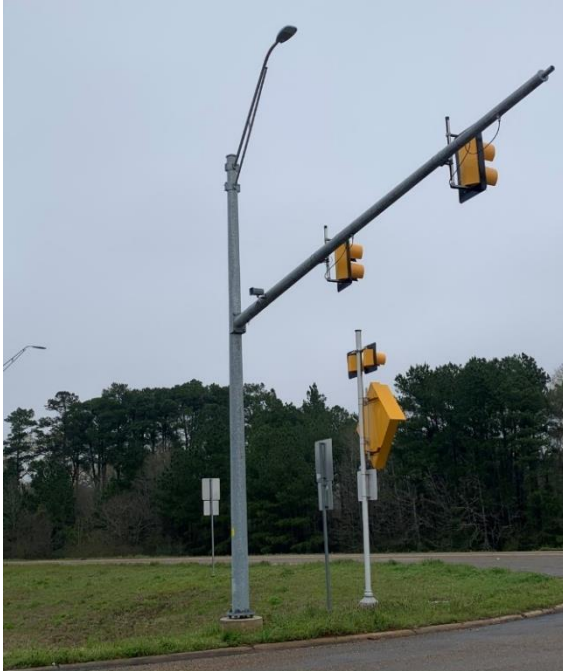
a. Mast Arm with Sensor.

b. Sensor Installed on Mast Arm.

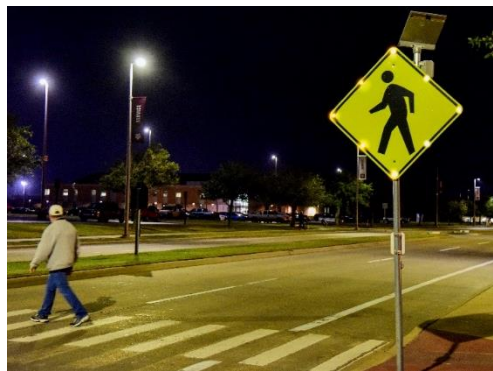
(a) PHB.

(b) RRFB.

(c) LED-Em.

- Pedestrian hybrid beacon (PHB) (see the example in Figure 57a).
- Rectangular rapid flashing beacon (RRFB) (see the example in Figure 57b).
- Light-emitting diode embedded (LED-Em) pedestrian/school crossing sign (see the example in Figure 57c).

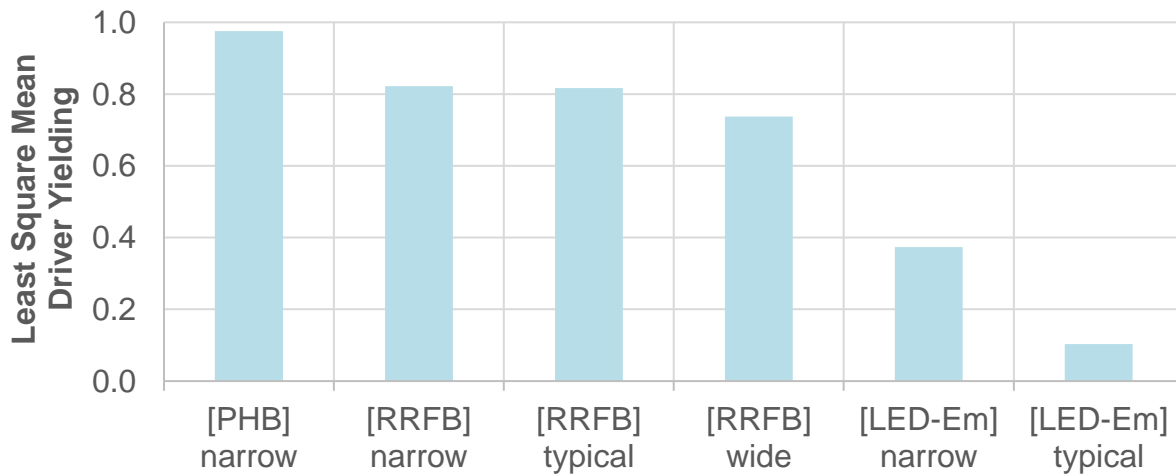
Figure 62. LSM Driver Yielding for Lane Width Group by Treatment Type.
