DEVELOPMENT AND *MASH* TL-4 EVALUATION OF TXDOT LARGE-SCUPPER MEDIAN BARRIER FOR FLOOD-PRONE AREAS

Test Report 0-6976-R1

TEXAS A&M TRANSPORTATION INSTITUTE
COLLEGE STATION, TEXAS

TEXAS DEPARTMENT OF TRANSPORTATION

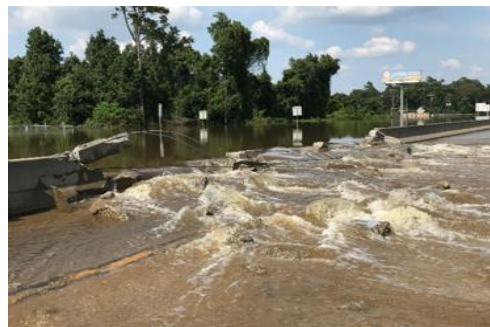
(a) In Beaumont, Texas, several sections of median barrier were exploded to help mitigate the increased flooding being caused by the solid concrete barrier (2).

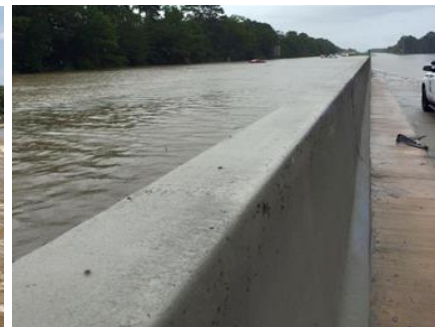
(b) The flooded westbound lanes of Interstate 12 with a concrete barrier damming up the flow of water (Louisiana) (3).

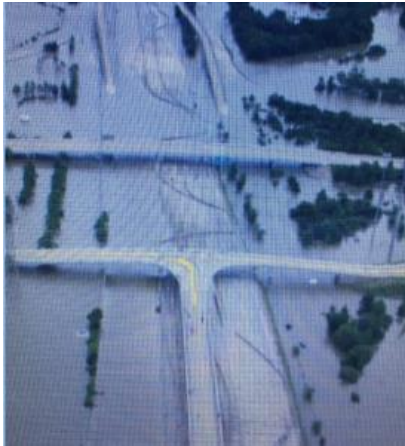
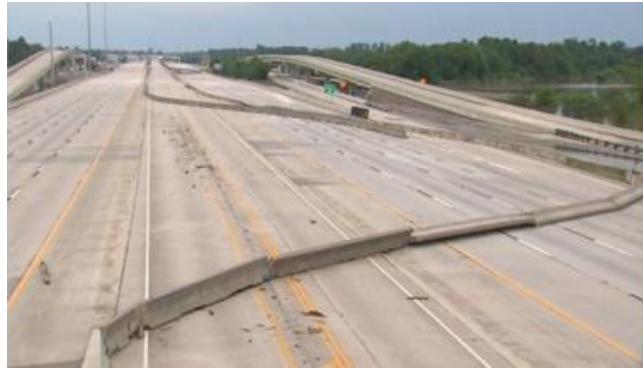
(a) Portable concrete median barrier on the Eastex Freeway was broken and thrust aside after Hurricane Harvey in Humble, Texas (left and above) (4).

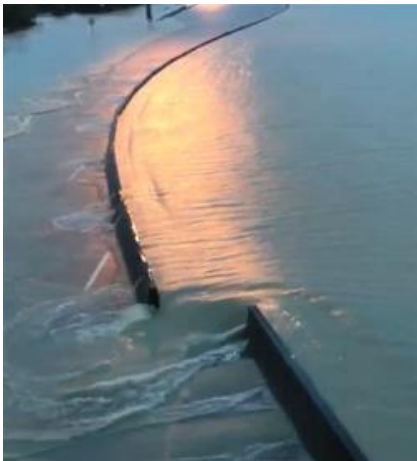
(b) Barrier pushed away from the roadway and finally split apart on Texas USHwy 59 (5).

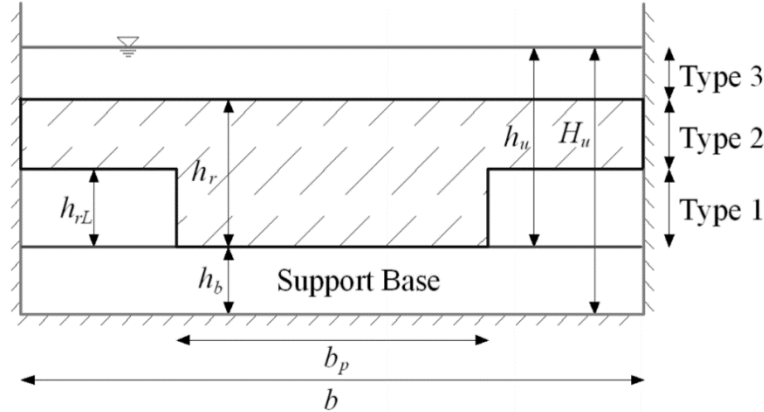
Three different flow types, designated Type 1, Type 2, and Type 3, are explored in the Charbeneau (18) model. These flow conditions are shown in Figure 2.6. Type 1 flow describes the condition in which the water depth at the rail is less than the height of the bridge rail opening

($h_u < h_{rL}$). This unsubmerged flow condition is defined by the continuity equation $Q = vA$. Type 2 flow describes the submerged condition of the bridge rail opening in which the water depth at the rail is greater than the height of the opening but less than the total rail height ($h_{rL} < h_u < h_r$). This condition is governed by orifice flow equations. Type 3 flow describes the condition in which the water depth is greater than the total bridge rail depth ($h_u > h_r$). This condition is governed by both weir and orifice equations. Based on the input parameters, this model predicts which flow type governs as well as defines the transition points between each different condition.

Figure 2.6. Three Different Flows in Charbeneau Model.

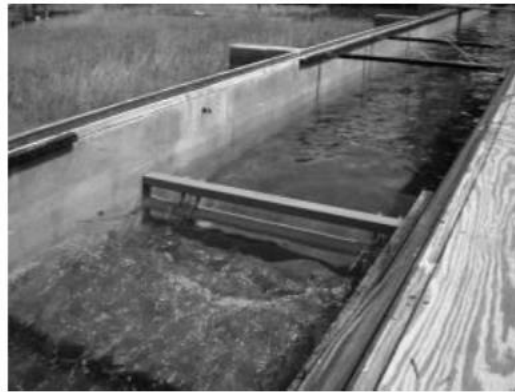
Figure 2.7. Experimental Setup for Bridge Rail in Rectangular Channel.

The parameters for the Charbeneau model must be obtained experimentally (24). Experimental testing was conducted independently for multiple model bridge rails in a 150-cm (5-ft) rectangular channel with zero slope (Figure 2.7). The nine rails tested were the single-slope traffic rail (SSTR), T221, T501, T411, T203, T101, T101D, weir rail, and Wyoming rail. The data collected for this experiment were upstream and downstream water depths through the use of pitot tubes connected to an inclined manometer board. The model rails were scaled to half the size of standard TxDOT dimensions in most cases; however, certain adjustments had to be made to accommodate the space limitations within the channel. In these cases, the fractional open space was conserved. The primary construction material was wood, while specific rails such as the T101 and Wyoming rail were constructed out of metal. To mitigate any swelling in the wood, all surfaces were coated with waterproof primer. Since this experiment was not analyzing the hydraulic stability of the rails, the bases were anchored down to the channel.

To test the free-flow rating curve, the flow rate was set and allowed to reach steady state before any measurements were taken. Once steady state was achieved, the flow rate and upstream water depth were measured. Each time the flow rate was changed, it was allowed to reach steady state before further measurements were taken. For submergence testing, a tailwater gate was used to vary the downstream depth by means of a hydraulic jump while the flow rate

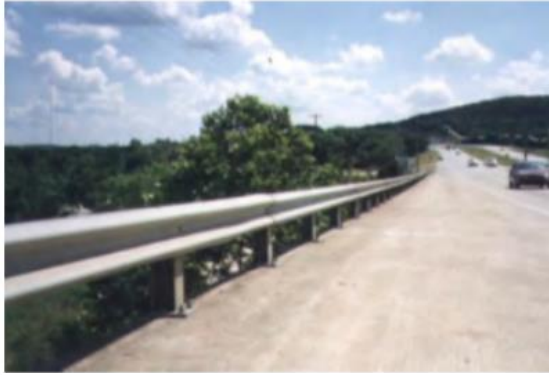
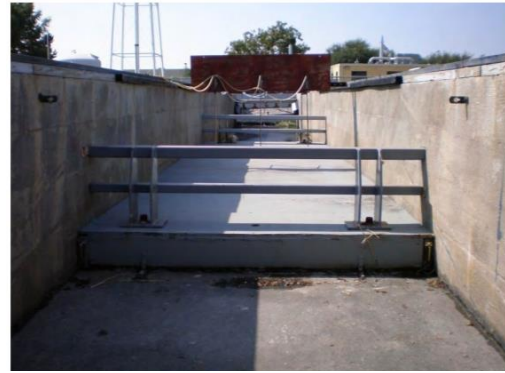
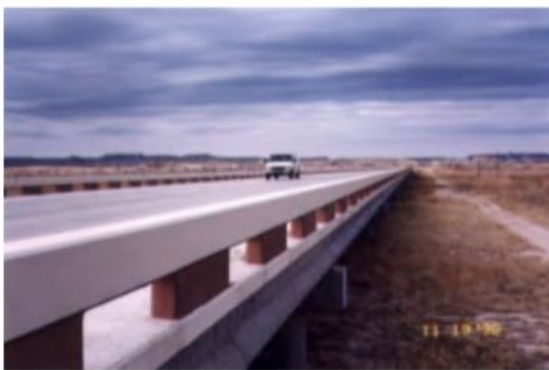
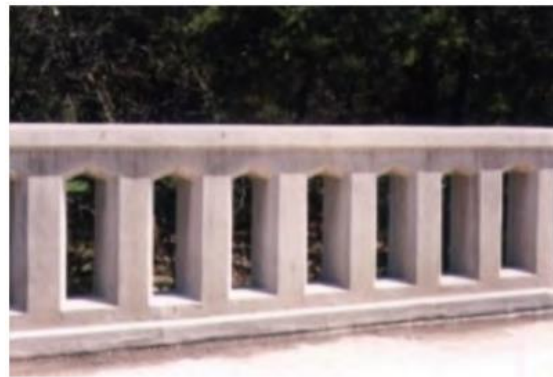
Figure 2.9. Tested Bridge Rails.

The primary factor for hydraulic efficiency is the fractional open space, as can be seen by comparing the data in Figure 2.8 with the physical barriers in Figure 2.9. The rails not presented in Figure 2.8 are all solid rails with minimal openings, resulting in a much lower hydraulic efficiency. Although the fractional open space between the rails T203 and T411 is similar, the location of the opening at the base combined with the greater opening width results in a greater hydraulic efficiency for T203. This factor is especially true at low flow rates.

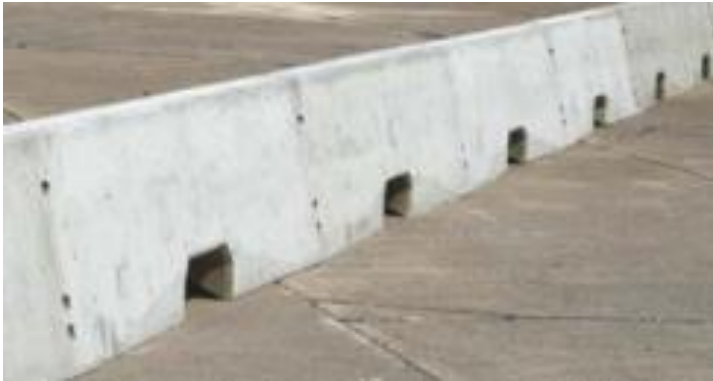
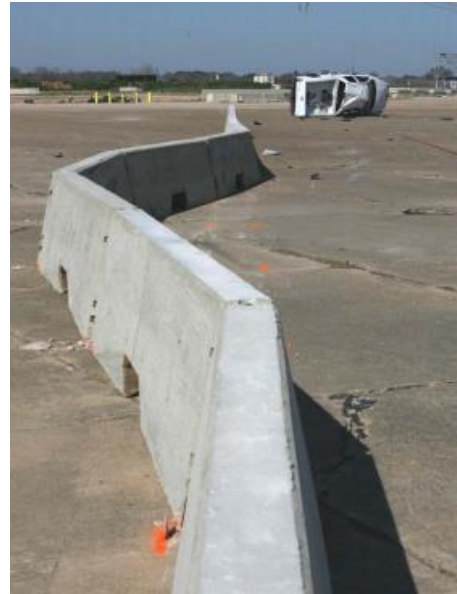
Figure 2.12. WSDOT Barrier Test 3-11.

A 2004 Dodge RAM 1500 quad-cab truck was used for the completion of *MASH* Test 3-11. The truck, traveling at 60.2 mi/h, impacted the barrier at an angle of 26.2 degrees at the critical point of impact—51.2 inches upstream of the segment joint. During the impact event, the test vehicle lost its stability and rolled on its side. The truck began rotating after being successfully redirected and contained by the barrier, causing the test to fail by *MASH* standards. Although the barrier did not pass the *MASH* testing evaluation criteria, it was concluded that the “drainage slots and scupper opening did not appear in any way to adversely affect the crash performance of the barrier system” (28). Figure 2.12 illustrates representative photos of this 2010 WSDOT Test 3-11.

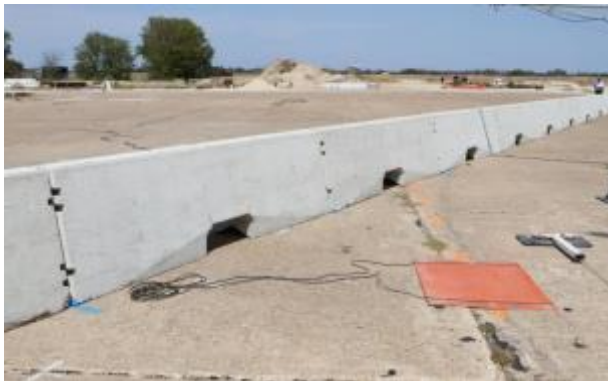
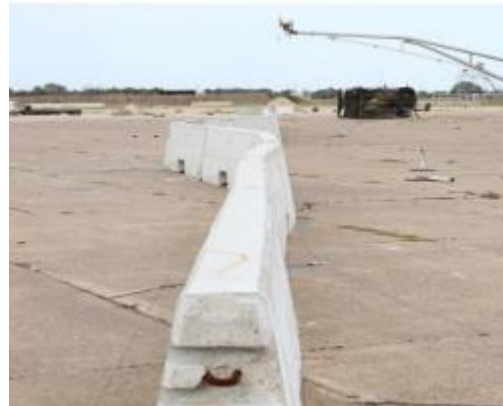
Figure 2.13. Revised WSDOT Barrier Test 3-11.

In 2011, a variation of the Washington pin-and-loop barrier was retested. In this second crash test scenario, the 1-inch-diameter AISI 4142 pins were replaced with 1¼-inch diameter F1554-grade 105 steel rods. The steel rods and the pins were the same length. The vehicle appeared to perform better than in the previous test; however, vehicle overturning still occurred after barrier contact. After being contained and redirected, the truck landed on its left side and remained that way as it eventually slid to a stop. Therefore, the barrier still did not pass *MASH* TL-3 standards. Figure 2.13 illustrates representative photos of the 2011 WSDOT Test 3-11 (29).

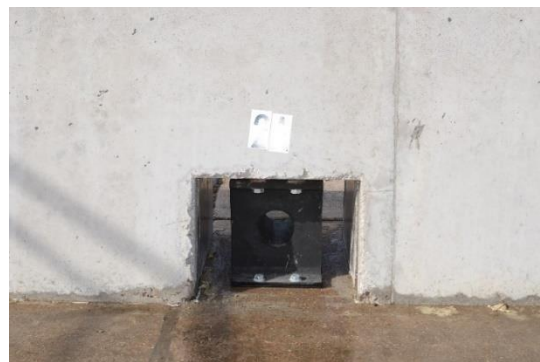
TTI researchers recently completed a project with TxDOT in which a new low-maintenance median barrier was developed (31). The barrier was thoroughly analyzed using extensive computer simulation and full-scale crash testing efforts. The final design includes anchoring a 42-inch-tall SSCB with a set of rubber anchor blocks that are bolted to the ground. Typically, the rigid SSCBs are anchored with the use of steel rebar connecting the concrete pavement to the barrier. This process prevents any significant deflection of the barrier from occurring, but the new design with rubber blocks allows the barrier to rotate upon impact. Figure 2.16 shows an opening in the barrier with the installed rubber block.

Figure 2.16. Opening in Concrete Barrier to Allow for Rubber Block Installation.

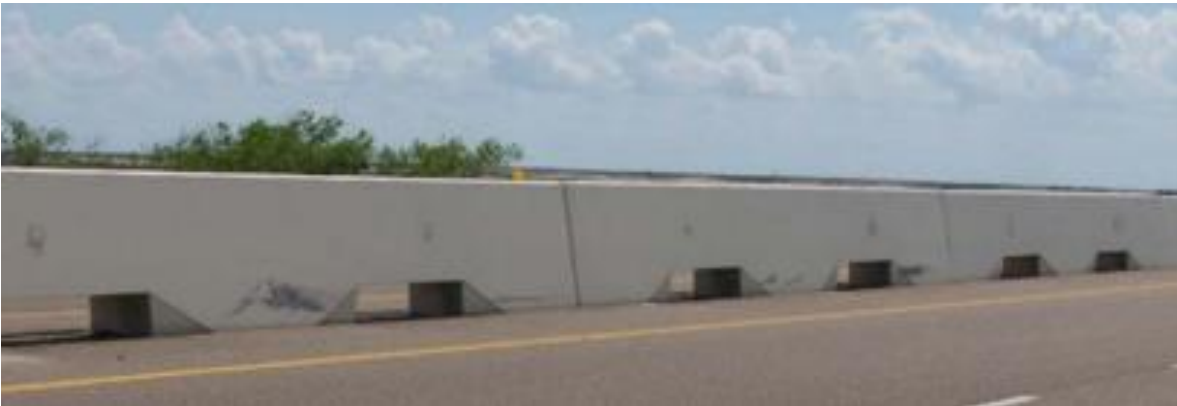
Figure 2.17. TxDOT SSCB (Wildlife Crossing).

The TxDOT wildlife crossing barrier is 42 inches in height and has openings for wildlife access through the barrier (Figure 2.17) (30). Each unit is 30 ft in length and contains two openings that are 12 inches high and 5 ft in length. Based on a review of the geometric features of this barrier, it was determined that the TxDOT wildlife crossing barrier was crashworthy with respect to NCHRP Report 350 TL-3 criteria.

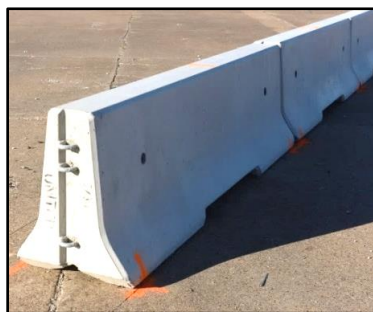
The primary concern with concrete barriers containing scuppers is that they can become a location for high stress concentration during an impact event. It is not infrequent for under-reinforced barriers or for high load impacts to have cracks propagating from scupper locations through the barrier during an impact event. The Massachusetts Department of Transportation (MassDOT) Highway Division developed a 32-inch-tall, precast F-shape portable concrete barrier (PCB) system for use as a temporary installation for construction projects requiring positive protection (Figure 2.18) (34). The 10-ft-long barrier segment had a single drainage relief/forklift slot (3 ft 4 inches long \times 3 inches high) precast and symmetrically centered in the bottom of each barrier segment. The barrier was crash tested and performed acceptably for *MASH* TL-2 impact conditions. However, it was noted that the impact segment cracked completely through near the center of the segment after *MASH* Test 2-11 (Figure 2.19).

Figure 2.18. MassDOT F-Shape PCB.

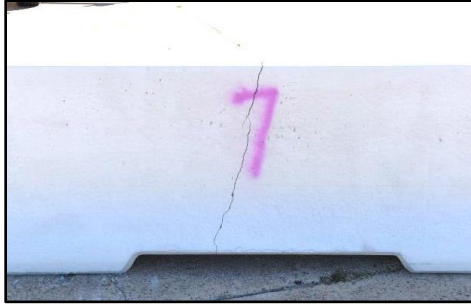
Figure 2.19. Concrete Crack after *MASH* Test 2-11.

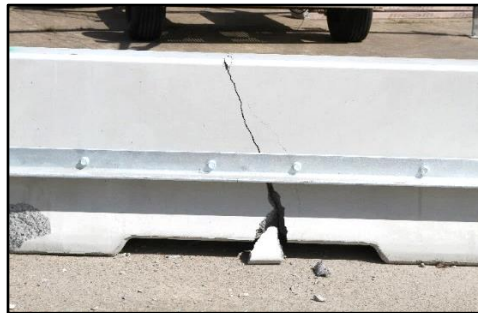
This barrier was then retrofitted and tested in accordance with *MASH* TL-3. Because of the crack on the barrier segment, TTI researchers developed a 9-ft-long 6-inch \times 4-inch \times ½-inch steel angle that was secured to the back (field) side of each barrier segment with six screw anchors. Although the MassDOT PCB with this newly applied angle rail stiffener performed acceptably for *MASH* TL-3 impact conditions, the barrier segment fractured vertically near the center of the segment on the impact side. Concrete spalling also occurred at the base of the segment on the traffic side (Figure 2.20).

Figure 2.20. Concrete Crack after *MASH* Test 3-11 (Retrofit System).

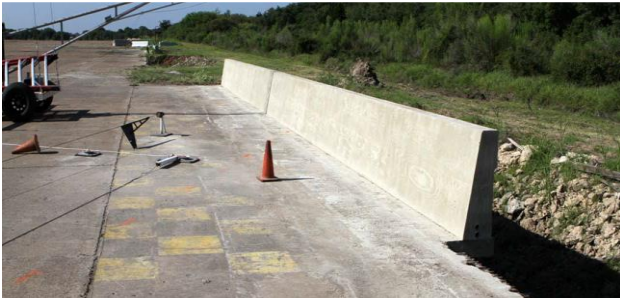
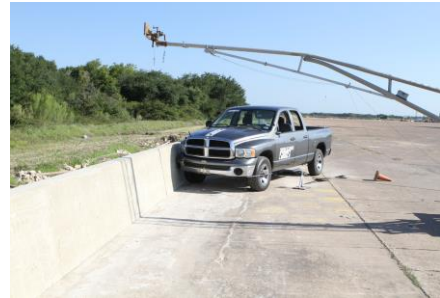
Figure 4.3. Single-Slope Barrier System with and without Test Vehicle before Testing.

Figure 4.3 shows the barrier and vehicle before testing, and Figure 4.4 illustrates the barrier system after testing. Figure 4.5 summarizes the full-scale crash test results.

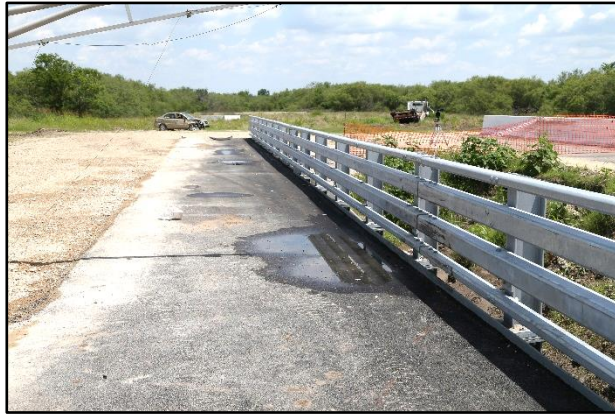
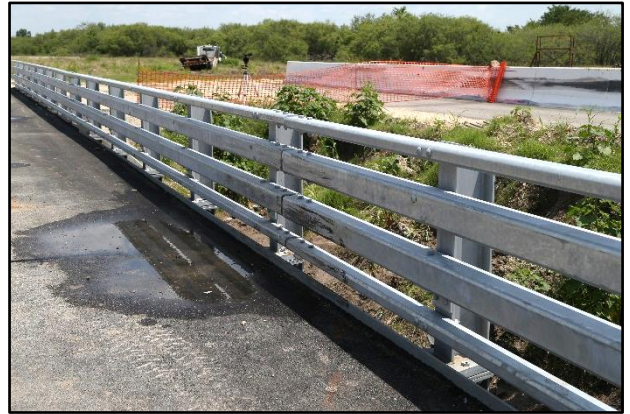
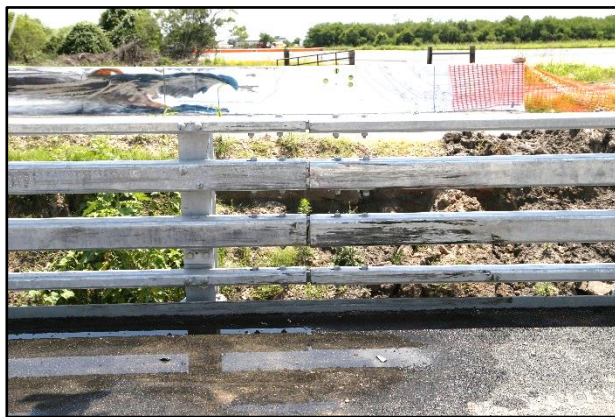
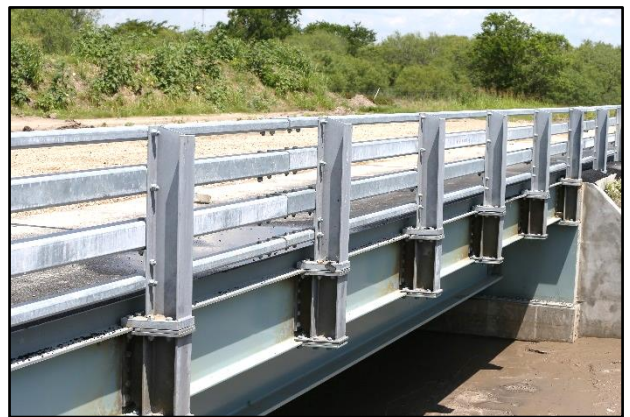
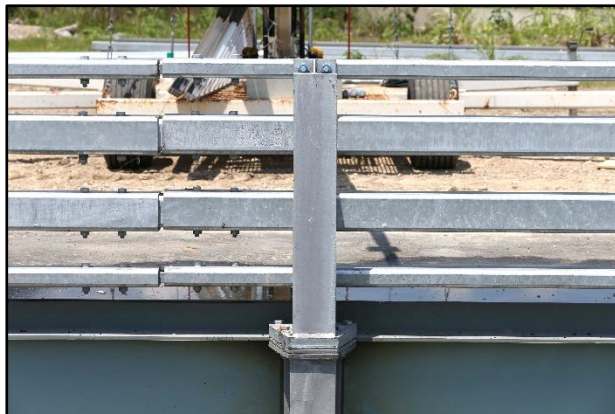
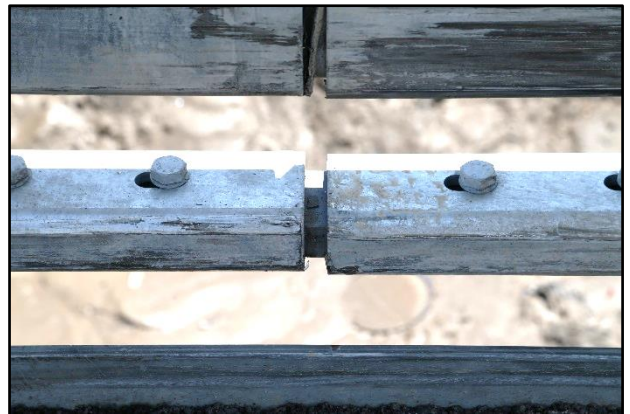
Figure 4.8. TBTA Bridge Rail.

Figure 4.8 illustrates the actual constructed TBTA bridge rail.

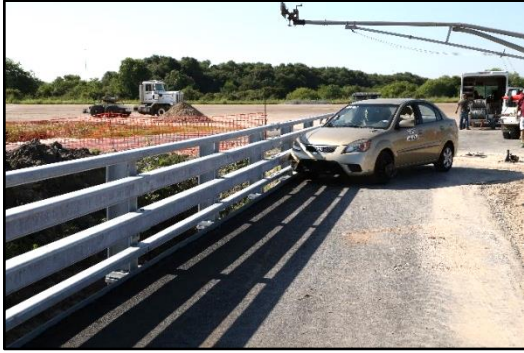
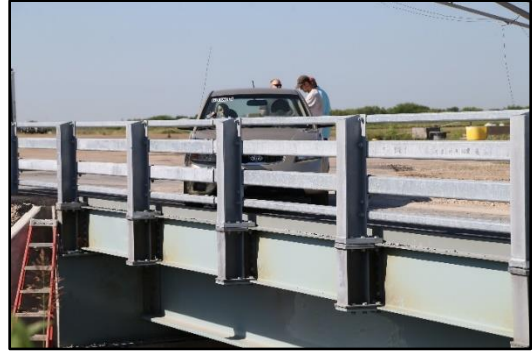
Figure 4.9. TBTA Bridge Rail/Test Vehicle Geometrics.

Figure 4.9 shows the bridge rail and test vehicle geometrics. Figure 4.10 and Figure 4.11 show the test vehicle before and after the test. Figure 4.12 shows the interior of the test vehicle before and after the test. Figure 4.13 summarizes the full-scale crash test results.

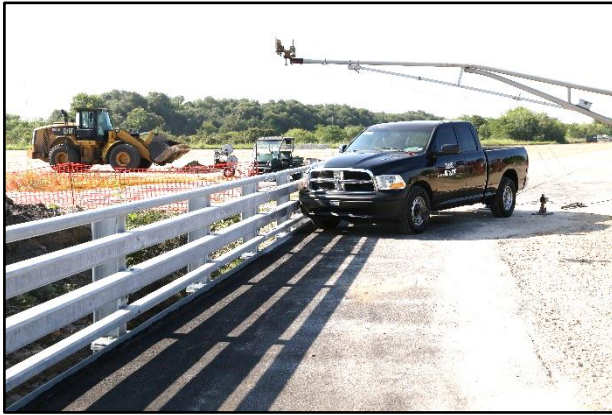
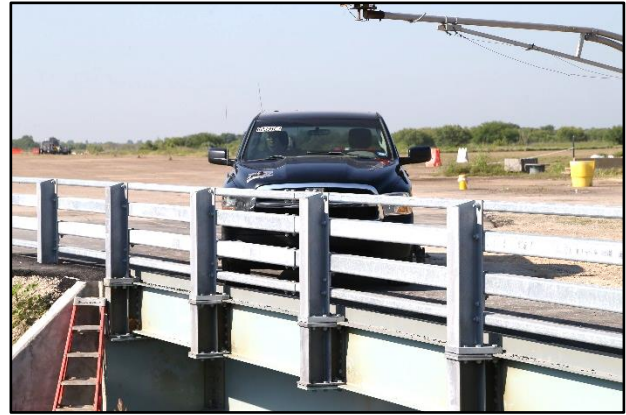
Figure 4.14. TBTA Bridge Rail/Test Vehicle Geometrics.

Figure 4.14 shows the bridge rail and test vehicle geometrics. Figure 4.15 and Figure 4.16 show the test vehicle before and after the test. Figure 4.17 shows the interior of the test vehicle before and after the test. Figure 4.18 summarizes the full-scale crash test results.

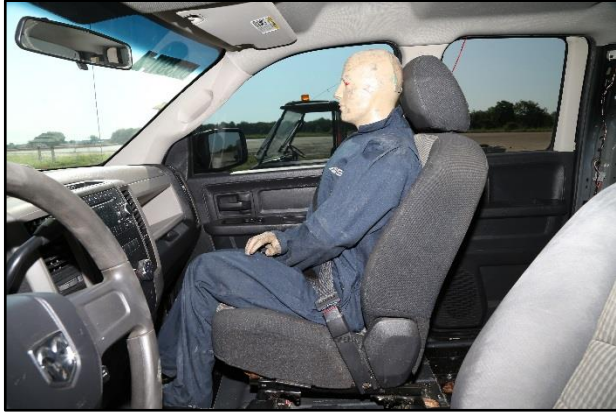
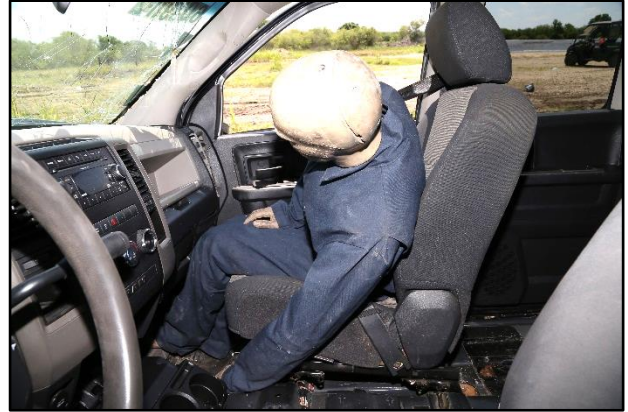
Figure 4.17. Interior of Test Vehicle.

Before Test

After Test

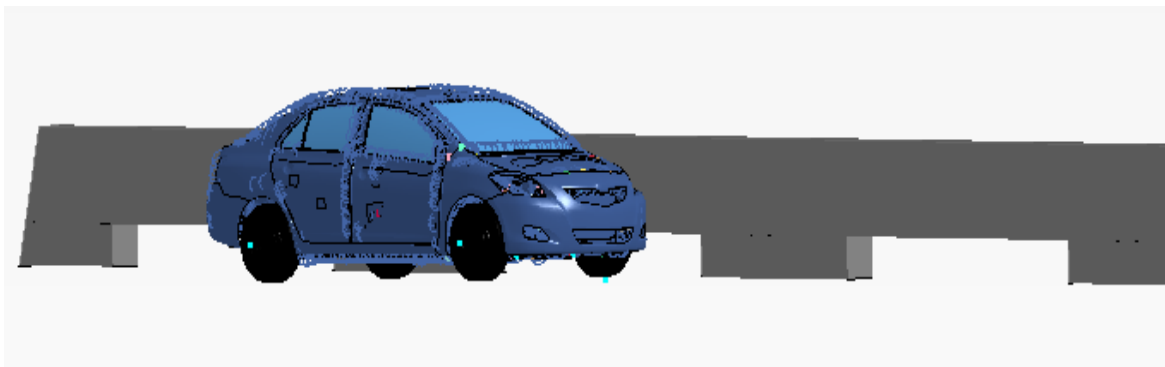
Figure 4.23 Computer Model for Option A with Passenger Car.

AUTOMATIC_SURFACE_TO_SURFACE and AUTOMATIC_SURFACE_TO_SURFACE contact keyword cards were used to define contact between the vehicle and the barrier. The vehicle impact speed and angle were 62 mi/h and 25 degrees, respectively. Figure 4.23 illustrates different views of the Option A barrier system with the passenger car (*MASH* 1100C vehicle).

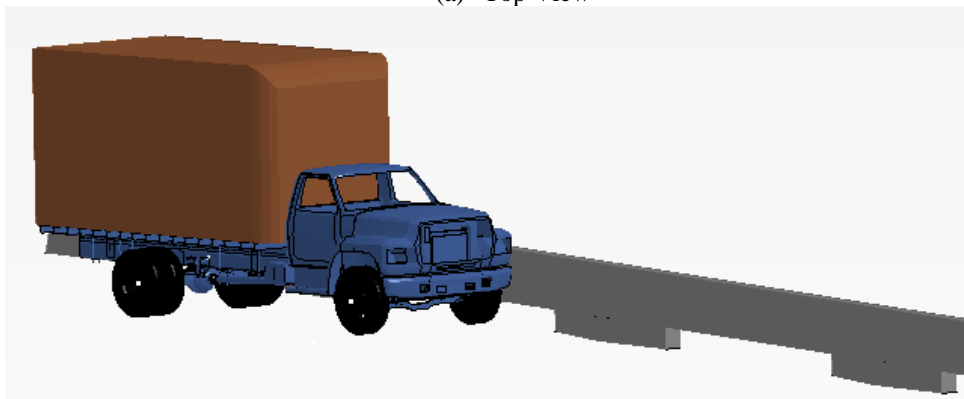
Figure 4.28. Computer Simulation Model for Option A with SUT.

For the SUT vehicle impact, a simulation was performed with the CIP being 5 ft upstream of the flared end of the barrier opening. The vehicle impact speed and angle were 56 mi/h and 15 degrees, respectively. Figure 4.28 illustrates different views of the Option A barrier system with the SUT (*MASH 1000S* vehicle).

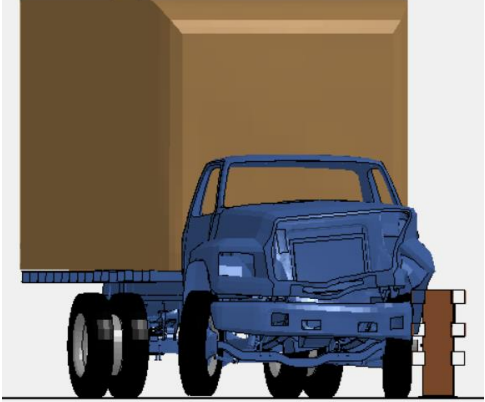
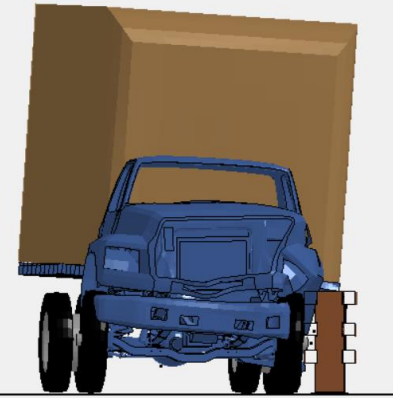
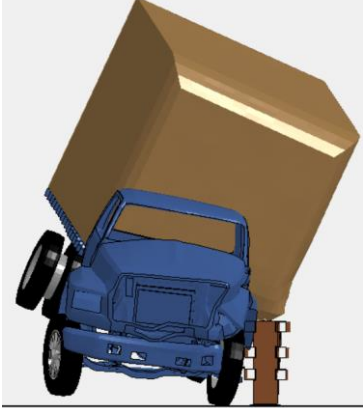
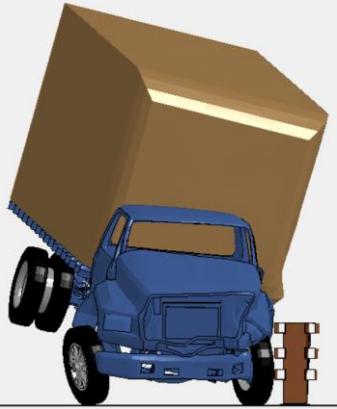
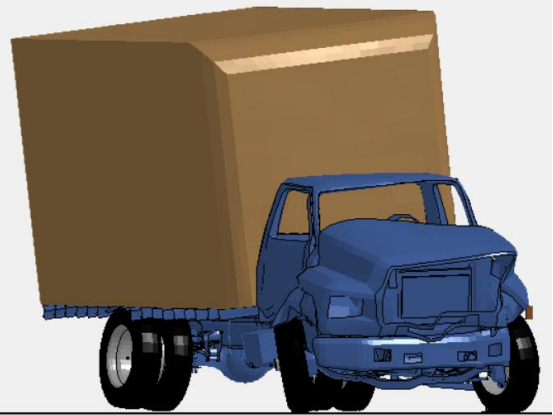
Table 4.21. Sequential Images of the Simulated Computer Model Impact Events for Option C with SUT.

Table 4.21 illustrates sequential images of the preliminary simulation results from the performed FEA computer simulations for Option C with the SUT.

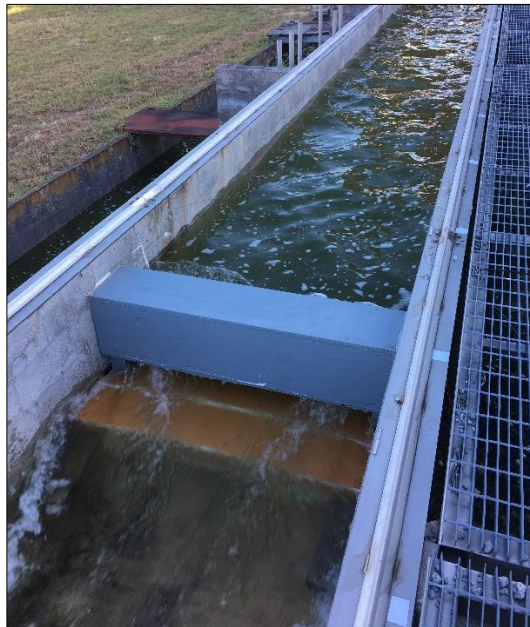
Figure 5.1. Hydraulic Testing.

The purpose of this research was to assess the hydraulic efficiency of median barriers with different geometries and compare the results against one another to explore key parameters in hydraulic performance. Model scale barriers were built for each design and installed in a concrete channel for hydraulic testing at the Center for Water and the Environment (CWE) on the J.J. Pickle Research Campus, University of Texas at Austin. Figure 5.1 displays an example of a barrier mid-test.

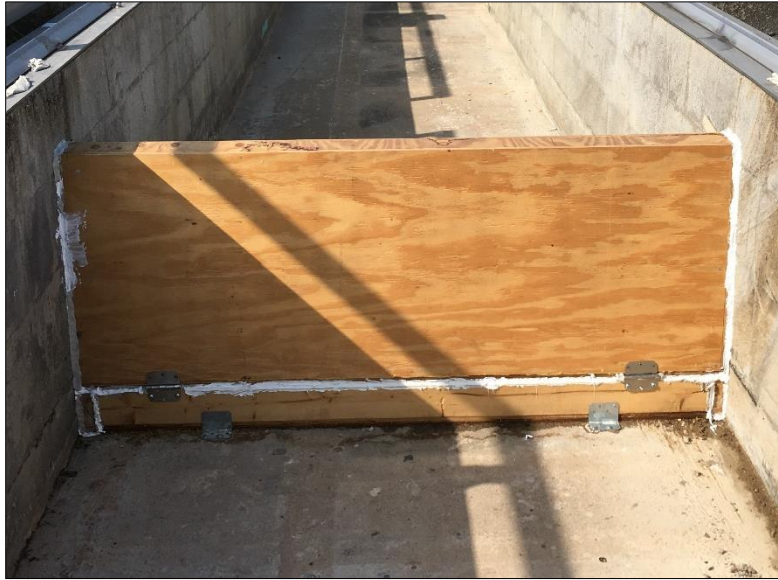
The weir barrier was constructed per the TxDOT SSCB standards. Since there is no drainage, this barrier serves as the worst-case scenario for hydraulic performance where flow overtops the barrier at all flow rates. The weir barrier has a height of 21 inches, bottom width of 12 inches, and top width of 4 inches. After all data were collected, this barrier failed during a redundancy test. Changes were then made in the design of the remaining barriers and the next iteration of the support base. Figure 5.3 displays the barrier installed on the first support base.

Figure 5.3. Weir Barrier.

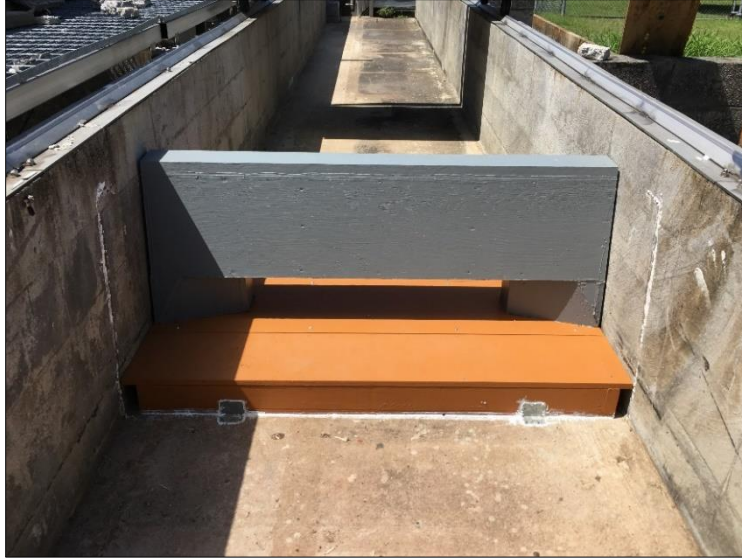
Figure 5.4. SSCB.

The SSCB was built to the same overall specifications as the weir barrier with the inclusion of a scupper. The scupper height is 6.5 inches, and the width is 3 ft. Starting at the barrier edge with a width of 1 ft, the barrier support tapers to a width of 4.5 inches at the scupper edge. While tapering the opening is expected to have marginal effects on the hydraulic performance, this design allows the opening height to be increased by an additional inch per structural design standards. This barrier was constructed entirely out of wood and covered in multiple coats of waterproof paint. Figure 5.4 displays the barrier installed in the channel before final seals were applied.

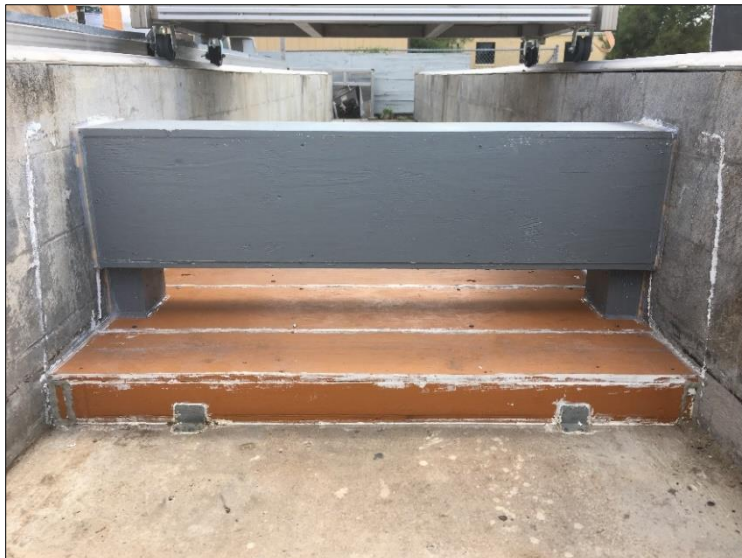
Figure 5.5. Post-and-Beam Barrier.

The post-and-beam barrier has a much greater fractional open space than the SSCB, controlled by an increase in scupper width between the two. The post-and-beam barrier has the simplest geometry of all the barriers, consisting of a rectangular beam supported by rectangular posts. The height of this barrier is 21 inches, the beam width is 1 ft, and the post widths are 4 inches. The scupper height is 6.5 inches, and the scupper length is 4 ft 4 inches. Figure 5.5 displays the barrier installed in the channel with all seals applied.

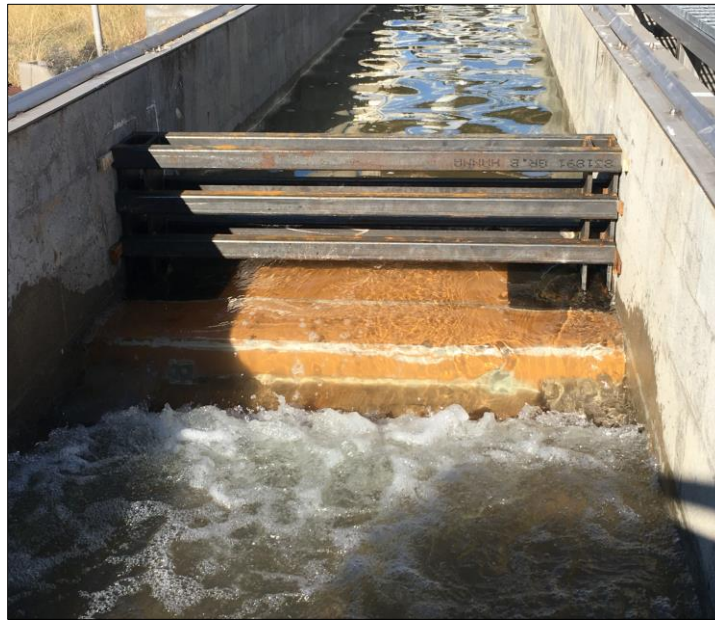
Figure 5.6. Steel Barrier.

The steel barrier has a substantially larger fractional open space than the previous two. This barrier is comprised of three 2.5-inch \times 2.5-inch HSS horizontal beams on each face that span the length of the channel, with 3 inches of vertical spacing between them. The space between the support base and the lowest beam is 5.875 inches. The posts on either side of the channel are each made up of two 19.375-inch \times 7-inch \times 0.5-inch metal plates spaced 2.5 inches apart. Both posts sit on a 16-inch \times 12.5-inch \times 0.5-inch metal base plate with four 0.625-inch diameter holes for connection to the support base with machine screws. All segments are connected through welds, and the barrier base is connected to the support base through eight machine screws. The downstream face of this barrier is displayed in Figure 5.6.

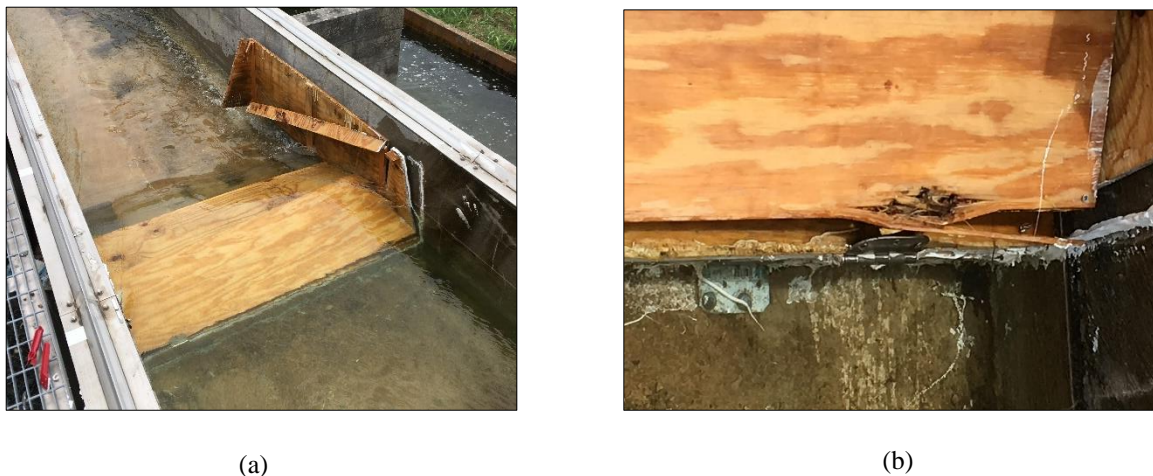
Additional hinged connections were added to the front of the barrier and base following an incident in which the force of the aluminum pipes on the wood blocks and surrounding concrete opened a crack in the center of the concrete itself. This crack opened space between the barrier and base, allowing the flowing water to infiltrate and lift the barrier off the base and carry it downstream. Multiple successful tests were then run with the hinge connection operating properly before the barrier itself gave way. Close inspection revealed a failure of the barrier at the hinge connection, but it was unclear if this was the cause of the accident or if the barrier structure broke first and ripped the connected pieces away from the hinges. In either event, the source of error lies in both a failure to properly seal the barrier and base as well as a hinge location that was too close to the barrier and base edges. Figure 5.8 shows the failed barrier and the failure at the hinged connection. A decision was made at this point to redesign the support base.

Figure 5.8. (a) Weir Barrier Failure; (b) Hinged Connection Failure.

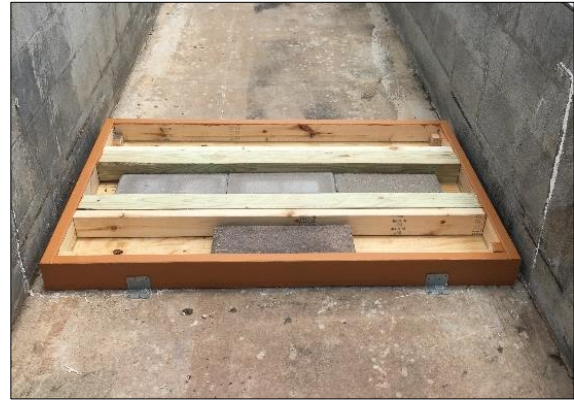
(b)

The first change in the new design was to place the barrier in the center of the support base because the previous 2 ft of empty space behind the barrier was determined to be unnecessary for any counter-moment effects. This new barrier location also allowed the addition of another layer of plywood immediately upstream and downstream of the barrier to simulate a pavement overlay on each side of a median barrier. In this new layout, each barrier was connected to a 5 ft × 1-ft 4-inch section of 0.75-inch plywood that rested on top of two lengths of 3.5-inch × 3.5-inch wood beams. Four threaded inserts were screwed into each wood beam, and small holes were drilled at corresponding locations in the barrier baseboard. This setup allowed for a total of eight removable machine screws to connect the barrier baseboards to the wood beams in the support base. The center section of the support base as well as the front and back sections were filled with concrete blocks for added weight. To prevent water infiltration into the base, all edges were sealed with silicone caulk, and exposed surfaces were covered in multiple coats of a waterproof paint. Figure 5.9 displays the final support base design and the physical base installed in the channel. Neither the removable boards nor the plywood support base cover are included in Figure 5.9b.

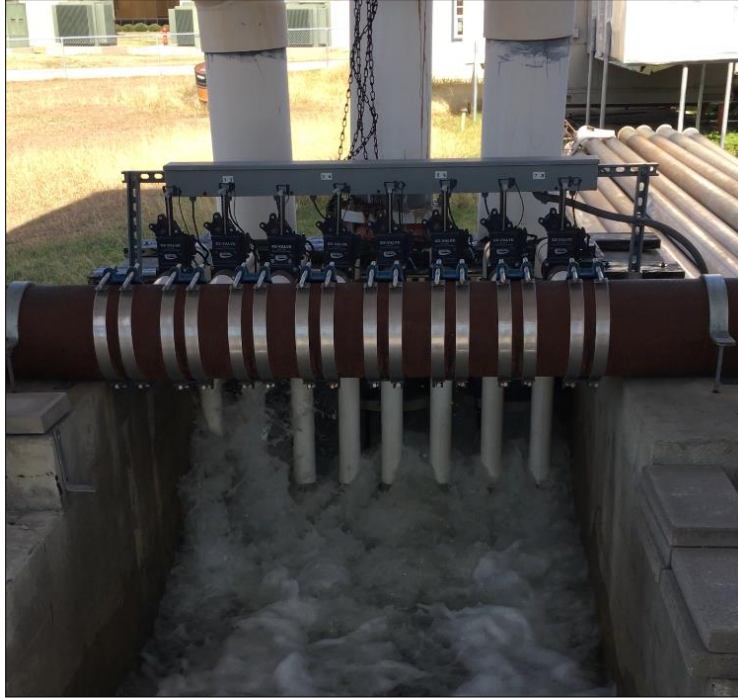
Figure 5.11. Pump Outlets.

The test channel is a rectangular concrete flume with a width of 5 ft, height of 2 ft 8 inches, and length of about 125 ft. The spanwise and lengthwise channel bed slope is approximately zero, and the walls are all at approximately 90-degree angles with the channel bed. Water enters the channel through the two pipe outlets at the channel's head, as shown in Figure 5.11.

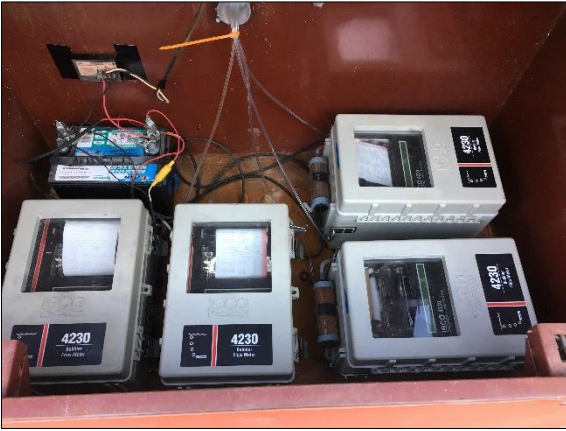
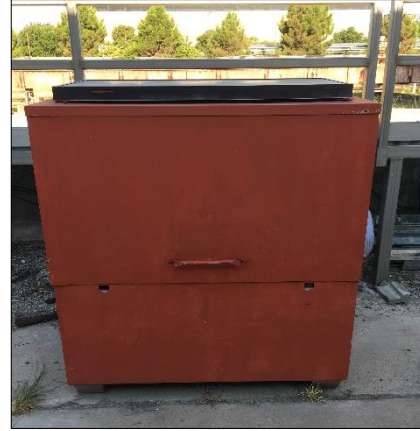
Figure 5.13. (a) ISCO 4230 Bubble Flow Meter; (b) Solar-Powered Housing Unit.

Each flow meter was set at a measurement frequency of 1 Hz and a reporting frequency of 0.2 Hz. Under the specified frequency settings, the flow meters report the mean value from five measurements every five seconds. The tubes were positioned along the channel walls and bed, normal to the direction of flow. This orientation negates interference from the fluid velocity at the tube outlet. A waterproof adhesive is applied to the entire length of the tubing that contacts the channel surface, removing any separation of the line from the channel bed where debris could otherwise get caught.

To ensure accurate measurements, moisture is removed from the air bubbles by passing the influent air through a desiccant chamber sitting on top of the flow meter. After about a month of consistent use, the desiccants begin to change color, indicating they are near their saturation point and must be recharged in an oven. The flow meters and housing unit can be seen in Figure 5.13.

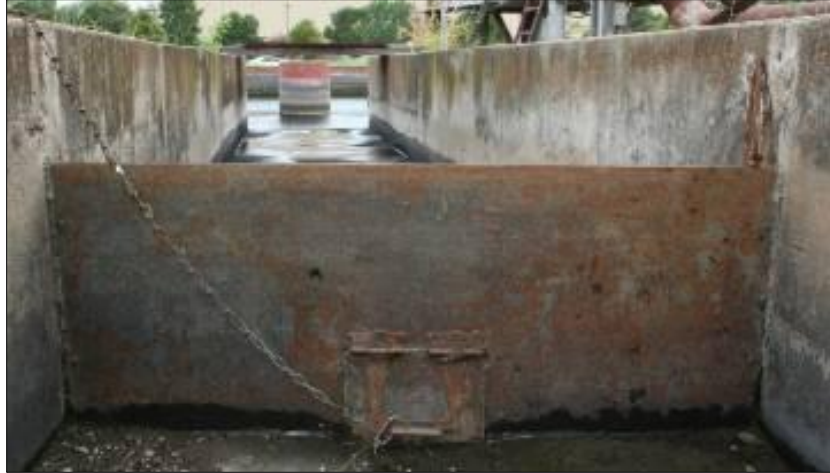
The discharge coefficient, C_d , for this specific weir was found to be 0.618 from experiments by Benson (35).

Figure 5.14. Discharge Weir and Gate.

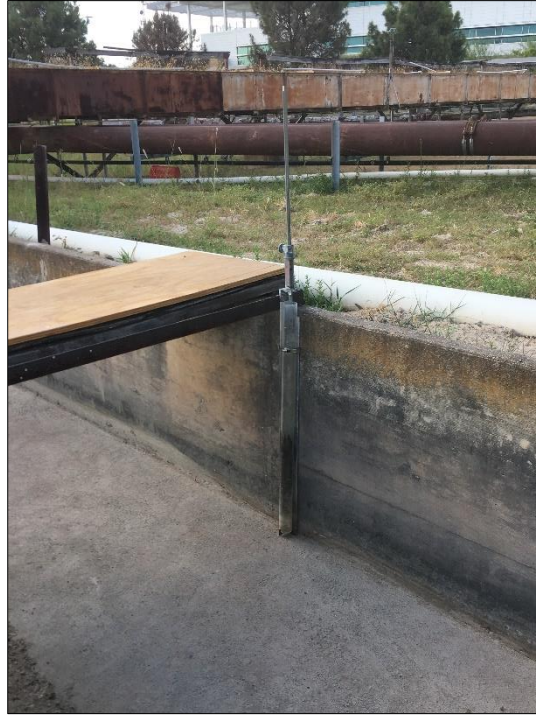
Figure 5.15. Point Gauge.

The water depth in the return channel is measured to one thousandth of a foot with a point gauge located 16 ft upstream of the discharge weir. At this location, there are negligible drawdown effects from the weir; however, there are slight variations in the water depth at any given moment due to turbulent effects from a 90-degree bend in the channel 27 ft upstream. To suppress these small waves, the point gauge resides in a 2-inch-diameter plastic stilling well. This setup is displayed in Figure 5.15. A datum is set at the weir crest to measure the water depth over the weir. This datum was measured through a method that began by allowing the return channel to fill completely until water was flowing over the discharge weir. The pumps were then shut off and the weir gate was kept closed, allowing water to only drain to the weir height. Since the weir has a small slope, the datum was set at the location of the intersection between the water surface and the center of the weir span. This measurement was not made in a vertically static condition, as water continued to drain slowly over the lower edge of the slanted weir crest. To increase accuracy, the measurement process was repeated multiple times and averaged. The gauge reading for the weir crest was determined to be 0.958 ft.

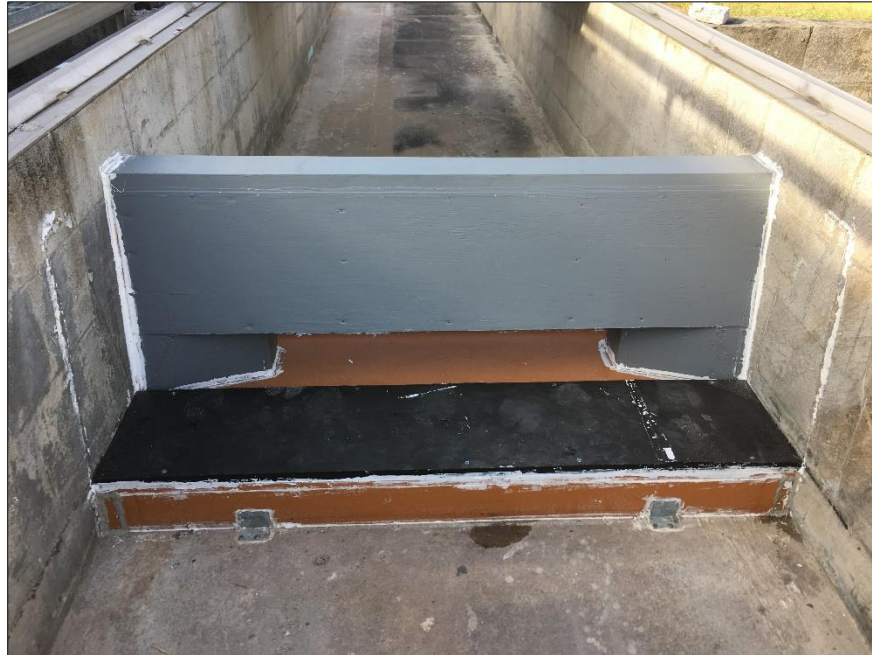
Figure 5.16. SSCB with Overlay.

The 2-inch asphalt overlay was simulated with a 1-inch board on top of the support base immediately upstream and downstream of the model barrier. An example of the overlay case can be seen with the SSCB in Figure 5.16. The datum for both cases was set at the support base height (3.5 inches above the channel bed) when developing the flow rate–water depth rating

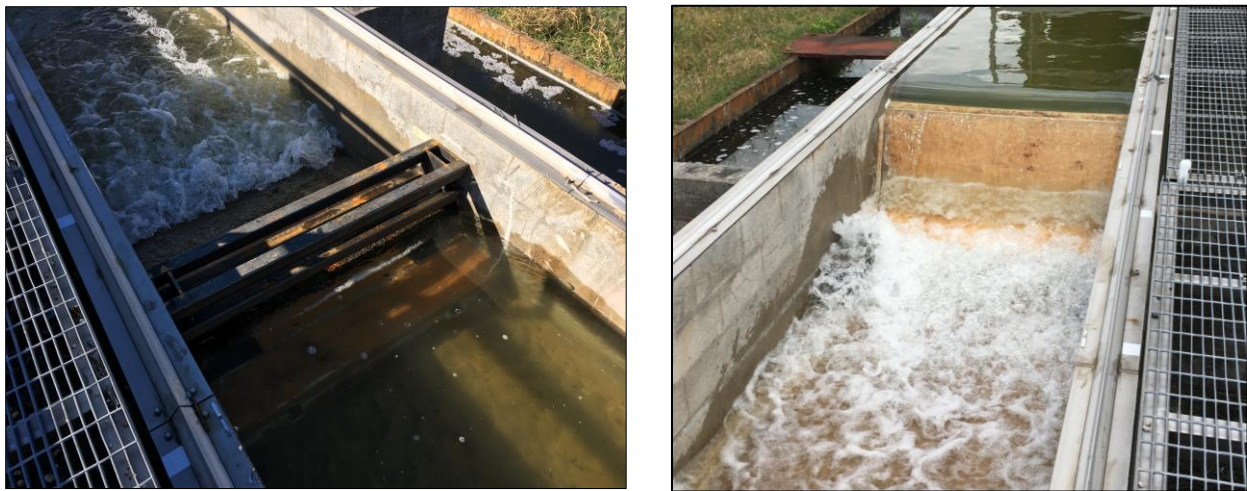
Figure 5.26. Downstream Behavior Comparison.

Given the large F_0 in the steel barrier, the assumption that flow reaches a critical point as it passes through the obstruction may no longer be valid. This can be seen in a hydraulic jump that is created just downstream of the barrier, resulting in a return to subcritical flow after passing through the steel barrier. In all previous barriers, the critical point assumption is verified by the transition of subcritical flow upstream of the barriers to supercritical flow immediately downstream of the barriers. A comparison of downstream behavior is displayed in Figure 5.26.

(a) Subcritical flow downstream of steel barrier (b) Supercritical flow downstream of weir barrier
