DEVELOPMENT AND *MASH* TL-4 EVALUATION OF TXDOT LARGE-SCUPPER MEDIAN BARRIER FOR FLOOD-PRONE AREAS

Test Report 0-6976-R1

TEXAS A&M TRANSPORTATION INSTITUTE
COLLEGE STATION, TEXAS

TEXAS DEPARTMENT OF TRANSPORTATION

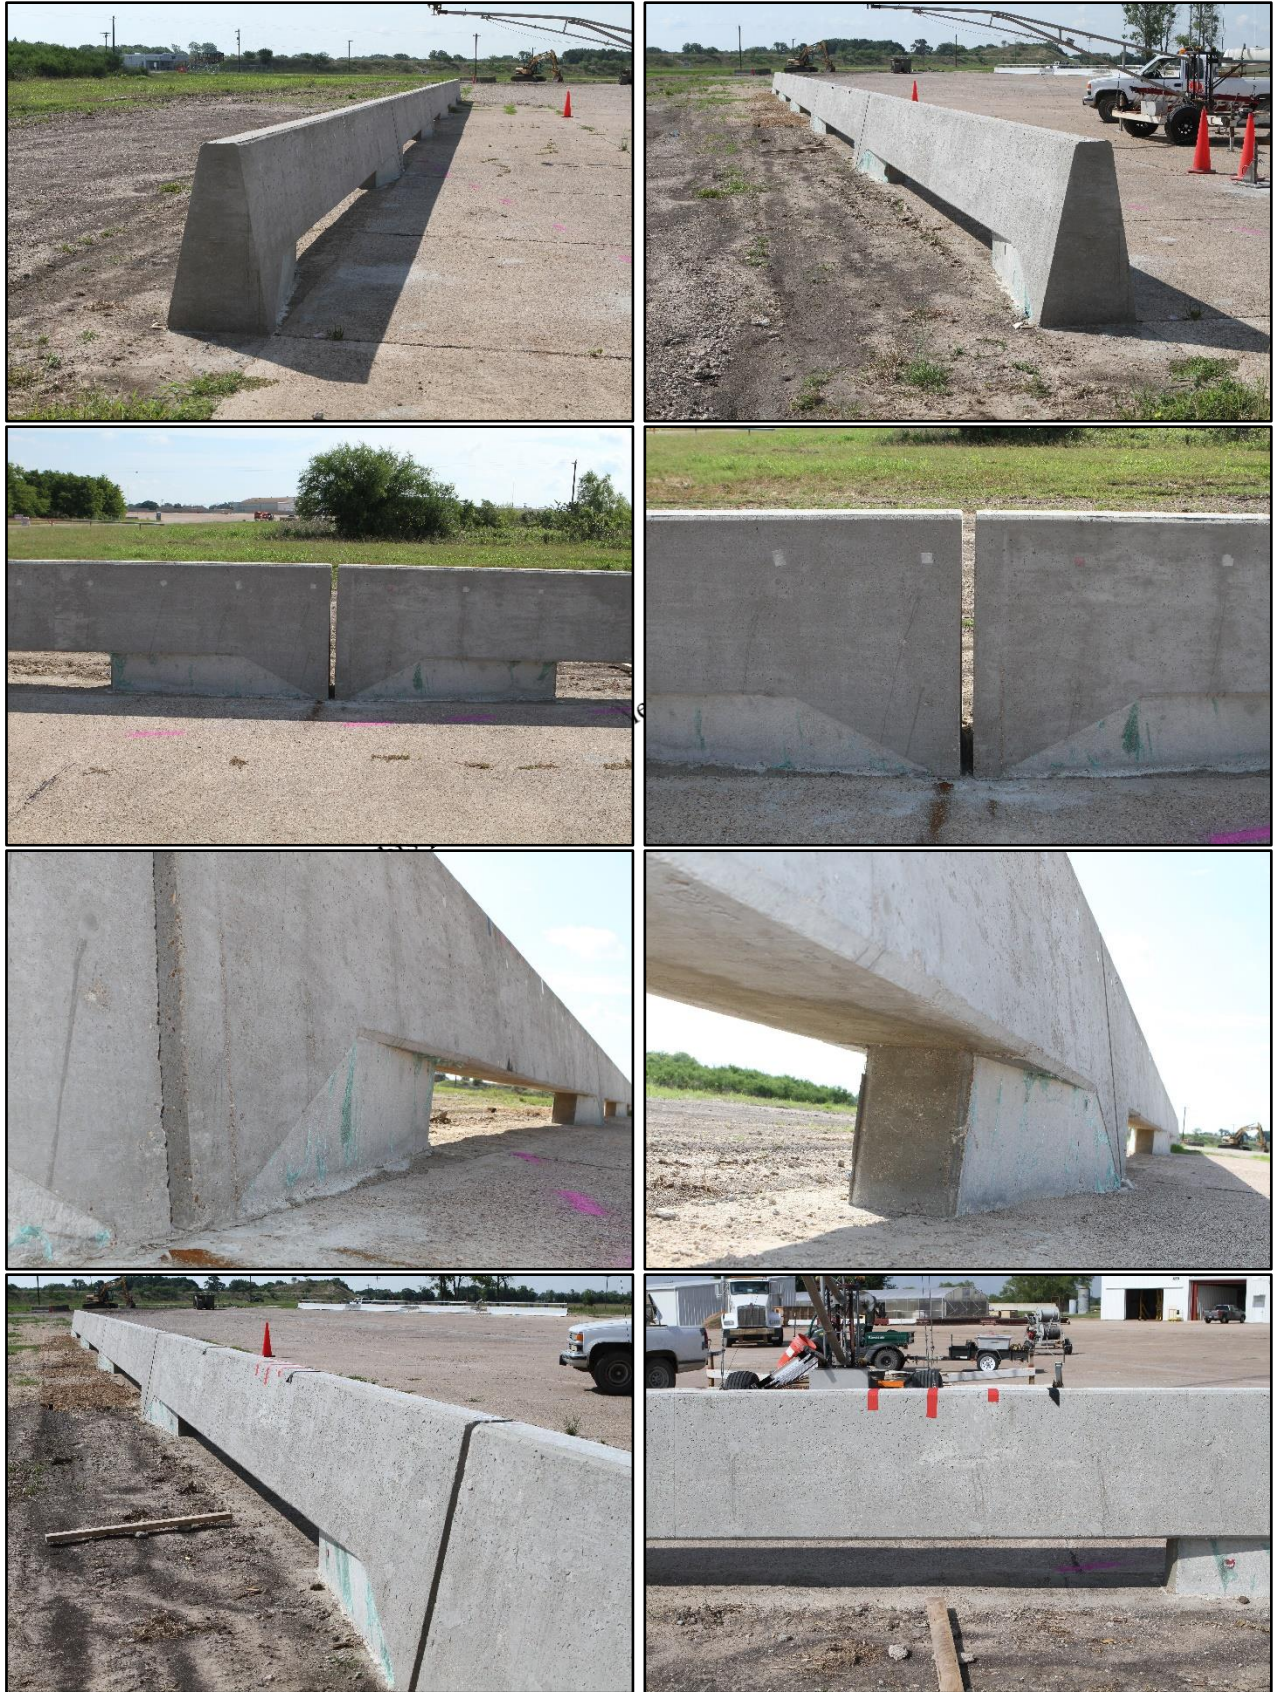
Figure 6.2. TxDOT LSMB prior to Testing.

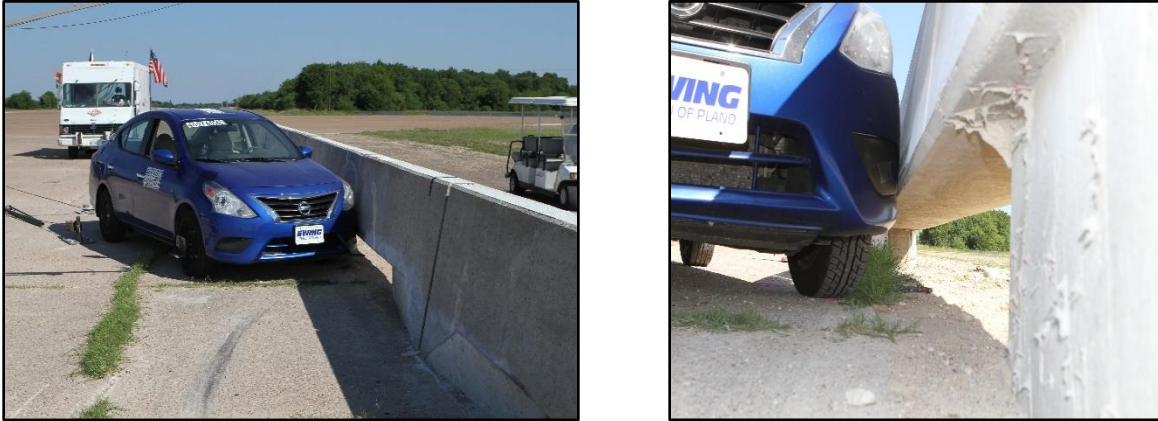
Figure 9.1. TxDOT LSMB/Test Vehicle Geometrics for Test No. 469760-06-1.

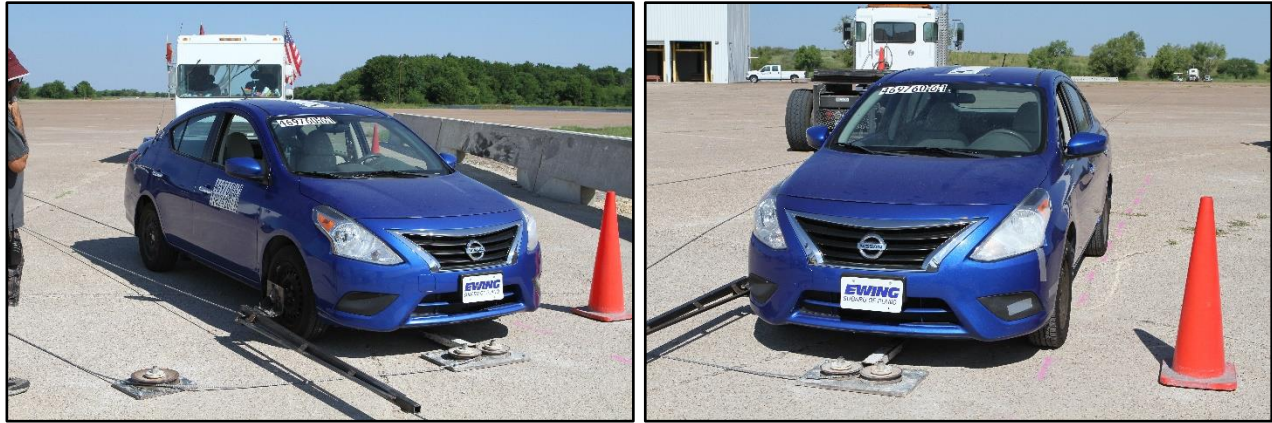
Figure 9.2. Test Vehicle before Test No. 469760-06-1.

Figure 9.2 shows the 2015 Nissan Versa used for the crash test. The vehicle's test inertia weight was 2449 lb, and its gross static weight was 2614 lb. The height to the lower edge of the vehicle bumper was 7.0 inches, and the height to the upper edge of the bumper was 22.25 inches. Table C.1 in Appendix C.1 gives additional dimensions and information on the vehicle. The vehicle was directed into the installation using a cable reverse tow and guidance system, and was released to be freewheeling and unrestrained just prior to impact.

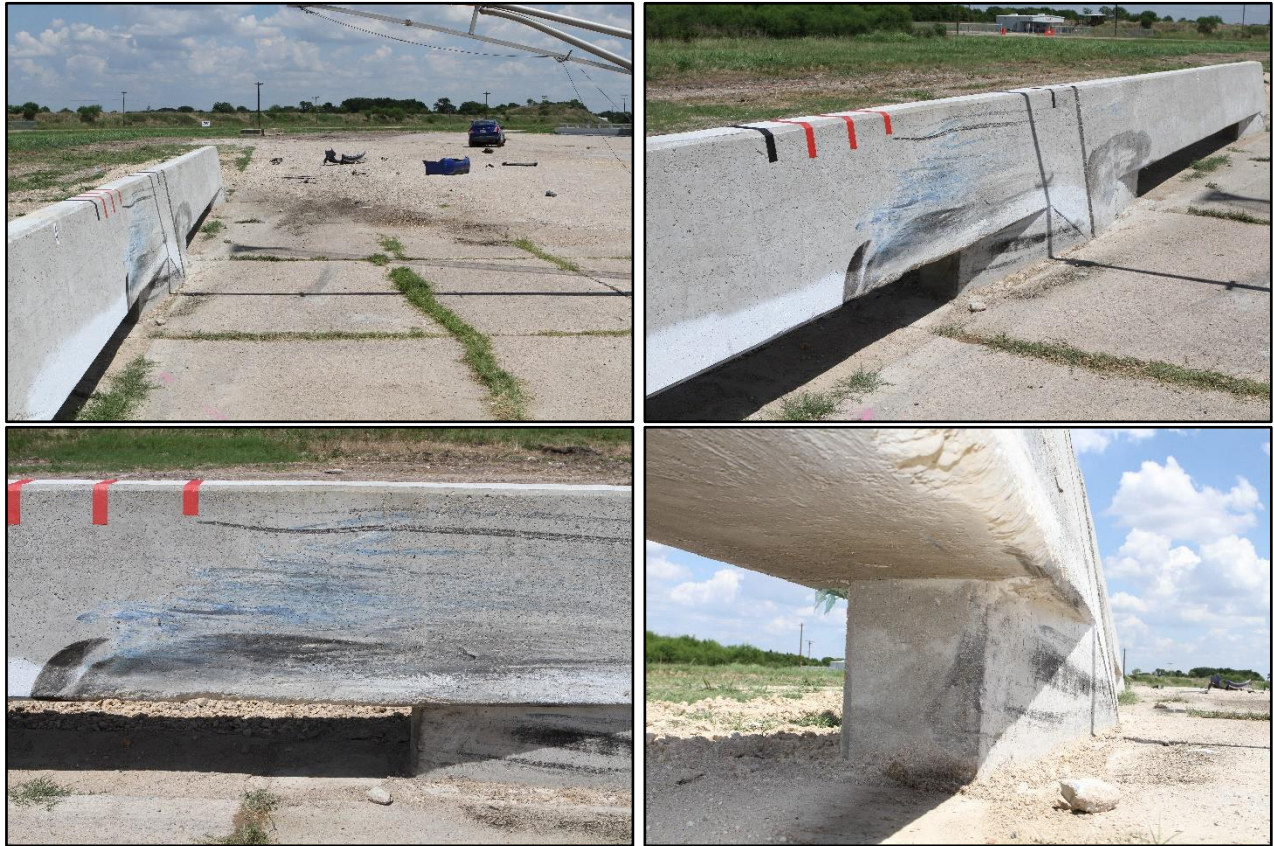
working width was at the toe of the barrier. Maximum dynamic deflection during the test was 1.8 inches, and maximum permanent deformation was 0.4 inches.

Figure 9.3. TxDOT LSMB after Test No. 469760-06-1.

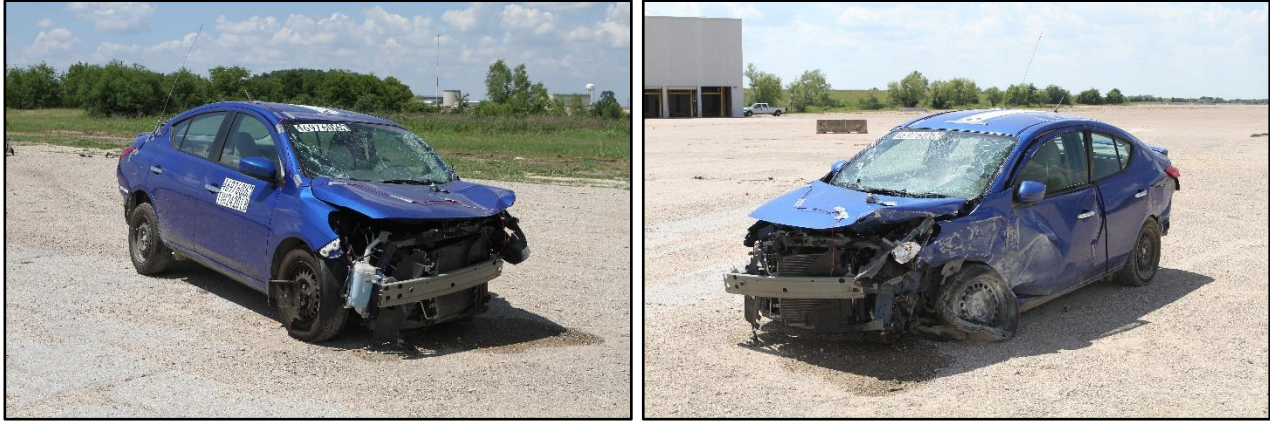
Figure 9.4. Test Vehicle after Test No. 469760-06-1.

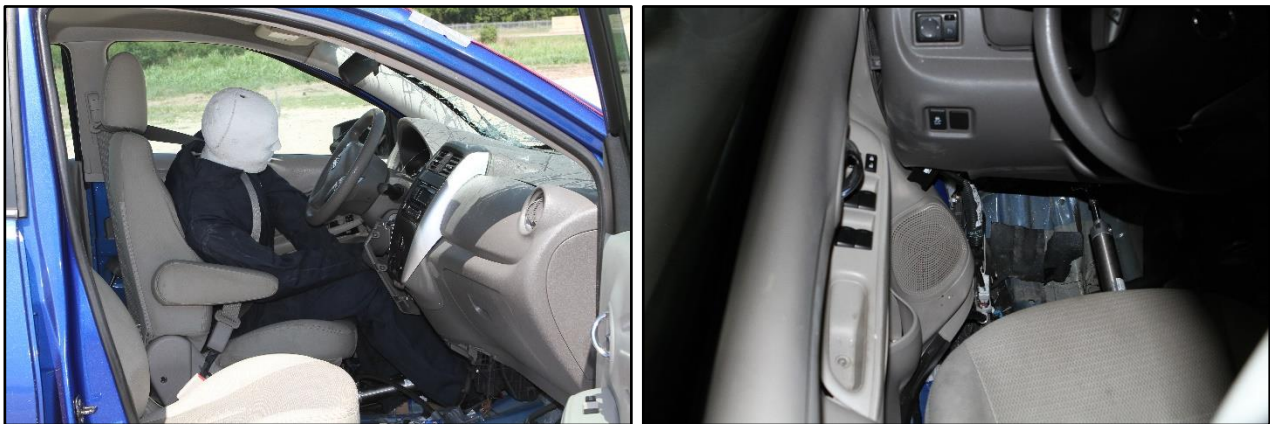
Figure 9.5. Interior of Test Vehicle after Test No. 469760-06-1.

Figure 9.4 shows the damage sustained by the vehicle. The front bumper, hood, left front fender, left front strut and strut tower, left front tire and rim, left front lower control arm, left A-post, left front floor pan, left front door, left rear door, and left rear quarter panel were damaged. The roof was deformed at the B-post, and the windshield was cracked upward and inward of the left A-post. No fuel tank damage was observed. Maximum exterior crush to the vehicle was 11.0 inches in the side plane at the left front corner at bumper height. Maximum occupant compartment deformation was 4.5 inches in the left kick panel area and 1.0 inch in the left front firewall. Figure 9.5 shows the interior of the vehicle. Tables C.2 and C.3 in Appendix C.1 provide exterior crush and occupant compartment measurements.

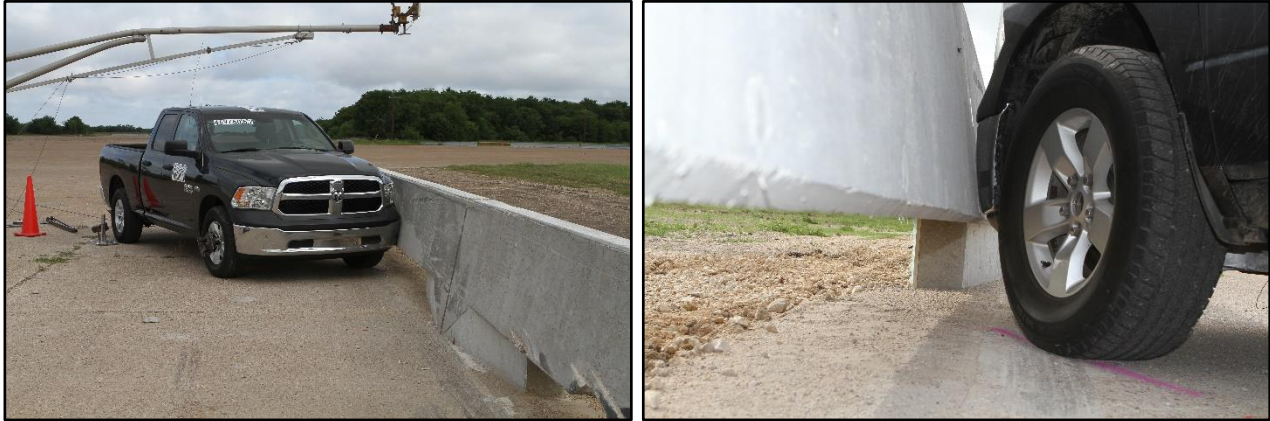
Figure 10.1. TxDOT LSMB/Test Vehicle Geometrics for Test No. 469760-06-2.

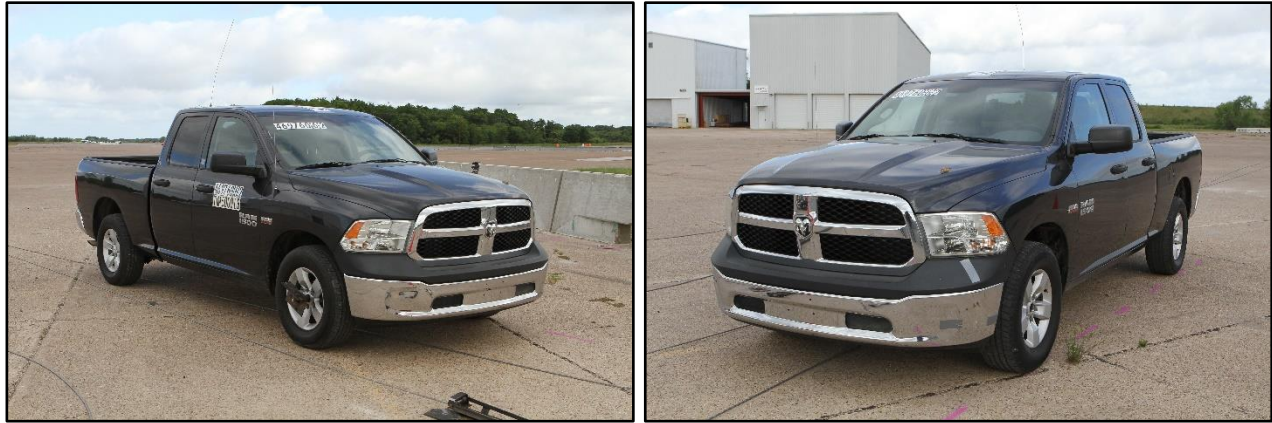
Figure 10.2. Test Vehicle before Test No. 469760-06-2.

Figure 10.2 shows the 2015 RAM 1500 pickup truck used for the crash test. The vehicle's test inertia weight was 5005 lb, and its gross static weight was 5170 lb. The height to the lower edge of the vehicle bumper was 11.75 inches, and height to the upper edge of the bumper was 27.0 inches. The height to the vehicle's center of gravity was 28.25 inches. Tables D.1 and D.2 in Appendix D.1 give additional dimensions and information on the vehicle. The vehicle was directed into the installation using a cable reverse tow and guidance system, and was released to be freewheeling and unrestrained just prior to impact.

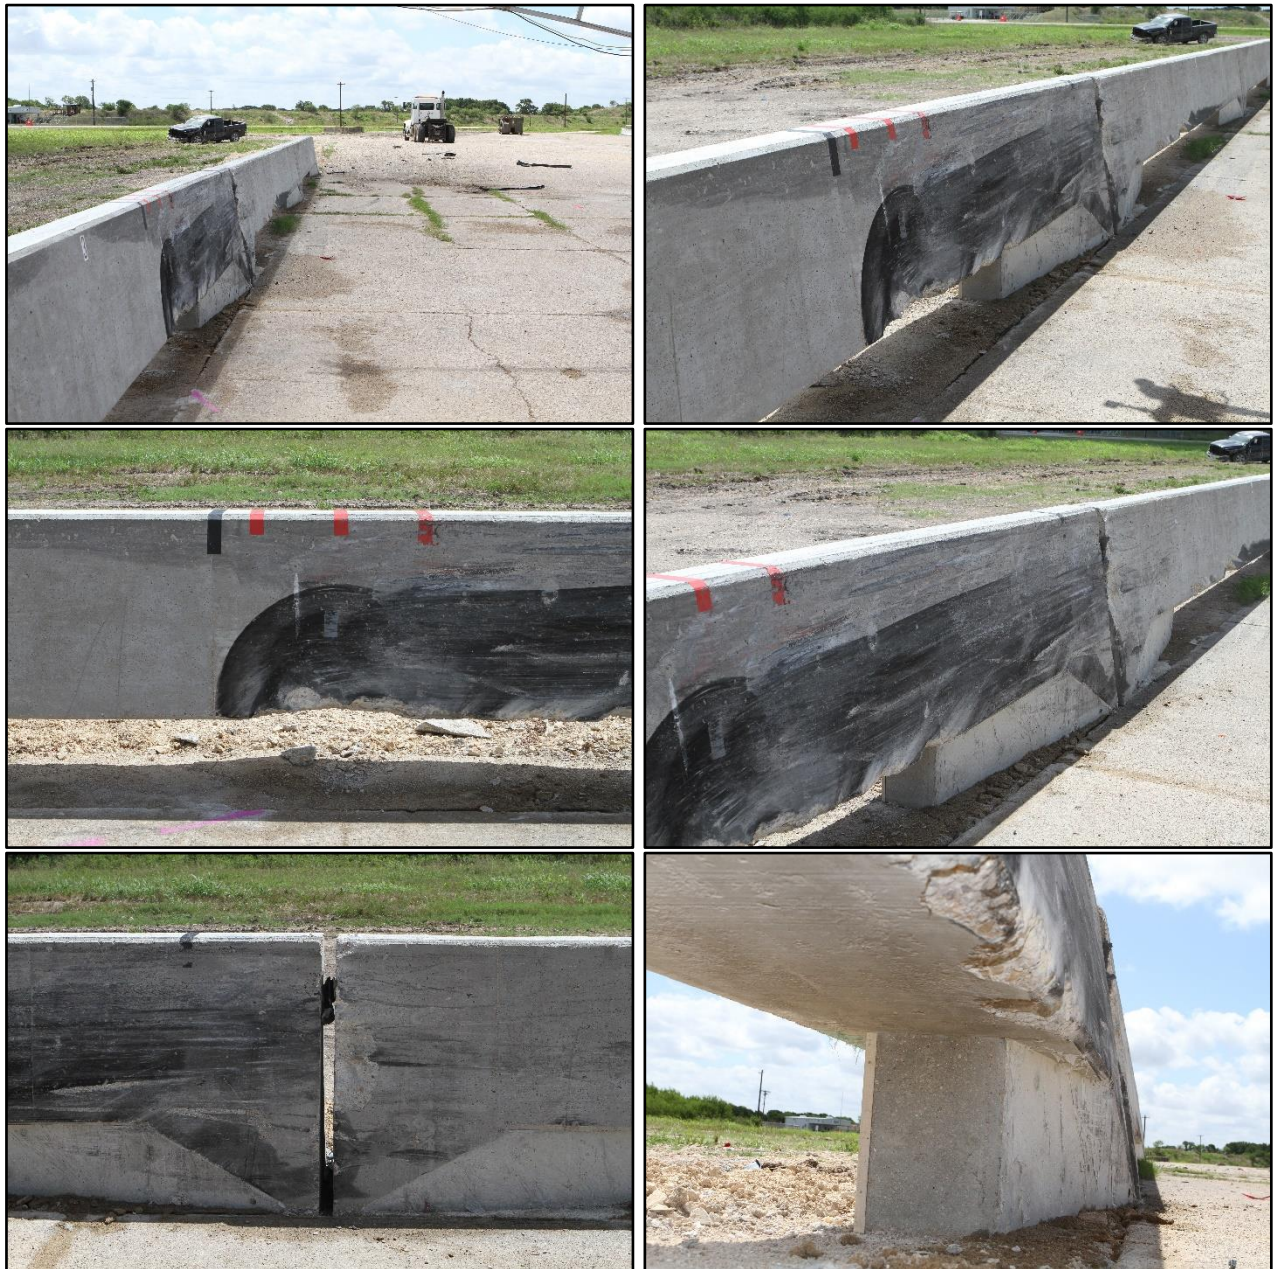
Figure 10.3. TxDOT LSMB after Test No. 469760-06-2.

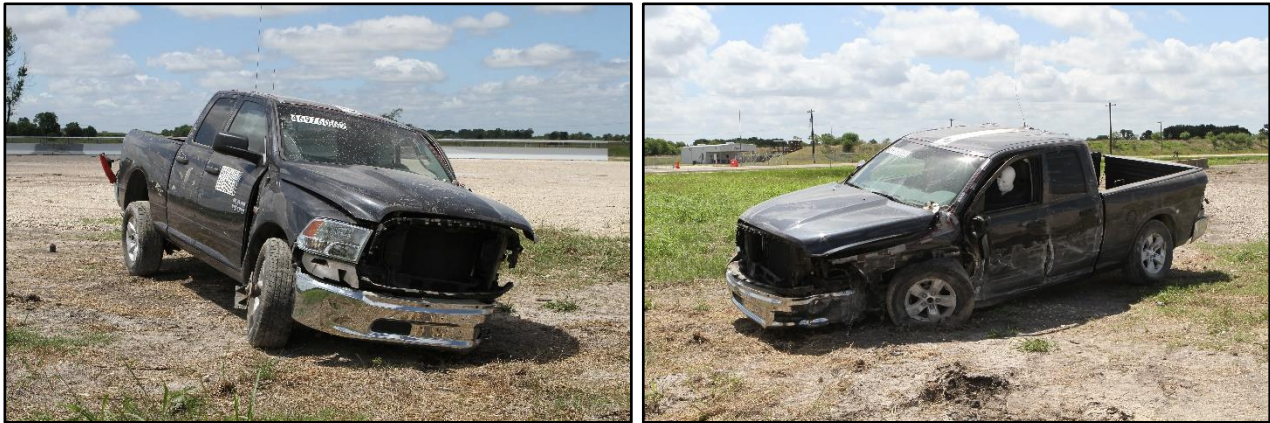
Figure 10.4. Test Vehicle after Test No. 469760-06-2.

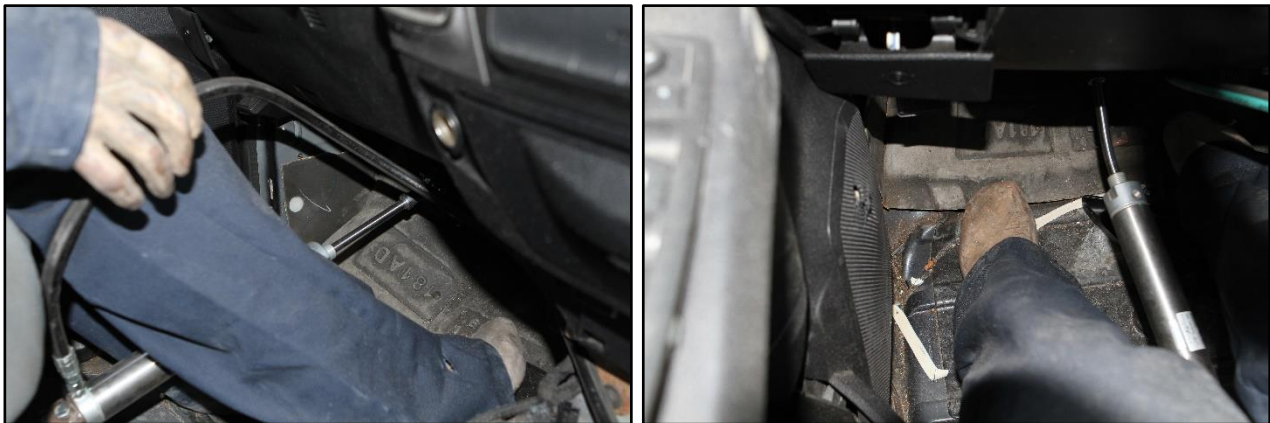
Figure 10.5. Interior of Test Vehicle after Test No. 469760-06-2.

Figure 10.4 shows the damage sustained by the vehicle. The front bumper, hood, grill, radiator and support, left front fender, left lower control arm, left front tire and rim, left front door and window glass, left front floor pan, left rear door, left rear cab corner, left exterior bed, and rear bumper were damaged. No fuel tank damage was observed. Maximum exterior crush to the vehicle was 14.0 inches in the front and side planes at the left front corner at bumper height. Maximum occupant compartment deformation was 2.0 inches in the left front floor pan and kick panel area. Figure 10.5 shows the interior of the vehicle. Tables D.3 and D.4 in Appendix D.1 provide exterior crush and occupant compartment measurements.

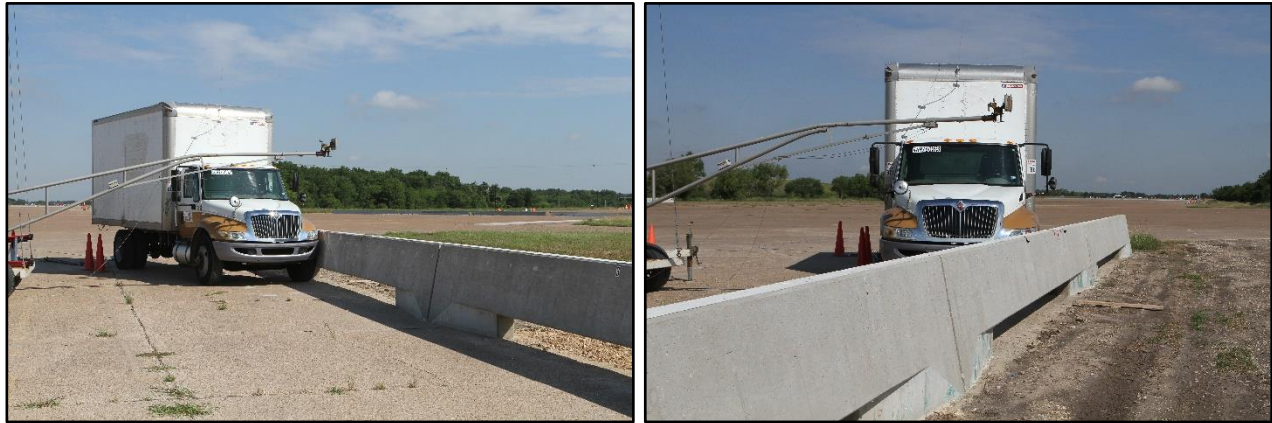
Figure 11.1. TxDOT LSMB/Test Vehicle Geometrics for Test No. 469760-06-3.

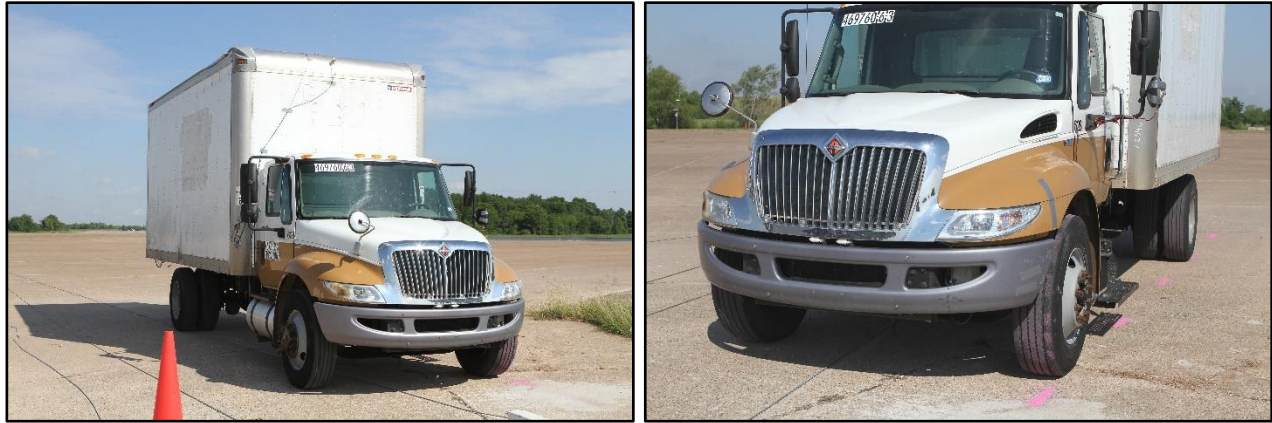
Figure 11.2. Test Vehicle before Test No. 469760-06-3.

Figure 11.2 shows the 2013 International 4300 SUT used for the crash test. The vehicle's test inertia weight was 22,300 lb, and its gross static weight was 22,300 lb. The height to the lower edge of the vehicle bumper was 18.5 inches, and height to the upper edge of the bumper was 33.5 inches. The height to the center of gravity of the vehicle's ballast was 61.5 inches. Table E.1 in Appendix E.1 gives additional dimensions and information on the vehicle. The vehicle was directed into the installation using a cable reverse tow and guidance system, and was released to be freewheeling and unrestrained just prior to impact.

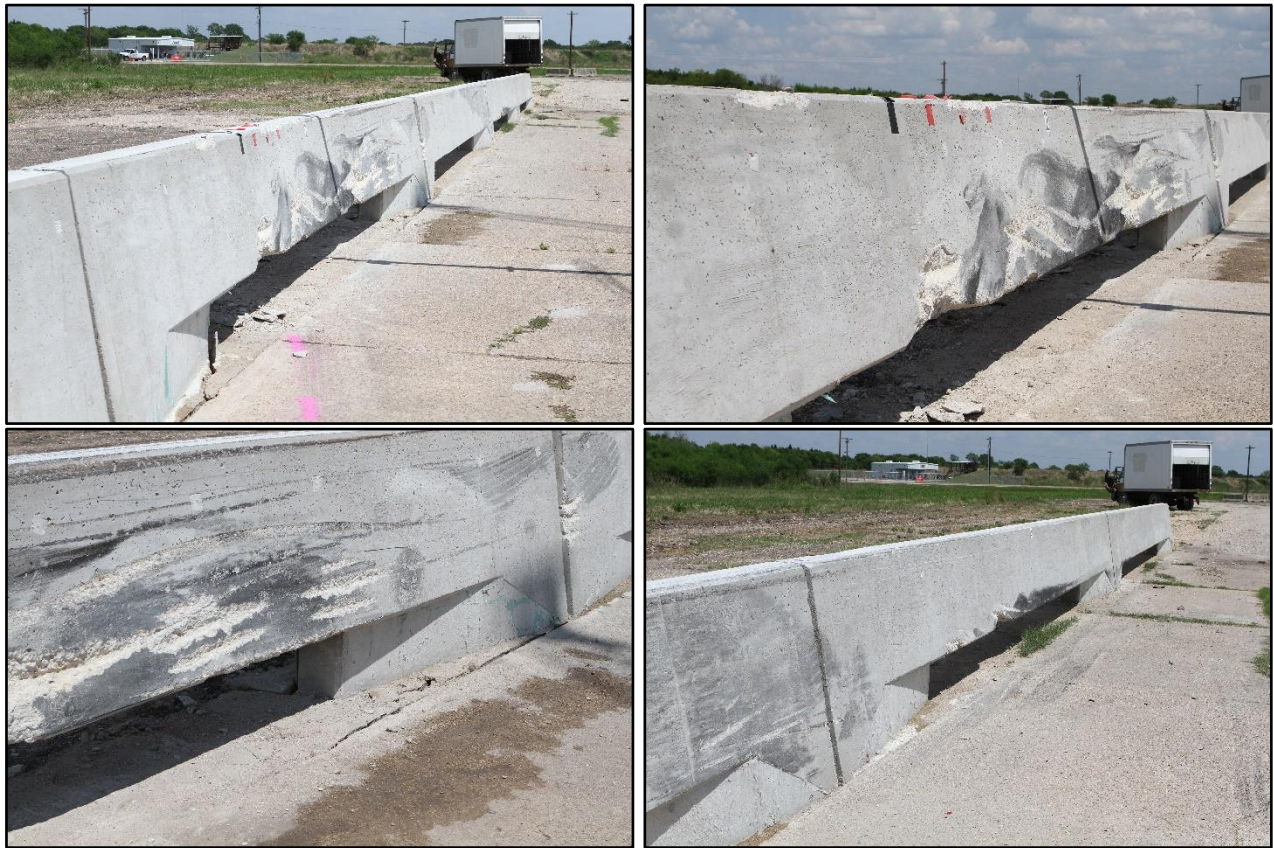
Figure 11.3. TxDOT LSMB after Test No. 469760-06-3.

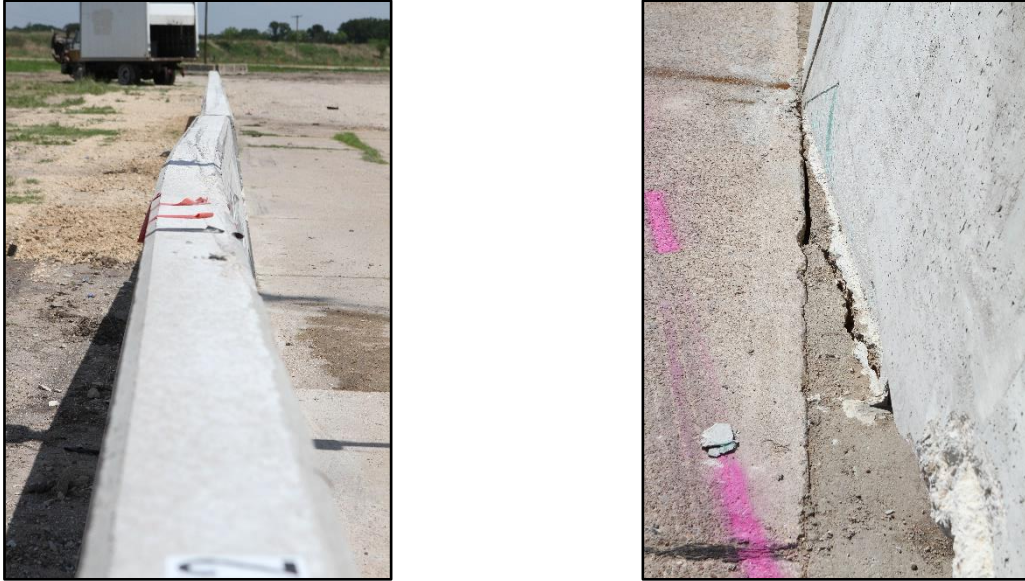
Figure 11.4. Movement of Barrier after Test No. 469760-06-3.

Figure 11.3 through Figure 11.5 show the damage to the TxDOT LSMB. The base of the barrier on both the upstream and downstream ends of Barrier 2 shifted 1.0 inch toward the field side, and the center of Barrier 2 had a permanent deflection of 3.6 inches. Gouging of the concrete was present along the traffic side of Barrier 2, and there was a stress crack along the field side of the barrier running vertically from the top of the barrier to the bottom. Gouging was also present on the traffic face of the upstream end of Barrier 3 and on Barrier 4 at the top of the traffic-side scupper, deep enough to expose rebar. There was scuffing on Barriers 3, 4, and 5 due

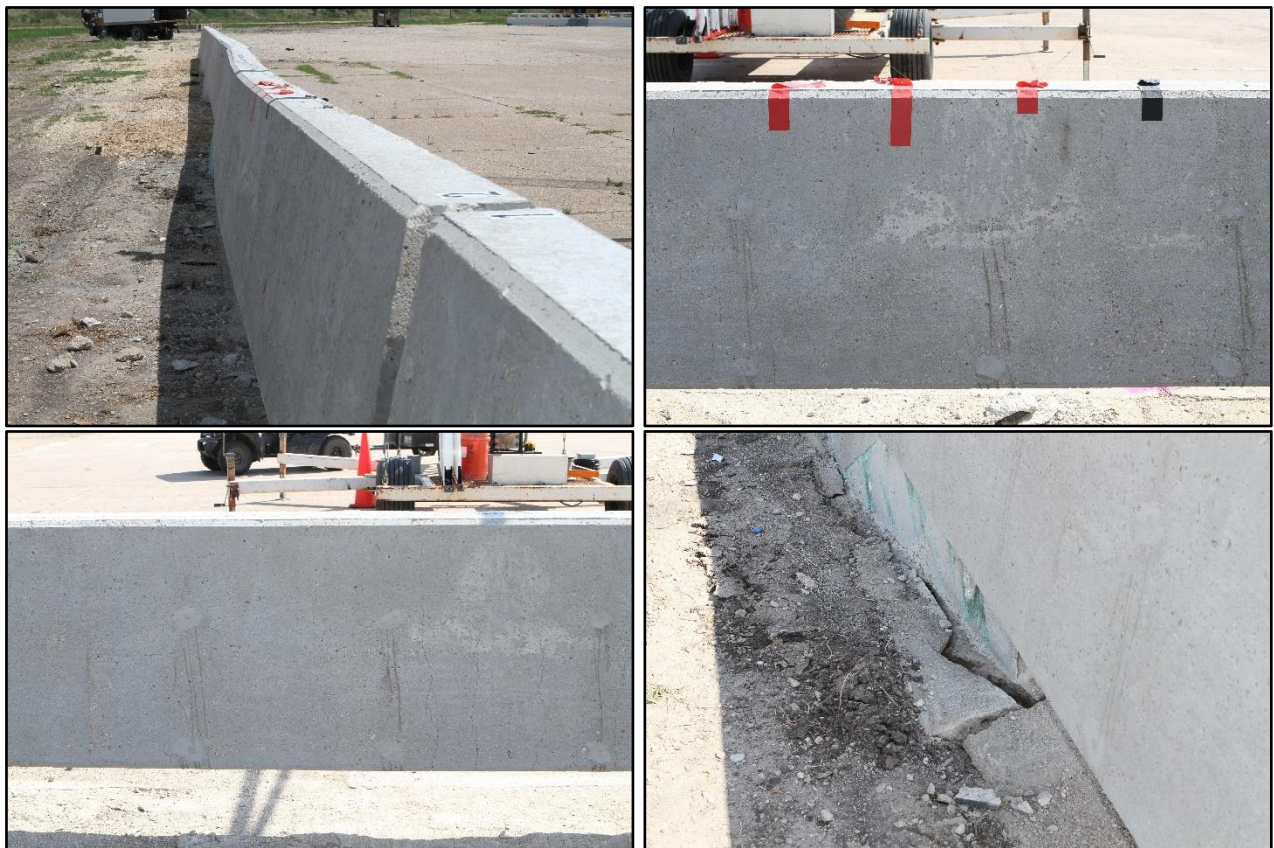
Figure 11.5. Field Side of Barrier after Test No. 469760-06-3.

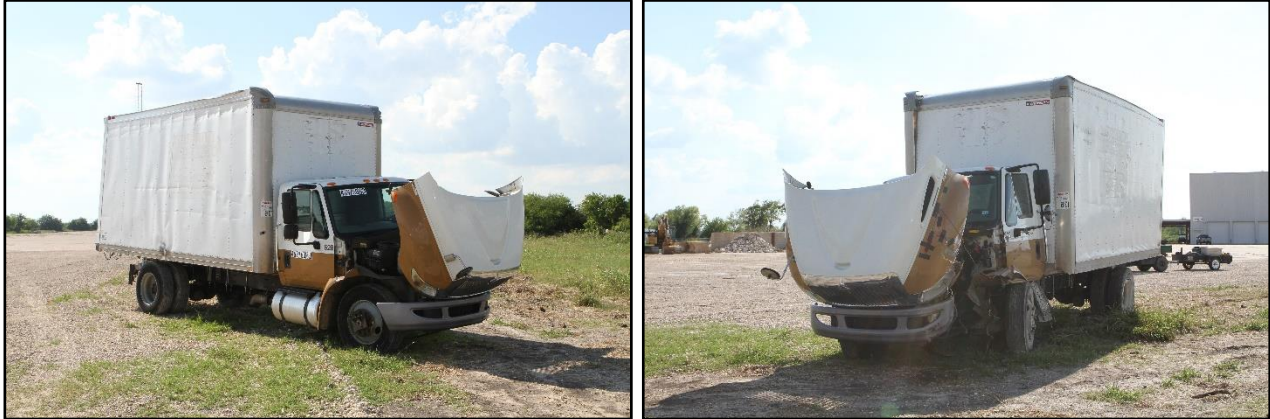
Figure 11.6. Test Vehicle after Test No. 469760-06-3.

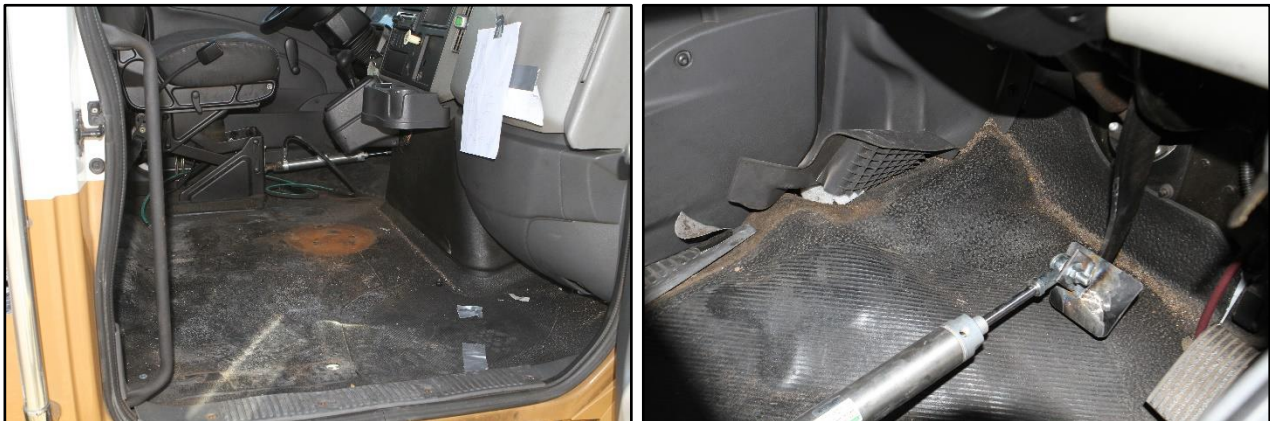
Figure 11.7. Interior of Test Vehicle after Test No. 469760-06-3.

front tire and rim, left door, left rear cab corner, left battery box, left side steps and air tank, left lower edge of box, left rear outer tire and rim, and right upper edge of the box were damaged. No damage to the fuel tank was observed. Maximum exterior crush to the vehicle was 16.0 inches in the side plane at the left front corner at bumper height. Maximum occupant compartment deformation was 3.75 inches in the left front corner of the floor pan. Figure 11.7 shows the interior of the vehicle.

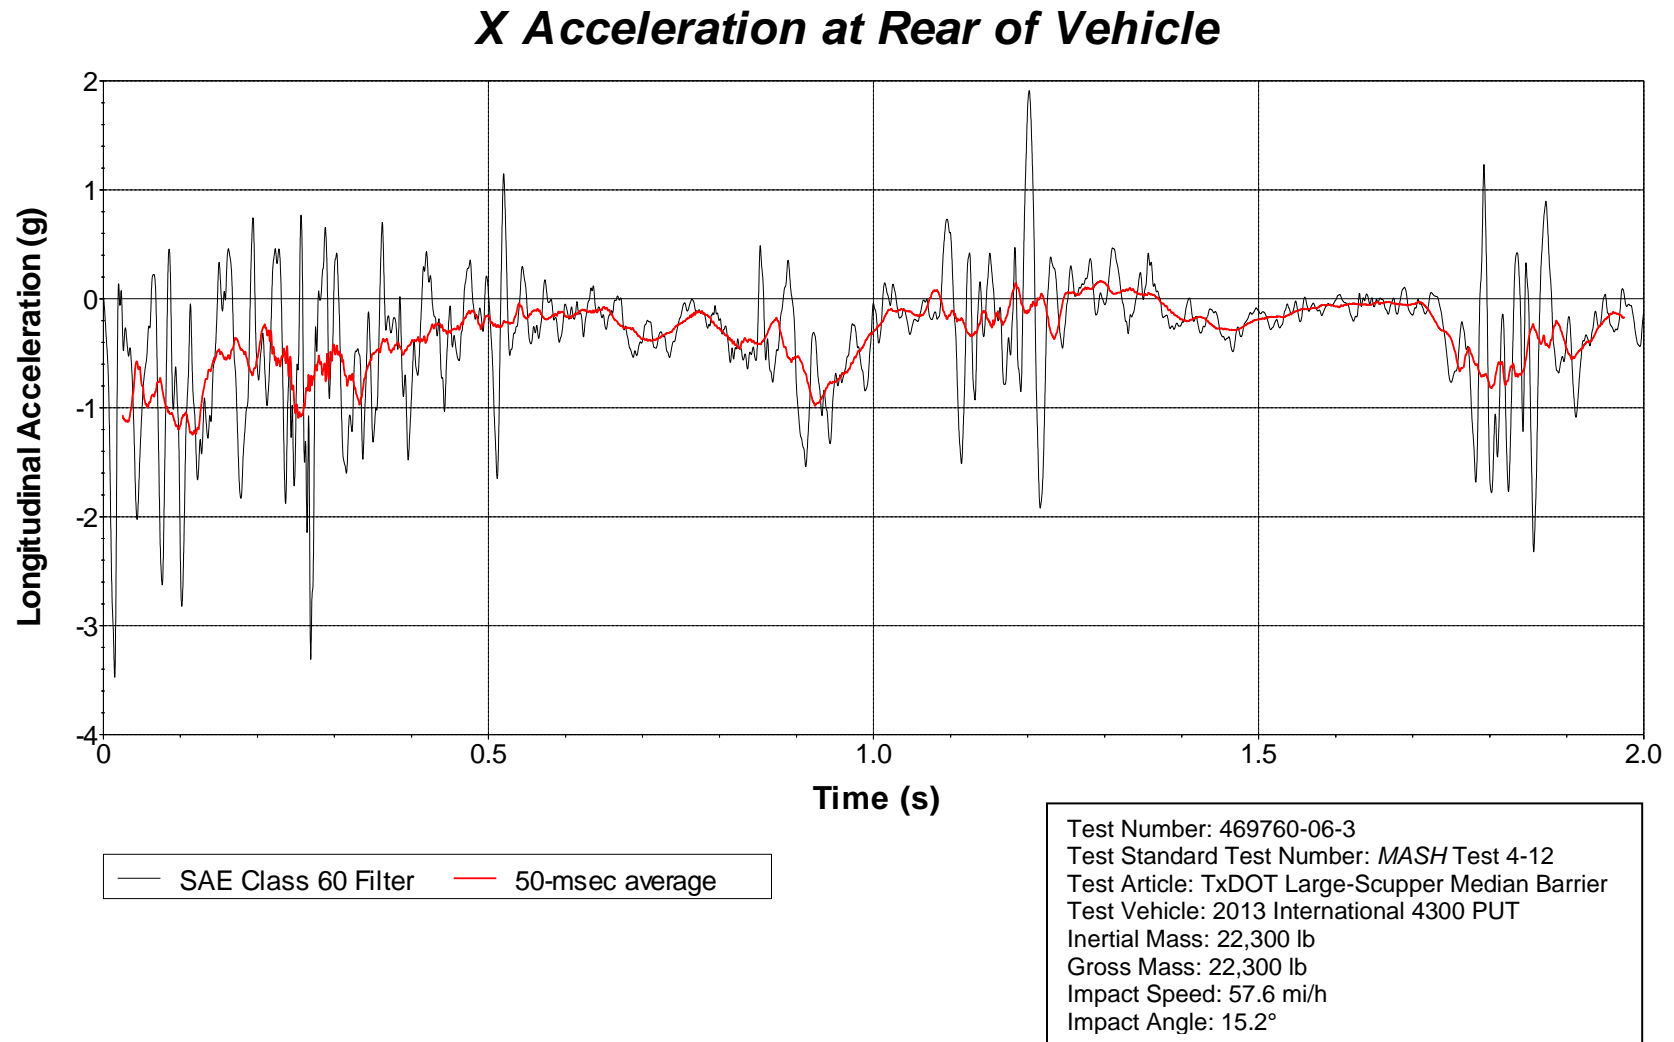
**Figure E.7. Vehicle Longitudinal Accelerometer Trace for Test No. 469760-06-3
(Accelerometer Located at Rear of Vehicle).**
