| 4. Title and Subtitle<br><b>Evaluation of Serviceability Requirements for Load Rating<br/>Prestressed Concrete Bridges</b> | | 5. Report Date<br>January 2007 | |
| 7. Author(s)<br><b>Sharon L. Wood, Michael J. Hagenberger,<br/>Bryan E. Heller, and Patrick J. Wagener</b> | | 8. Performing Organization Report No.<br>1895-1 | |
| 12. Sponsoring Agency Name and Address<br>Texas Department of Transportation<br>Research and Technology Implementation Office<br>P.O. Box 5080<br>Austin, TX 78763-5080 | | 13. Type of Report and Period Covered<br>Research Report (9/1999 - 8/2002) | |

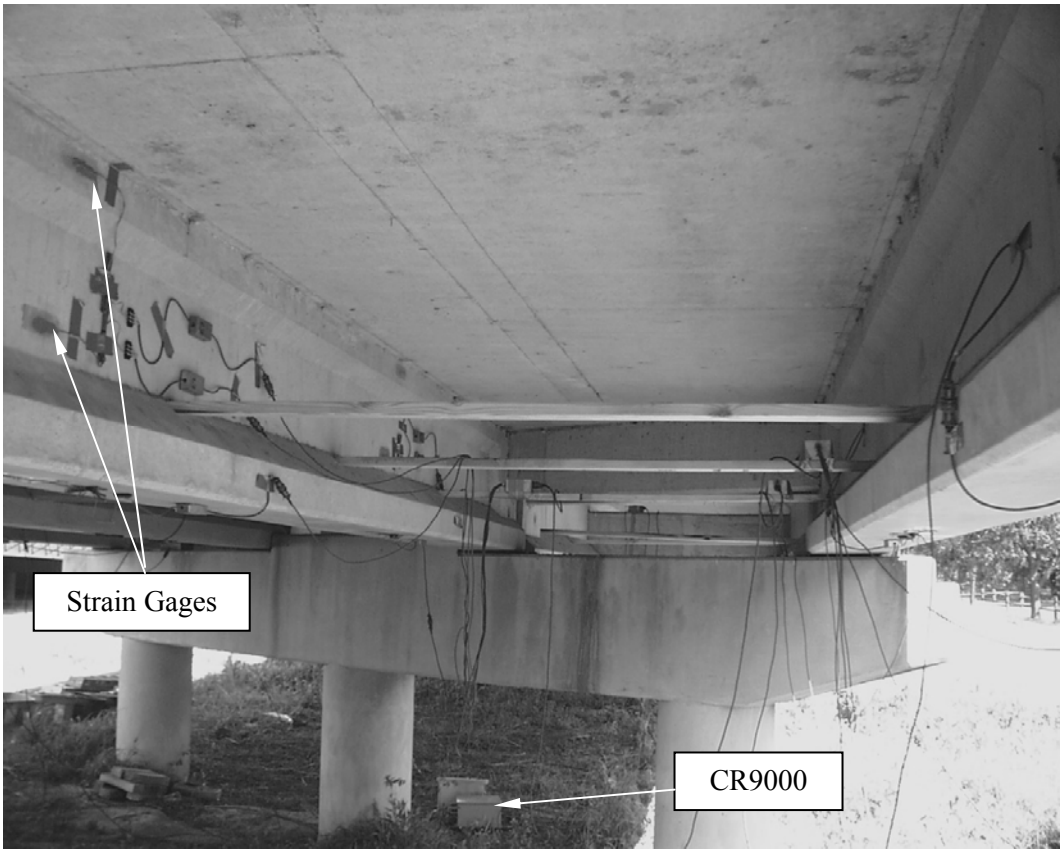
The instrumentation, cables, and data acquisition system are shown in place beneath a bridge in Figure 3.13, and a detailed view of the strain gage attached to the bottom flange is shown in Figure 3.14. The research team spent three to five days installing instrumentation and routing the cables in preparation for each diagnostic load test.

**Figure 3.13 Instrumentation Used to Monitor Bridge Response during Diagnostic Load Tests**

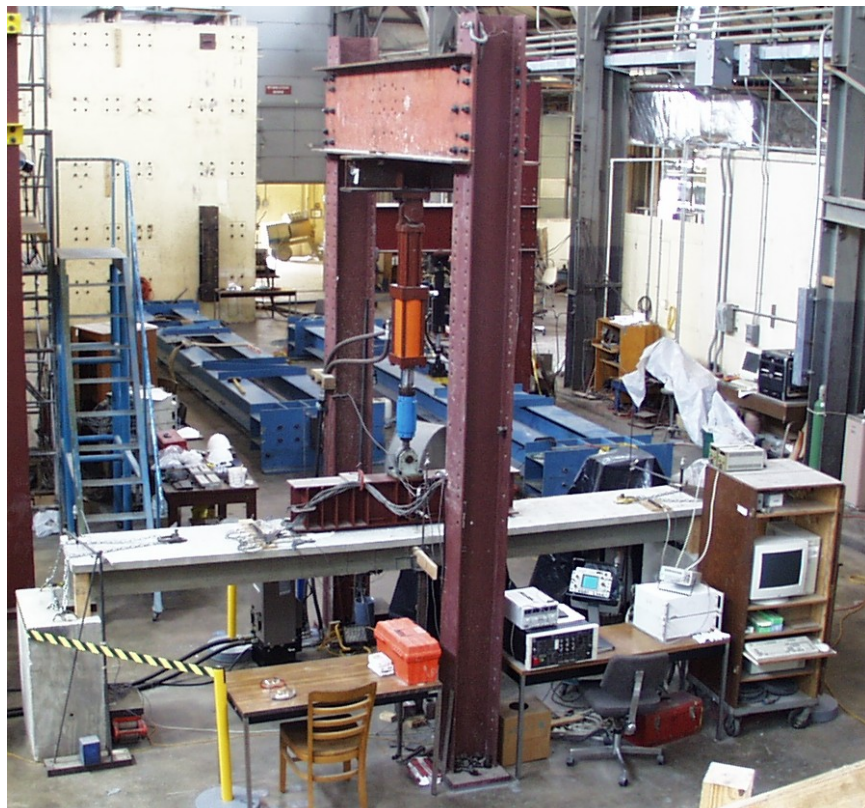
A single hydraulic ram was used to apply the load to the beam (Figure 5.7). This load was distributed to two equal loads through a spreader beam. The load was transferred from the spreader beam to the test specimen through two, 1-in. thick elastomeric bearing pads. This loading configuration created a 4-ft constant moment region.

**Figure 5.7 Photograph of Test Specimen**

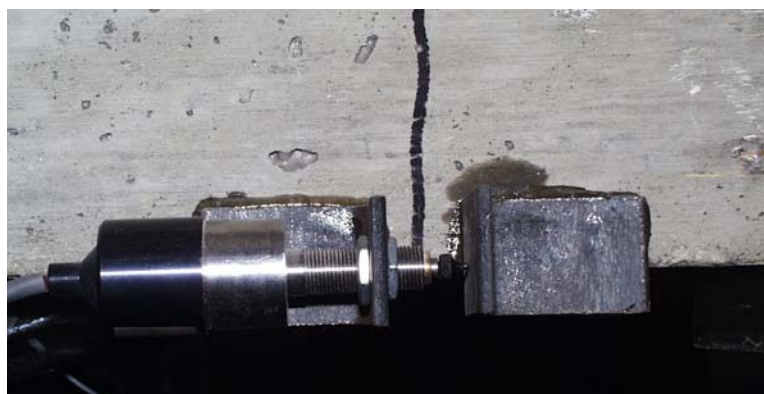
Beams 1, 2, 4, and 5 cracked during the initial static test. After unloading, a horizontal displacement transducer was installed across the most prominent crack (Figure 5.17) and two surface concrete strain gages were installed, one on each side of the prominent crack. After this instrumentation was installed, the static test was repeated.

**Figure 5.17 Displacement Transducer used to Opening and Closing of Flexural Crack**

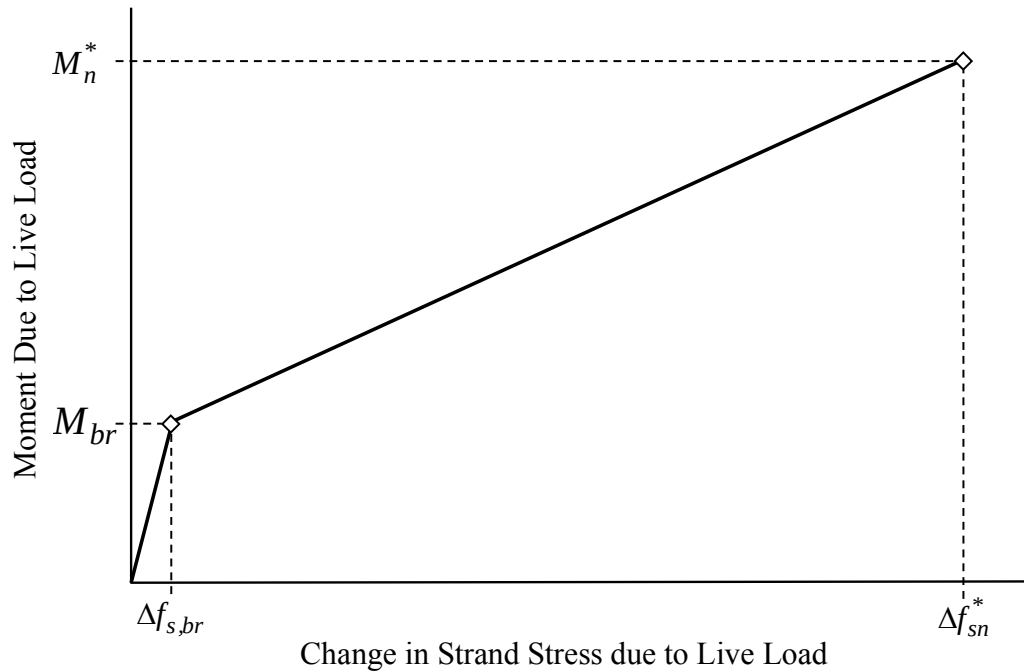
**Figure 9.10 Idealized Bilinear Relationship between Live Load Moment and Strand Stress Range**
