| 4. Title and Subtitle<br><br><b>Evaluation of Two Monitoring Systems for Significant Bridges in Texas</b> | | 5. Report Date<br>January 2004 | |
| 7. Author(s)<br>C. T. Bilich and S. L. Wood | | 8. Performing Organization Report No.<br>Research Report 0-4096-1 | |

Two monitoring systems for bridges were evaluated for use by the Texas Department of Transportation. The first system was designed to increase the quantitative information obtained during a routine inspection of a steel bridge. The miniature, battery-powered data acquisition system selected for study has the ability to record a single channel of strain data and use a rainflow counting algorithm to evaluate the raw data. This system was considered to be particularly useful for evaluating fracture critical bridges. The second system provided long-term monitoring of bridge displacements using global positioning systems (GPS). The accuracy threshold of the GPS data was found to be 3 to 4 mm when the data were averaged for 24 hr. Significantly larger errors were observed for shorter averaging durations when satellite coverage was poor. Both monitoring systems are evaluated in this report.

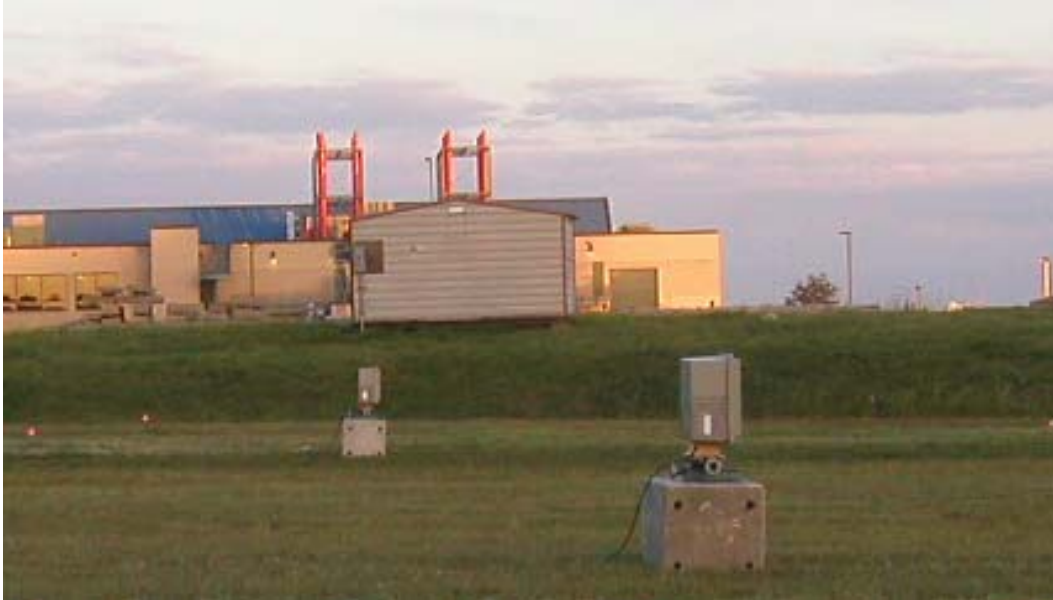
**Figure 4.2: Layout of Rover Stations**

To facilitate these requirements, large concrete blocks were selected as the foundations. Each block was leveled after positioning in the open field (Figure 4.2). A Palmgren two-axis milling table (Figure 4.7) was bolted to the top of each concrete block. Milling table dimensions and directional precision data are presented in Table 4.1.

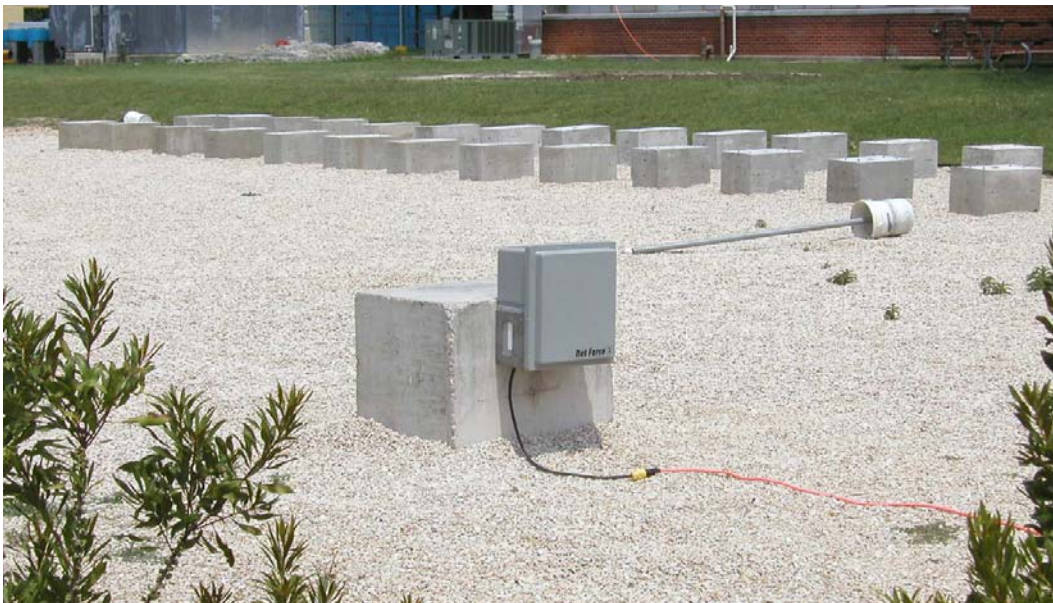
**Figure 4.3: Layout of Reference Station**

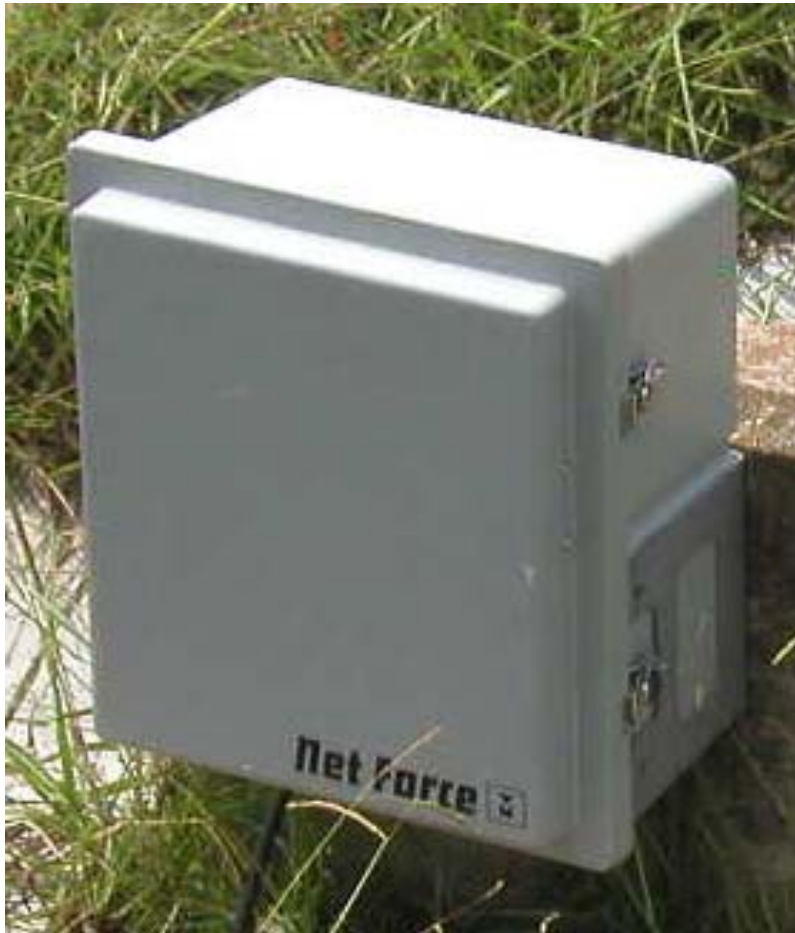
After the antenna receives the satellite signals, the GPS receiver sends them via serial cable to the cellular modem. The modem then transmits the signals to Mezure's Network Operations Center (NOC) via cellular signal and the Internet.

**Figure 4.5: GPS Hardware Package**
