1. Report No. FHWA/TX-08/0-4586-2		2. Government Accession No.		3. Recipient's Catalog No.	
4. Title and Subtitle Field Testing of Cantilevered Traffic Signal Structures under Truck-Induced Gust Loads			5. Report Date March 2007, Revised November 2007

Field Testing of Cantilevered Traffic Signal Structures under Truck-Induced Gust Loads

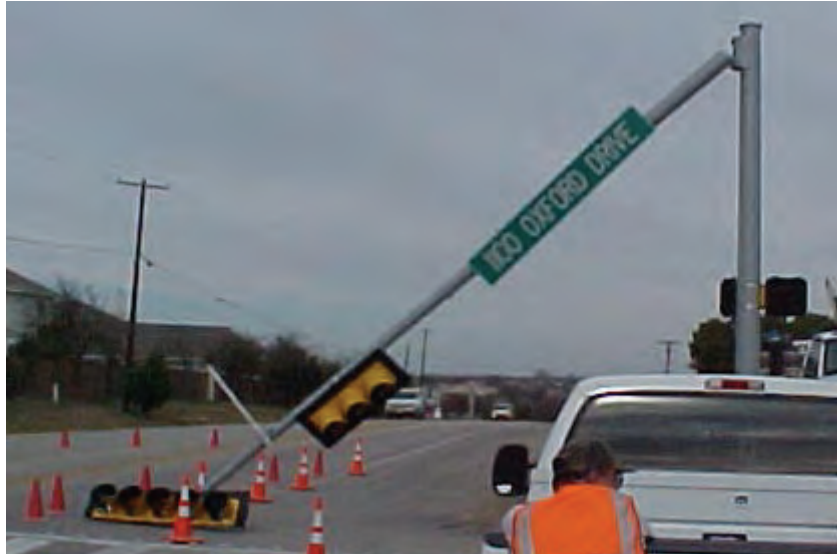
Figure 1.1: Failure of Cantilevered Traffic Signal Structure in Pflugerville, Texas in December 2003

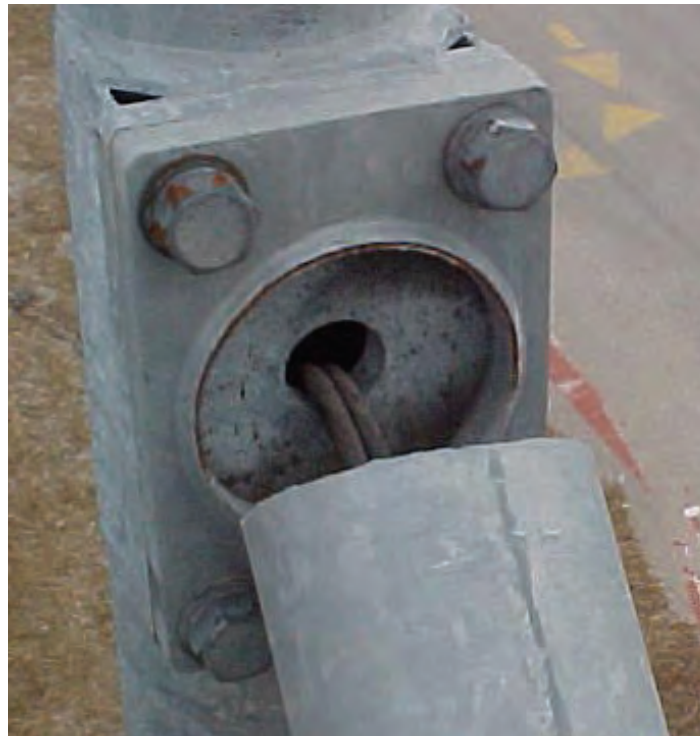
Figure 1.2: Fatigue Crack Initiated by Cyclic Loading

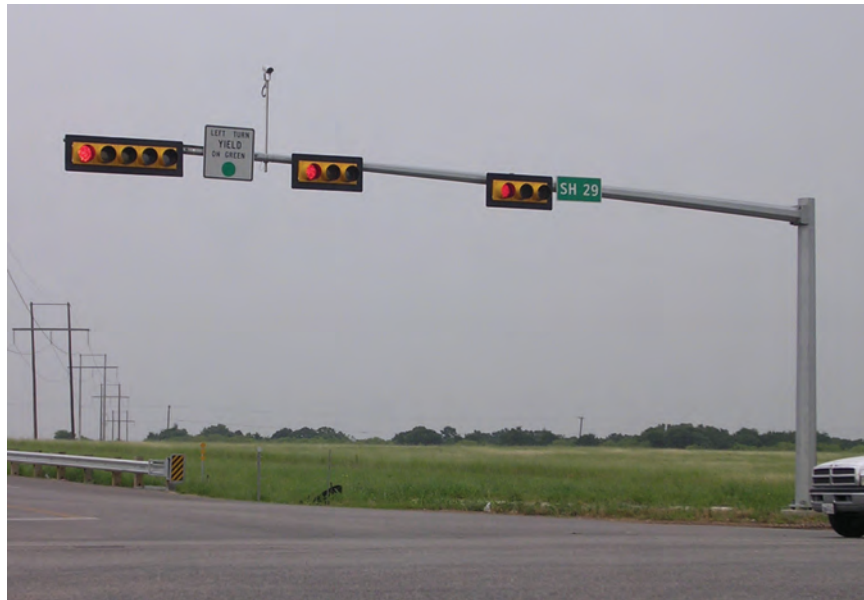
Figure 1.3: Typical Cantilevered Traffic Signal Structure in Texas

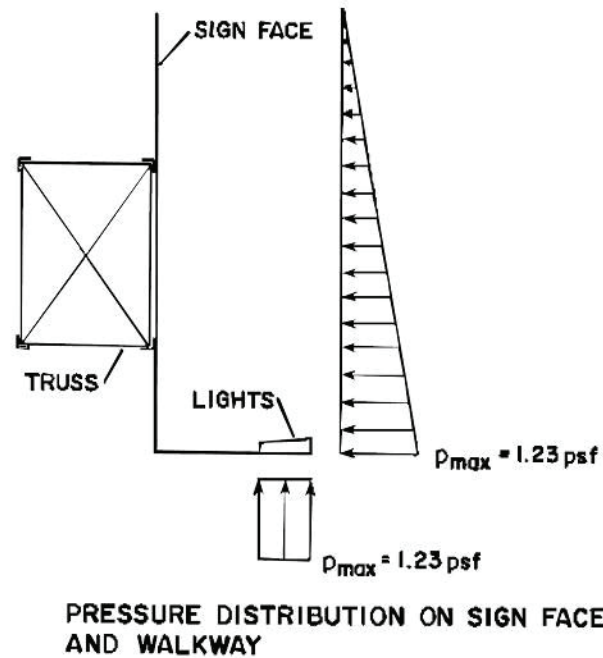
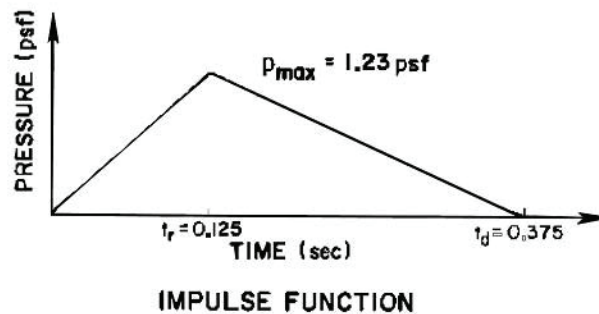
Figure 2.1: Pressure Distribution and Impulse Function To Simulate a Truck-Induced Gust (Creamer et al., 1979)

The foremost study of truck-induced gust loading was performed by Bruce M. Creamer, Karl H. Frank, and Richard E. Klingner at The University of Texas at Austin in 1979. Their research report, titled “Fatigue Loading of Cantilever Sign Structures from Truck Wind Gusts,” describes an experimental and analytical study where three cantilevered highway sign structures were instrumented in the field to determine how they would respond when trucks passed beneath them. Because of the low inherent damping of cantilevered highway sign structures, there were concerns that an impulse load from a single truck could produce a large number of cycles of motion and ultimately cause a fatigue failure. During the development of the field tests, the researchers realized that measuring the actual truck-induced gust using pressure gages on the sign face was not practical due to the highly turbulent flow of the gust. By measuring strains during the field tests, it was observed that the magnitude of the member response varied depending upon the truck speed, truck shape, and time interval between trucks. Trucks with a large projected flat area, such as box-type trucks and gravel trucks, produced the greatest sign movement. Based on the largest recorded event, the researchers were able to develop a pressure distribution, shown in Figure 2.1, that when applied to an analytical model of a cantilevered highway sign support structure, resulted in member stresses that matched the stresses observed during the field tests. The pressure distribution consisted of a uniform maximum pressure of 1.23 psf (58.9 Pa) applied vertically to the lighting fixtures while horizontally the pressure varied linearly from 0 psf (0 Pa) at the top of the sign face to the maximum pressure of 1.23 psf (58.9 Pa) at the bottom of the sign face. The researchers understood that this pressure distribution did not accurately represent the actual loading that was observed in the field, but rather it was one that simulated measured member stresses. For this reason and for convenience, it was recommended that a maximum pressure of 1.25 psf (60 Pa) be used for design. The anchor bolts were determined to be critical elements governing the design of the cantilevered highway sign structures for truck-induced gusts.

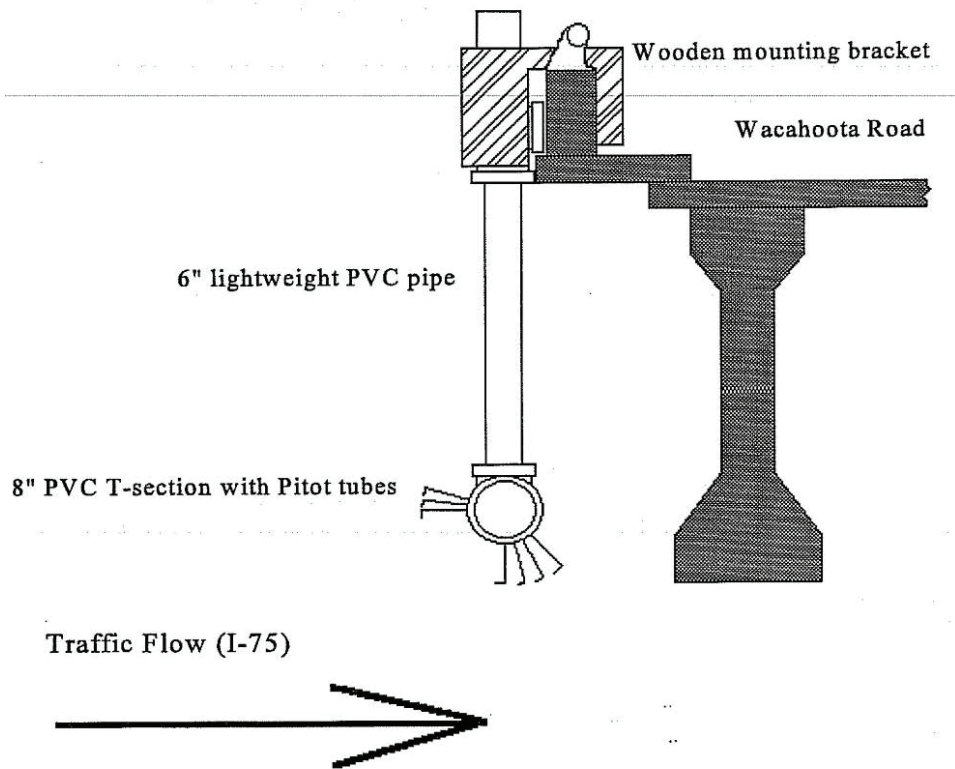
Figure 2.2: Bridge Mounted Apparatus (Cook et al., 1996)

In 1996, Ronald A. Cook, David Bloomquist, Angelica M. Agosta, and Katherine F. Taylor at the University of Florida, Gainesville, conducted the most extensive experiments to date to determine the magnitude, direction, and frequency of truck-induced gust pressure distributions. In order to obtain the data, pressure transducers and pitot tubes were instrumented on an existing bridge over an interstate highway. Wind pressures were recorded simultaneously at a rate of 714 readings per second from instruments mounted at 15 degree increments between 0 degrees and 90 degrees to the traffic flow as trucks passed beneath the apparatus. The setup can be seen in Figure 2.2. It required four people to complete the field data collection: one controlled the computer, another used the radar gun, another recorded the speeds of the trucks, and the fourth took a picture of each truck and signaled when a truck was approaching.

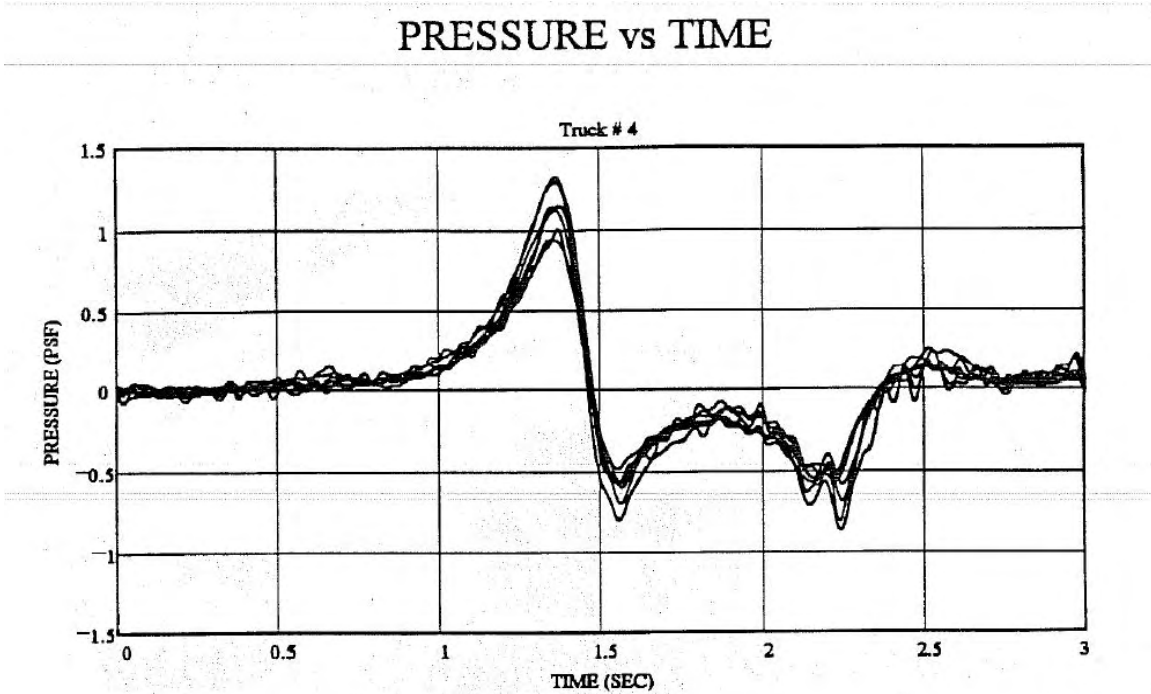
Figure 2.3: Typical Truck-Induced Gust Pressure (Cook et al., 1996)

increase in elevation from 17 ft (5.2 m) above the road surface, the design pressure pulse could be decreased by 10%. Finally, the significant frequencies of truck-induced gust pressure pulses were observed to range from 0.5 to 2 Hz. These frequencies are close to the natural frequencies of VMS structures and could lead to resonance of such structures.

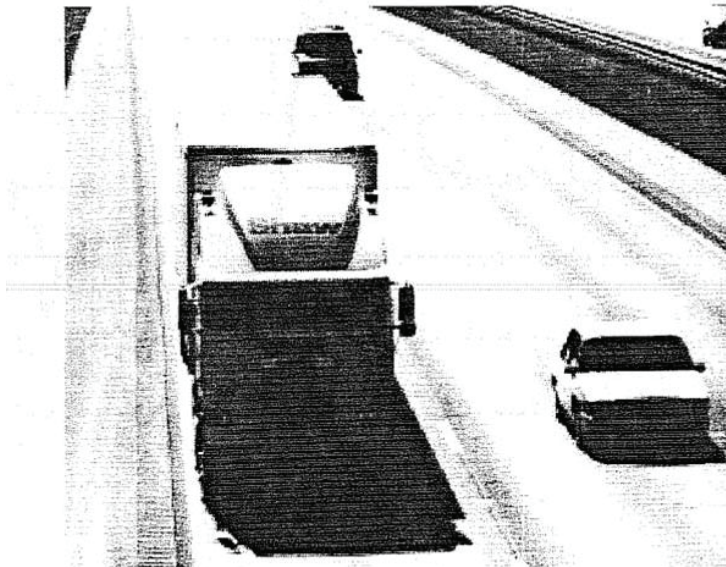
TRUCK # 4

Speed: 65 mph

Figure 2.4: Typical Truck (Cook et al., 1996)

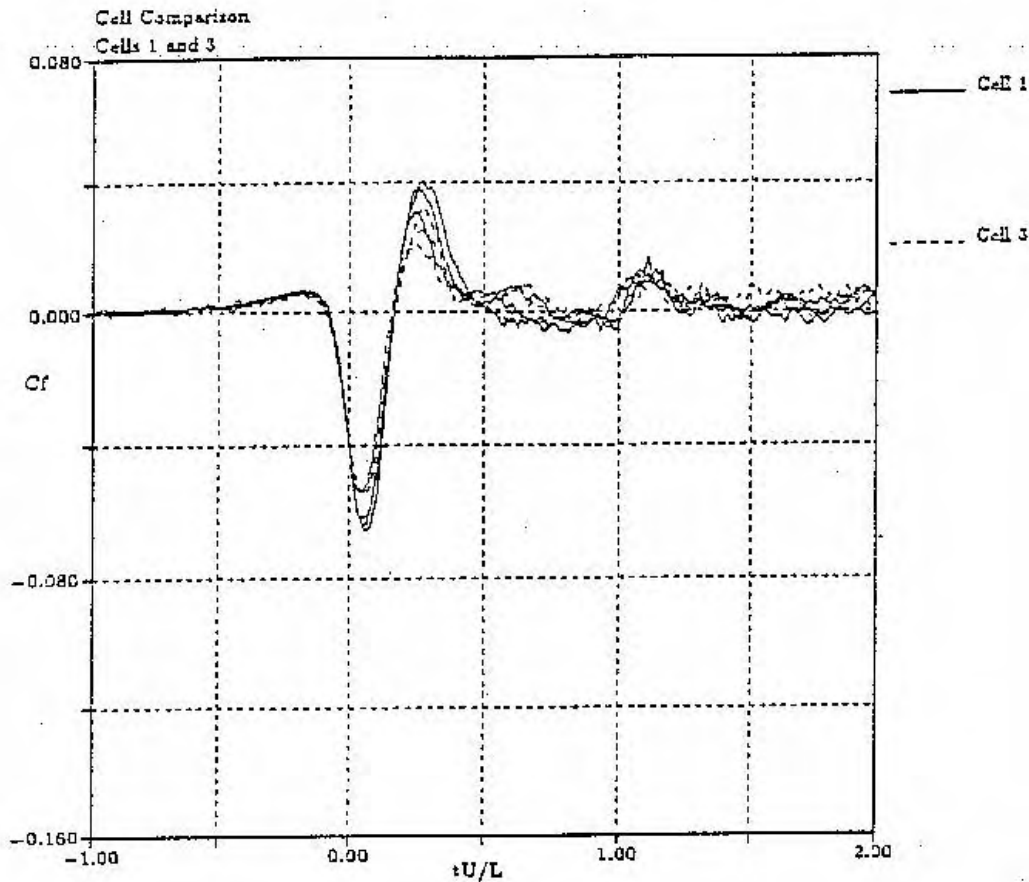
Figure 2.5: Pressure on Front of Highway Signs (Cali and Covert, 1997)

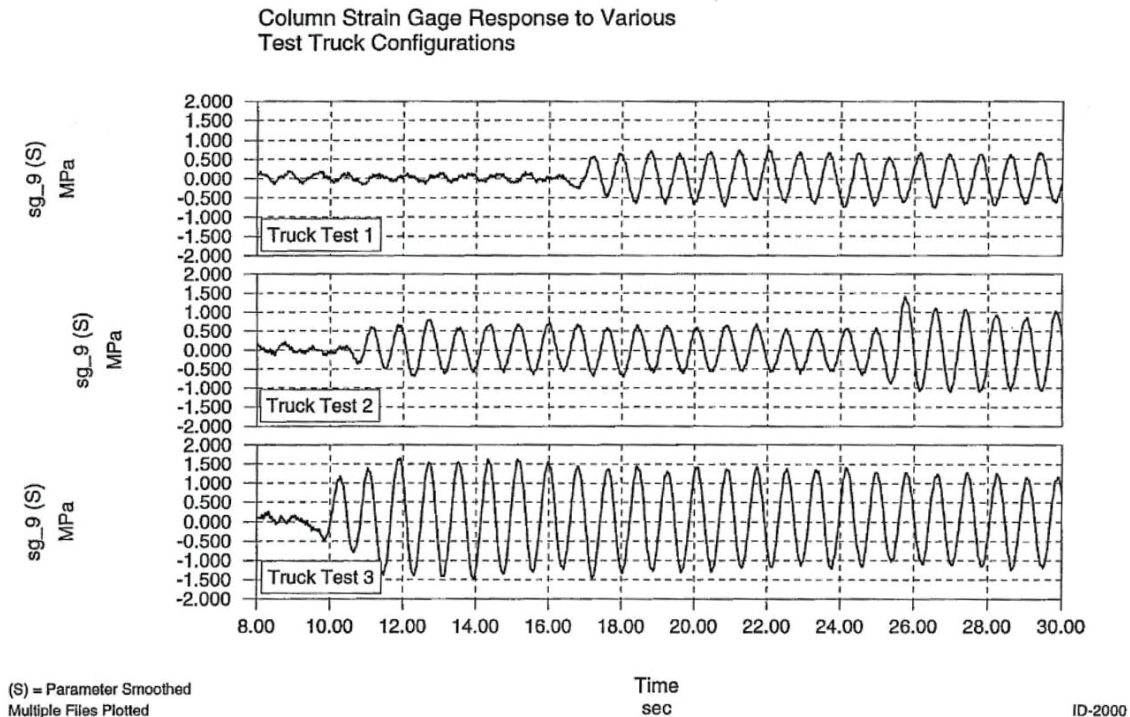
Figure 2.6: Column Response Due to Truck-Induced Gust (Johns and Dexter, 1998)

After monitoring the structure for 3 months, the researchers back-calculated an equivalent static pressure of 11 psf (525 Pa) based on the largest stress recorded. In the recommendations

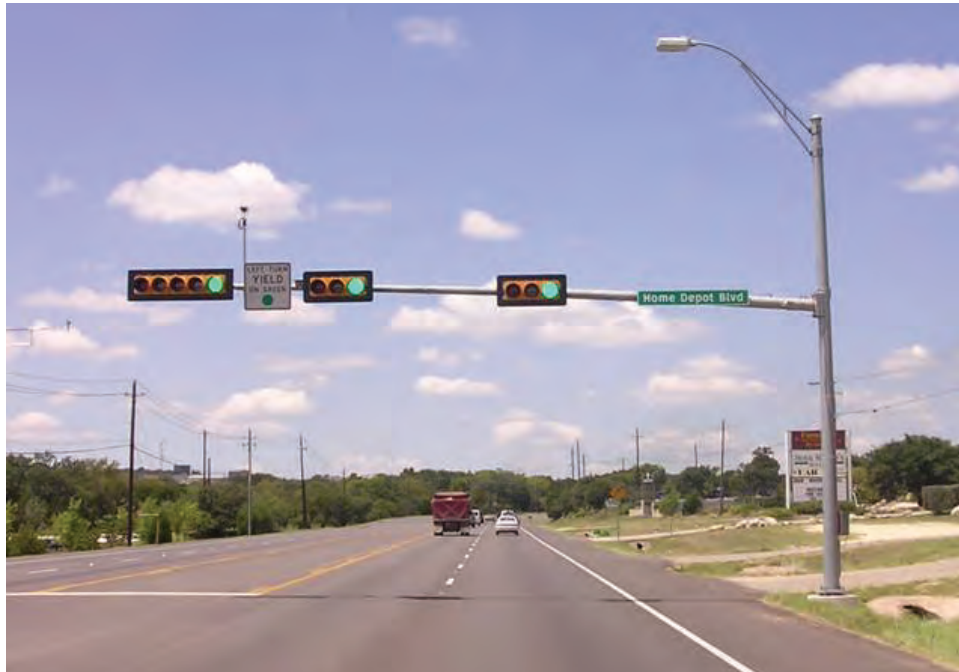
Figure 3.2: The Field Test Site on RM 620 at Home Depot Blvd

dampening plate, a camera, and a luminaire on top of the column. There were two northbound lanes of traffic that passed beneath the mast arm, and the posted speed limit was 55 mph. The dimensions of the cantilevered traffic signal structure and the TxDOT drawings for the intersection are shown in Appendix D.

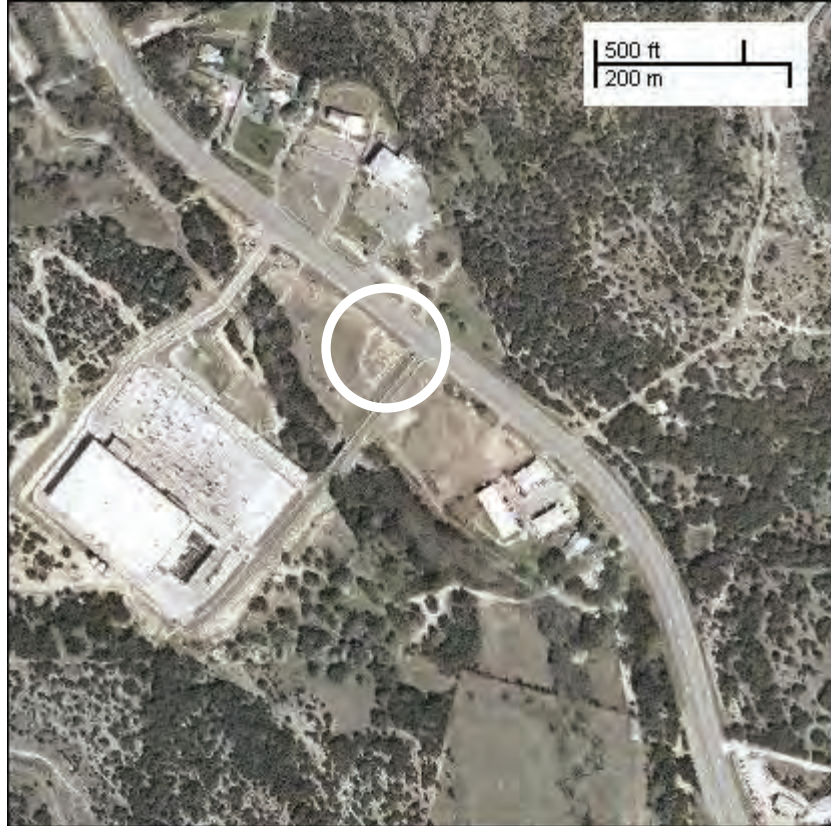
Figure 3.3: Aerial View of the Field Test Site on RM 620 at Home Depot Blvd (Google Maps, 2006)

The cantilevered traffic signal structure on RM 620 at Home Depot Blvd in Bee Cave, Texas, shown in Figure 3.2, was located at a tee-intersection, shown in Figure 3.3. Home Depot Blvd only provided access to a Home Depot store and a few smaller stores. The structure that was monitored served the northbound traffic on RM 620. This site was chosen because the majority of the box-type trucks and dump trucks that use RM 620 would likely not be affected by the traffic lights in the northbound lanes of the intersection since this was not a very busy tee-intersection. The structure consisted of a 40-foot mast arm with three traffic signals, two signs, a

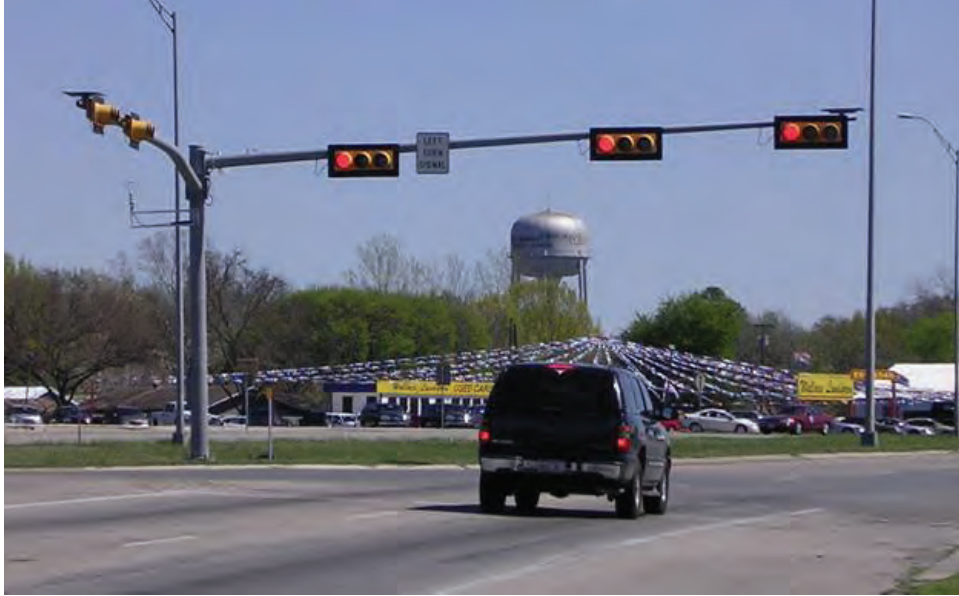
Figure 3.4: The Field Test Site on US 290 at SH 95

The cantilevered traffic signal structure on US 290 at SH 95 in Elgin, Texas, shown in Figure 3.4, was located at a tee-intersection, shown in Figures 3.5 and 3.6. At the intersection, SH 95 bends in such a manner as to join with US 290 through Elgin; however, there is a small road that services a gas station on the other side of the tee-intersection. The structure that was monitored served the eastbound traffic on the divided US 290. This site was chosen because of the potential for a significant volume of truck traffic between Austin and Houston that used this section of US 290, especially semi/tractor-trailer trucks that were not very common at the RM 620 field test site. The structure consisted of a dual mast arm assembly (two arms orthogonal to each other) with a 40-foot mast arm with three traffic signals, one sign, and a dampening plate. There were two lanes of traffic that passed beneath the mast arm, and the posted speed limit was 50 mph (22.35 m/s). The dimensions of the cantilevered traffic signal structure and the TxDOT drawings for the intersection are shown in Appendix D.

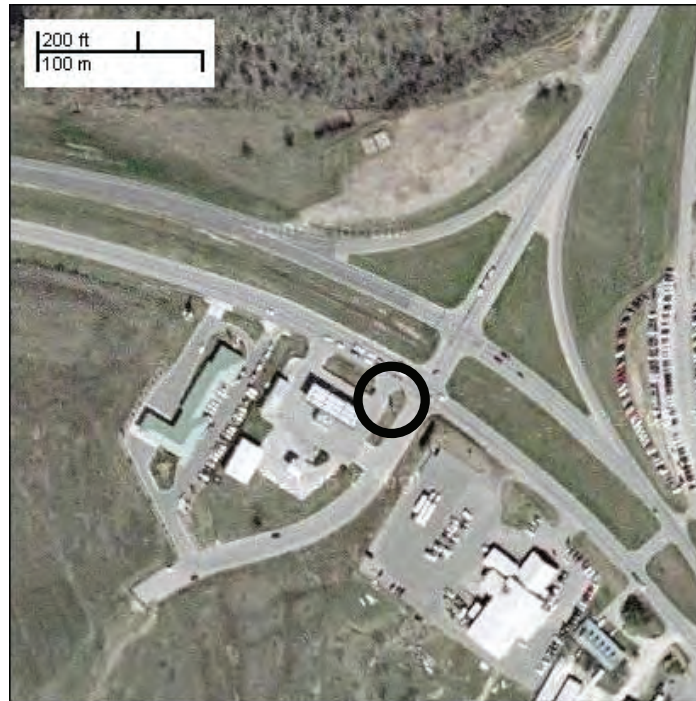
Figure 3.6: Aerial View of the Field Site on US 290 at SH 95 (Google Maps, 2006)

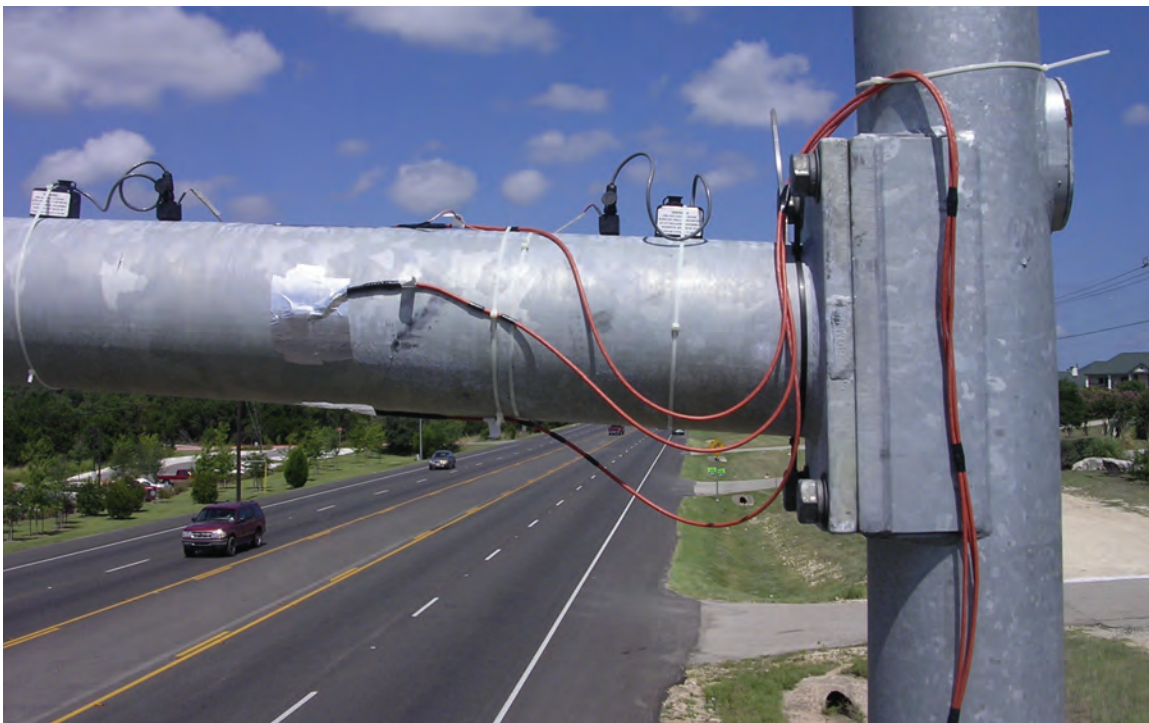
Figure 3.7: Strain Gauges Attached to Mast Arm and Shielded Cables

This method had remarkable success in the field. The only suggested change for future tests is to use strain gauges of type WFLA-6-11-3LT because the additional third wire allows for the benefit of temperature-compensation along its entire length. This difference did not present any problems for the field tests because each strain gauge's wires were cut to approximately five inches and soldered to a 22 AWG (American Wire Gauge) three conductor shielded control cable made by Belden CDT making them temperature-compensating gauges. Each shielded control cable was approximately 22 ft long allowing the strain gauges located on the mast arm to be plugged into the datalogger located at the base of the traffic signal, as seen in Figure 3.7.

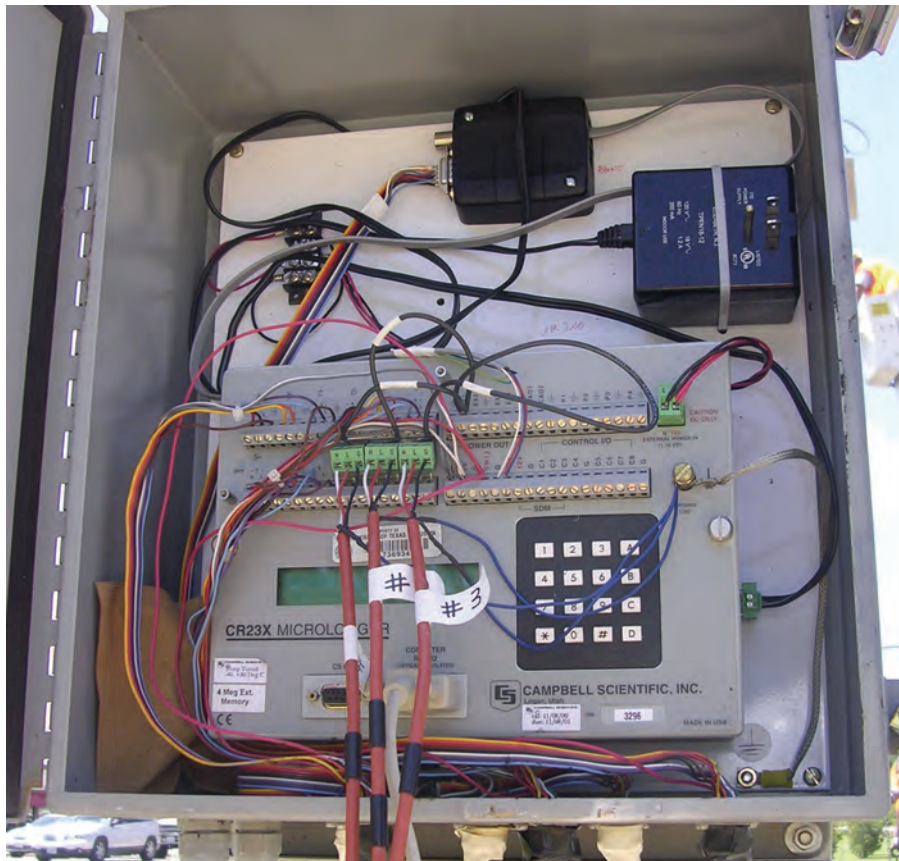
Figure 3.8: CR23X Datalogger

A Campbell Scientific CR23X Micrologger data acquisition unit was used to collect the short-term data in the field. This unit was selected because of its positive performance in earlier field tests for galloping of cantilevered traffic signal structures (Florea, 2005). The CR23X, shown in Figure 3.8, is a compact, self-contained datalogger that was easily attached to the traffic signal base. The unit was able to record up to twelve channels; however, at the field test site on RM 620 at Home Depot Blvd, only three channels were used, one for each of the strain gauges. At the field test site on US 290 at SH 95, nine channels were used—six for strain gauges and three for the anemometer (discussed in Section 3.2.4). To communicate with the CR23X datalogger, the Campbell Scientific PC208W software was used and the program used at the second site (US 290 at SH 95) is presented in Appendix E. The only difference between the programs used at the two sites was that at the site on RM 620 at Home Depot Blvd, the data from the three strain gauges was recorded every 0.04 seconds or at a sampling rate of 25 Hz, while at the site on US 290 at SH 95, the data was recorded from six strain gauges and the anemometer (wind speed in three directions) every 0.07 seconds or at a sampling rate of 14.286 Hz. At each site, these data sampling rates were the fastest that could be obtained across all the channels. During the field tests, it was powered by its own batteries and then recharged at night. The CR23X datalogger performed exceptionally well in the field.

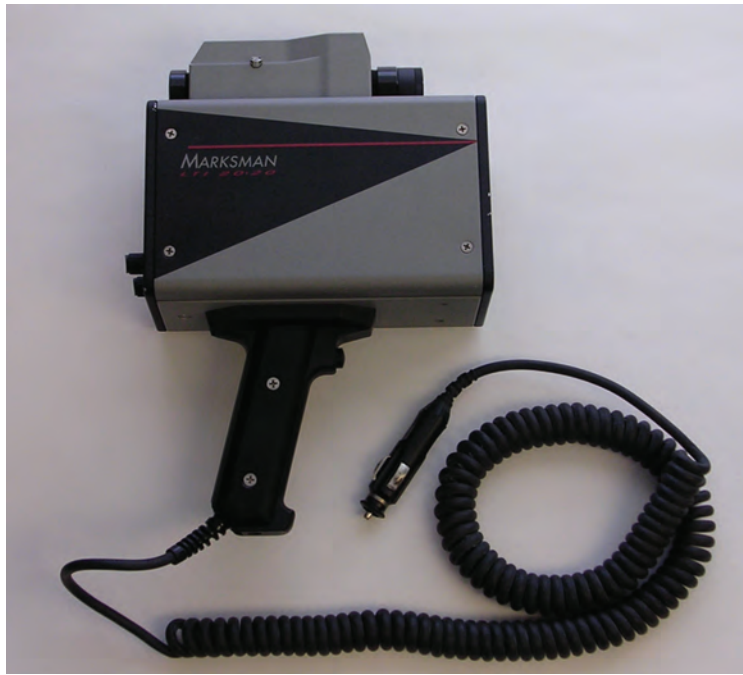
Figure 3.9: Radar Gun

A Marksman model of the LTI 20-20 laser speed detection system from TxDOT, shown in Figure 3.9, was used to record the speed of trucks that passed beneath the instrumented structure. The Marksman model was different from the more conventional radar guns in that it uses a laser light beam instead of microwaves to detect the speed of a vehicle. This Marksman model was able to measure speeds up to 200 mph (89.41 m/s) from as far away as 2,500 ft (762 m). However, for this project, the speeds were recorded as close to the mast arm as possible in order to obtain the speed as the truck passed beneath the arm. The Marksman model was very easy to use and the only concern for future researchers is that it required a vehicle's cigarette lighter socket for power. A battery-powered radar gun would work just as well and would allow for a wider range of movement for the test personnel involved in recording the truck speeds.

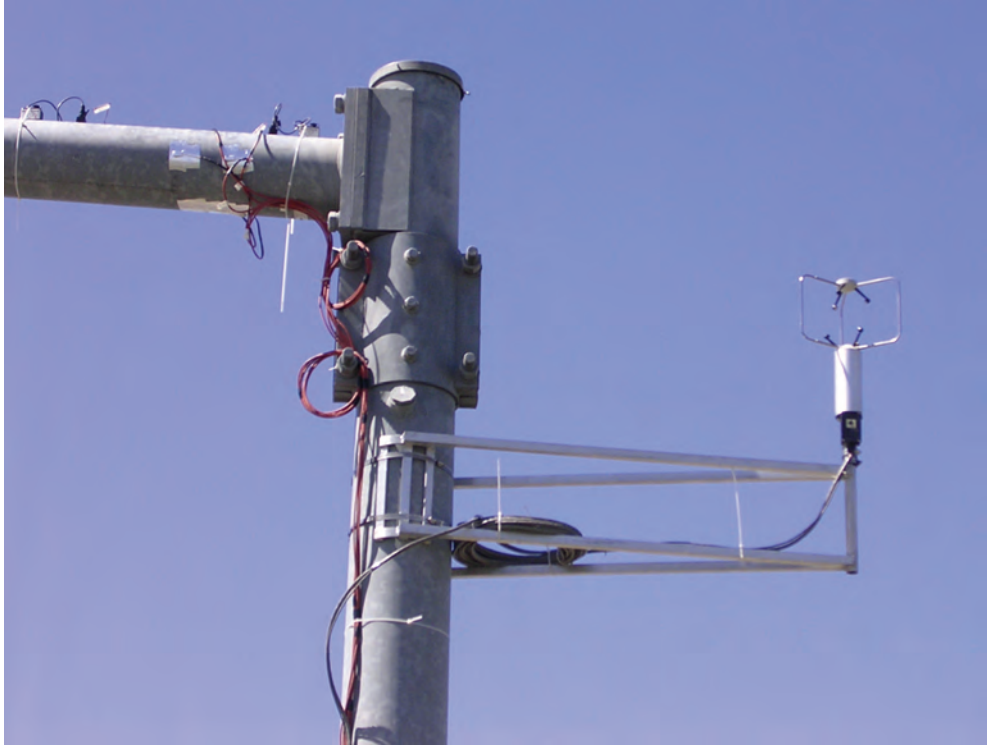
Figure 3.10: Anemometer

A RM Young Model 81000 Ultrasonic Anemometer was used to determine wind speed and direction at the field site. The three-axis ultrasonic anemometer is able to measure wind speeds of 0-90 mph (0-40.23 m/s) in any direction. The anemometer was attached to the column so that it was at the same height as the mast arm, as can be seen in Figure 3.10. This anemometer was only used at the field test site on US 290 at SH 95. It is recommended that future researchers always record wind speed and direction even if truck-induced gusts are the primary focus as was the case in this study. The anemometer was instrumented so that “north” was pointing in the direction of the oncoming traffic.

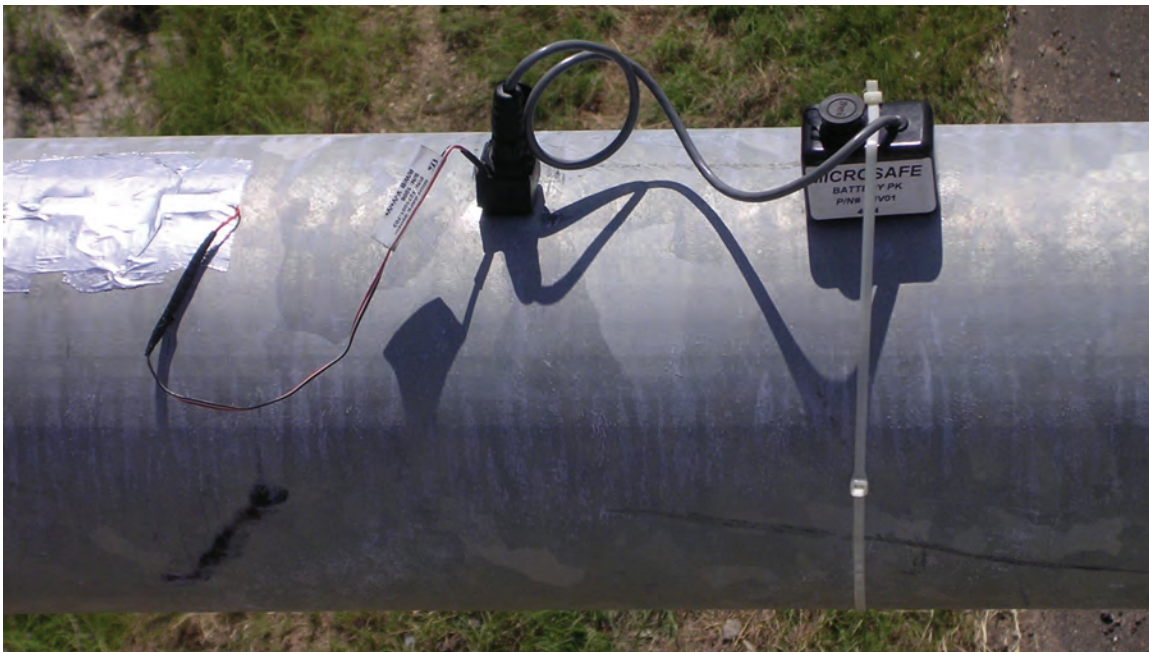
Figure 3.11: MicroSAFE Unit with Battery

In order to record rainflow histogram data, the units had to be programmed with a desired bin size. There were exactly 32 available bins for the rainflow analysis. Therefore, care had to be taken to select an appropriate bin size so that all the data would fall within the 32 bins. Any cycles that exceeded the largest bin were placed in the last bin, emphasizing the need to choose a correct bin size. Previous research had shown that a good starting point would be to have a bin size that would be able to record a value of 240 microstrain (Brisko, 2002), while others recommended a bin size of 17.2 microstrain (Connor et al., 2004). Therefore, at the field site on RM 620 at Home Depot Blvd, a bin size of 20 microstrain was used. This proved to be too large,

and hence, a bin size of eight microstrain was used at the second field site on US 290 at SH 95. The MicroSAFE units were programmed to collect data for one hour and 59 minutes and to then take the next minute to record this data. This was done mainly to eliminate a problem the MicroSAFE units have due to temperature changes throughout the day. In addition, this method provided an added unforeseen benefit of comparing the rainflow data over two-hour intervals instead of daily intervals.

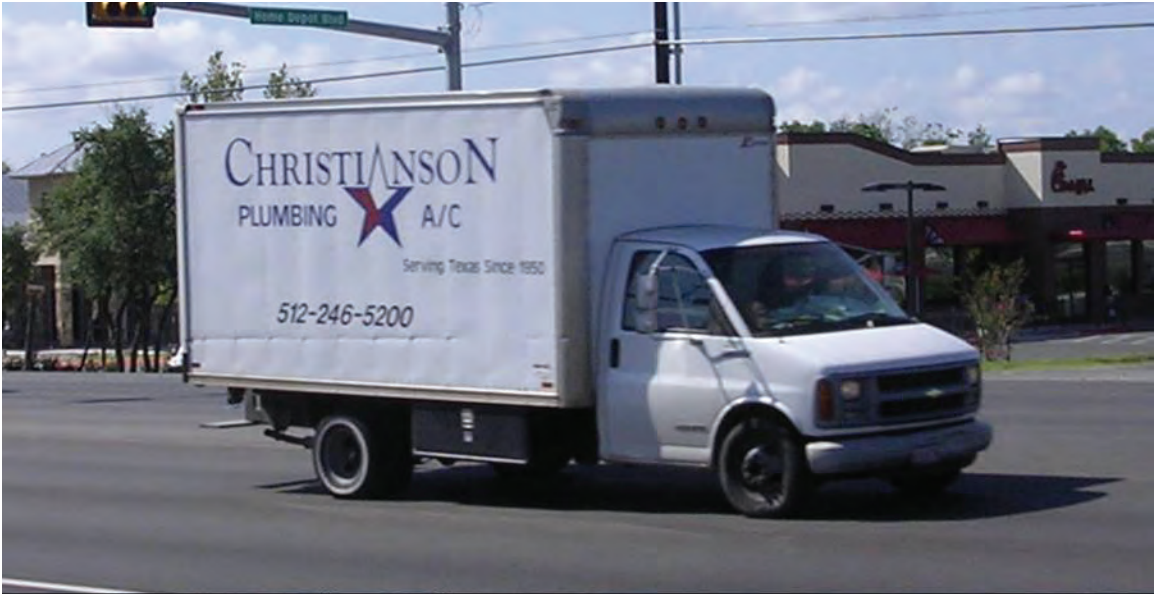
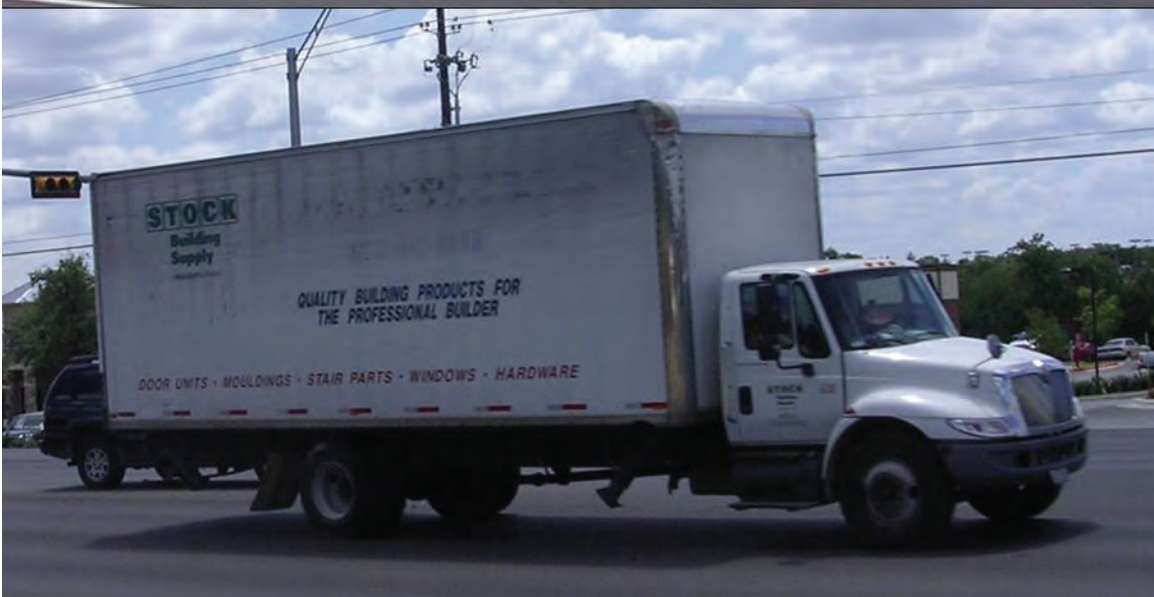
Figure 3.12: Box-Type Trucks (Box-Small and Box-Tall)

The different types of trucks that were observed during the field testing were categorized into six major groups: Box-Type Trucks, Concrete Trucks, Dump Trucks, Garbage Trucks, School Buses, and Semi/Tractor-Trailer Trucks. Not all trucks fell into one of these groups, so some trucks were classified on an individual basis. For both the box-type trucks and the semi/tractor-trailer trucks, additional classification was necessary. Box-type trucks were separated into Box-Tall and Box-Small groups; while semi/tractor-trailer trucks were divided into Semi-Tall, Semi, and Semi-Low groups. A Box-Tall was a large box-type truck while a Box-Small was a small box-type truck. A Semi-Tall was a semi/tractor-trailer truck where the trailer was taller than the cab; a Semi was a semi/tractor-trailer truck with a trailer the same height as the cab; and a Semi-Low was a semi/tractor-trailer truck with a trailer shorter than the cab. Examples of the different types of trucks can be seen in Figures 3.12 to 3.17. In Appendix F, a complete list of all the trucks observed during the field testing is presented.

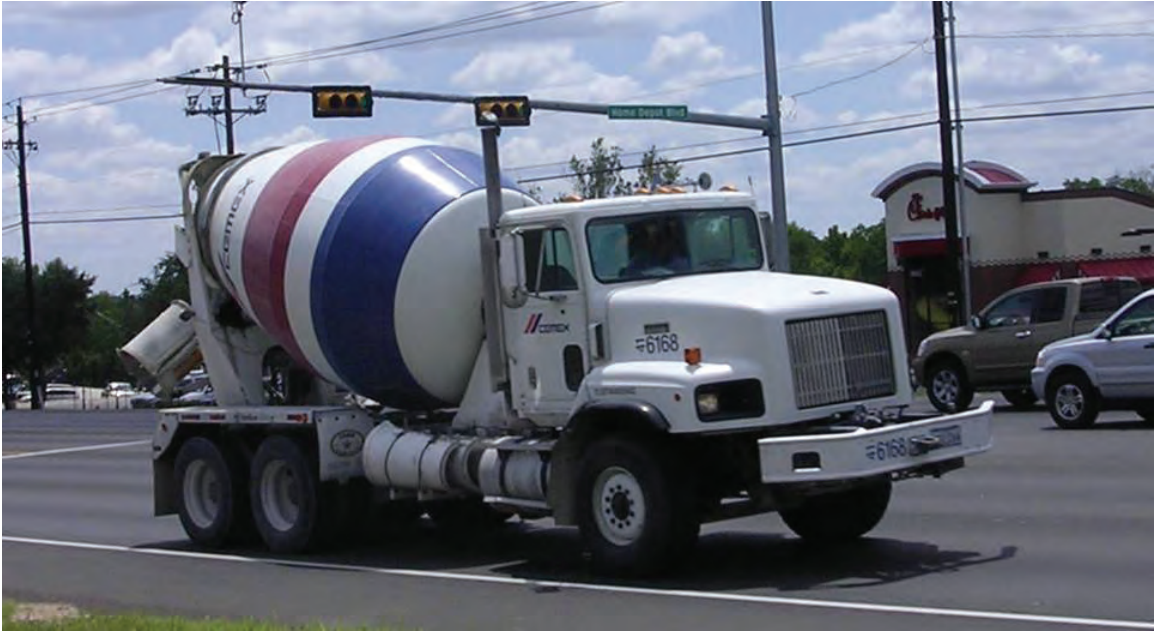
Figure 3.13: Concrete Truck

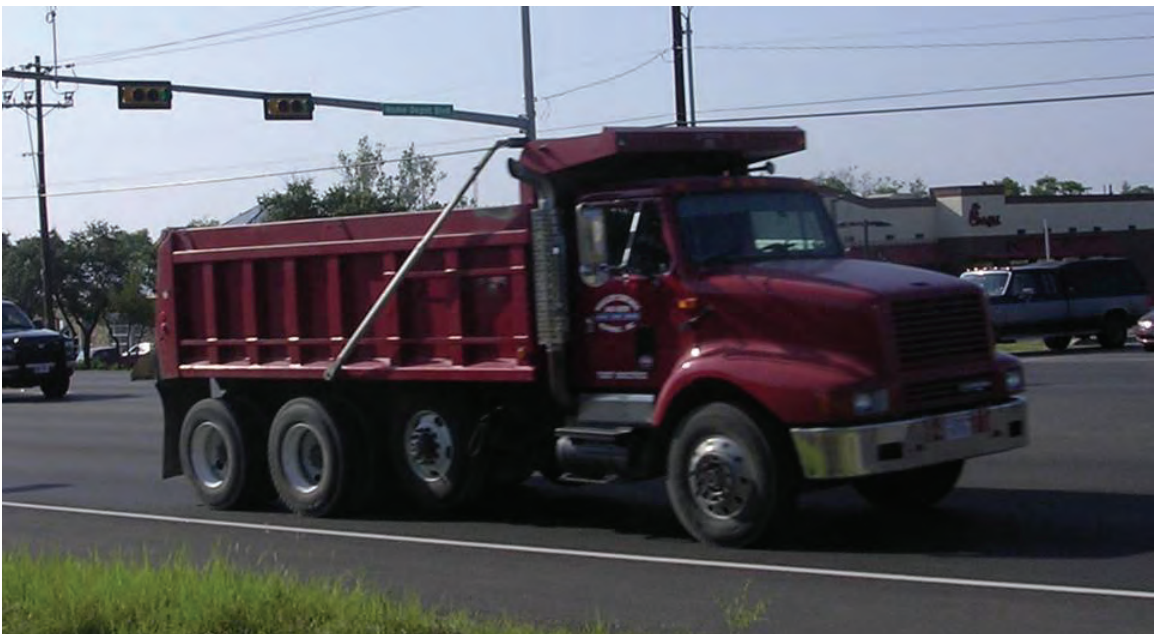
Figure 3.14: Dump Truck

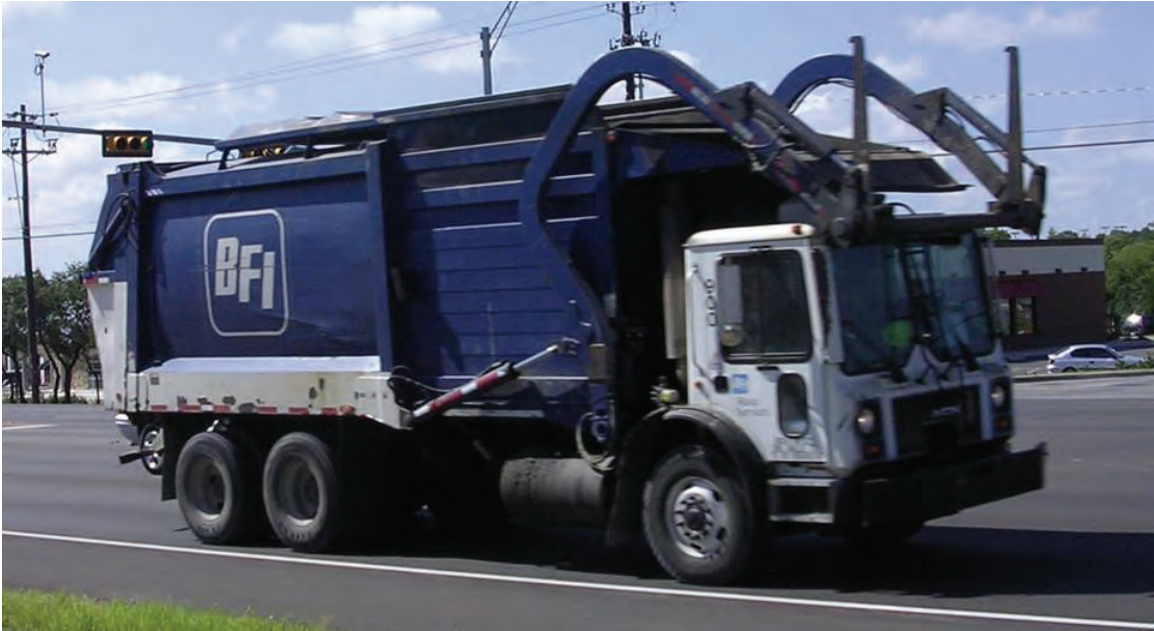
Figure 3.15: Garbage Truck

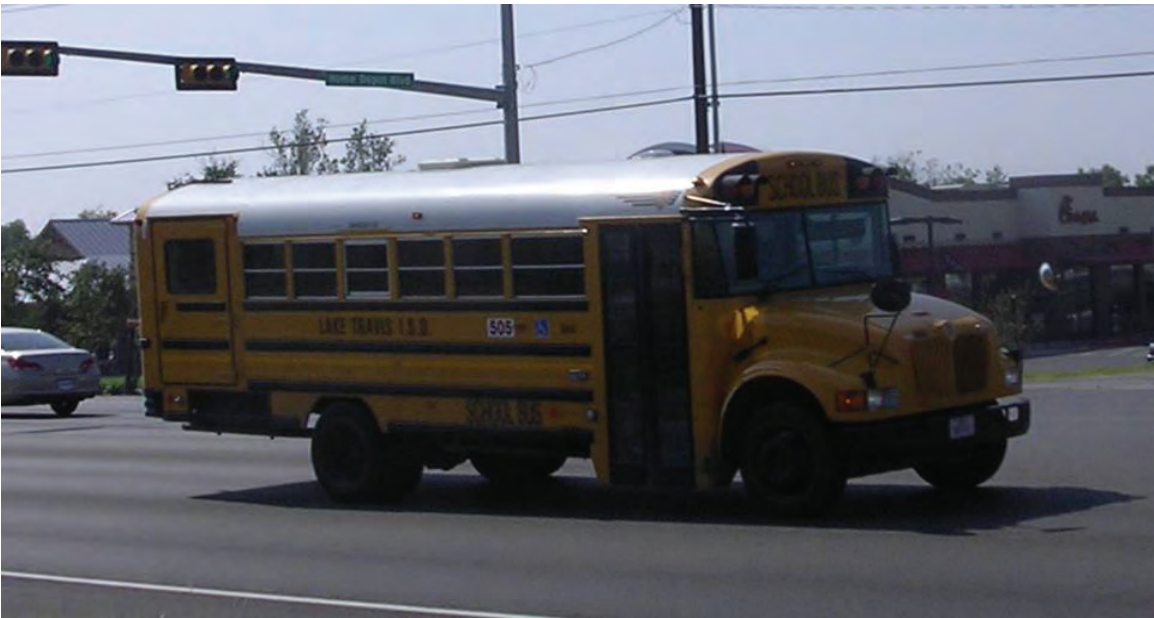
Figure 3.16: School Bus

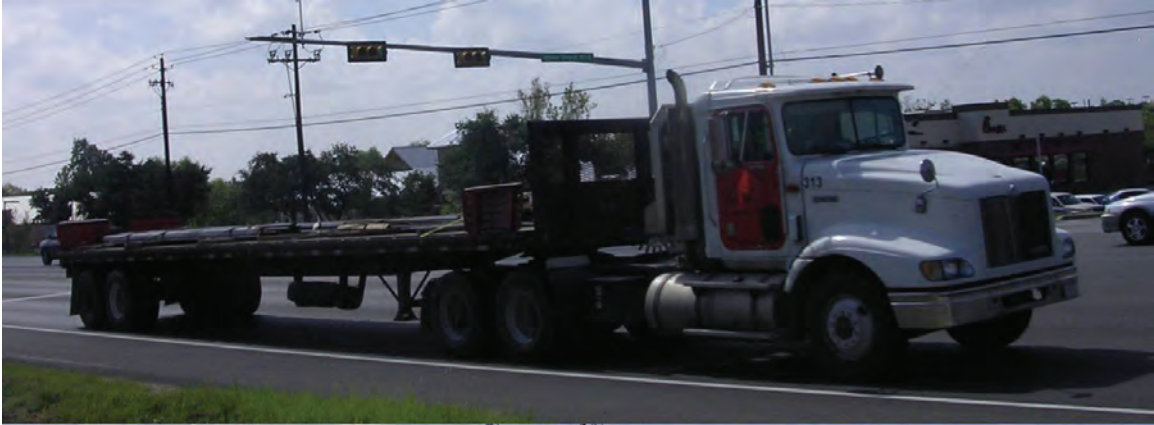
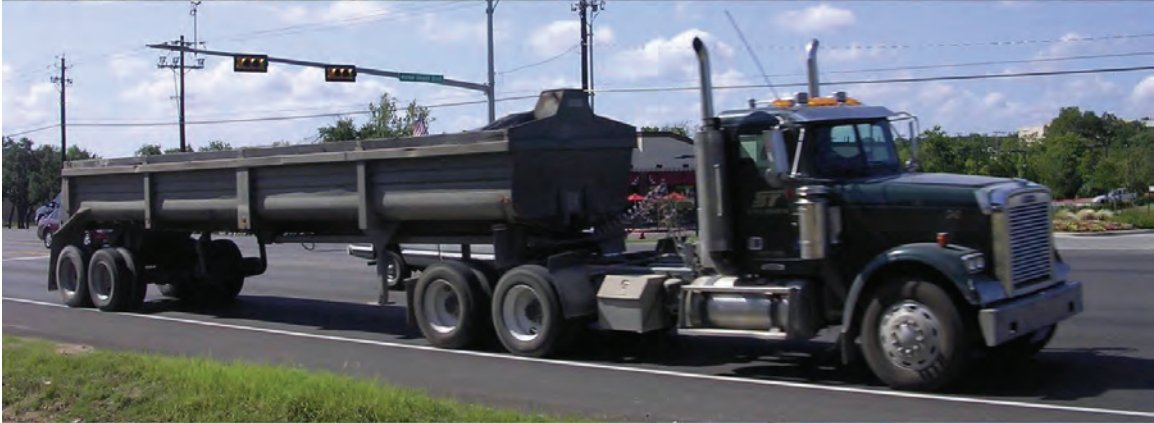
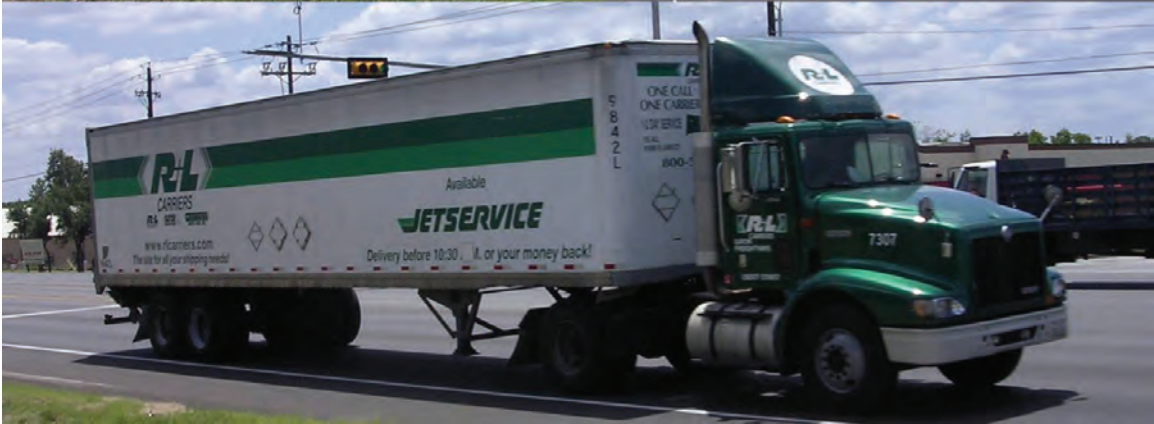
Figure 3.17: Semi/Tractor-Trailer Truck (Semi-Low, Semi, Semi-Tall)

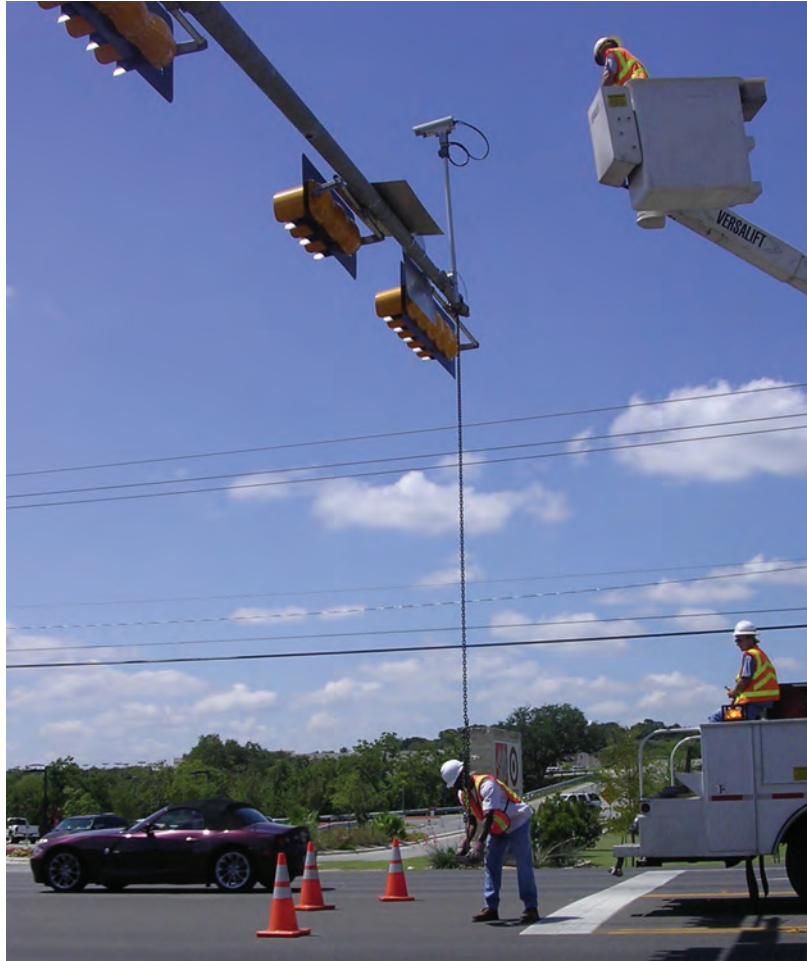
Figure 4.1: Static Load Test

A static load test has numerous valuable benefits including verification that the equipment is working properly, confirmation (or calibration) of structural analysis models, and enhanced insight into the behavior of the cantilevered traffic signal structure being studied. At each field test site, a static load test was performed by hanging weights from the tip of the mast arm while recording strain data, as shown in Figure 4.1. The weights were hung from a chain that weighed 31.00 lbs (14.06 kg). The five weights that were added to the chain weighed 22.62, 21.90, 25.70, 28.58, and 32.14 lbs (10.26, 9.93, 11.66, 12.94, and 14.58 kg). This resulted in a total of 161.94 lbs (73.455 kg) when all five weights were attached to the chain. Applying different weights incrementally verified that the structures responded in a linear elastic manner. Since this was a static test, the results from both field test sites are very similar; therefore, the data are only shown in Figure 4.2 for the site on US 290 at SH 95. The plot shows the data from two strain gauges—one located on the top of the mast arm and the other located on the bottom of the mast arm. As expected, the strain values from the two strain gauges are equal and opposite. Also, the strain readings increase linearly with each incremental change in applied weight at the tip of the mast arm.
