1. Report No. FHWA/TX-08/0-4586-2		2. Government Accession No.		3. Recipient's Catalog No.	
4. Title and Subtitle Field Testing of Cantilevered Traffic Signal Structures under Truck-Induced Gust Loads			5. Report Date March 2007, Revised November 2007

Field Testing of Cantilevered Traffic Signal Structures under Truck-Induced Gust Loads

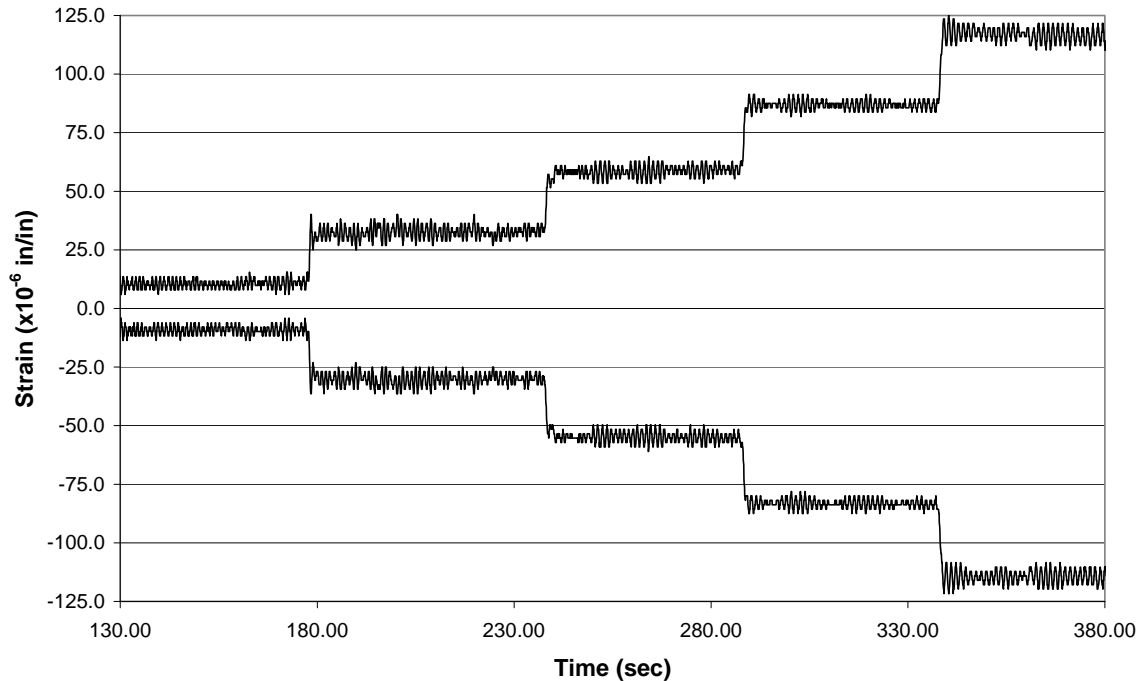
Figure 4.2: Static Load Test Data (Strain Data at the Top and Bottom of the Mast Arm) for the Field Test Site on US 290 at SH 95

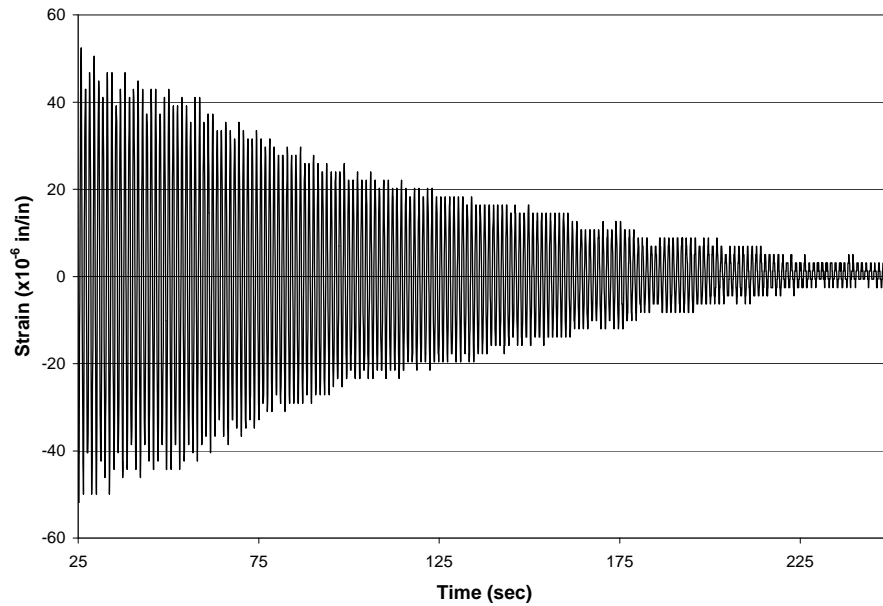
Figure 4.3: Free Vibration Response of the Instrumented Structure at the Field Site on RM 620 at Home Depot Blvd

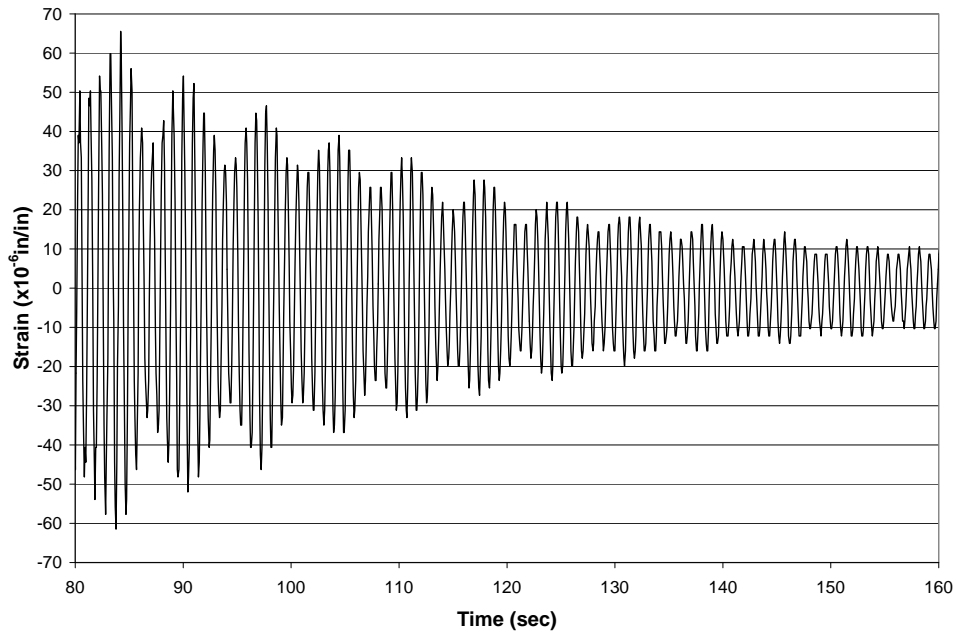
Figure 4.4: Free Vibration Response of the Instrumented Structure at the Field Site on US 290 at SH 95

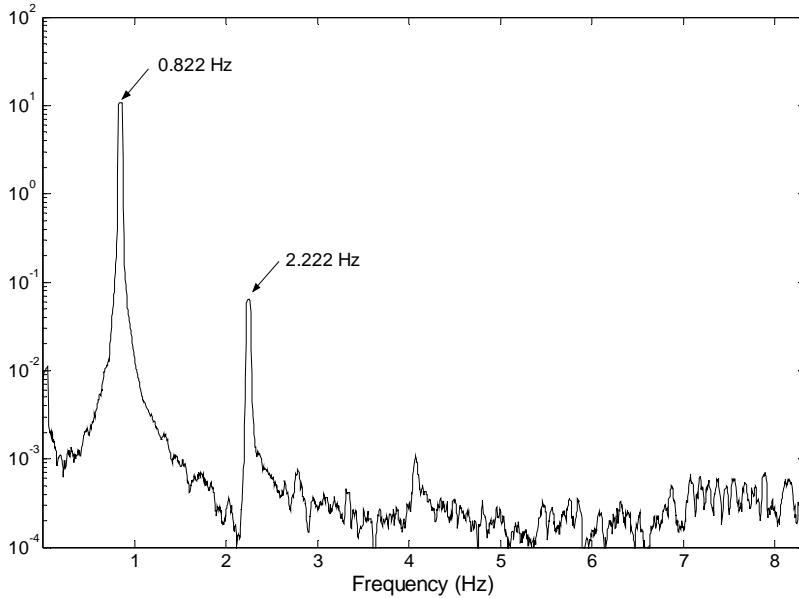
Figure 4.5: Smoothed Power Spectra of the Strain Data from the Top of the Mast Arm as Obtained from the Pluck Test at the Field Site on RM 620 at Home Depot Blvd

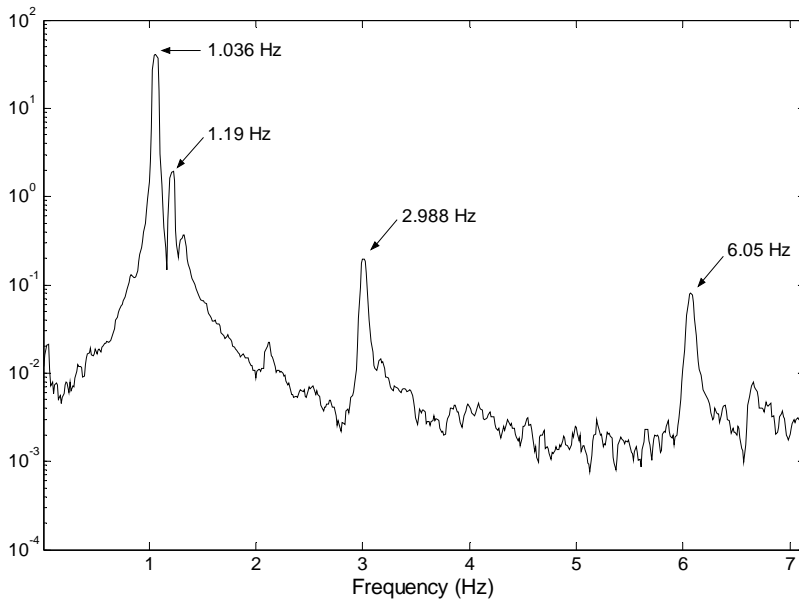
Figure 4.6: Smoothed Power Spectra of the Strain Data from the Top of the Mast Arm as Obtained from the Pluck Test at the Field Test Site on US 290 at SH 95

Figures 4.5 and 4.6 show smoothed power spectra of the strain data from the pluck tests at the two field sites. It is easy to pick out the fundamental natural frequencies (of 0.822 Hz and 1.036 Hz) for the cantilevered traffic signal structures at the two sites. Other higher mode frequencies are also indicated on the plots.

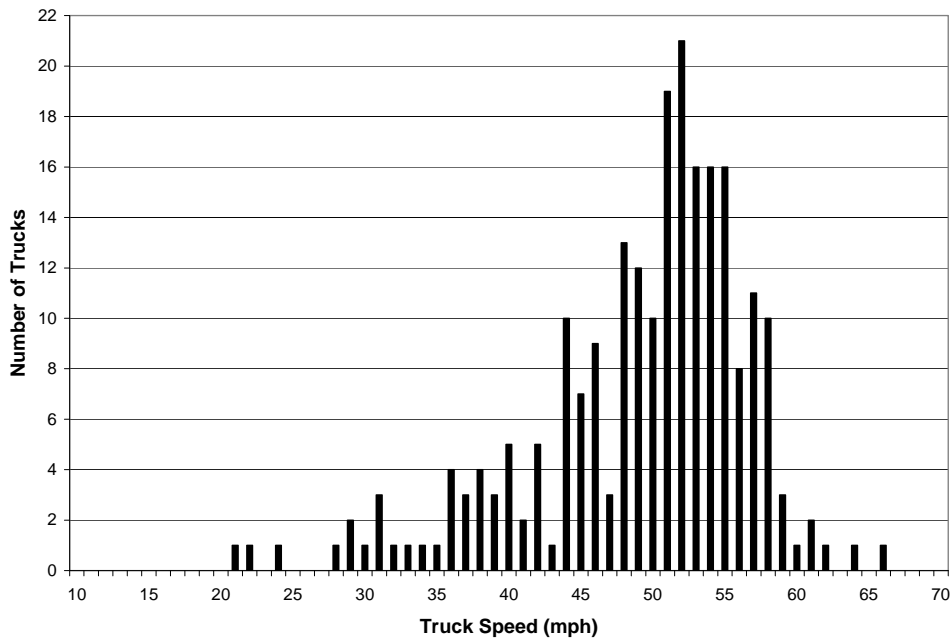
Figure 4.7: Histogram of Truck Speeds at the Field Test Site on RM 620 at Home Depot Blvd

traffic light were not included. At the field site on RM 620 at Home Depot Blvd, most of the trucks were box-type trucks, dump trucks, and concrete trucks traveling close to the posted speed limit of 55 mph (24.59 m/s). The distribution of truck speeds at this site is summarized by the histogram shown in Figure 4.7. On the other hand, the trucks at the field test site on US 290 at SH 95 were mostly semi/tractor-trailer trucks traveling at speeds below the speed limit of 50 mph (22.35 m/s), as summarized in the histogram shown in Figure 4.8. The reason for this difference observed at the two sites is that the RM 620 at Home Depot Blvd site had a very long light cycle allowing most vehicles to make it through the intersection without being stopped or slowed down by the traffic light. However, the US 290 at SH 95 site had a very short light cycle causing most of the vehicles to be slowed down by the traffic light. Figures 4.9 and 4.10 show the distribution of trucks according to the lane in which they were traveling for the aggregated data from both field test sites. Lane 1 represents the right lane while Lane 2 is the left lane or the “passing lane.” As expected, the majority of trucks traveled in Lane 1, the right lane.

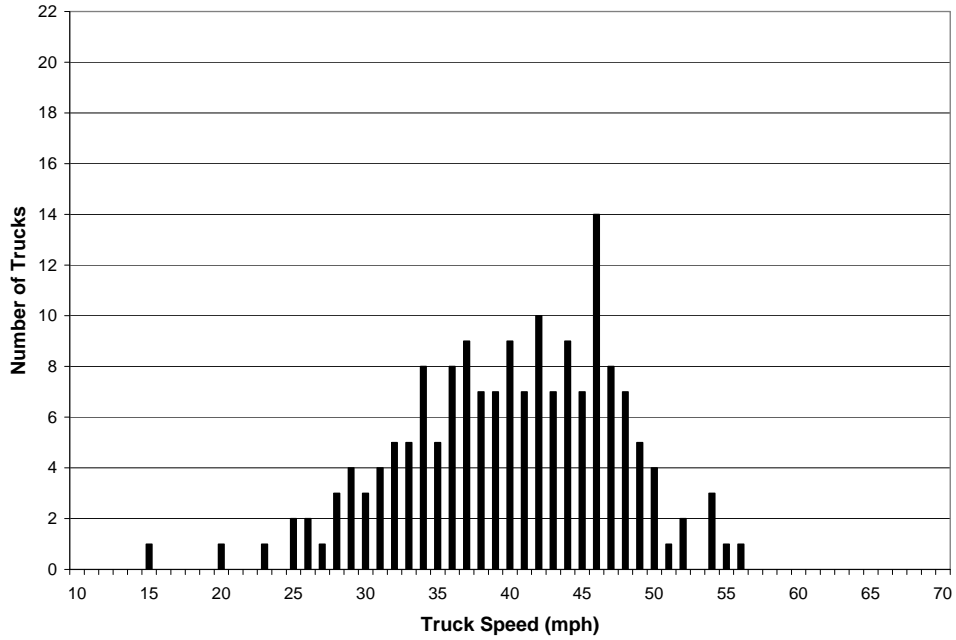
Figure 4.8: Histogram of Truck Speeds at the Field Test Site on US 290 at SH 95

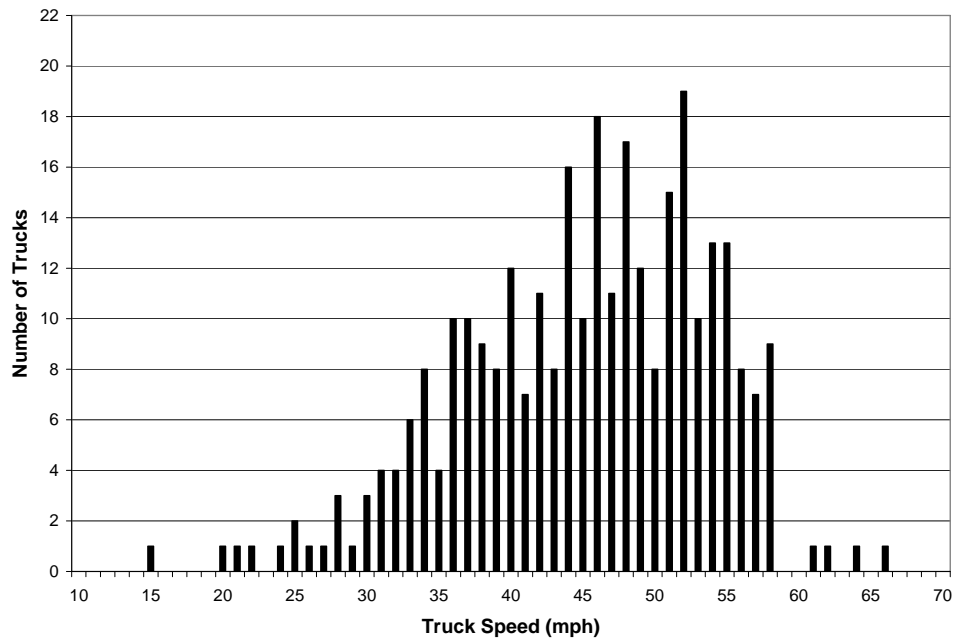
Figure 4.9: Histogram of Speeds for Trucks Traveling in Lane 1 Based on Data from Both Field Test Sites

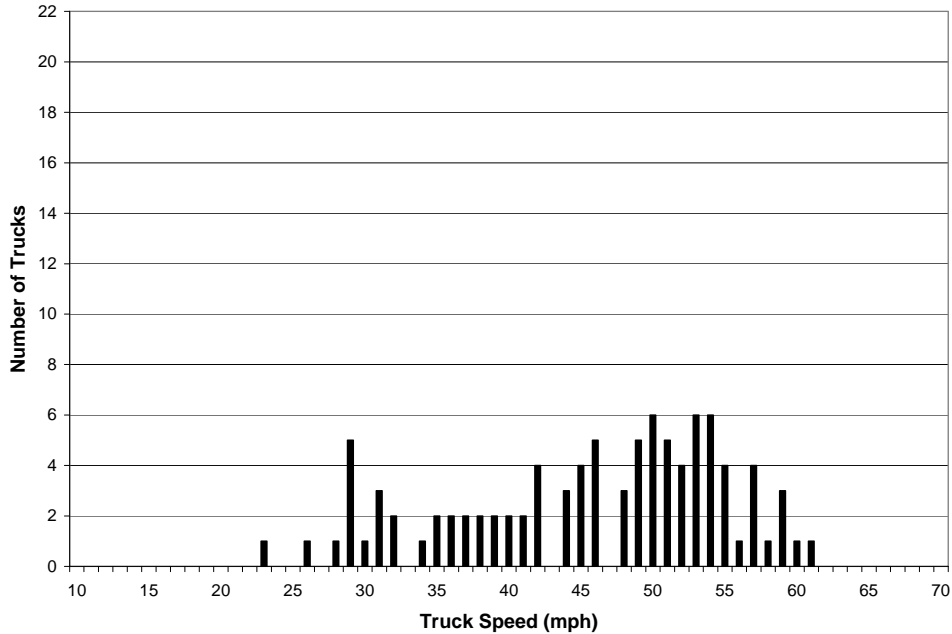
Figure 4.10: Histogram of Speeds for Trucks Traveling in Lane 2 Based on Data from Both Field Test Sites

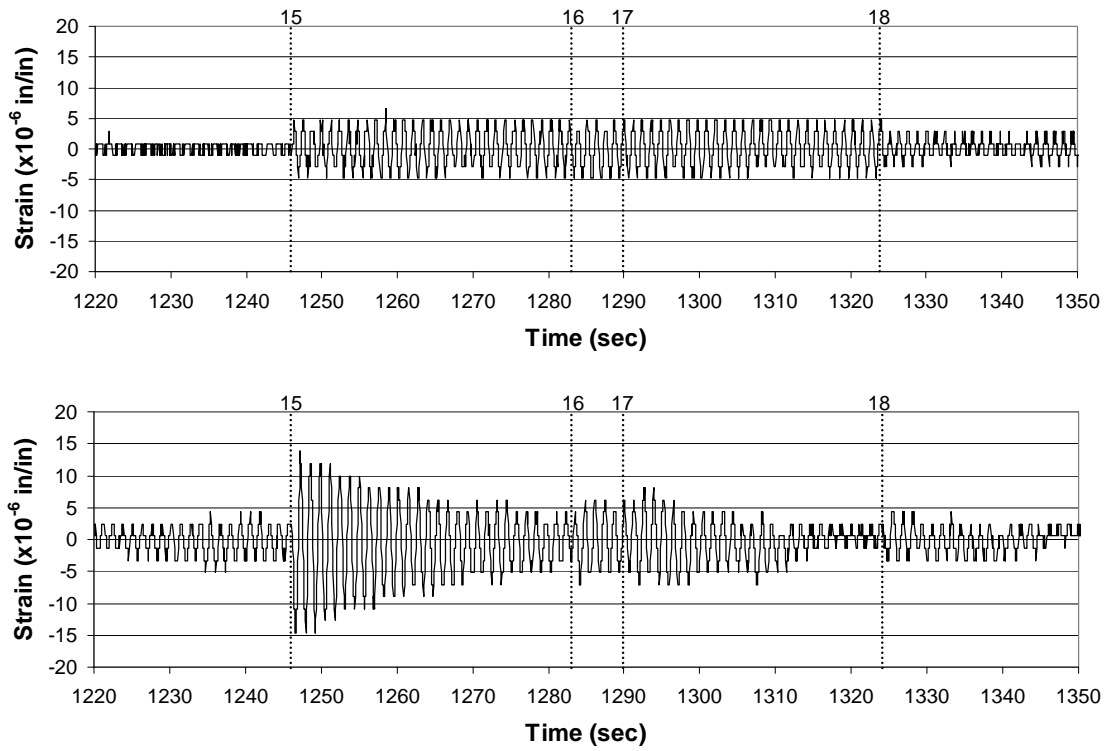
Figure 4.11: Strain Data from the Top of the Mast Arm (top) and the Side of the Mast Arm (bottom) Recorded at the Field Test Site on RM 620 at Home Depot Blvd

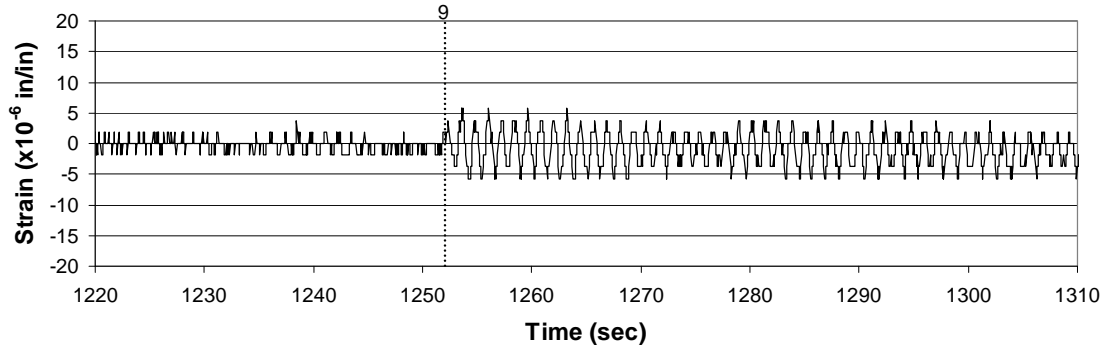
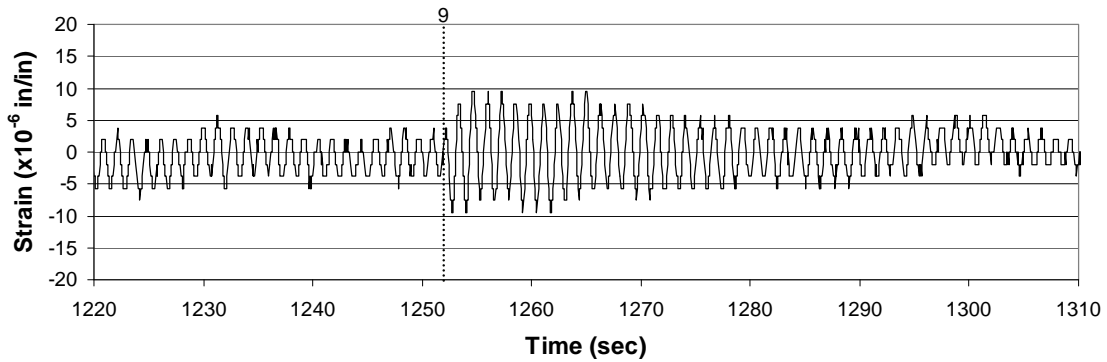
Figure 4.12: Strain Data from the Top of the Mast Arm (top) and the Side of the Mast Arm (bottom) Recorded at the Field Test Site on RM 620 at Home Depot Blvd

After analyzing the recorded strain time histories from all the trucks, it appeared that at both field test sites, the majority of trucks did not produce significant strains in the mast arms. Some examples of field data gathered are described to illustrate the level of response measured in the field. Figures 4.11 and 4.12 show truck events (indicated by vertical dotted lines on the plots) recorded at the field test site on RM 620 at Home Depot Blvd where there was a significant change in the strain readings either from the strain gauges located at the top of the mast arm (in-plane), the strain gauges located on the side of the mast arm (out-of-plane), or both. The information on these truck events is given in Tables 4.1 and 4.2. More details regarding the events can also be found in Appendix F. In Figure 4.11, the first truck (Truck No. 15) produced an obvious increase in the side strain data when it passed beneath the mast arm. However, this truck did not produce a similar effect on the in-plane strain. Also, note that the other three trucks (Truck Nos. 16, 17, and 18) did not have an appreciable effect on either strain measurement. It is important to note that the resolution of the datalogger was 0.001 mV/V (millivolt/volt) which corresponds to 1.9×10^{-6} in/in when converted to strain units for strain gauges that have a 2.11 strain gauge factor. Thus, the smallest incremental change in strains that could be recorded or resolved in the field was 1.9 microstrain. Therefore, as a quick screening to ensure that the change in strain measurements was in fact due to the truck and not due to noise or wind, a strain range of at least 7.6 microstrain (4×1.9 microstrain) when a truck event occurred was considered to be significant. As shown in Figure 4.12, not all truck events were as obvious to pick out as the one (Truck No. 15) in Figure 4.11. The truck event (Truck No. 9) shown in Figure 4.12 was still considered as one that caused a change in the strain data. However, of the over 400 trucks that were analyzed at the two field sites most did not produce any appreciable change in the strain data as is illustrated in Figure 4.13 with data from the field test site on US 290 at SH 95. None of the seven truck events (Truck Nos. 2-8) presented in Figure 4.13 caused any change

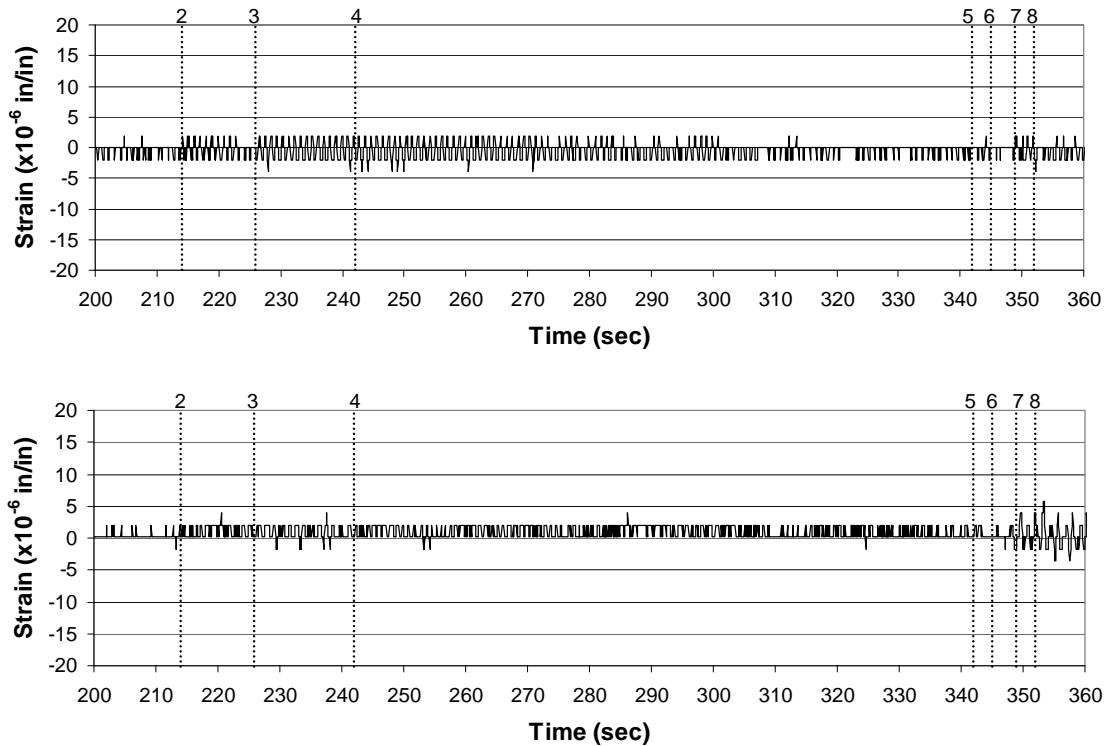
Figure 4.13: Strain Data from the Top of the Mast Arm (top) and the Side of the Mast Arm (bottom) Recorded at the Field Test Site on US 290 at SH 95

in the strain data. To verify that the trucks in Figure 4.13 were not the slowest or smallest trucks observed, information on these trucks is presented in Table 4.3.

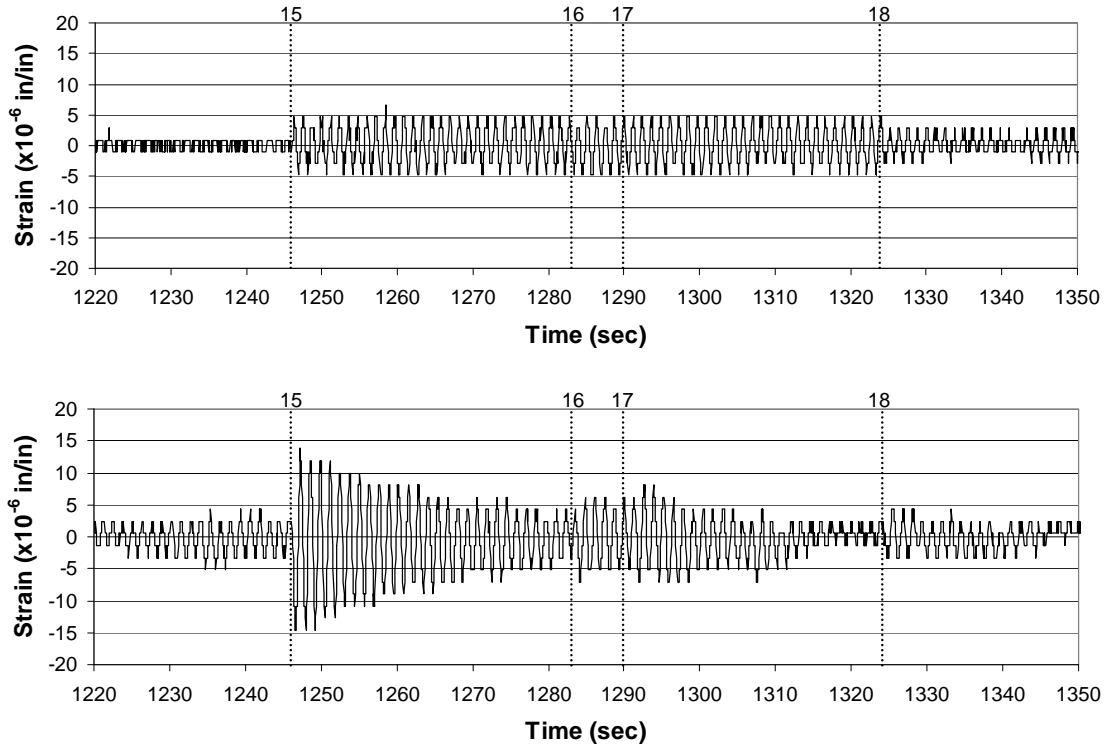
Figure 4.14: Strain Data from the Top of the Mast Arm (top) and the Side of the Mast Arm (bottom) Recorded at the Field Test Site on RM 620 at Home Depot Blvd

Consider Event No. 7 in Table 4.4. This is an example of an “ideal” truck event where the truck produced a large increase in strain and then the motion damped out. As shown in Figure 4.14, before the Box-Small (Dump Truck) (Truck No. 15) passed beneath the mast arm, the in-plane strain range was only two microstrain (practically zero microstrain) and the out-of-plane strain range was six microstrain. Even though the in-plane strain range only increased to about ten microstrain (an insignificant change), the out-of-plane strain range increased to just under 30 microstrain. This out-of-plane strain amplitude then proceeded to damp out in free vibration over the next 35-40 seconds (i.e., very slowly due to the very light damping). This is an important finding because the AASHTO Specifications states that “although loads are applied in both the horizontal and vertical direction, horizontal support vibrations caused by forces in the vertical

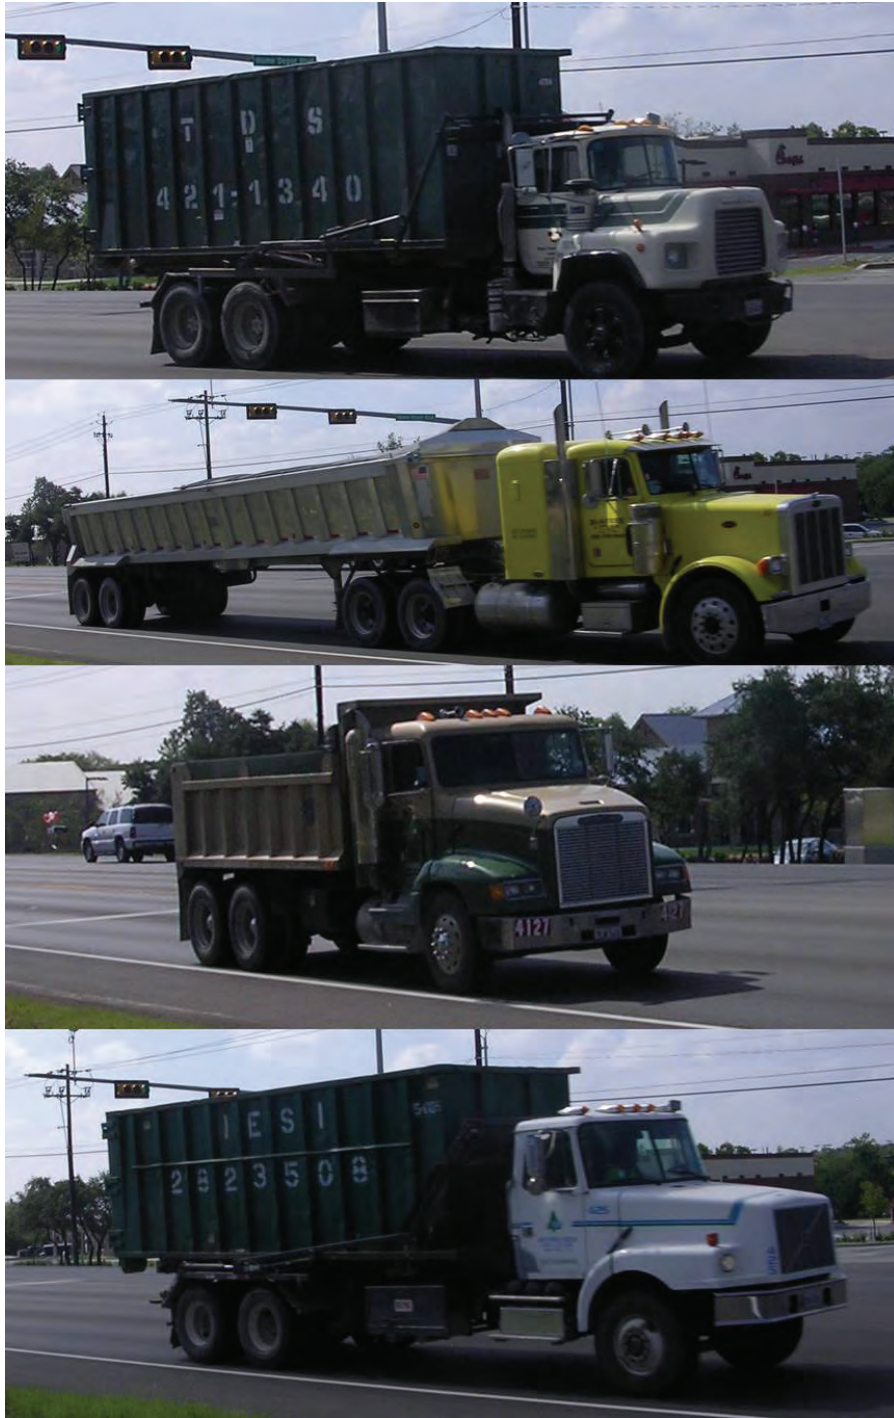
Figure 4.15: Trucks that Produced the Strain Data Shown in Figure 4.14

direction are most critical” (AASHTO, 2003). As shown in Table 4.5 and Figure 4.15, the first truck and the fourth truck were the same Box-Small (Dump Truck) type of truck. However, the fourth truck (Truck No. 18) did not produce the same strain response as the first truck (Truck No. 15). The reasons for this might include the different speeds (59 mph vs. 52 mph), different lanes (Lane 2 vs. Lane 1), and different heights (from the picture in Figure 4.15, the first truck appears to be a little taller than the fourth truck).

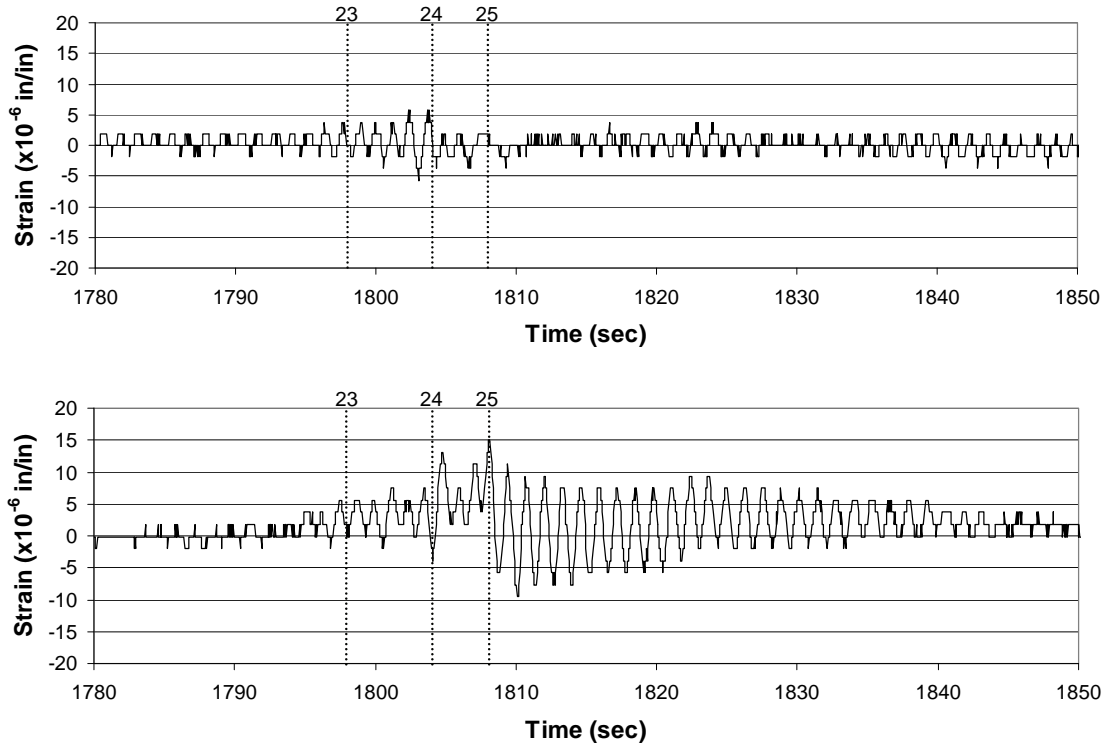
Figure 4.16: Strain Data from the Top of the Mast Arm (top) and the Side of the Mast Arm (bottom) Recorded at the Field Test Site on RM 620 at Home Depot Blvd

the other, all in Lane 1. As shown in Figure 4.16, none of the trucks (Truck Nos. 23, 24, and 25) caused any appreciable strains in the in-plane direction. However, changes in the out-of-plane direction were again noticeable larger. As shown in Table 4.6, all three of the trucks were traveling only slightly above the speed limit. A picture of the first truck is shown in Figure 4.17; unfortunately, the next two trucks passed too quickly, before another picture could be taken.

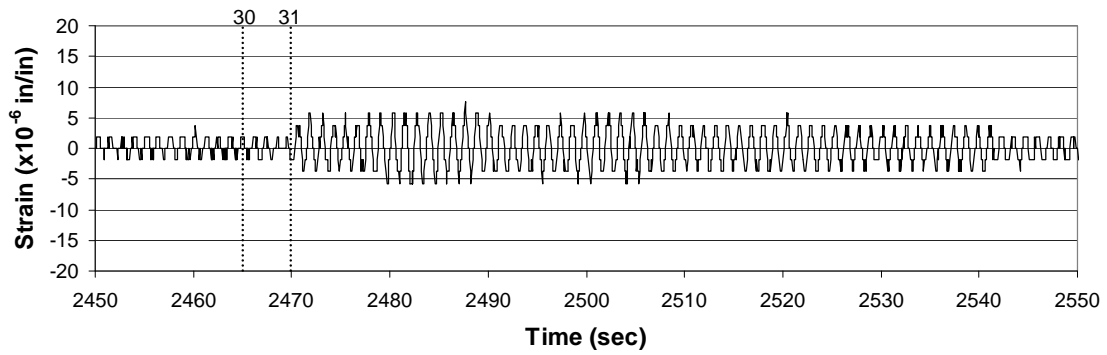
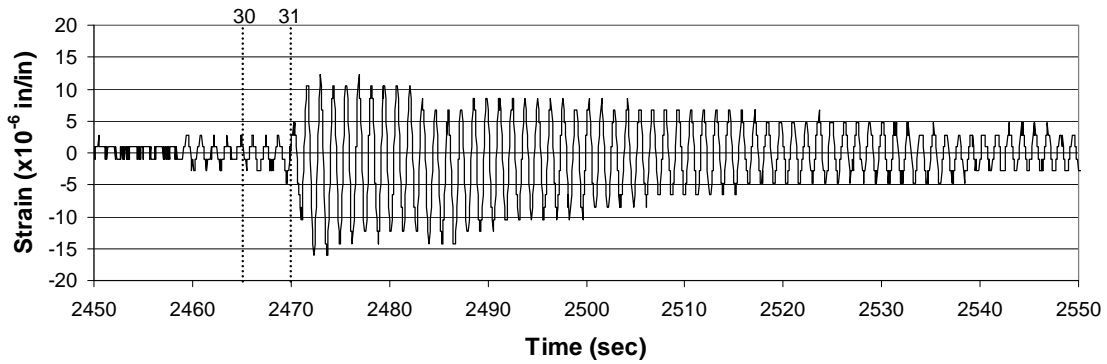
Figure 4.18: Strain Data from the Top of the Mast Arm (top) and the Side of the Mast Arm (bottom) Recorded at the Field Test Site on RM 620 at Home Depot Blvd

As previously discussed, the box-type trucks seemed to have the greatest effect on cantilevered traffic signal structures. The following is another example of a truck (Event No. 9 in Table 4.4) that produced a noticeable change only in the out-of-plane strain data as can be confirmed by studying Figure 4.18. It is interesting to note that, for this truck, the motions of the mast arm do not decay as quickly as in the previous examples discussed. It appears to take between 60-70 seconds for the motion to damp out completely. As stated in Table 4.7, the second truck (Truck No. 31) shown in Figure 4.19 was a Box-Tall type truck traveling at 54 mph (24.14 m/s) in Lane 2.

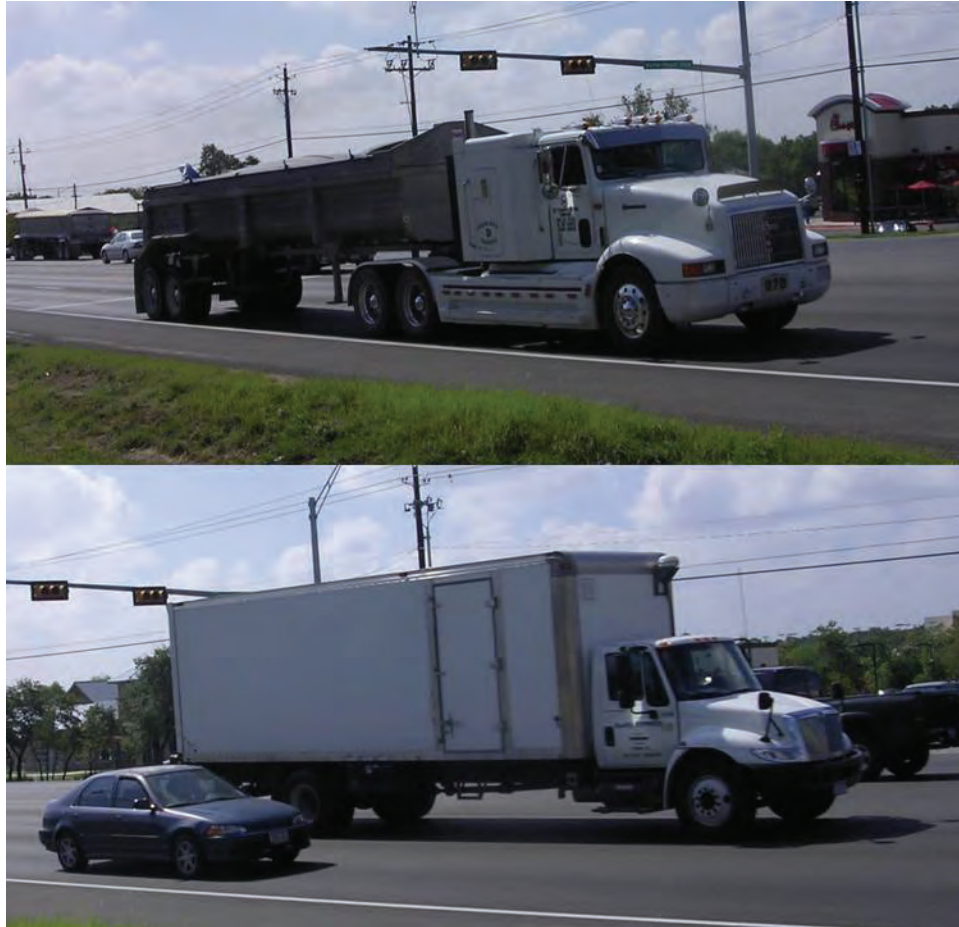
Figure 4.19: Trucks that Produced the Strain Data Shown in Figure 4.18

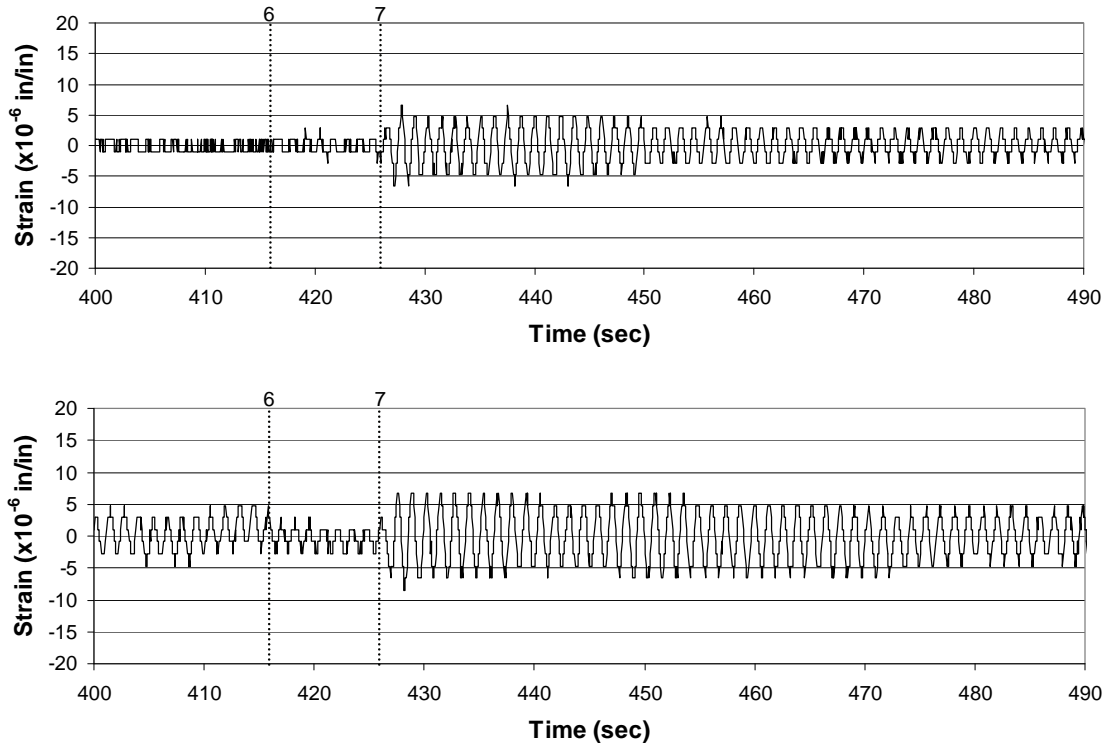
Figure 4.20: Strain Data from the Top of the Mast Arm (top) and the Side of the Mast Arm (bottom) Recorded at the Field Test Site on RM 620 at Home Depot Blvd

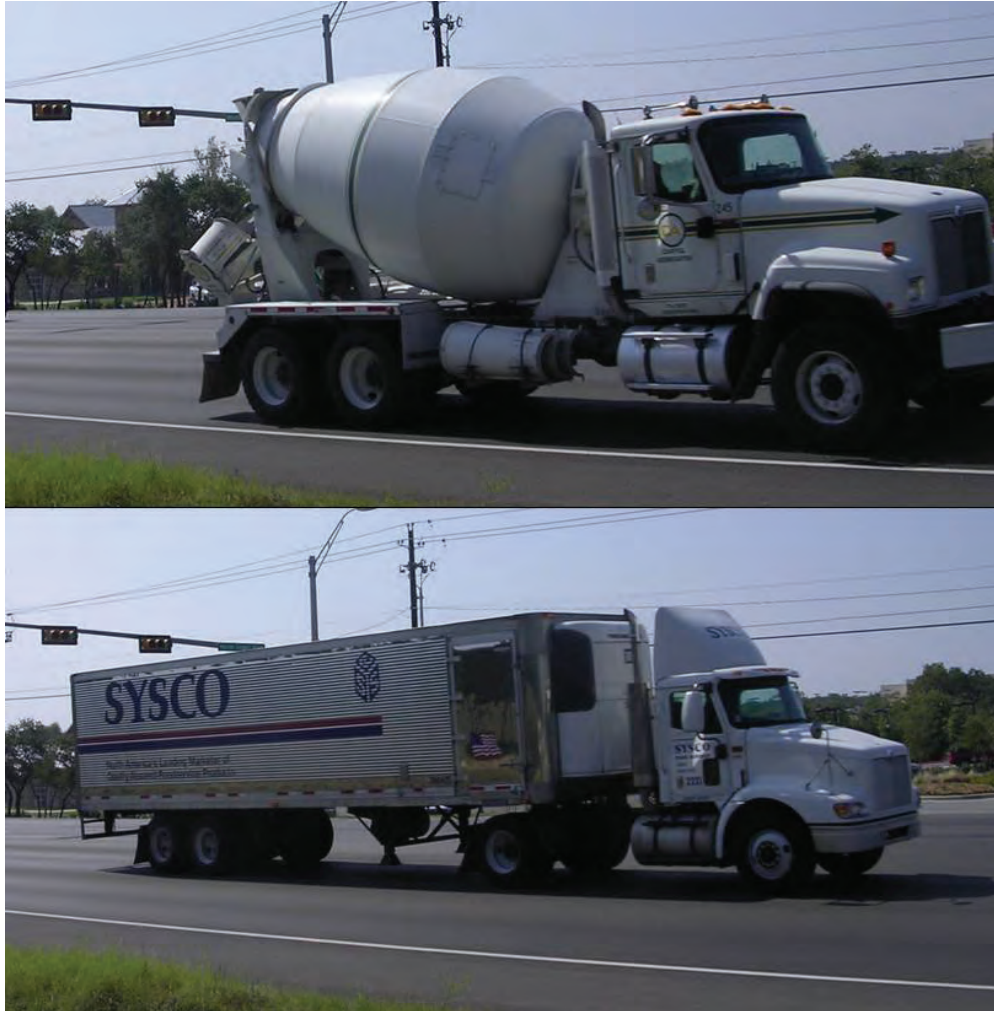
Figure 4.21: Trucks that Produced the Strain Data Shown in Figure 4.20

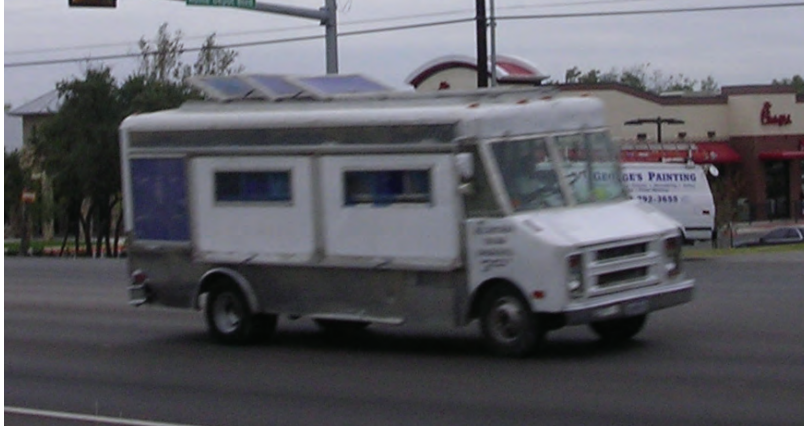
Figure 4.22: Trucks that Produced the Strain Data Shown in Figure 4.23

In one of the more unusual truck events (Event No. 16 in Table 4.4), a delivery truck, shown in Figure 4.22, produced an unexpectedly large strain response in the out-of-plane direction, as seen in Figure 4.23. As Table 4.9 states, the delivery truck (Truck No. 2) was only traveling at 45 mph (20.12 m/s) in Lane 2. The truck produced almost no vertical movement of the mast arm but it caused a strain cycle of 39 microstrain in the out-of-plane horizontal direction. It appears from Figure 4.23 that roughly 6 seconds before the truck passed beneath the mast arm, the side strain was influenced by something. This could perhaps have been a wind gust but because no wind data were recorded at the field test site on RM 620 at Home Depot Blvd, this cannot be verified. However, additional field notes did indicate that the day of the test in question—September 29, 2005 – was indeed a windier day than the previous days when data were recorded at this site.

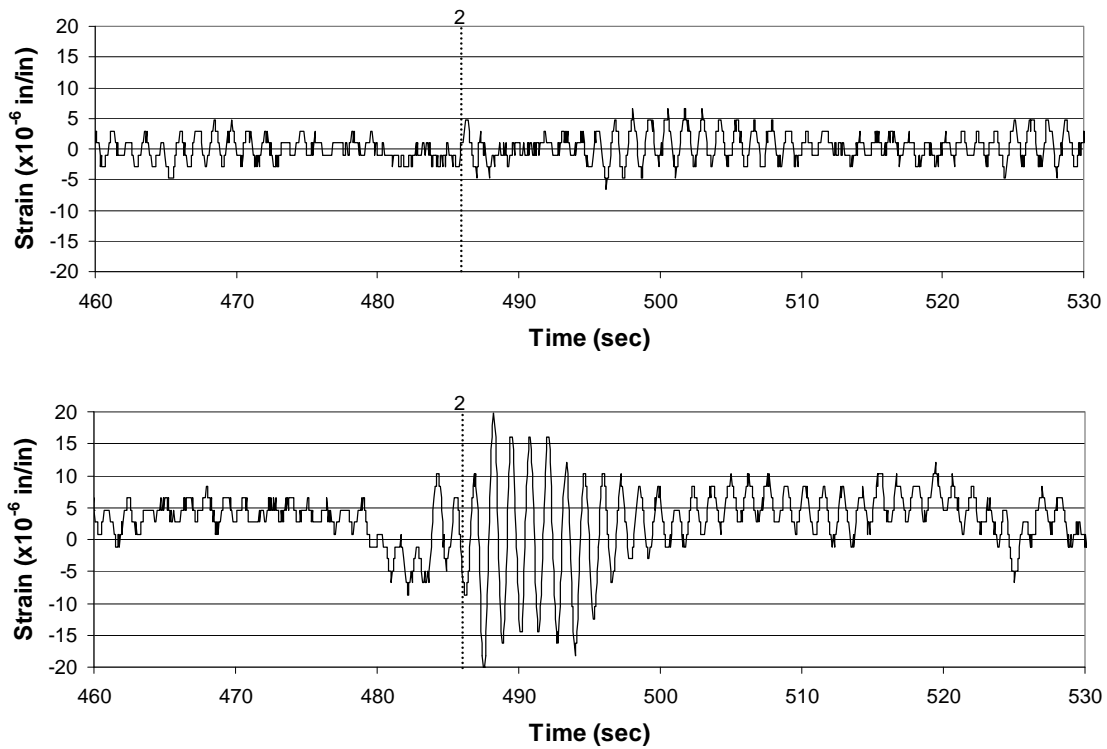
Figure 4.23: Strain Data from the Top of the Mast Arm (top) and the Side of the Mast Arm (bottom) Recorded at the Field Test Site on RM 620 at Home Depot Blvd

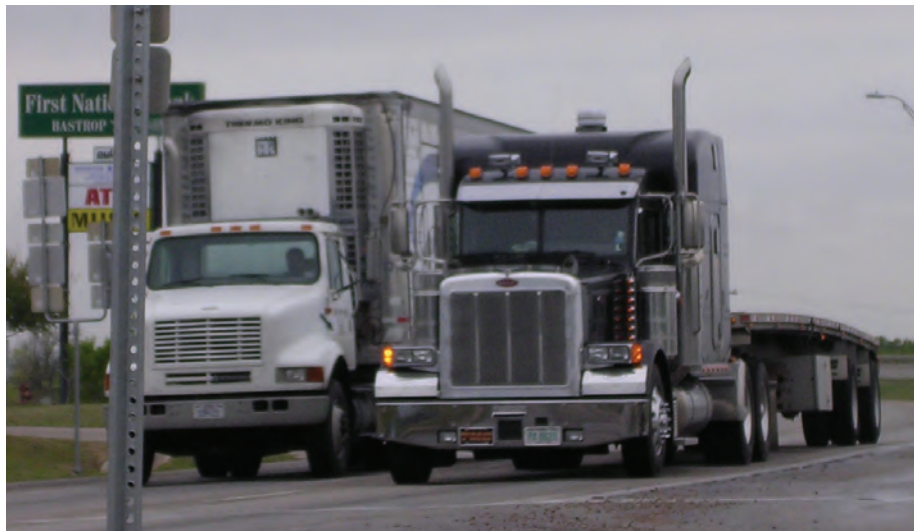
Figure 4.24: Trucks that Produced the Strain Data Shown in Figure 4.25

The overall worst case truck-induced gust loading scenario for a cantilevered traffic signal structure is believed by some to be one where two trucks pass simultaneously beneath the mast arm. The following is an example of a Semi-Tall truck in Lane 1 and a Semi-Low truck in Lane 2, as shown in Figure 4.24, both traveling simultaneously at 49 mph (21.9 m/s) beneath the cantilevered traffic signal structure at the field test site on US 290 at SH 95 (see Truck No. 10 in the data from March 27, 2006, Part 3 in Appendix F). As seen in the strain response of the structure in Figure 4.25, the two semi/tractor-trailer trucks together produced virtually no change in the in-plane response and only limited change in the out-of-plane response. This is an important finding since it is generally believed that this scenario might cause large truck-induced gust response for such structures; yet, the response was barely noticeable. This demonstrates that even though this field test site on US 290 at SH 95 should have been an ideal location for truck-induced gust loads because of the significant truck traffic and the relatively high posted speed limit (50 mph) there, the instrumented cantilevered traffic signal structure at that site was not affected by truck-induced gusts.

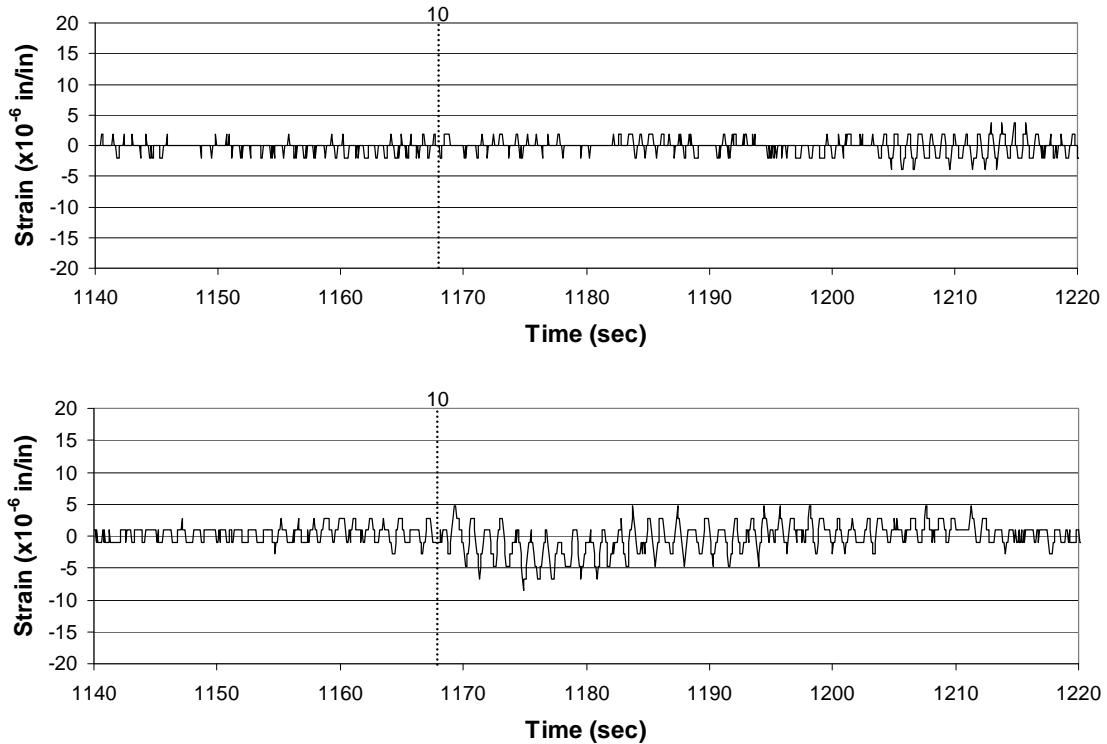
Figure 4.25: Strain Data from the Top of the Mast Arm (top) and the Side of the Mast Arm (bottom) Recorded at the Field Test Site on US 290 at SH 95

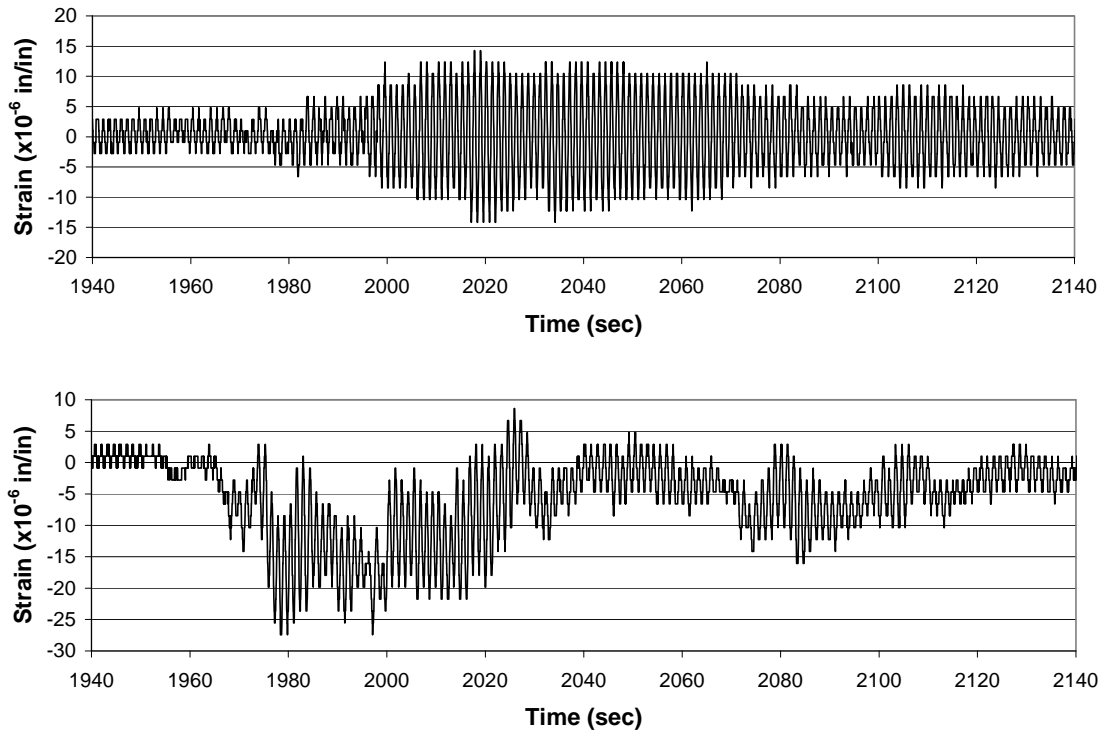
Figure 4.26: Large Strain Cycles (from the top of the mast arm (top figure) and side of the mast arm (bottom figure)) not Caused by Trucks at the Field Test Site on RM 620 at Home Depot Blvd

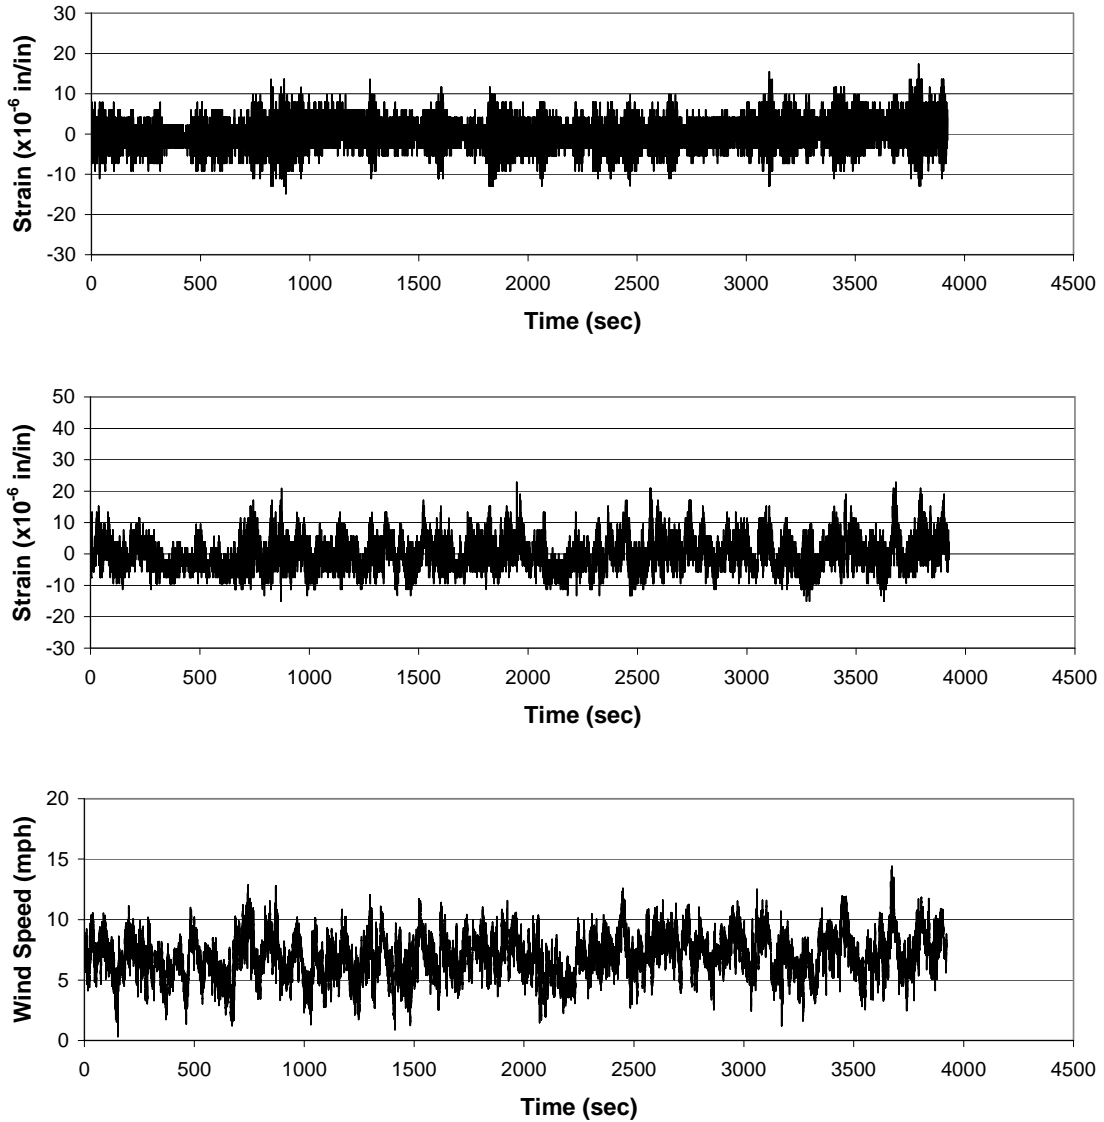
*Figure 4.27: Strain and Wind Data Recorded at the Field Test Site on US 290 at SH 95z—
03-15-06, Part 1: Top Strain (top), Side Strain (middle), Wind Speed (bottom)*
