1. Report No. FHWA/TX-08/0-4586-2		2. Government Accession No.		3. Recipient's Catalog No.	
4. Title and Subtitle Field Testing of Cantilevered Traffic Signal Structures under Truck-Induced Gust Loads			5. Report Date March 2007, Revised November 2007

Field Testing of Cantilevered Traffic Signal Structures under Truck-Induced Gust Loads

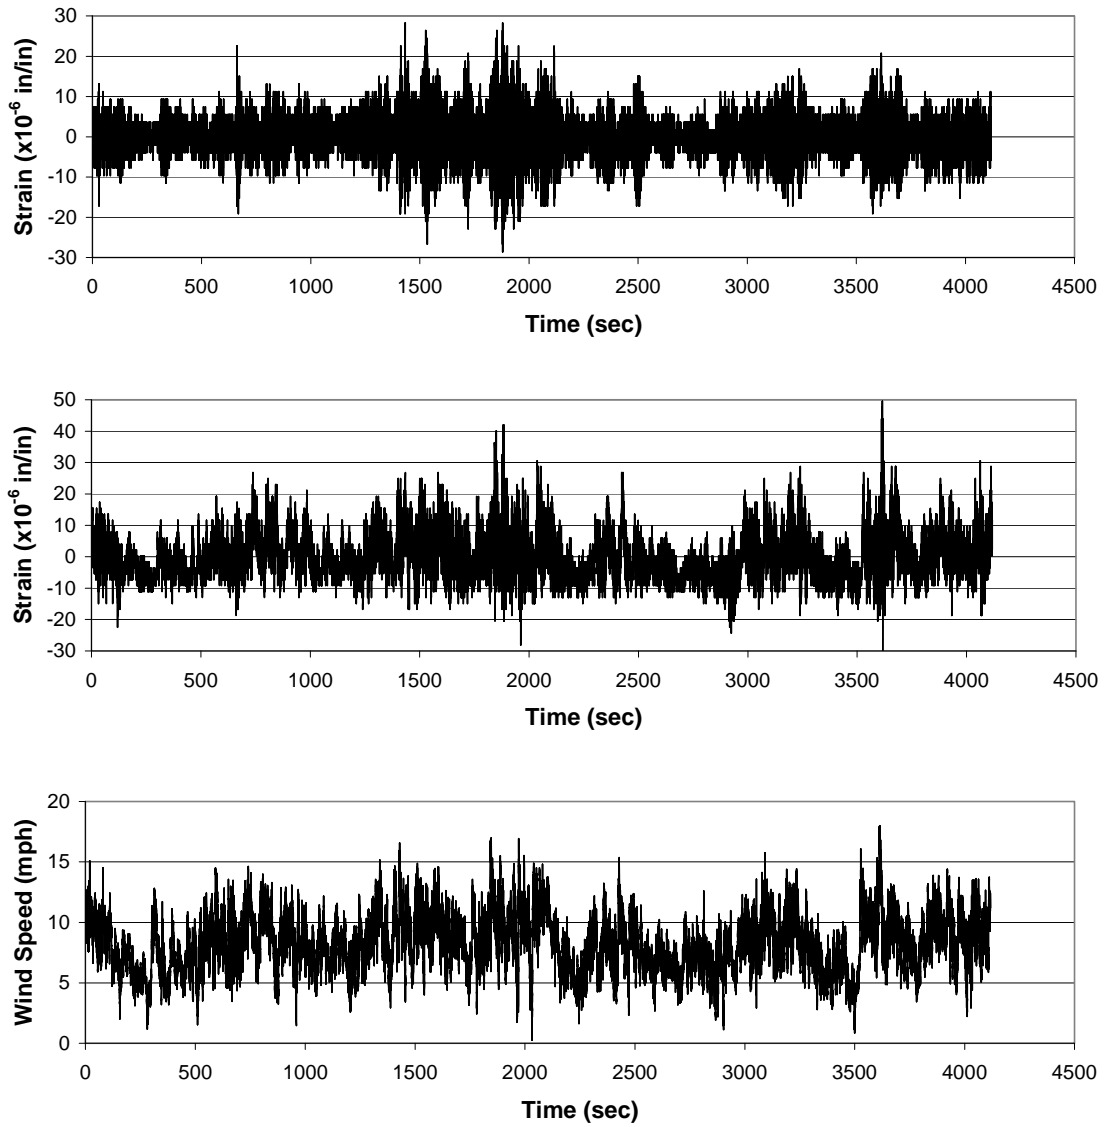
Figure 4.28: Strain and Wind Data Recorded at the Field Test Site on US 290 at SH 95—03-15-06, Part 2: Top Strain (top), Side Strain (middle), Wind Speed (bottom)

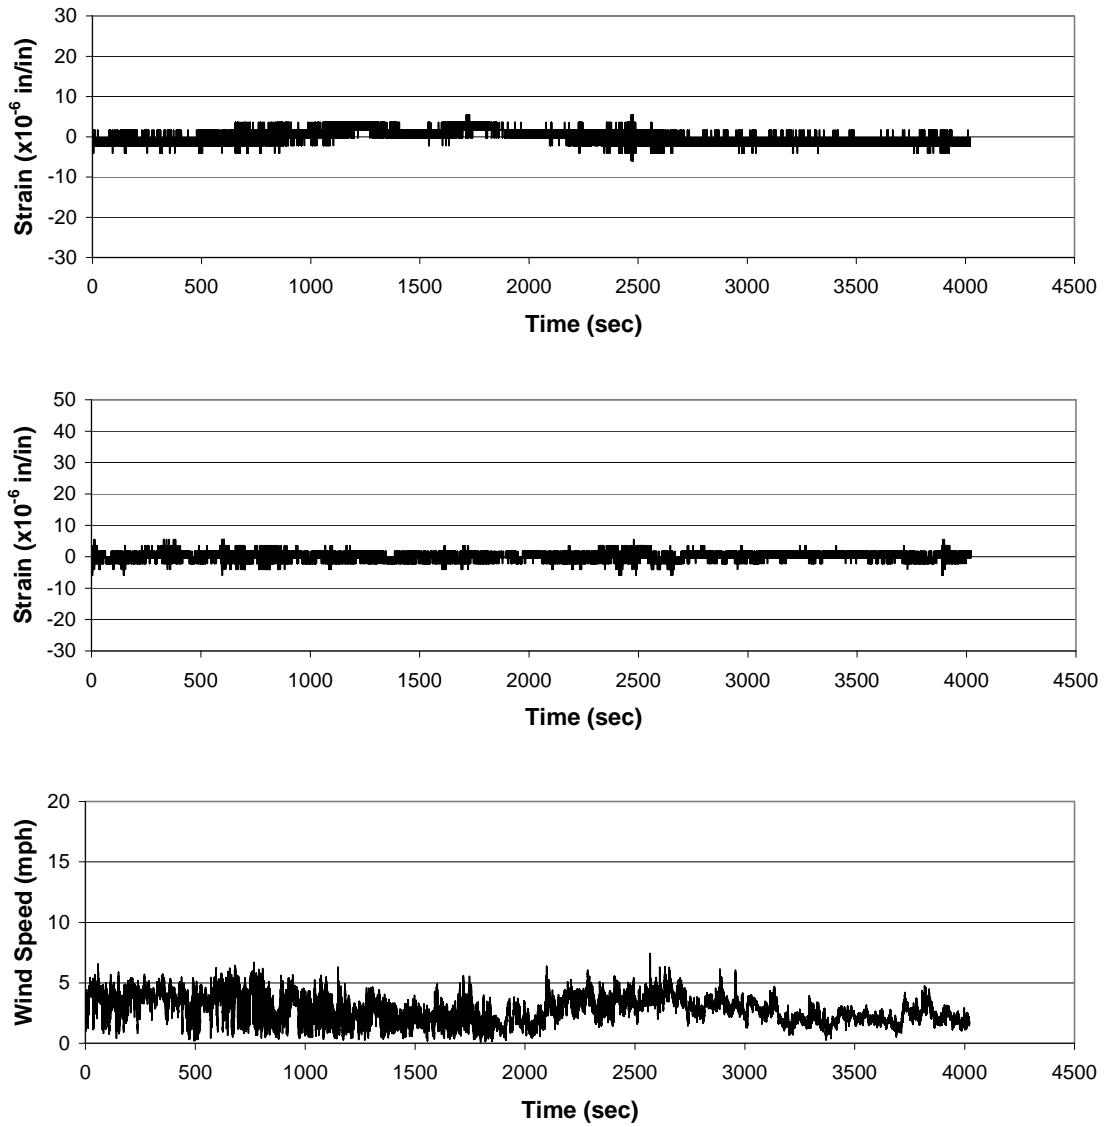
Figure 4.29: Strain and Wind Data Recorded at the Field Test Site on US 290 at SH 95—03-16-06, Part 1: Top Strain (top), Side Strain (middle), Wind Speed (bottom)

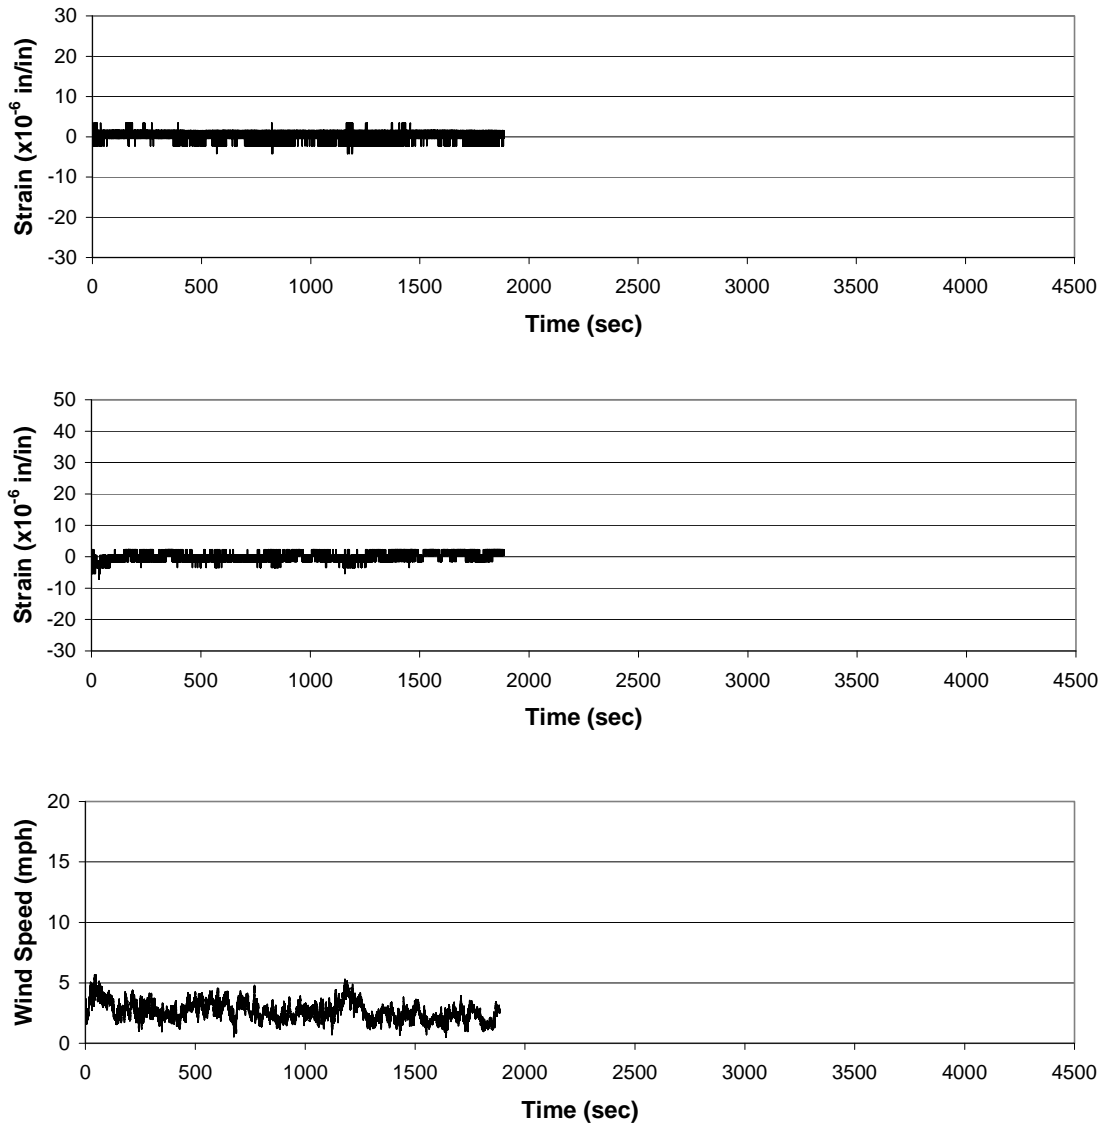
Figure 4.30: Strain and Wind Data Recorded at the Field Test Site on US 290 at SH 95—03-16-06, Part 2: Top Strain (top), Side Strain (middle), Wind Speed (bottom)

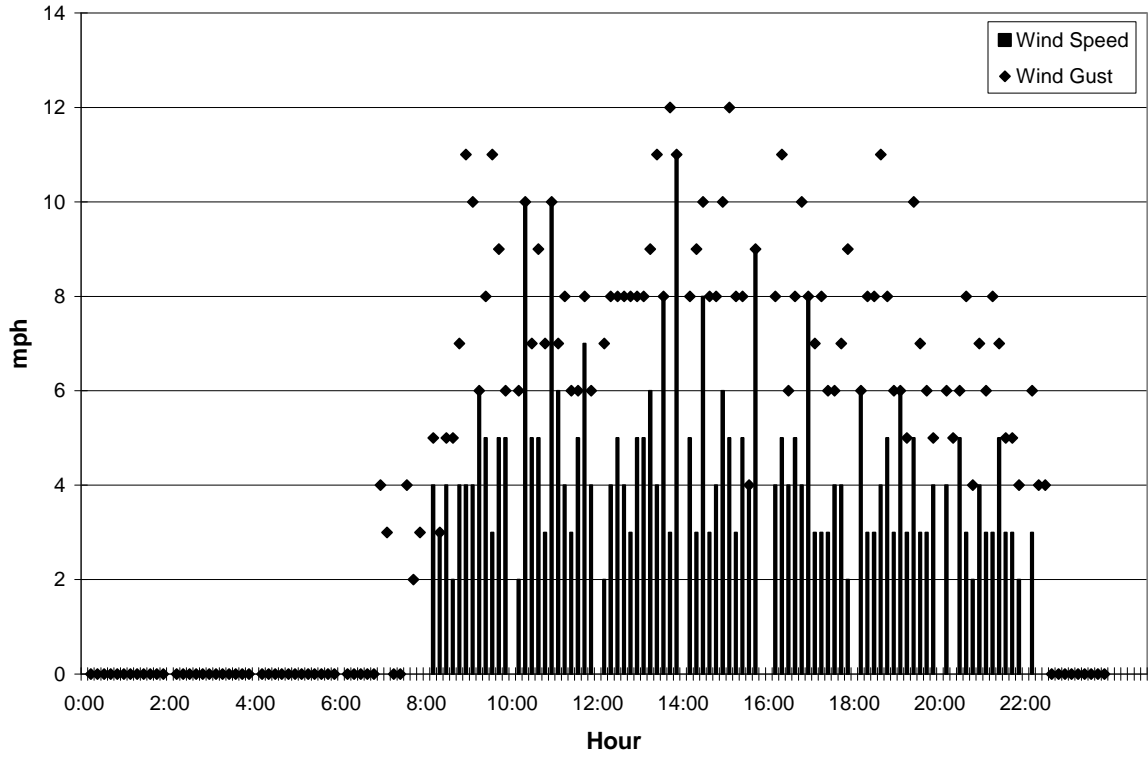
Figure 4.31: Wind Data for March 15, 2006 at the Field Test Site on US 290 at SH 95

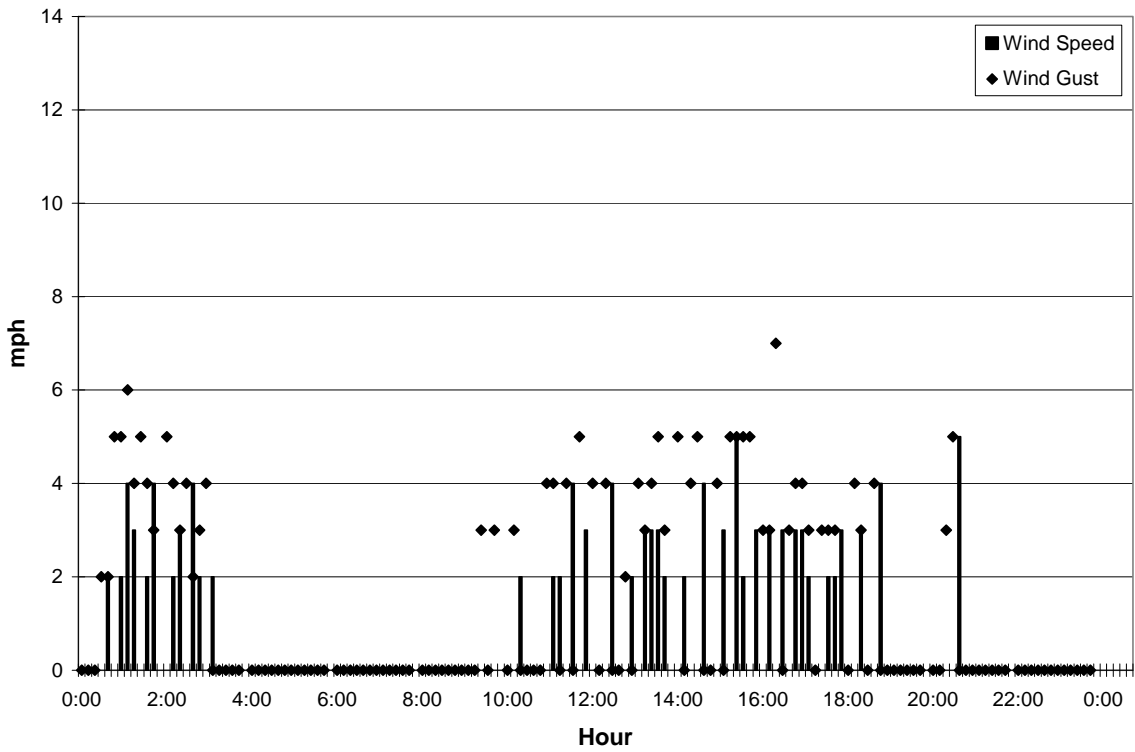
Figure 4.32: Wind Data for March 16, 2006 at the Field Test Site on US 290 at SH 95

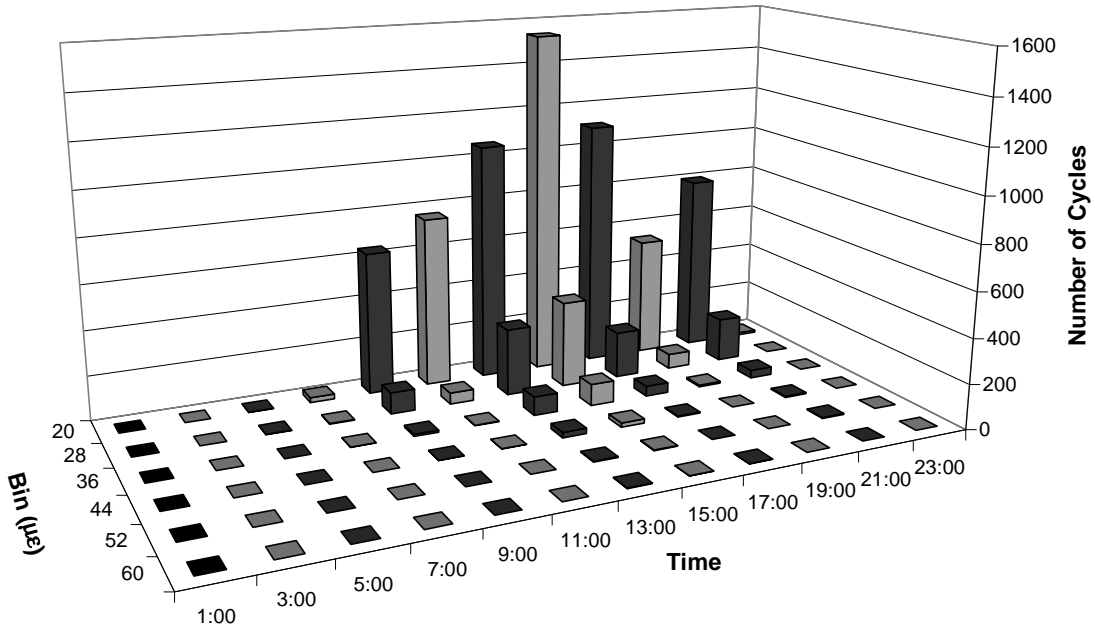
Figure 4.33: 3-D Rainflow Cycle Counts Histogram for March 15, 2006 at the Field Test Site on US 290 at SH 95

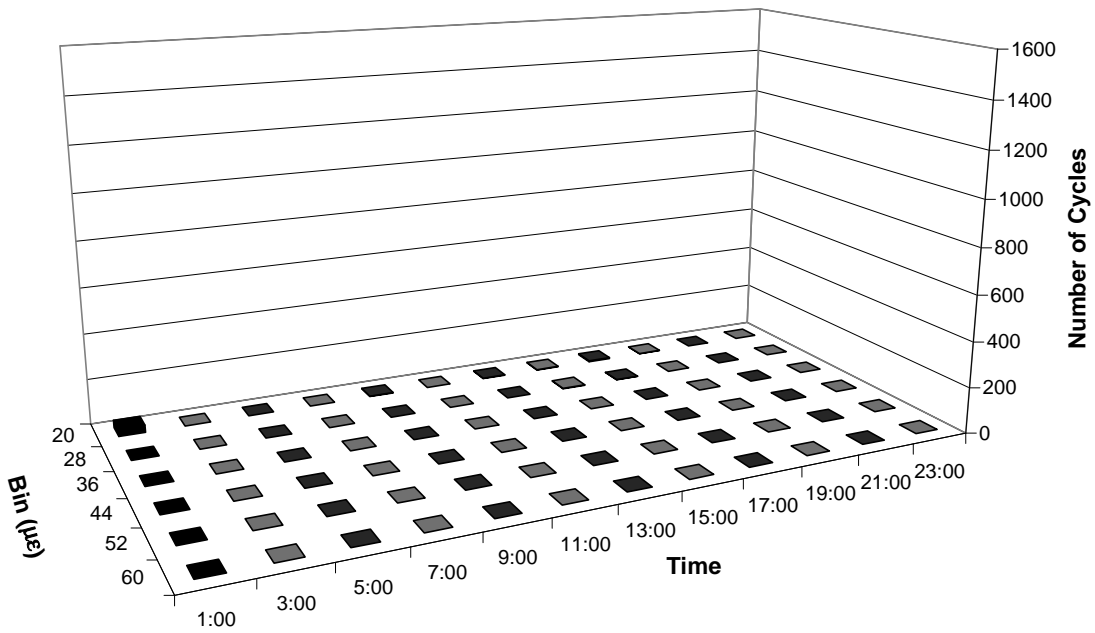
Figure 4.34: 3-D Rainflow Cycle Counts Histogram for March 16, 2006 at the Field Test Site on US 290 at SH 95

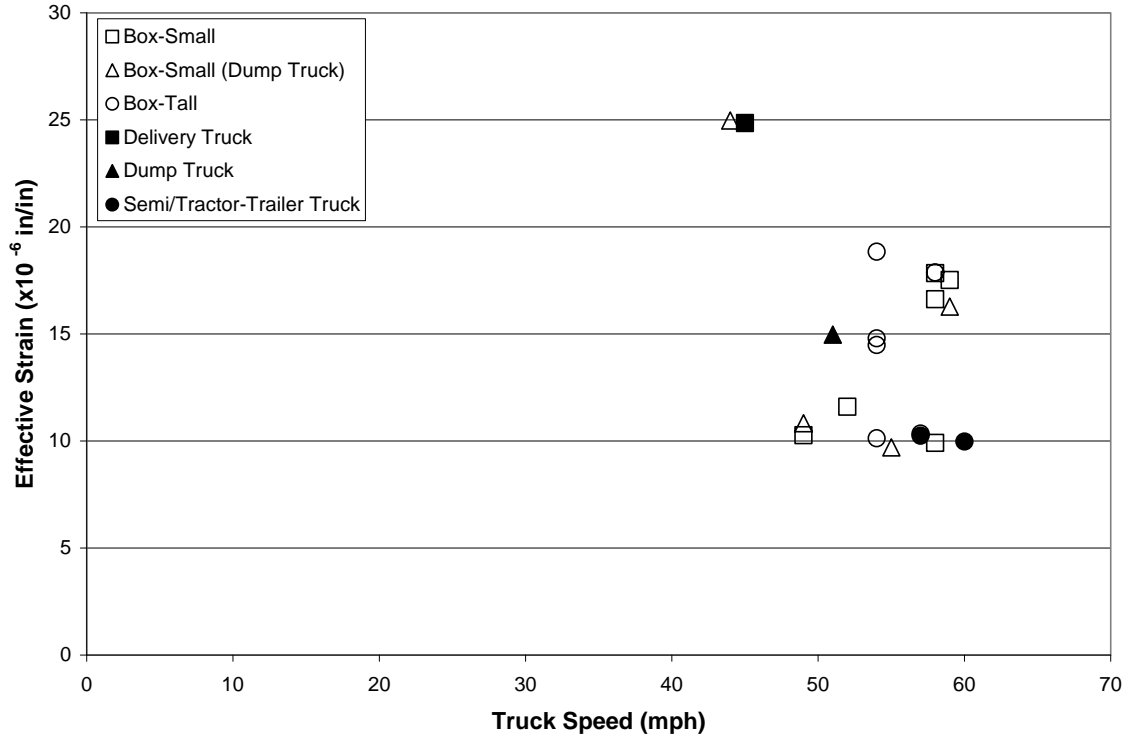
Figure 5.1: Influence of Truck Type on Mast Arm Structural Response (Strain)

From the contours of the cab to the height of the trailer, all trucks are shaped differently. Thus, it is a reasonable assumption that each type of truck has a different effect on a cantilevered traffic signal structure. This was noted in the literature review in Chapter 2—for instance, previous researchers stated that box-type trucks, gravel trucks, and semi/tractor-trailer trucks caused some structural motions (Creamer et al., 1979 and Edwards and Bingham, 1984). The influence of truck shape and height were also noted by Cali and Covert (1997). In Section 4.4, it was shown that very few of the trucks analyzed during the field tests caused any significant movement in the mast arm at all. Of all the trucks, the box-type trucks appear to have the greatest influence on the response of the cantilevered traffic signal structure as seen in Figure 5.1. Interestingly, a specific box-type truck carrying a dumpster (called a Box-Small Dump Truck in this study) seemed to affect structural motions to the greatest extent (four of eight such trucks influenced structural motions). A picture of a Box-Small Dump Truck is shown in Figure 5.2. One possible solution is that the top front edge of the dumpster is not rounded at all, as is the case with most other trucks, making the truck less aerodynamic producing a greater pressure pulse.

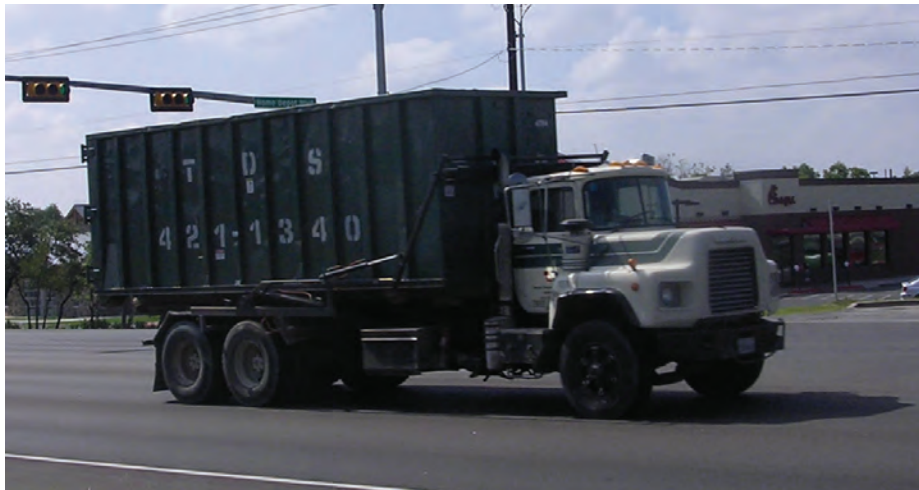
Figure 5.2: Box-Type Dump Truck

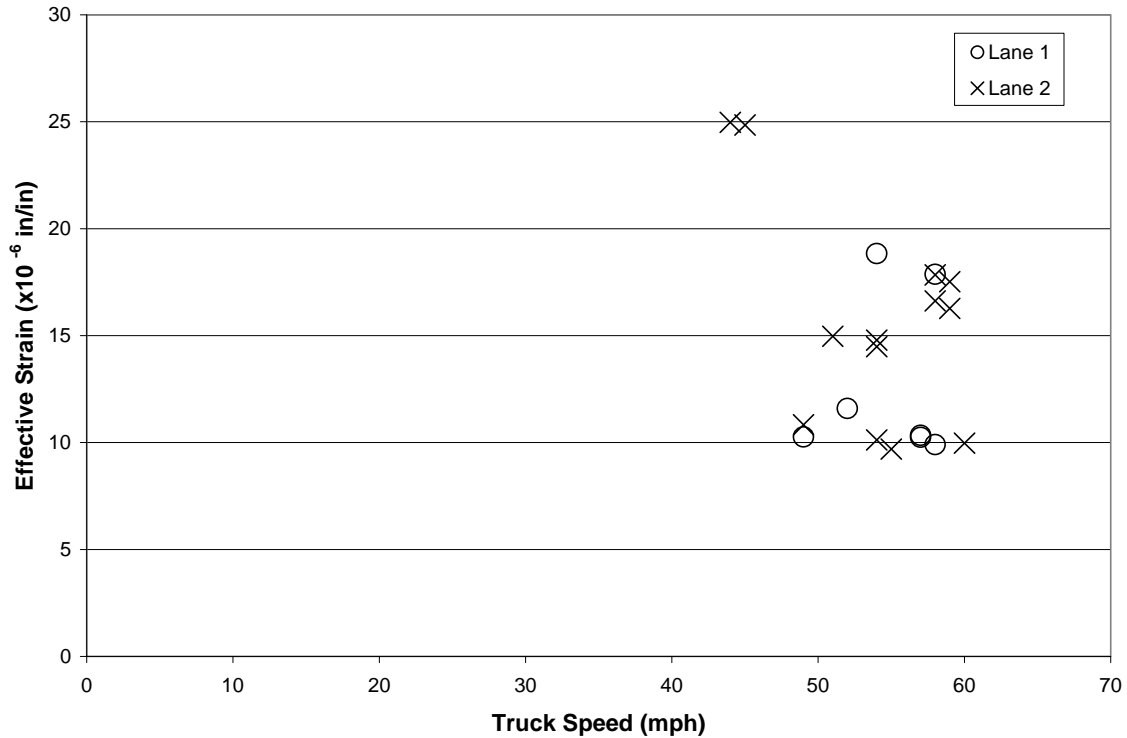
Figure 5.3: Influence of Traffic Lane on Mast Arm Structural Response (Strain)

Figure 5.3 shows that most of the trucks that caused any appreciable structural response (greater than ten microstrain) were traveling in Lane 2 (thirteen, compared to seven in Lane 1) even though, overall, the majority of all trucks traveled in Lane 1. Earlier, it was noted that none of the trucks in Lane 1 caused appreciable in-plane structural response. The dampening plate on the mast arm was located directly over Lane 2, which would increase the horizontal area that the truck's vertical pressure could affect. It is not known whether the trucks in Lane 2 would still cause in-plane structural response if the dampening plate were removed.

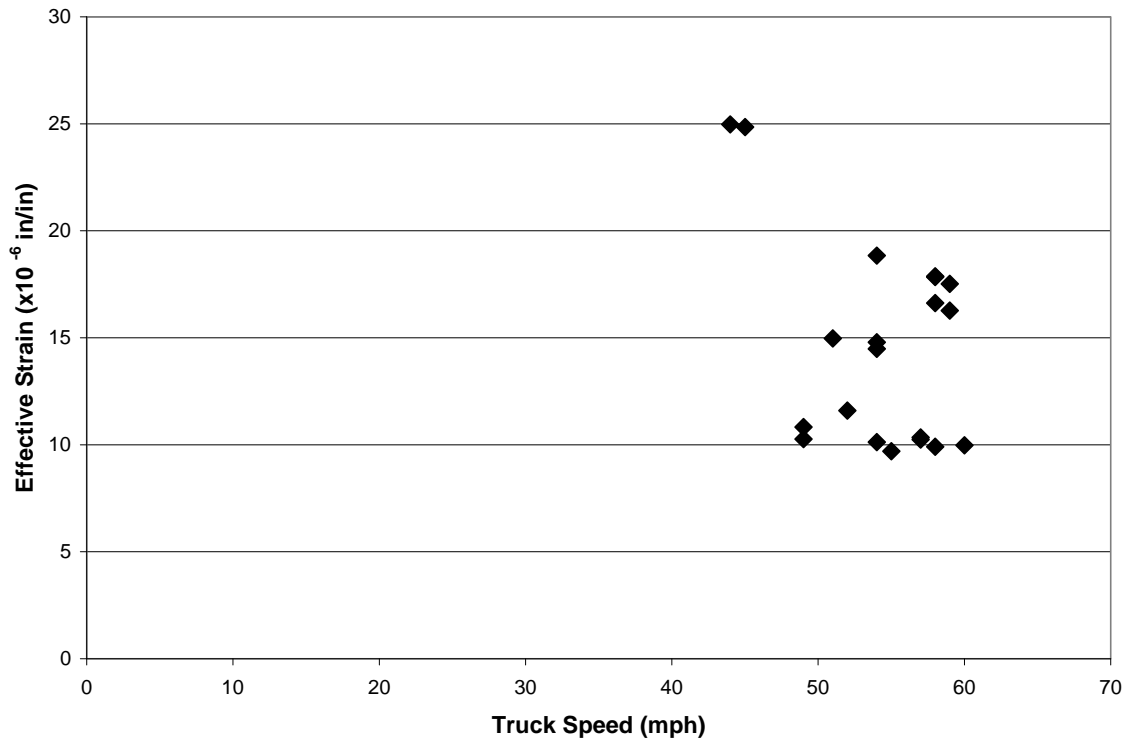
Figure 5.4: Influence of Truck Speed on Mast Arm Structural Response (Strain)

The AASHTO Specifications allow a reduction in the design equivalent static pressure by a factor of $(V / 65 \text{ mph})^2$ where V is the truck speed in mph or, equivalently, a reduction by a factor of $(V / 30 \text{ m/s})^2$ if the truck speed is in m/s (AASHTO, 2002). Thus, for a location with a speed limit of 55 mph (24.59 m/s), such as the test site on RM 620 at Home Depot Blvd, the reduction factor would be 0.716, while for a location with a speed limit of 50 mph (22.35 m/s), such as the test site on US 290 at SH 95, it would be 0.592. However, as noted in Section 4.3, the majority of the trucks that were not affected by the traffic signal were still traveling at speeds below the posted speed limit, especially at the site on US 290 at SH 95.

By studying Figure 5.4, it is apparent that most of the trucks that caused any appreciable strains were traveling at speeds above 50 mph (22.35 m/s). Interestingly, there are a few cases such as the delivery truck, discussed in Section 4.4.5, which caused one of the largest out-of-plane strain ranges, even though that truck was only traveling at 45 mph (20.12 m/s). In Figure 5.4, the two truck events with effective strains of approximately 25 microstrain both occurred on September 26, 2005, which was a relatively windy day. Therefore, it should be noted that these two data points probably reflect the combined effects of both truck-induced gusts as well as natural wind gusts.

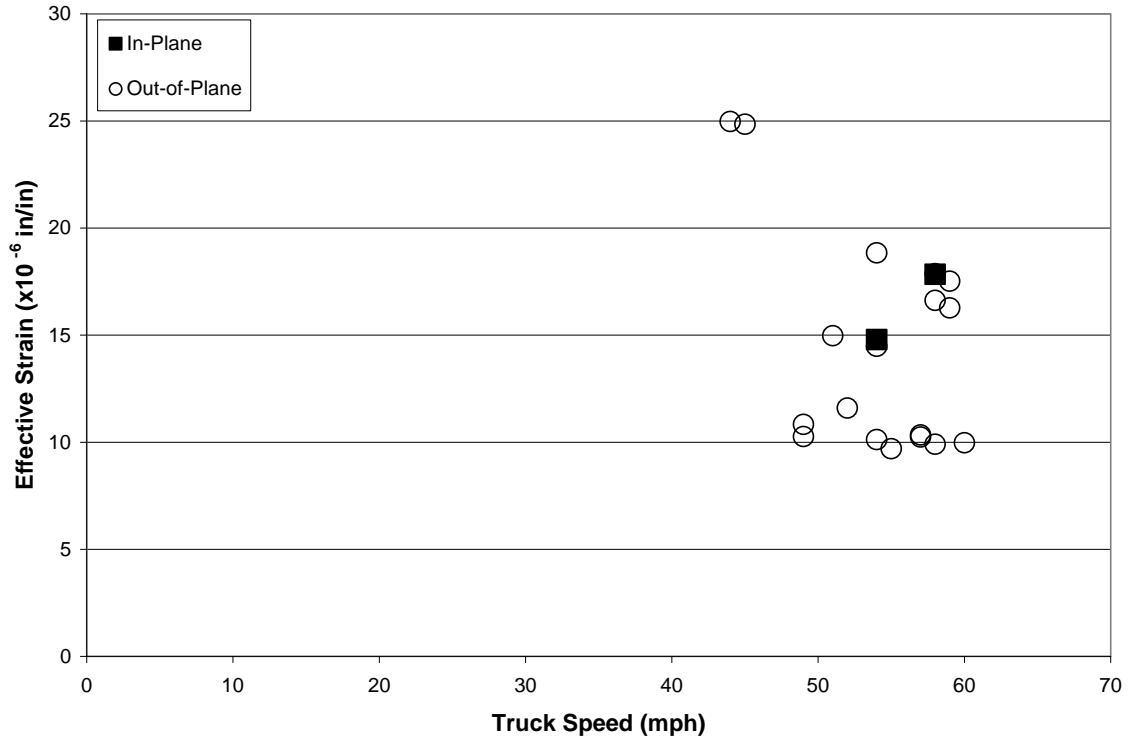
Figure 5.5: In-Plane versus Out-of-Plane Mast Arm Strains

One of the most unexpected results from this study was that truck-induced gusts appear to have a significant, and often greater, effect in the out-of-plane direction than was the case in the in-plane direction as shown in Figure 5.5. According to the AASHTO design specifications, only vibrations caused by the vertical force of the truck-induced gust need to be considered because in the horizontal direction, vibrations resulting from the natural wind are more dominant than those produced by truck-induced gusts (AASHTO, 2003). The code does not state where the information that led to these conclusions came from. However, there are some important things to note. First, as already discussed in the literature review in Chapter 2, most of the previous research on truck-induced gusts was performed on variable message sign structures. Previous research has shown that the damping of motions due to truck-induced gusts for a VMS structure is much greater in the out-of-plane direction than the in-plane direction. This can be confirmed by studying Figure 5.6. The greater damping for out-of-plane motions was stated to be due to the large amount of wind resistance as the sign moves through the air (Johns and Dexter, 1998). Johns and Dexter state that “this proves that it is not necessary to apply the truck-induced gust loads to the front of the structure because a natural wind gust will undoubtedly govern in this direction” (Johns and Dexter, 1998). Cantilevered traffic signal structures, though, are very different from VMS structures and generally exhibit similar damping characteristics and natural frequencies in in-plane and out-of-plane directions of motion (Florea, 2005). In this study, it was found that trucks often caused greater response levels in the horizontal (out-of-plane) direction than in the vertical (in-plane) direction for the cantilevered signal structures studied.

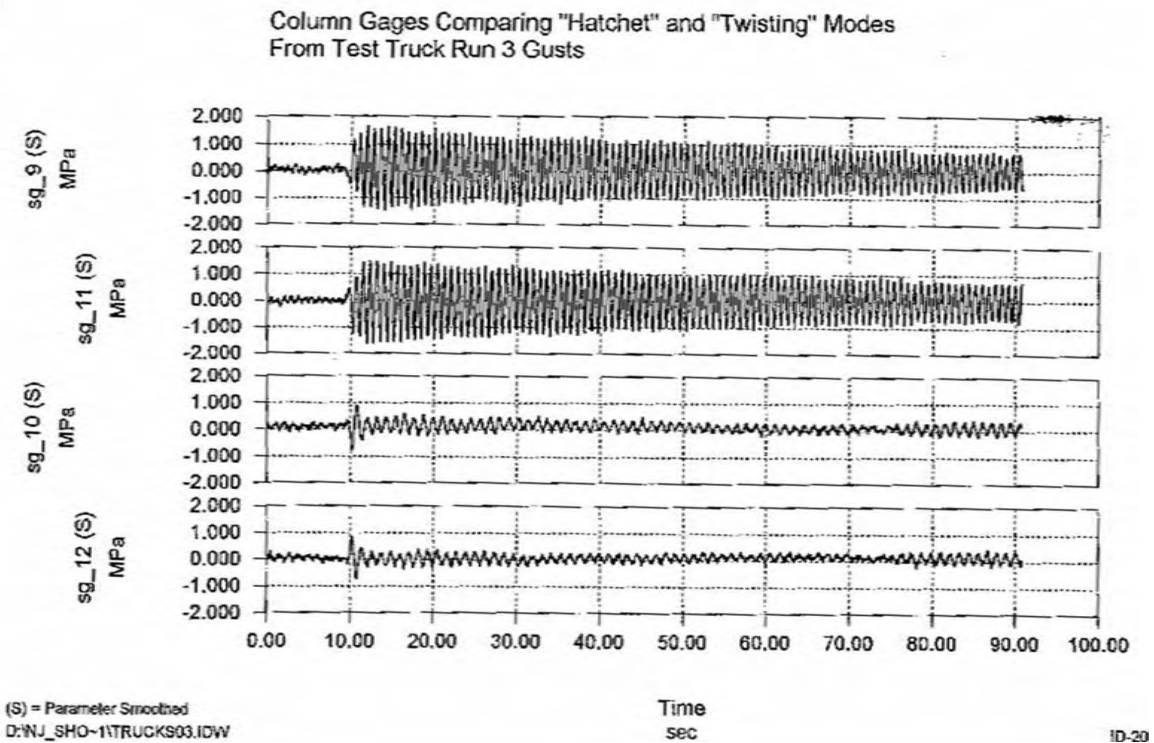
Figure 5.6: In-Plane versus Out-of-Plane Stresses for a VMS Structure (Johns and Dexter, 1998)

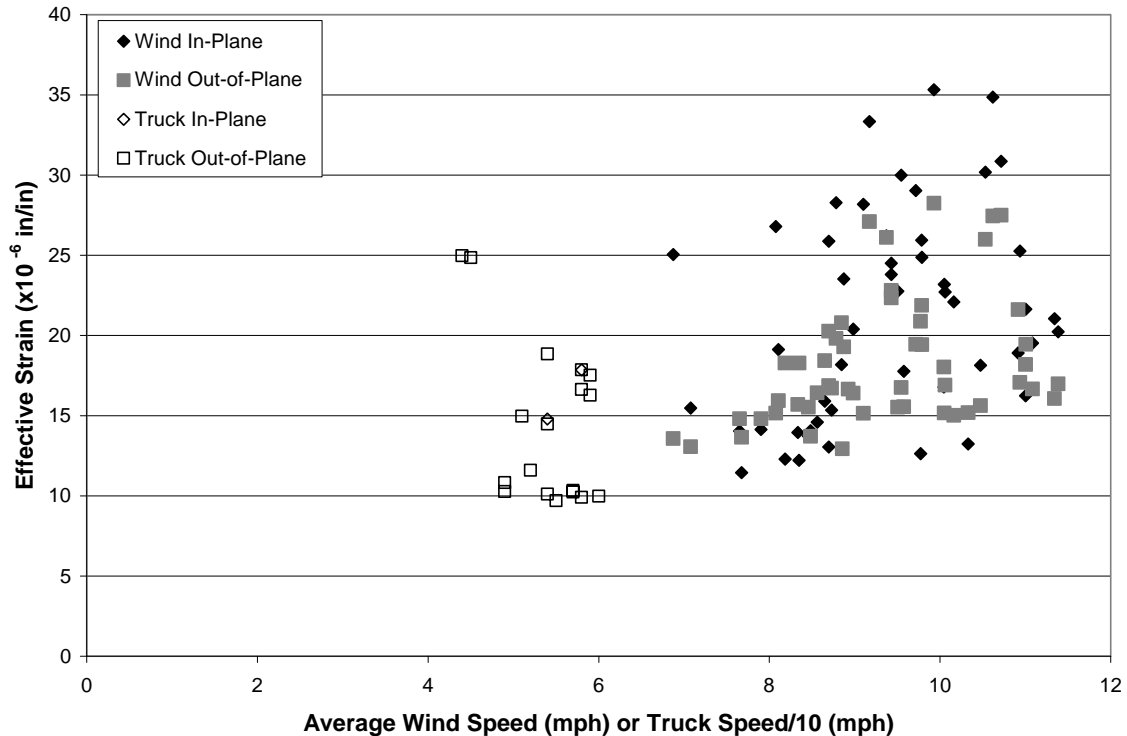
Figure 5.7: Influence of Truck-Induced Gust versus Natural Wind on In-Plane and Out-of-Plane Mast Arm Strains

Throughout the field testing program, it was clear that the majority of the trucks caused no significant movement of the mast arms studied. However, the natural wind would sometimes cause noticeable tip displacements. As discussed in Section 4.5, there were virtually negligible strains in the mast arm on days without wind; yet, on windy days there were sometimes significant recordings of strains in both directions. In Figure 5.7, the twenty most important truck events are compared with some natural wind events. As seen in the figure, the natural wind is more critical for both in-plane and out-of-plane directions of motion. While comparing the influence of truck-induced gusts with that of natural wind gusts, it is assumed that the maximum truck-induced gusts at the sites were captured in the short-term monitoring of the structures because of the variety of different truck types that were recorded in each lane at speeds above the posted speed limit. However, it is known that the wind speed at a particular site can vary throughout the year. Thus, it cannot be assumed that the maximum natural wind loading was actually observed during the limited duration of field testing in this study. Therefore, the natural wind has the potential to have an even greater influence on the response of a cantilevered traffic signal structures over its service life than was found here. As previously discussed, truck-induced gust loads will only affect a small percentage of cantilevered traffic signal structures, but natural wind, on the other hand, affects every structure. Thus, it is imperative to correctly design cantilevered traffic signal structures for the more critical loading case of natural wind gusts, and if this is done correctly, the design will effectively account for truck-induced gusts.

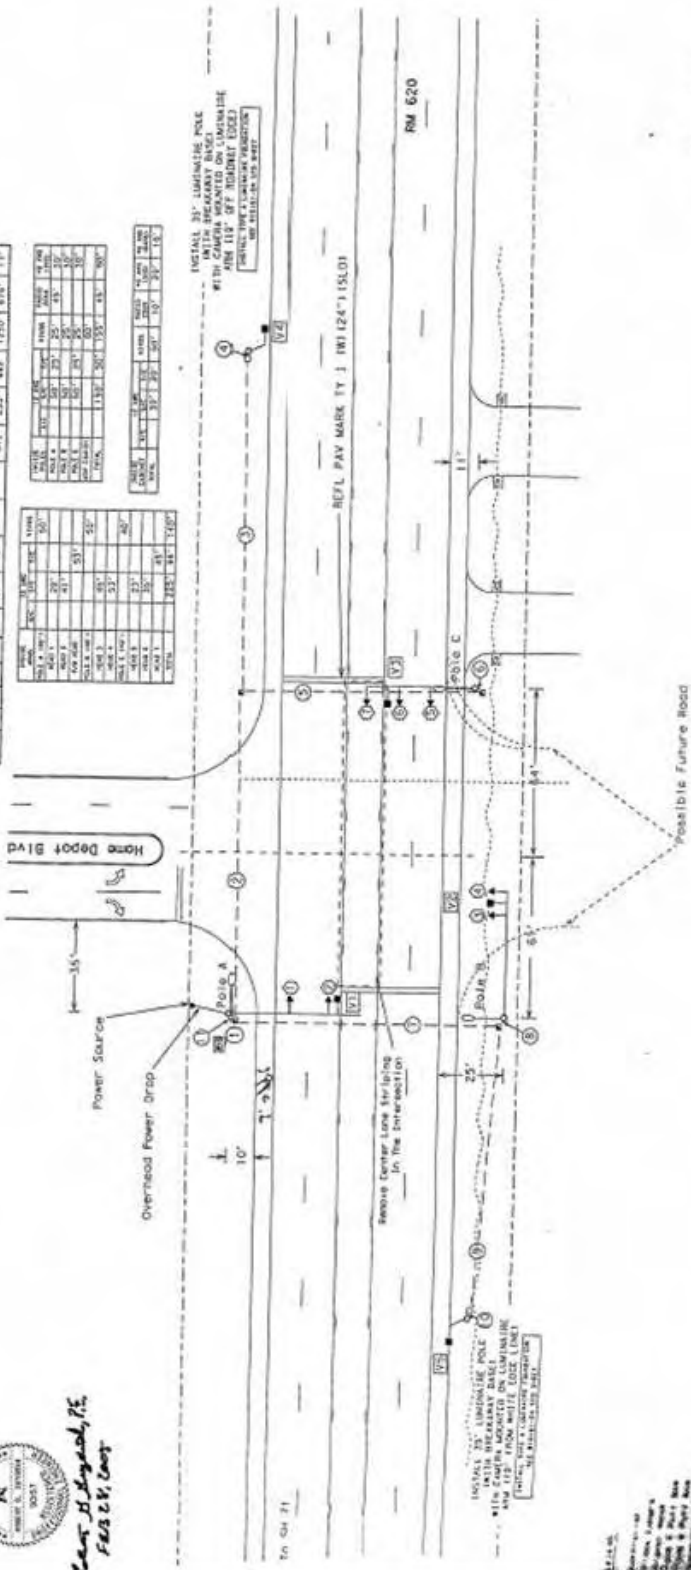
Signal Layout
 RM 620 of Home Depot Blvd.
 Travis County
 Scale 1" = 40'
