| 4. Title and Subtitle<br><br><b>Evaluation of Two Monitoring Systems for Significant Bridges in Texas</b> | | 5. Report Date<br>January 2004 | |
| 7. Author(s)<br>C. T. Bilich and S. L. Wood | | 8. Performing Organization Report No.<br>Research Report 0-4096-1 | |

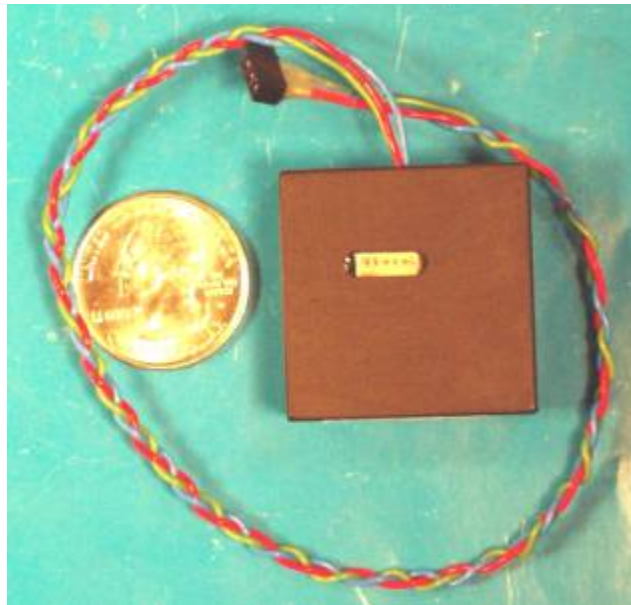
In 2000, researchers at the University of Texas at Austin began working with Invocon to build a series of similar devices that could be used to monitor bridges. A photograph of the first device is shown in Figure 2.2. The unit measured 1.2 in. x 1.2 in. x 0.6 in. The system could record data at 7.1 Hz and compute rainflow counts as the data were acquired. An internal battery with an expected life of 36 hours provided power. Once programmed for acquisition, the system was 100% autonomous.

**Figure 2.2: First Generation MicroSAFE Device**

Limited testing was done using this device. Available battery power and data acquisition speed were deemed to be the limiting factors for bridge applications. Also, this unit was not enclosed in a weatherproof container.

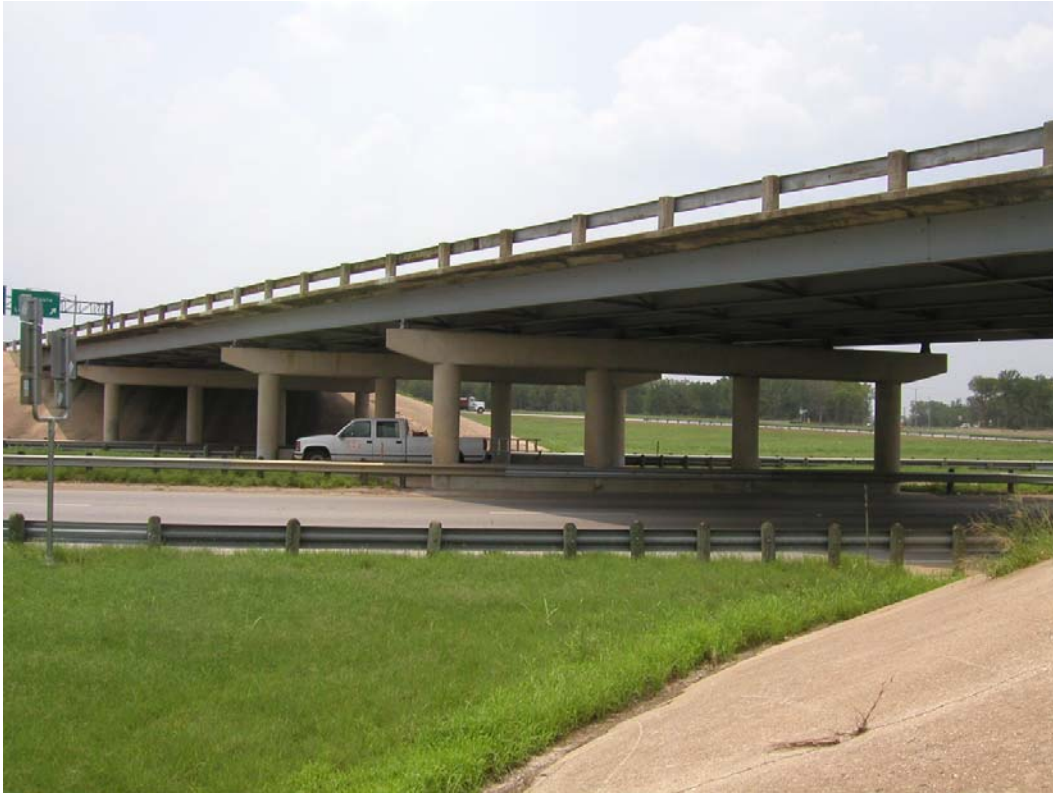
**Figure 2.5: Texas 71/US 183 Overpass**

Field-testing of the MicroSAFE units was performed near Austin, Texas, on the bridge that carries westbound Texas State Highway 71 over US Highway 183 (Figure 2.5). This structure was selected because the layout permitted access to the girders at midspan of the center span without obstructing traffic.

An interesting observation was made during field-testing on the TX 71/U.S. 183 overpass. When two MicroSAFE units were programmed to begin identical acquisitions at the same time, small timing discrepancies between the two units were observed. This discrepancy results from the manner in which time is kept on each MicroSAFE unit.

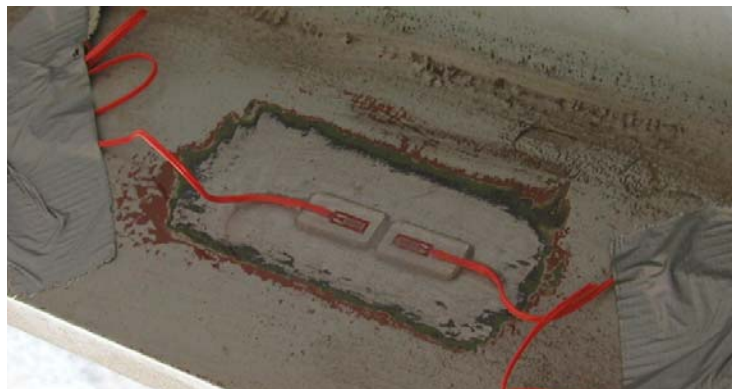
**Figure 2.6: Placement of Pairs of Strain Gages**

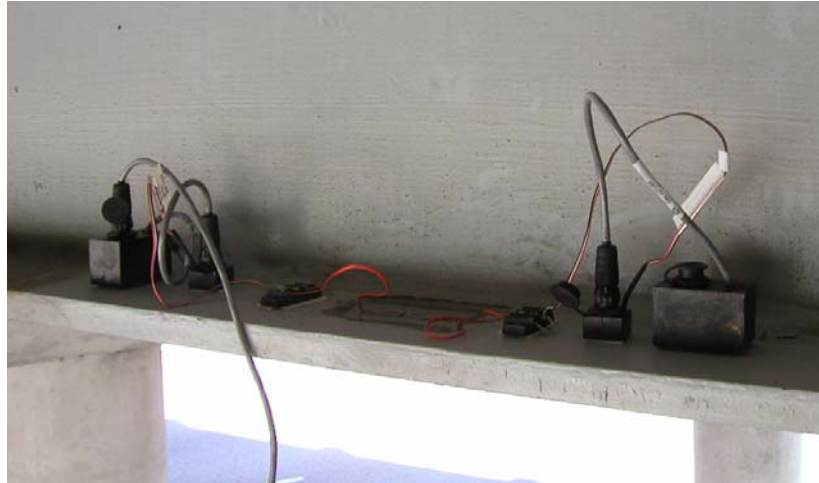
Figure 2.7 shows a pair of MicroSAFE units installed on the bridge. All gage pairs were installed with identical configurations. Because both gages in a given pair were positioned in almost identical locations on the structure, this configuration allowed a pair of MicroSAFE units to record identical strain data simultaneously in the field. Figures 2.9 through 2.12 contain plots of the measured data. These figures show nearly identical strain histories when corrected for minor initial strain and time differences between MicroSAFE units. These corrections are discussed later in this section.

**Figure 2.7: MicroSAFE Units Paired on Bridge**

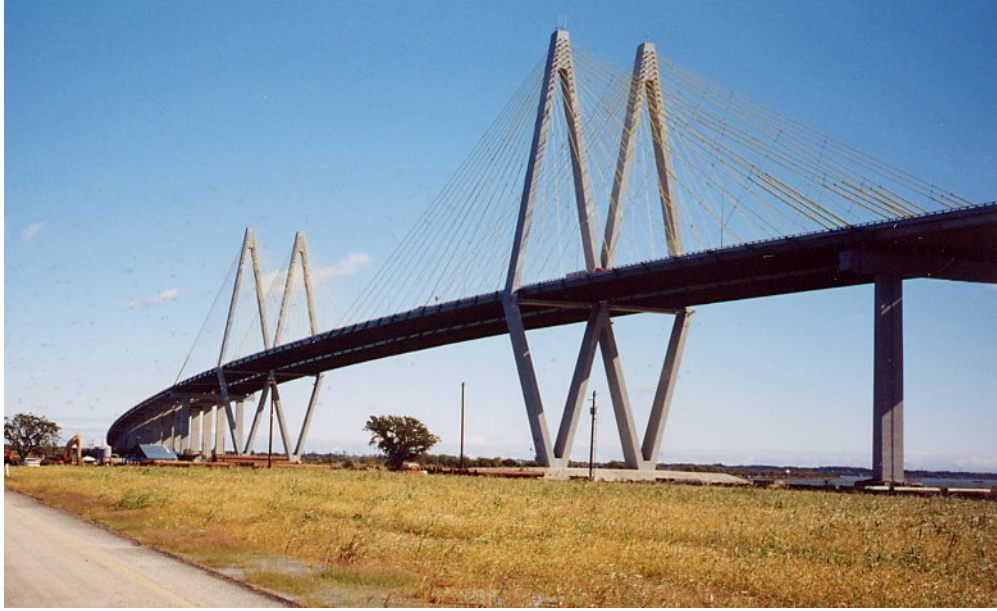
**Figure 2.12: Fred Hartman Bridge (TexasFreeway.com, 2003)**

To test the durability of the MicroSAFE system in a corrosive environment, a single MicroSAFE unit was installed at the center of the main span of the Fred Hartman Bridge. This bridge (Figure 2.12) spans the Houston Ship Channel between Baytown and LaPorte, Texas. The environment in this area is known for being highly corrosive and was, therefore, selected for this durability study.

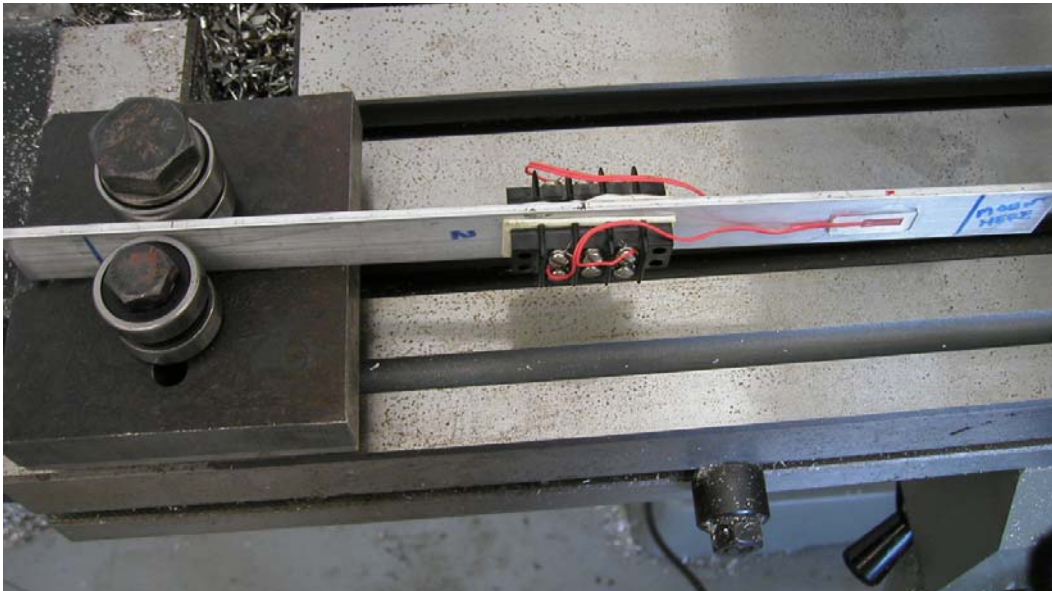
0.001” of the programmed displacement. The displacement scheme generated strains in the cantilevered bar, which were recorded by the MicroSAFE units.

**Figure 2.14: Test Beam on CNC Milling Machine**

Two strain gages were mounted on the bar, one on each side. Both gages were located 1” from the fixed end, where high strains were expected. Terminal blocks were attached to each strain gage to facilitate easy attachment of the MicroSAFE lead wires.

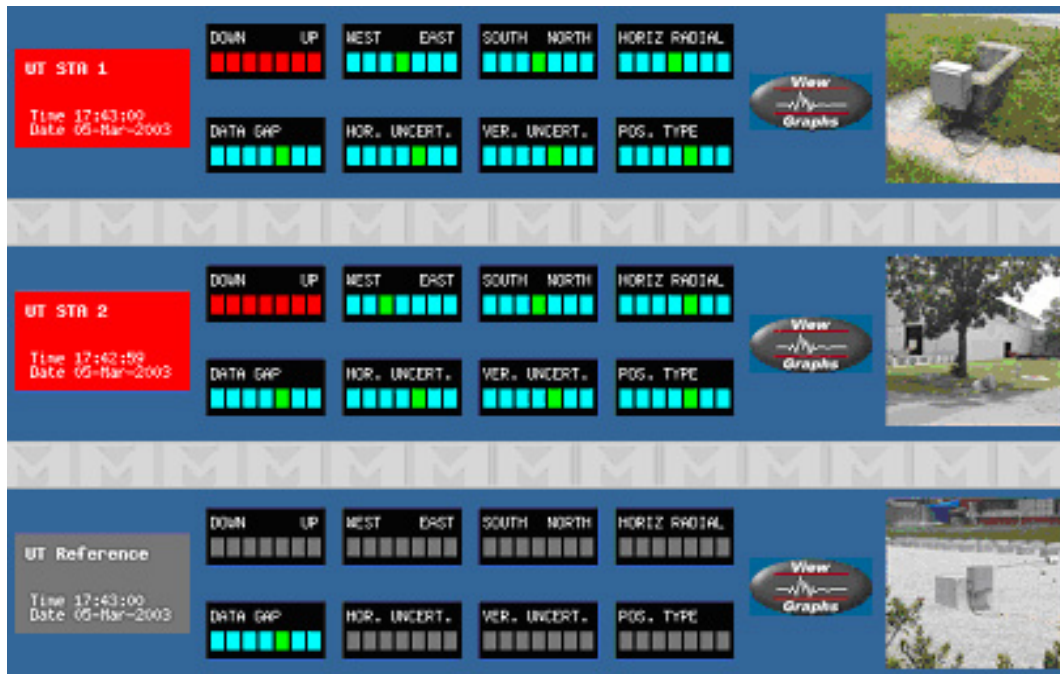
**Figure 3.2: MezureNet Home Screen**

When a customer logs on to their MezureNet website, they are presented with an overview of the positions of each NetForce station. Each station is presented with a customer-specified name ("North Tower 1" or "West Abutment," for example). A photograph of each station can also be incorporated for easy station identification and user friendliness, as shown in Figure 3.2.

Eight color-coded horizontal bar charts present the current state of certain parameters associated with each station, as seen in Figure 3.2. A consistent blue bar chart with a centered green square indicates that the value of that parameter is centered within its specified limits. If the green square moves off center, that parameter is approaching a limit value. When the entire bar chart is colored red, that parameter has exceeded its specified limits. An event that exceeds limits will trigger an alarm, which would in turn alert the user of a potential problem.

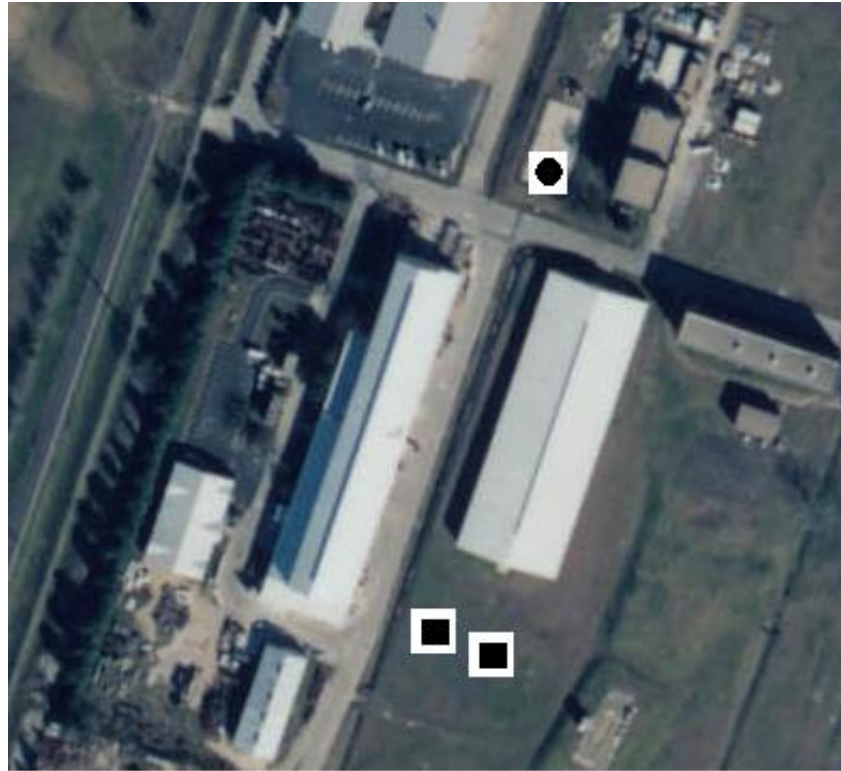
The rovers were placed as close to each other as possible to remove experimental differences caused by environmental variables such as atmospheric signal disturbances. Because of the high-power cellular signals being transmitted by each rover station, it was recommended by Mezure that the stations be separated by at least 100 ft. Therefore, the rovers were placed approximately 100 ft from each other, as shown in Figure 4.2. Each rover station was attached to a 20" x 20" x 28" concrete block. Each block weighed approximately 1000 lb.

**Figure 4.1: Testing Site Layout**

The elevations of all three stations are approximately the same. The large buildings shown in Figure 4.1 to the north and west of the rover stations are not more than 40 ft in height. Short structure heights combined with distance from the structures help to reduce multipath effects to acceptable limits. Multipath effects, depicted in Figure 4.4, are caused by satellite signals being reflected off the ground, surrounding structures, or anything else that does not absorb radio waves. When the signal is reflected, it travels farther than a direct satellite signal. This extra distance requires additional travel time, giving the illusion that the satellite is farther away than it actually is. Normally, shielding on the underside of the GPS antenna absorbs some of the ground reflection. Unfortunately, it is not possible to shield against all reflective paths. These signals must be minimized to obtain the best GPS signals. For these reasons, all stations have a clear view of the majority of the sky at all times. This is the most important key to any successful GPS station installation.

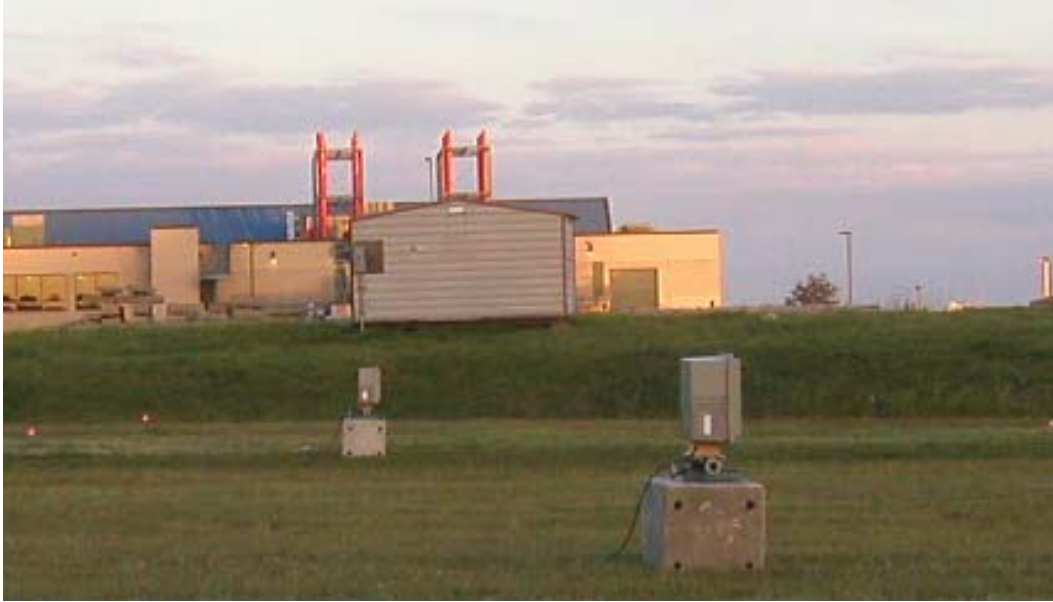
**Figure 4.2: Layout of Rover Stations**

To facilitate these requirements, large concrete blocks were selected as the foundations. Each block was leveled after positioning in the open field (Figure 4.2). A Palmgren two-axis milling table (Figure 4.7) was bolted to the top of each concrete block. Milling table dimensions and directional precision data are presented in Table 4.1.

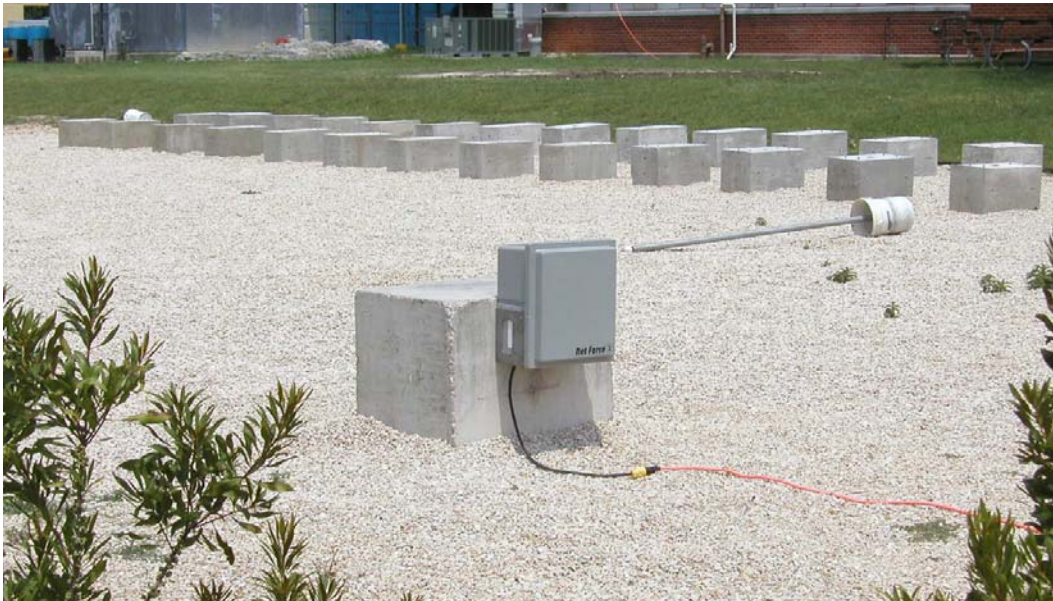
**Figure 4.3: Layout of Reference Station**

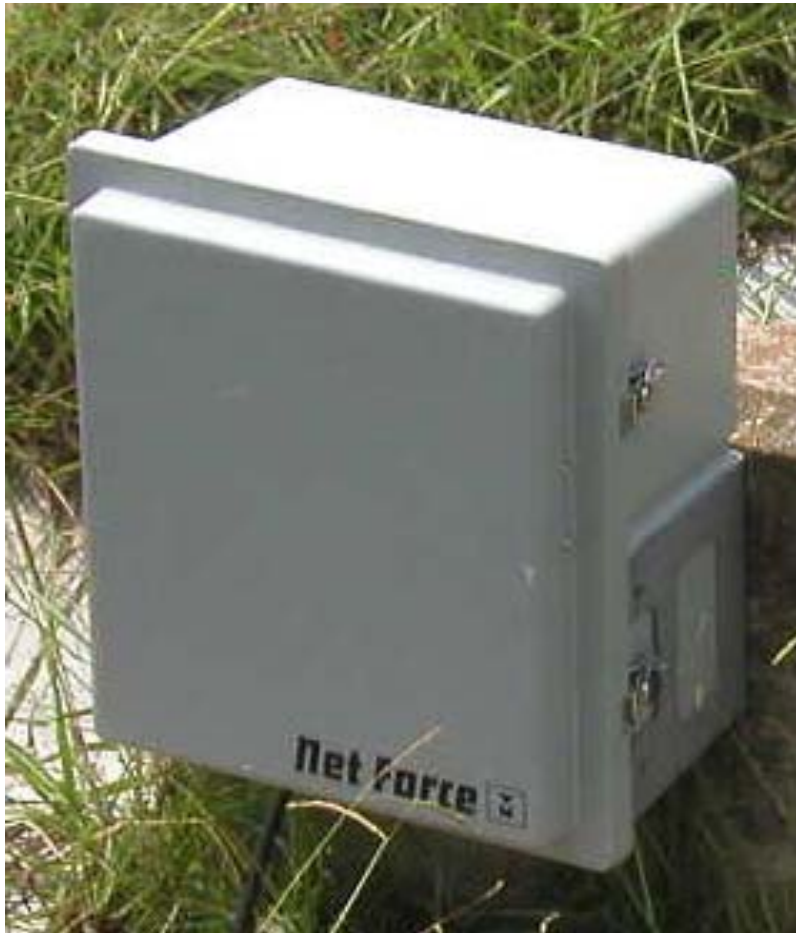
After the antenna receives the satellite signals, the GPS receiver sends them via serial cable to the cellular modem. The modem then transmits the signals to Mezure's Network Operations Center (NOC) via cellular signal and the Internet.

**Figure 4.5: GPS Hardware Package**

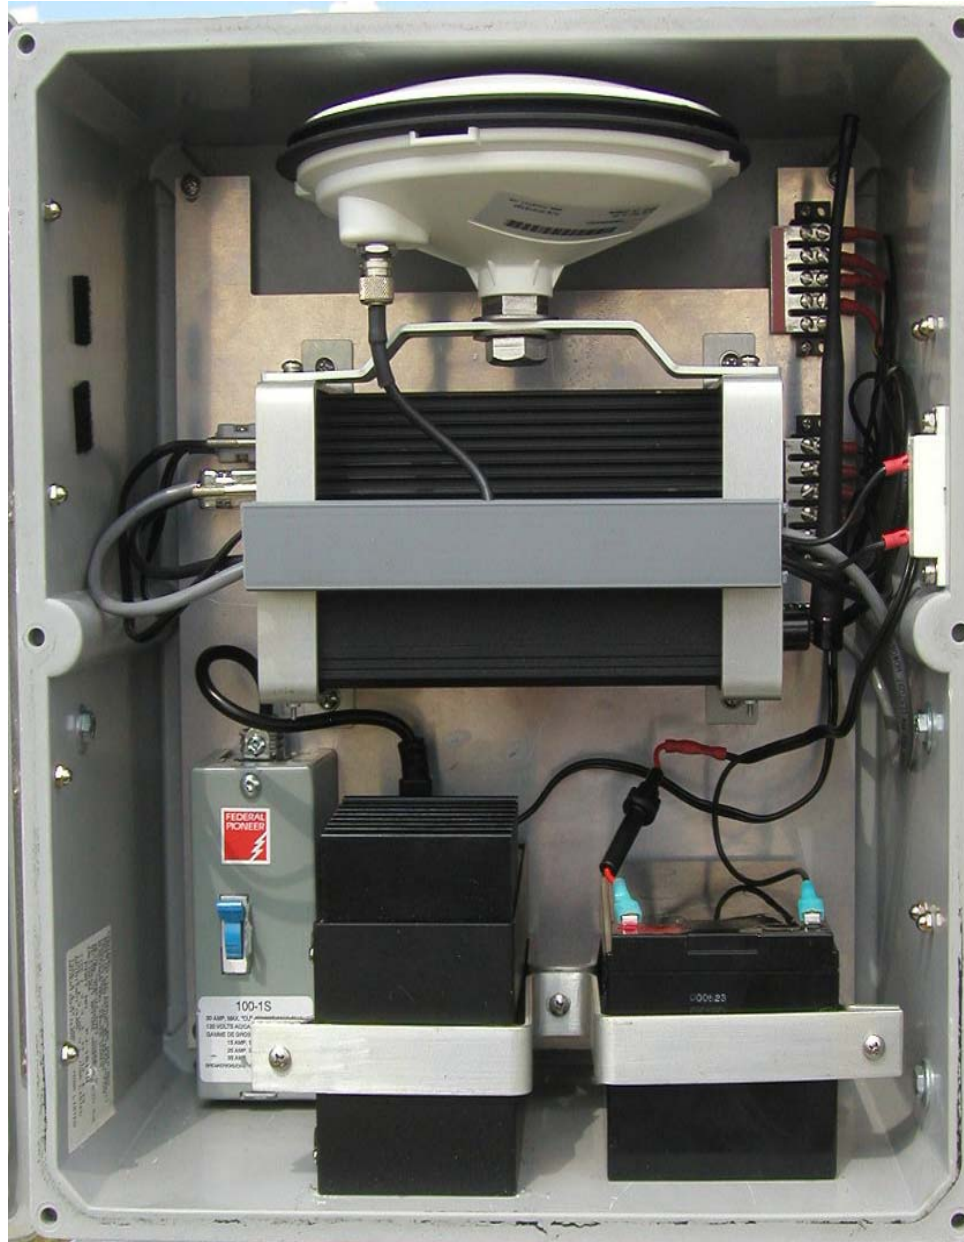
Mounting the GPS unit is facilitated through the use of the supplied mounting bracket. This bracket is a galvanized steel cradle, shown around the base of the fiberglass enclosure in Figure 4.5, which can be bolted to any object using appropriate anchors. Once the bracket is mounted to the structure, the GPS enclosure is seated in the cradle and bolted from within. When mounting is complete and 120 V AC power is supplied to the unit, the GPS hardware can be switched on and data collection can begin immediately.

**Figure 4.6: GPS Hardware Package (cover removed)**

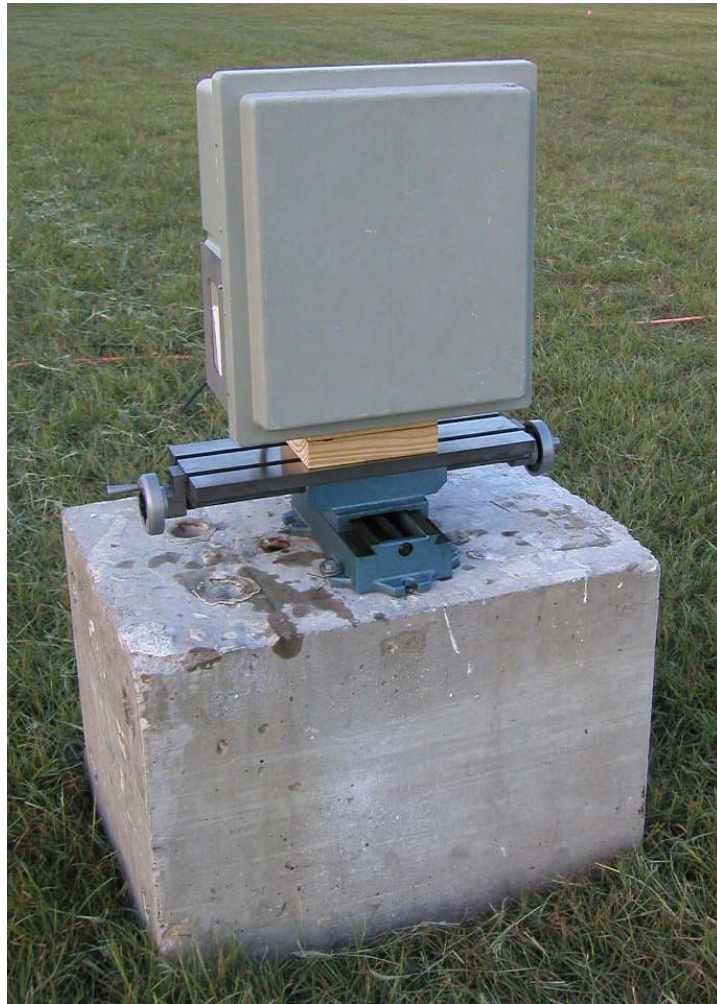
The GPS hardware package was attached to the milling table. The completed apparatus, (Figure 4.8), allows the precise movement of the GPS hardware enclosure in two directions within the horizontal plane.

**Figure 4.8: Horizontal Testing Apparatus**
