1. Report No. FHWA/TX-05/7-4975-1		2. Government Accession No.		3. Recipient's Catalog No.	
4. Title and Subtitle Development of an Automatic Pavement Surface Distress Inspection System				5. Report Date October 2003

DEVELOPMENT OF AN AUTOMATIC PAVEMENT SURFACE DISTRESS INSPECTION SYSTEM

CTR Research Report:	7-4975-1
Report Date:	October 2003
Research Project:	7-4975
Research Project Title:	<i>Implementation of an Automated Pavement Surface Rating System for Asphaltic Pavements</i>
Sponsoring Agency:	Texas Department of Transportation
Performing Agency:	Center for Transportation Research at The University of Texas at Austin

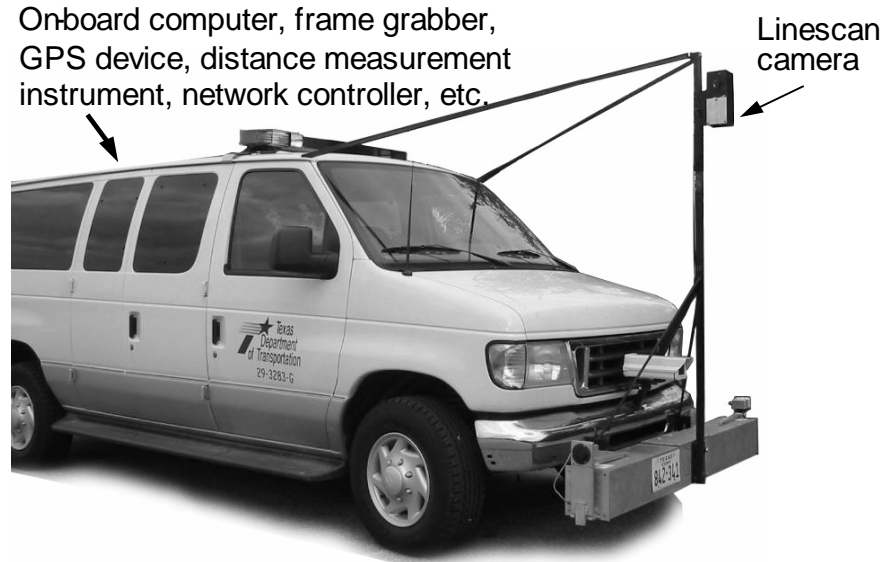
Figure 1 shows a TxDOT pavement inspection vehicle equipped with the VCrack system, which consists of a linescan CCD camera, a PCI frame grabber, and a PC computer. The linescan camera, mounted in a waterproof enclosure, is a Dalsa Piranha2 camera that has a linear array of 2048 pixels. When the camera covers 3.65 m in width, it has a ground resolution of 1.786 mm/pixel. The camera captures a line image at a time and sends individual lines to the frame grabber through a high speed Camlink interface. Once 512 lines, covering 914.4 mm (3 ft) in distance, are accumulated on the board, an image of 2048 x 512 pixels is transferred to the main memory of the computer. The cumulative lines per image can be set to a different number. The line scan rate of the camera can be dynamically adjusted either by the frame grabber or by the computer through Camlink's communication port. The rate must be synchronized with the vehicle speed to ensure that each line covers exactly the same distance on the pavement. The exposure time of the CCD array is also controlled for each scan through the communication port. The brightness of the current image can be used to calculate a reasonable exposure time for the next scan to avoid an over or under exposed image. It takes about 5 ms to transfer this 8-bit grayscale image from the frame grabber to the system memory, leaving only less than 25 ms for image processing when the vehicle travels at the speed of 112 km/h. The VCrack can communicate to the other inspection modules on the vehicle through a local network. It supports multiple data clients during run time. It also accepts external GPS and time data from other modules for the system synchronization.

Figure 1. TxDOT Pavement Inspection Vehicle

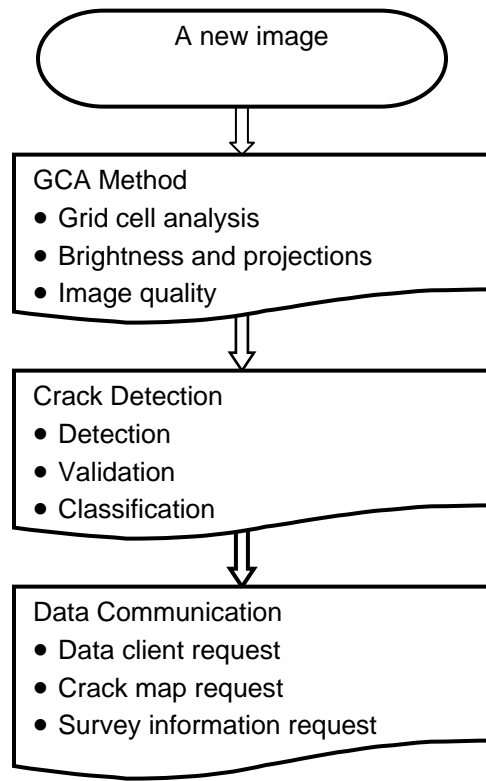
Figure 2 shows the flowchart of the crack detection algorithm. A special designed grid cell analysis (GCA) method is applied to the original image to extract features in each cell. A cell represents an 8×8 pixel sub-image. It takes about 5 ms for a 3.0 GHz Pentium VI processor to perform this GCA. After this GCA, all further analysis will take place at the cell level for fast crack detection. The GCA will be discussed in detail later.

Figure 2. Flow chart

The average pixel grayscale values of cells and their vertical and horizontal projections are used to calculate the overall brightness of the image. According to the nature of the linescan image acquisition, when the survey vehicle stands still or makes a sharp turn, its grabbed image shows vertical strips or blurs in some areas. These images should be excluded from further processing. The vertical cell value projection and its contrast between each neighbor cell can be used to detect this defect. If an image is affected by a shadow of the vehicle body or camera mounting post under nature lighting, the distribution of its vertical cell value projection will show a clear pattern reflecting the affected area.

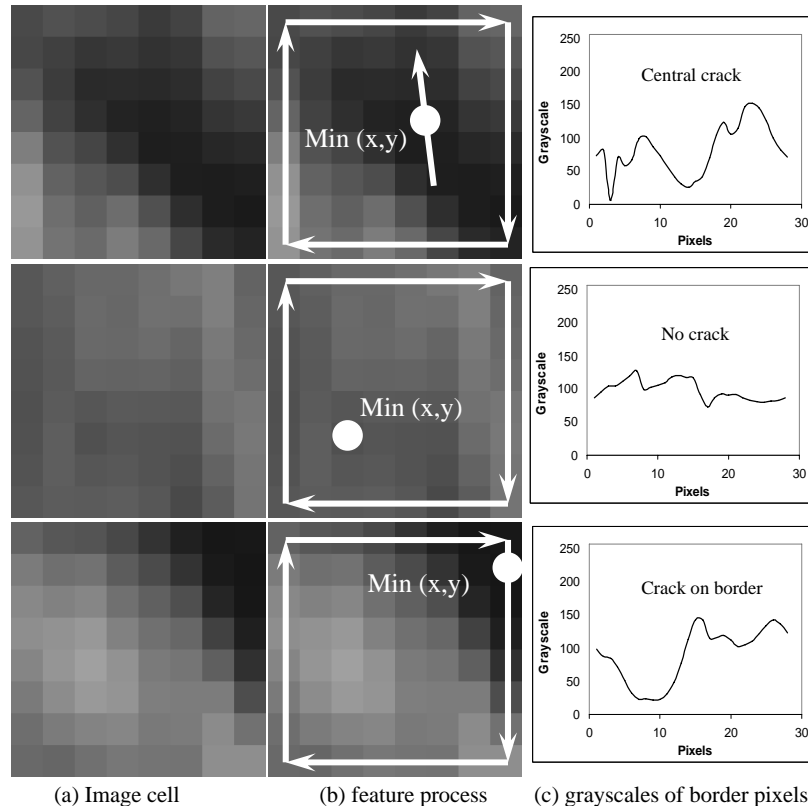
Figure 3 (a) shows three different grid cells. The top one contains crack pixels (dark), the middle one does not have crack pixels and the bottom one has crack pixels on its border. The average grayscale of the border pixels, indicated by arrows in Figure 3 (b), can be used as an overall brightness of the cell. Figure 3 (c) shows the brightness profiles of the border pixels of the three cells. In the top profile, the brightness shows two sharp valleys, indicating the crossing points of a crack on the border. The center of these two valley pixels can be selected as crack seed, and its grayscale can be replaced by one of its immediate neighbors that has the minimum grayscale value. This minimum grayscale and the coordinates of the center of the original image are recorded for later crack verification. This information is useful for checking the orientation, length, width and contrast of the crack. When a cell does not contain a crack, its border profile (middle) shows no apparent valley. This cell will be marked with a non-crack flag at the pixel that has the minimum grayscale in the cell. If the border grayscale profile shows only one significant valley (bottom), the cell may have an edge crack. The darkest pixel on the border is

selected as a crack seed. Whether this cell is part of a crack depends on the characteristics of its neighbor cells.

Figure 3. Cell characteristics in a pavement image

A primary clue for detecting cracks in a pavement image is that a crack is a thin strip of pixels whose intensities are appreciably darker than the surrounding background. In order to save time in crack tracing and classification, we attempt to divide an image into grid cells of 8 x 8 pixels and to extract cracking information of small cells rather than the entire image. The cracking information from each cell, the length, width, and contrast of a dark object, includes its mean brightness and minimum brightness and the presence of a dark strip within the cell. A cell is then categorized as either a non-crack cell or a crack seed by comparing its features to the preset thresholds. Only crack cells will be used as potential seed that may form cracks in further processing.

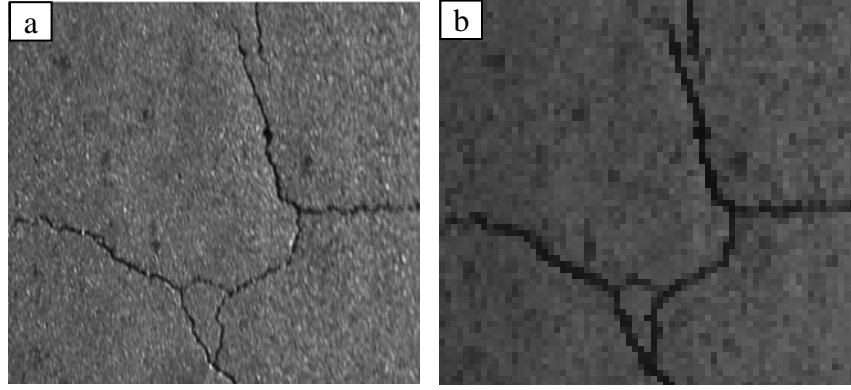
The cell map of a pavement image can be created by setting the grayscales of the 8 x 8 pixels of each grid cell to the selected minimum value (Figure 4). Furthermore, each cell can be reduced to one pixel to form a scaled down image in which potential crack seeds are marked. The scaled down image of crack seeds is the one to be used for further verifications of cracks.

Figure 4. Pavement image and cell map, original image (a) and cell map (b)

The white dots in Figure 6 (a) present all verified seeds of the image in Figure 4 (a). Compared to the original image, the volume of data has been dramatically reduced. The next step is to connect individual seeds into seed clusters. Starting from one seed, a crack cluster grows by accepting adjacent seeds one at a time until no close seed can be taken. The size of crack clusters varies in the image. The information, such as the weight or the number of seeds in the cluster, the GCA parameters of each seed, the direction, and the starting and ending seeds, should be stored for each cluster. Figure 6 (b) shows the crack clusters of Figure 6 (a).

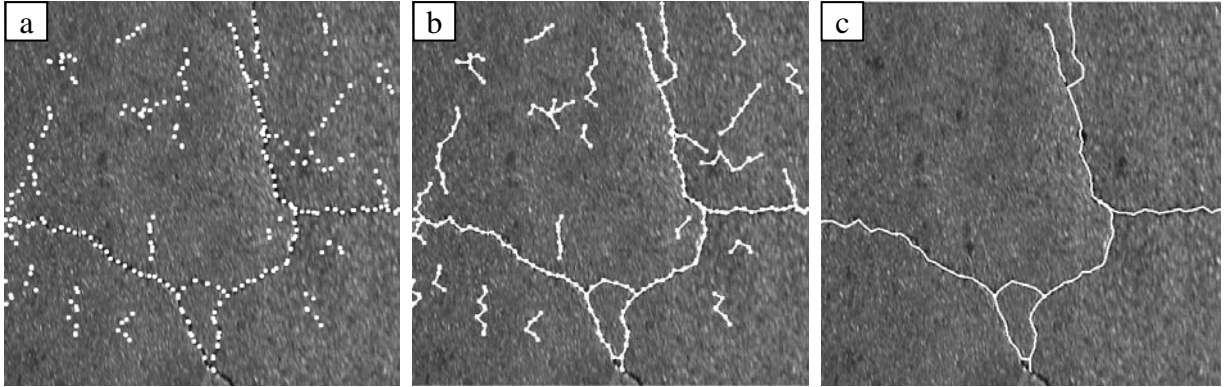
Figure 6. Tracing cracks from the seeds, verified seeds (a), seed clusters (b) and traced cracks (c)

A crack cluster can be used to draw a path in the corresponding pavement image. A valid crack cluster must have a clear, dark, and narrow strip along the path. To verify whether a crack cluster corresponds to a real crack, we need to examine three features of the crack path in the original image. First, the contrast of the pixels on the path to the neighbor pixels on both sides should not exceed a threshold to avoid light marks of skid or paint. Second, the width and the width variation of the strip should not go beyond the given limits to omit shadows, pavement joints, and other non-crack objects. Finally, the path must have a certain length to be separated from short segments that may be simply caused by pavement noise or unwanted features. After crack clusters are verified and short clusters are deleted, the clusters that are in the vicinity and have similar orientations can be traced to become a long crack (Figure 6 (c)). The direction of a traced crack is calculated based on its starting and ending coordinates, and therefore the crack can be classified as longitudinal or transverse.

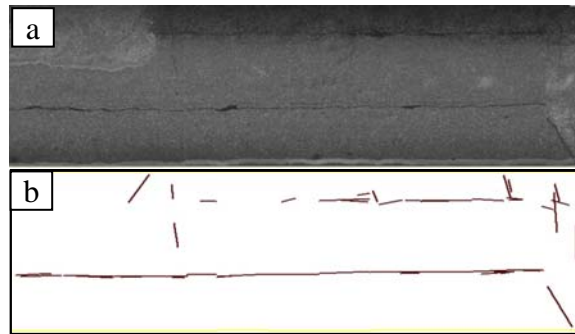
To facilitate the validation tests, the VCrack system also provides the functions for capturing and saving pavement images over a long distance and the functions for visual feedback (crack maps) of the detection results. It continuously records the full size images of 1 km (0.62 mile) pavement or the compressed images of 16 km (10 miles) pavement. The VCrack measurements are compared with those obtained from the on-screen visual examinations of the same images. Figure 7 shows a 10-meter pavement section with its crack map output from the VCrack. The cracks in the crack maps are the simplified drawings of verified crack clusters, which do not intend to reflect the fine details of cracks rather than their locations and orientations. Continuous crack maps are stored along with interval crack, providing both summary data and distributed data for scanned pavements.

Figure 7. A 10-meter pavement image (a) and its crack map (b)

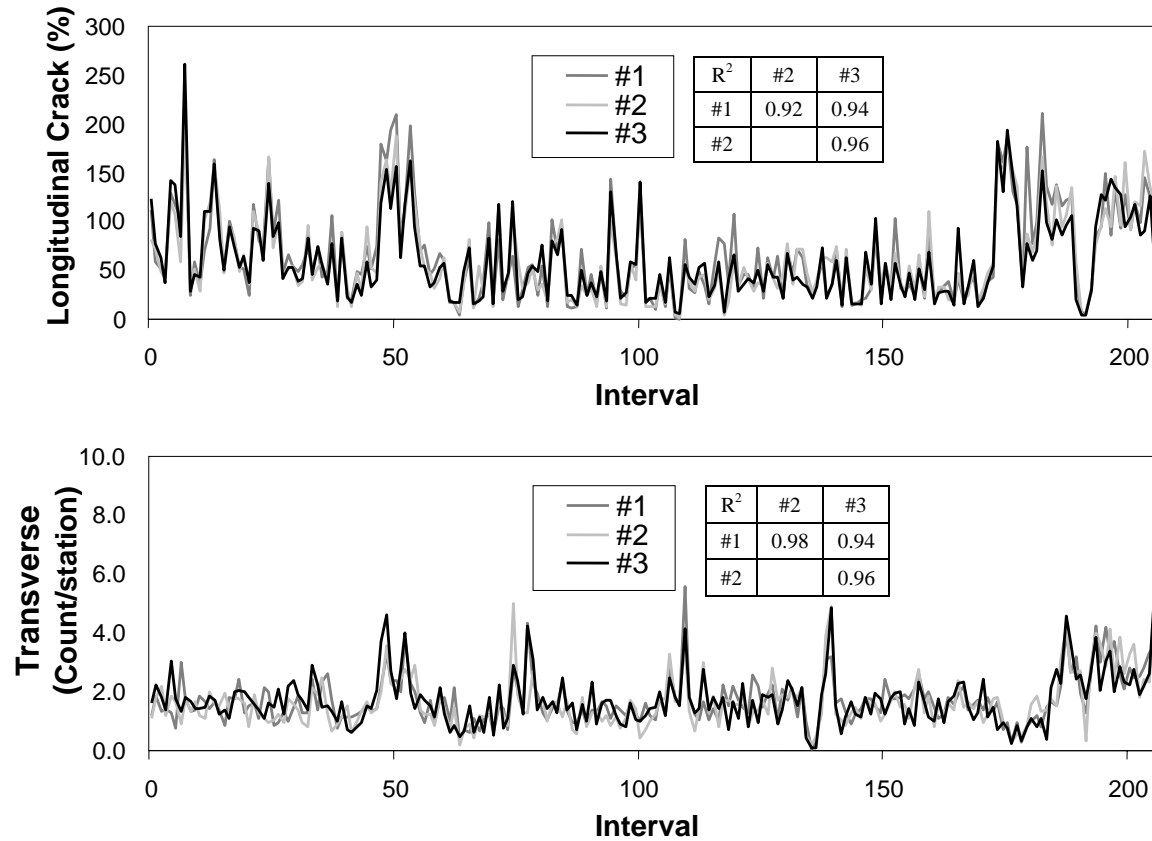
The repeatability test of the VCrack was performed by scanning the same pavement (asphalt) section multiple times. The survey data were recorded at an interval of 30.5 m (100 ft). The correlations of the cracking data of any two scans were used to examine the consistency or repeatability of multiple tests. Figure 8 shows the cracking data of the three scans (#1, #2, and #3) on a 3.2 km (2 mile) pavement at a constant speed of 88 km/h (55 mph). The correlations of both longitudinal and transverse cracking data between two scans are all above 0.9. Similar results were achieved on many other pavements. Since it is difficult to maintain the driving path of the vehicle to be the same in different runs, it is logical to see the difference in the outputs as shown in Figure 8. Other factors that may contribute to the variations of multiple scans are the difference in the lighting condition and the vehicle speed.

Figure 8. Repeatability test with multiple scans

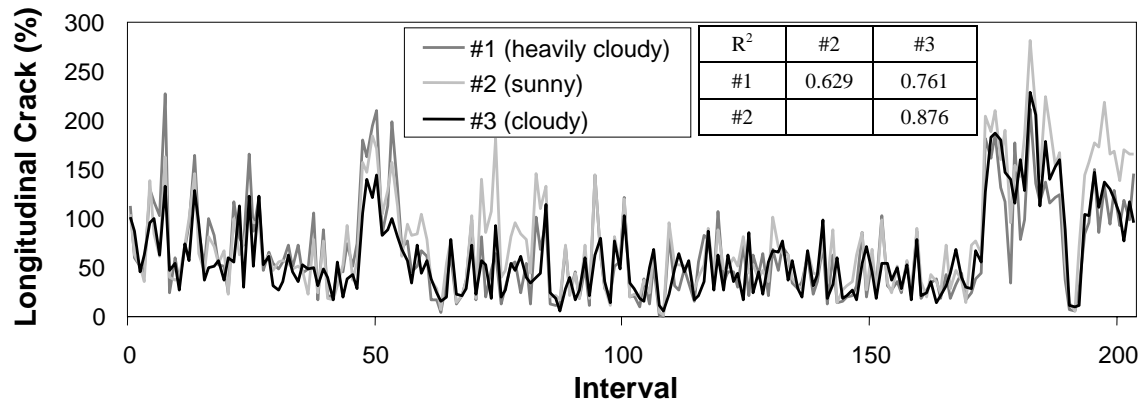
The weather condition can affect the image quality and the output data since the VCrack just uses the natural lighting for image capturing at the reporting time. Figure 9 shows the longitudinal cracking of an asphalt pavement measured on three days which had different weather conditions (sunny, cloudy and heavily cloudy). The correlation analysis of these scans suggested that the VCrack can provide fairly consistent measurements under different lighting conditions, but the consistency drops significantly. The cloudy day had sufficient natural lighting for image capturing, but did not cause any shadow in the images. Therefore, it provided an ideal lighting condition for the VCrack. On the heavily cloudy day, the image became dark and the contrast was low. Detecting shallow cracks became more problematic. On the sunny day, the sunlight might be partially obstructed by the vehicle, causing errors for the cracks under the shadow. It is asserted that a device that is able to provide a constant lighting condition is essential for an automated pavement cracking inspection system to ensure the reliable and consistent performance. A linear lighting device is being developed for the VCrack system. Besides the lighting variations in those days, the difference in driving path and speed may be another main factor contributing to the lower correlations.

Figure 9. Repeatability test under different weather conditions

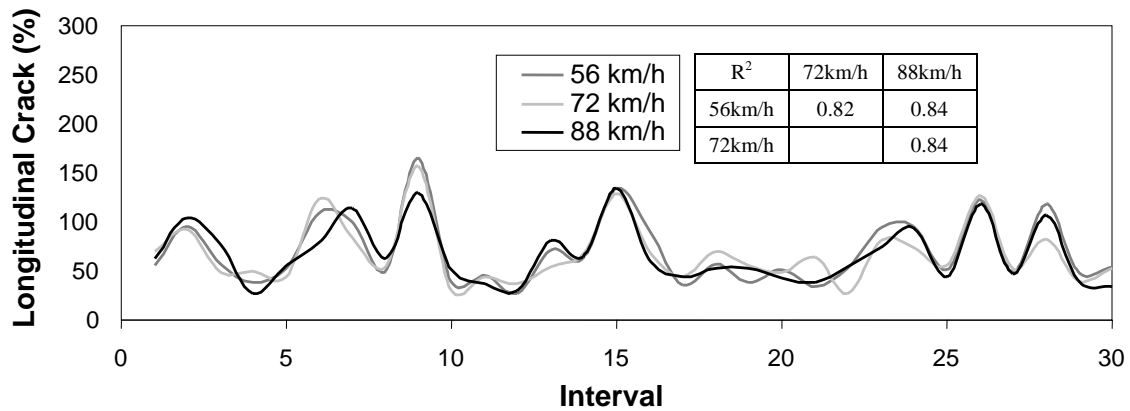
The scanning rate of the linescan camera varies with the speed of the vehicle to keep the image resolution in the longitudinal direction constant. The vehicle may generate different levels of vibrations when it travels at different speeds. Therefore, the vehicle speed may affect output results. Figure 10 displays the longitudinal cracking data collected at three different speeds on a shorter distance pavement (asphalt) where public traffic was limited. The data show that the VCrack can provide consistent results when the vehicle travels at a speed varying from 56 to 88 km/h. However, it is observed that at 88 km/h the system seemed less sensitive to small cracks.

Figure 10. Repeatability test with different vehicle speed

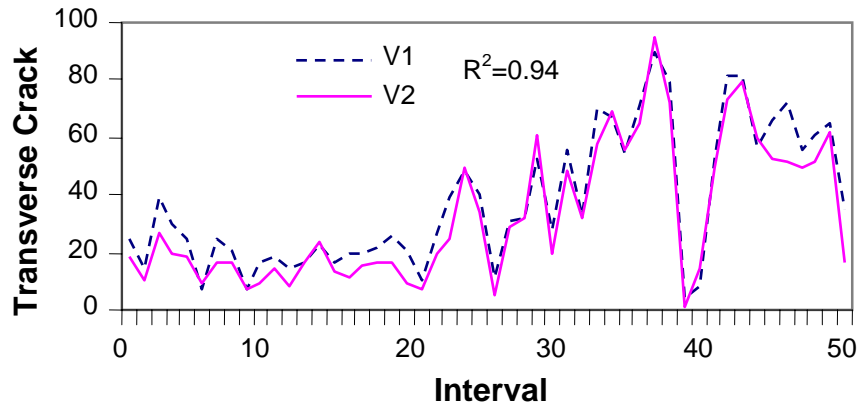
The reproducibility of the VCrack was also tested by comparing the data generated by multiple units installed on different vehicles (V1 and V2). This test was performed on a concrete pavement, and the two vehicles output highly consistent counts for transverse cracks (Figure 11). Table I provides further information about the correlations of the multiple scans (#1, #2, and #3) of the two vehicles on the same pavement. Both vehicles have a similar level of correlations for their multiple scans.

Figure 11. Reproducibility of multiple units

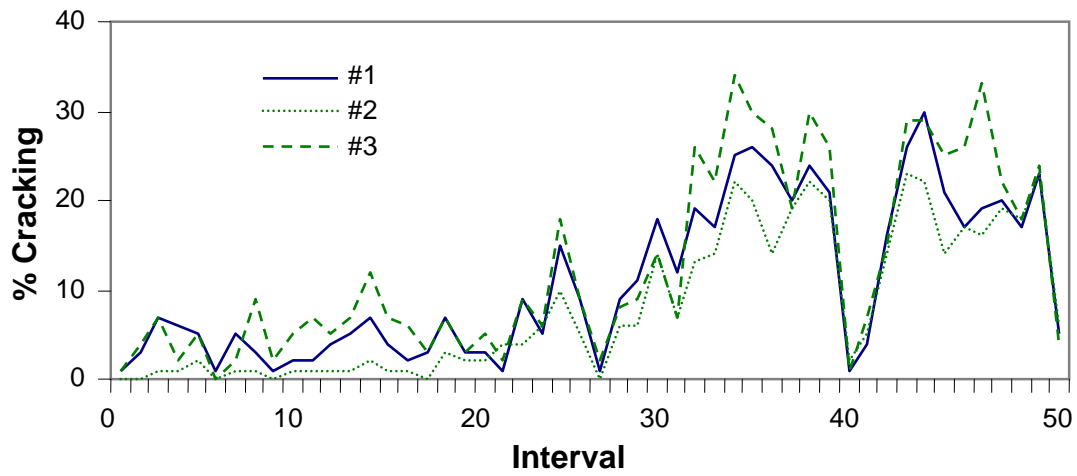
The same concrete pavement was tested in the AASHTO protocol in which a pavement is longitudinally divided into four paths, left wheel path (LWP), right wheel path (RWP), between wheel path (BWP) and outside wheel path (OWP), and the linear density of cracks in each path is calculated. The high repeatability of the VCrack is also evident by the AASHTO data presented in Figure 12 and Table II. The cracking data in Figure 12 are the percentiles of the cracks in each interval within the left wheel path. Three different scans on LWP show the consistent trend. The correlations of the AASHTO data in all the paths are presented in Table II.

Figure 12. Repeatability test of AASHTO data in LWP
