Effects of Bicycle Boxes on Bicyclist and Motorist Behavior at Intersections

The City of Austin Bicycle Team
Jeff Loskorn, Alison Mills, John Brady, Jen Duthie, Randy Machemehl
Center for Transportation Research
The University of Texas at Austin
Phone: (512) 471-4541, Fax: (512) 475-8744
Email: jloskorn@gmail.com

The City of Austin
Bicycle and Pedestrian Program
Department of Public Works

Draft Submitted June 20, 2010

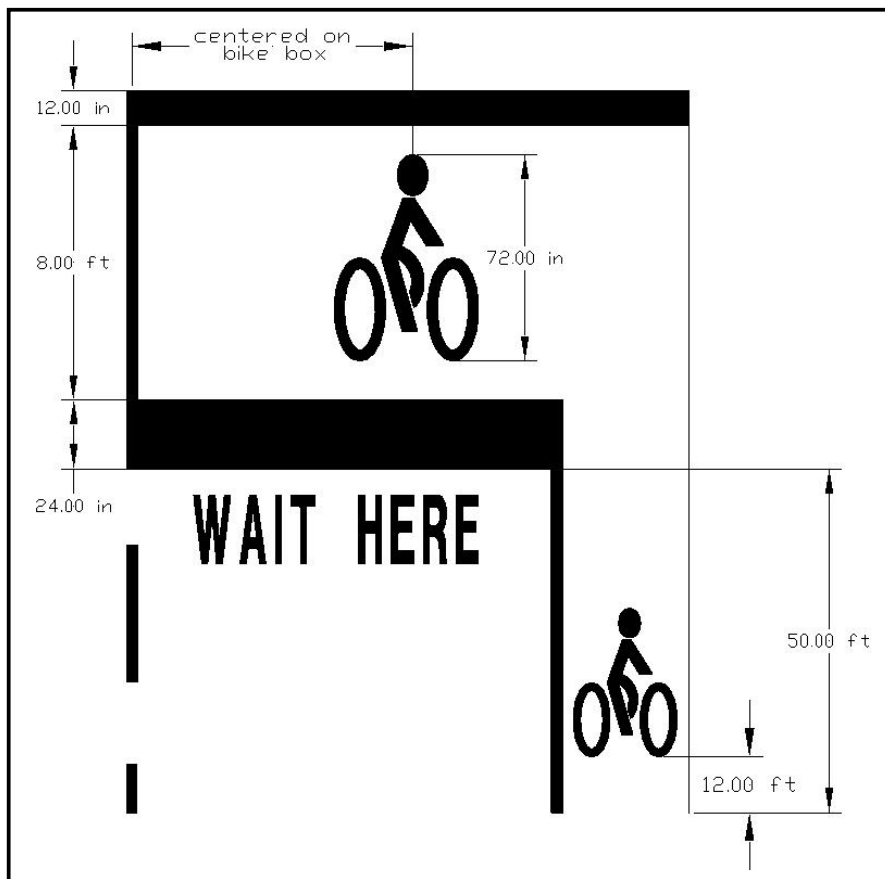
The dimensions of the bicycle box are shown in Figure 1. The bicycle box consists of a 24-inch advanced stop bar and an eight foot deep box (based on bicycle box measurements in Eugene, Oregon) containing a bicycle symbol. Before bicycle box installation, both intersections studied in Austin had the motorist stop line set back 4.5 feet from the crosswalk (measurement taken between the painted lines). After bicycle box installation, this distance increased to between 8 and 8.5 feet. "Wait Here" is painted on the roadway to instruct motorists to wait at the stop bar. The cost of the "Wait Here" symbol is \$267.66. Cold thermoplastic material was purchased at \$4.46 per square foot and was used for the box and approaching bicycle lane. As recommended by NCUTCD, a chartreuse (or strong yellow green) color was used. The material is embedded with corundum for traction. In addition, bicycle symbols were installed at the beginning of the green thermoplastic and in the middle of the bicycle box. Each symbol costs \$98.21. Given these numbers, an eight foot deep bicycle box in a ten foot wide lane costs \$1596.92 in materials.

Figure 1. Dimensions of bicycle box

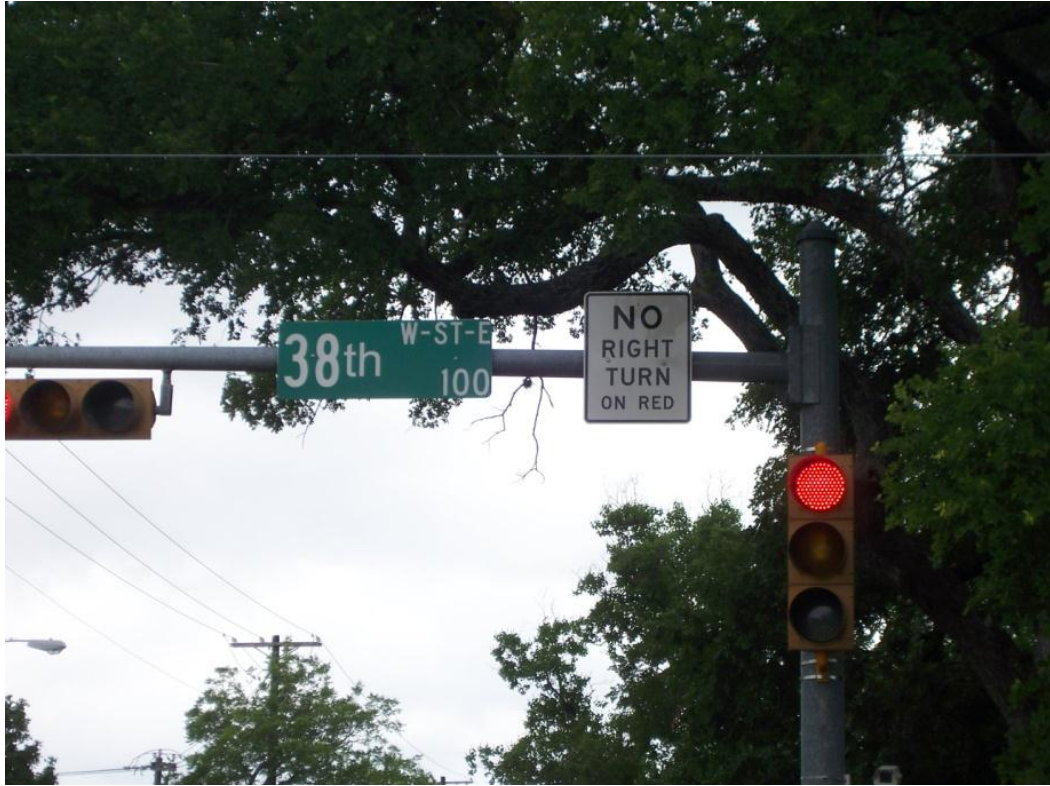
Additionally, "No Right Turn on Red" signs were installed when the color was added to the bicycle boxes in attempts to prevent motorists from encroaching on the bicycle box and to further prevent right-hooks, where a right turning motorist sideswipes a bicyclist traveling straight through the intersection. The "No Right Turn on Red" sign installed at 38th Street and Speedway is shown in Figure 2.

Figure 2. The "No Right Turn On Red" sign installed at 38th Street

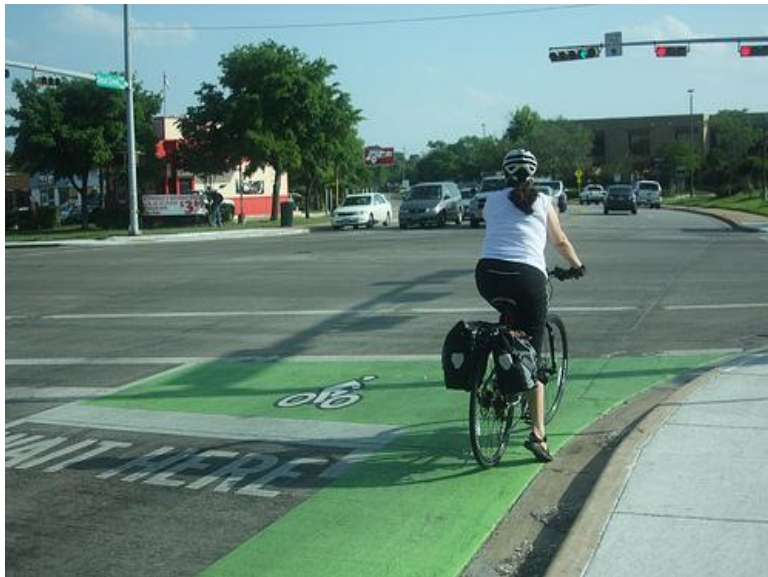
A bicycle box was installed on Shoal Creek Boulevard heading south to alert motorists of the presence of bicycles at the intersection and give bicyclists the right-of-way as they transition from the bicycle lane to the stretch of roadway where the bicycle lane ends briefly. Figure 3 shows the colored bicycle box and a map of the intersection and the location of the bicycle box is shown in Figure 4.

Figure 3. The bicycle box on Shoal Creek Boulevard at Anderson Lane

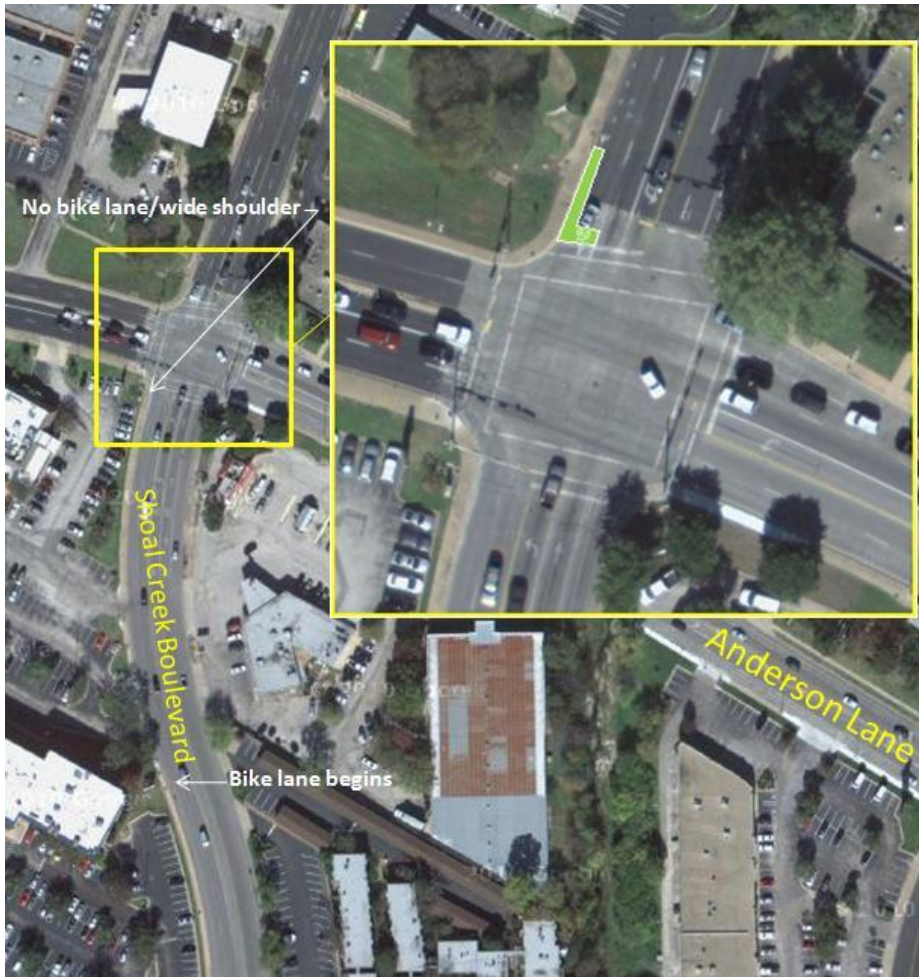
Figure 4. The intersection of Anderson Lane and Shoal Creek Boulevard

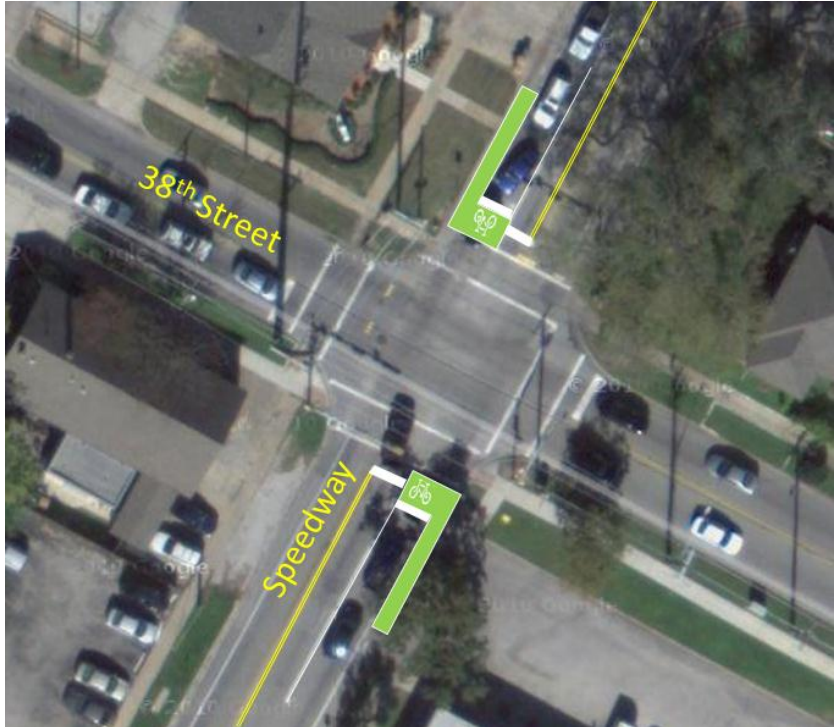
Speedway is primarily a one lane street that runs north-south through The University of Texas and connects the Hyde Park area with campus. Bicycle lanes in both directions make this facility attractive to many students living north of campus. Bicycle boxes were installed on both sides of Speedway at 38th Street to alert motorists to the presence of bicycles at the intersection and give them the right-of-way. The researchers hypothesized that bicyclists would be less likely to use the bicycle box at this location because the bicycle lane continues on the opposite side of the intersection. Data was collected on northbound Speedway during afternoon hours as students departed the university. A map of the intersection and the location of the bicycle boxes is shown in Figure 5. The posted speed limit is 25 mph and the observed hourly traffic volumes ranged from 150 vph to 250 vph in the afternoon.

Figure 5. The intersection of Speedway and 38th Street

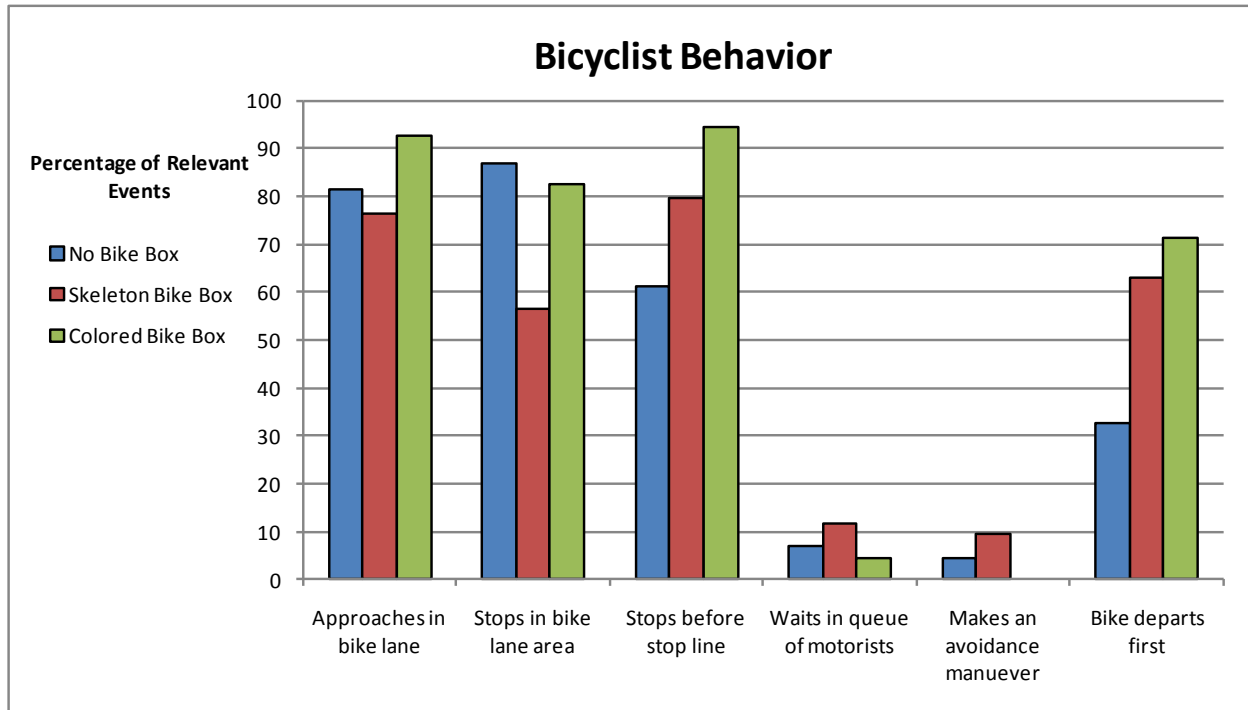
Figure 6 shows the changes in bicyclist behavior before the bicycle box existed, after the skeleton bicycle box was installed, and after the chartreuse color was added. The percentage of bicyclists who approached the intersection in the bicycle lane remained about the same after the bicycle box skeleton was installed. However, after the color was added to the bicycle box the percentage of bicyclists who approached the intersection using the bicycle lane significantly increased from 77% to 93% ($p = 0.005$). This may suggest that the colored lane leading to the bicycle box encourages bicyclists to approach in the bicycle lane rather than the full lane.

The proportion of bicyclists that stopped before the stop line increased significantly after each phase of bicycle box installation as shown in Figure 6. This suggests that the bicycle box skeleton and added color were successful in encouraging bicyclists to stay behind the stop line within the bike box area. The percentage of bicyclists that departed first at the intersection also steadily increased after each phase of installation. This increase proved to be more significant from the before condition to the skeleton bicycle box condition than from the skeleton bicycle box condition to the implementation of color ($p < 0.001$ versus $p = 0.267$). This could indicate that the presence of the bicycle box causes motorists to be more aware of the presence of the bicyclist. However, the higher percentage of bicyclists departing first may simply be attributed to the fact that the motorist stop bar is advanced four feet further from the intersection when the bicycle box is in place than under the original conditions. So even though bicyclists are stopping further back from the intersection (because they are encroaching on the crosswalk less frequently), right-turning and through-movement motorists are stopping even further back (behind the advanced stop line) and are often allowing the bicyclists to pull into the intersection first.

Figure 6. Bicyclist behavior at Anderson Lane and Shoal Creek Boulevard

The percentage of bicyclists that waited in the queue did not change significantly across the three bicycle box phases ($p = 0.286$ and $p = 0.103$ for the two phase changes). Researchers discovered that bicyclists waited in the queue more often when it is dark so only daytime events were considered for the "Waits in the queue of motorists" variable. Incidences where a bicyclist made an avoidance maneuver increased after the bicycle box skeleton was installed ($p = 0.132$). However, no instances of avoidance occurred after the color was added indicating that

color may make bicyclists more comfortable with stopping at the intersection rather than on a sidewalk. While only data observed during daylight hours was incorporated into the analysis, it is interesting to note that bicyclists riding at night were observed to stop in the motor vehicle lane significantly more frequently perhaps to increase their visibility to oncoming motorists.

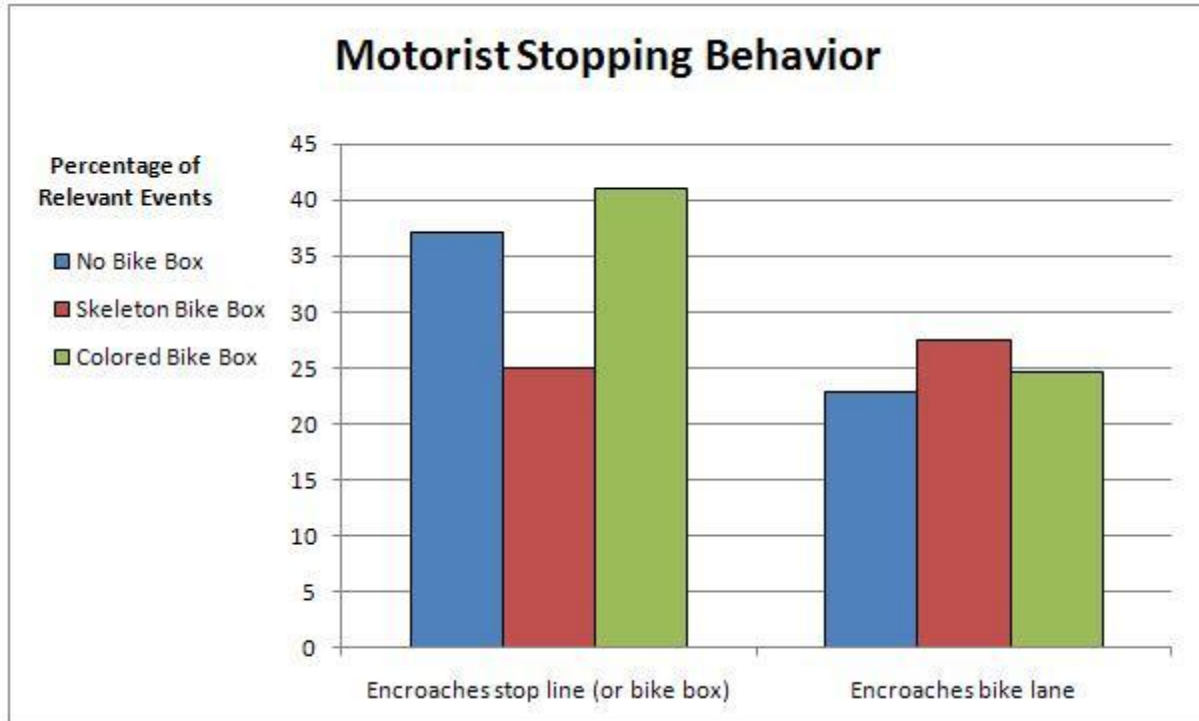
Motorist stopping behavior is shown in Figure 7. The percentage of motorists that encroached on the stop line significantly decreased after the bicycle box skeleton was installed ($p = 0.099$). After the color was added the percentage of motorists encroaching on the stop line increased compared to the Phase 1 condition. One hypothesis for why this occurred is that motorists were inclined to initially comply with the new site design, but as it became clear that the percent of time when a bicyclist was in the box was low, they began to ignore the advanced stop line. Incidences of encroachment on the bicycle lane remained mostly constant over the different phases of implementation.

Figure 7. Motorist stopping position when a bicyclist is present at Anderson Lane and Shoal Creek Boulevard

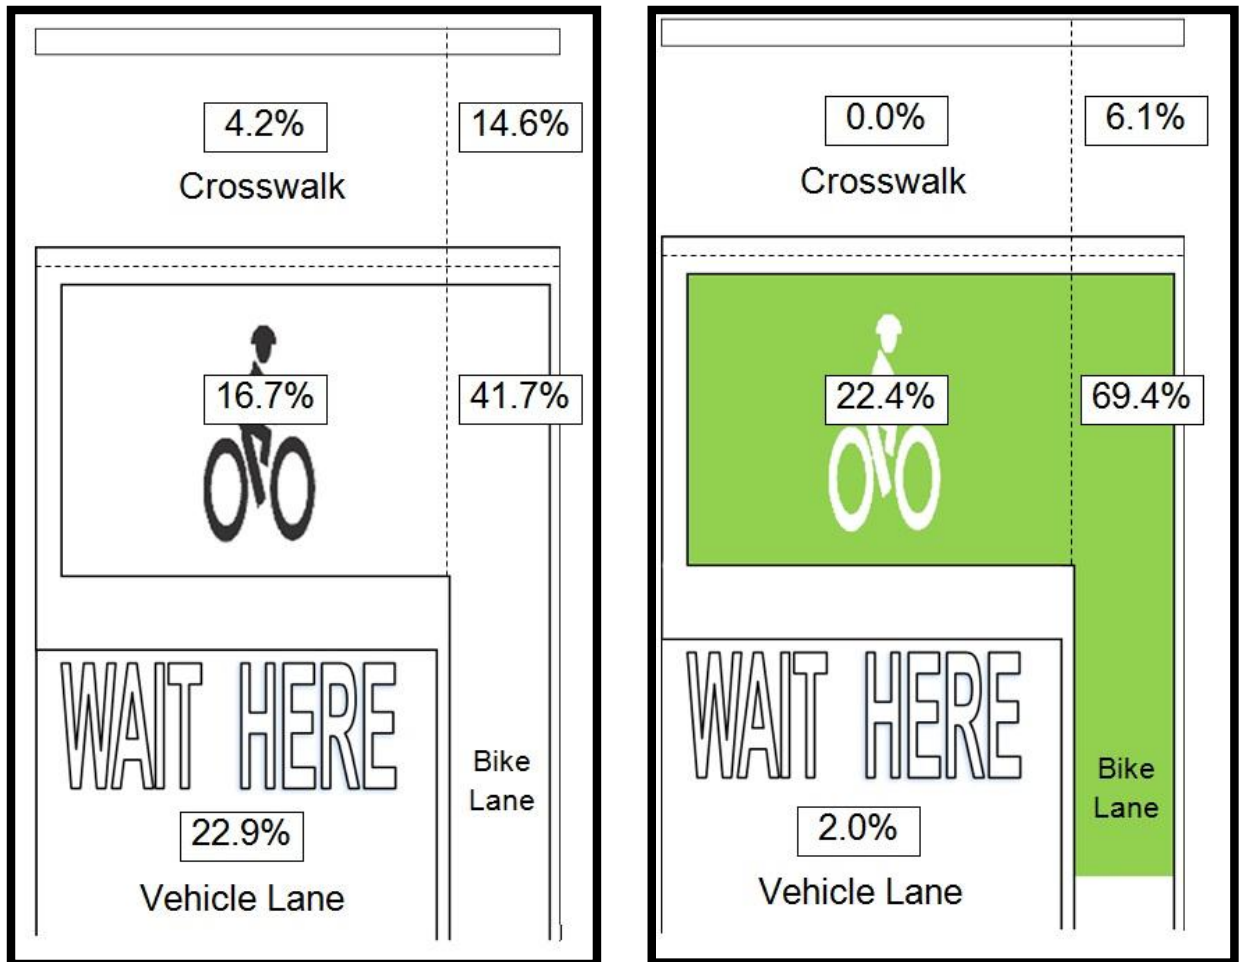
Figure 8 shows the percentage of bicyclists that stopped in each location at Shoal Creek Boulevard and Anderson Lane before and after color was added to the bicycle box. Only events when a bicyclist had the opportunity to access the bicycle box are shown. A bicyclist had the opportunity to access the bicycle box when a motorist did not encroach on the bicycle lane or stop line and there was no additional bicyclist blocking the bicycle box. This figure supports the assertion that the color in the bicycle box encourages bicyclists to stay within the bicycle box area. The percentage of bicyclists in this area increased while the percentage of bicyclists in the queue and beyond the stop line decreased. Ultimately, not taking into account the bicyclists who avoid or stop in the queue, the percentage of bicyclists who stopped behind the stop line increased from about 76% to 94%. This increase proved to be significant ($p = 0.012$).

Figure 8. Bicyclist stopping position by percentage on Shoal Creek Boulevard before and after color is added to the bicycle box

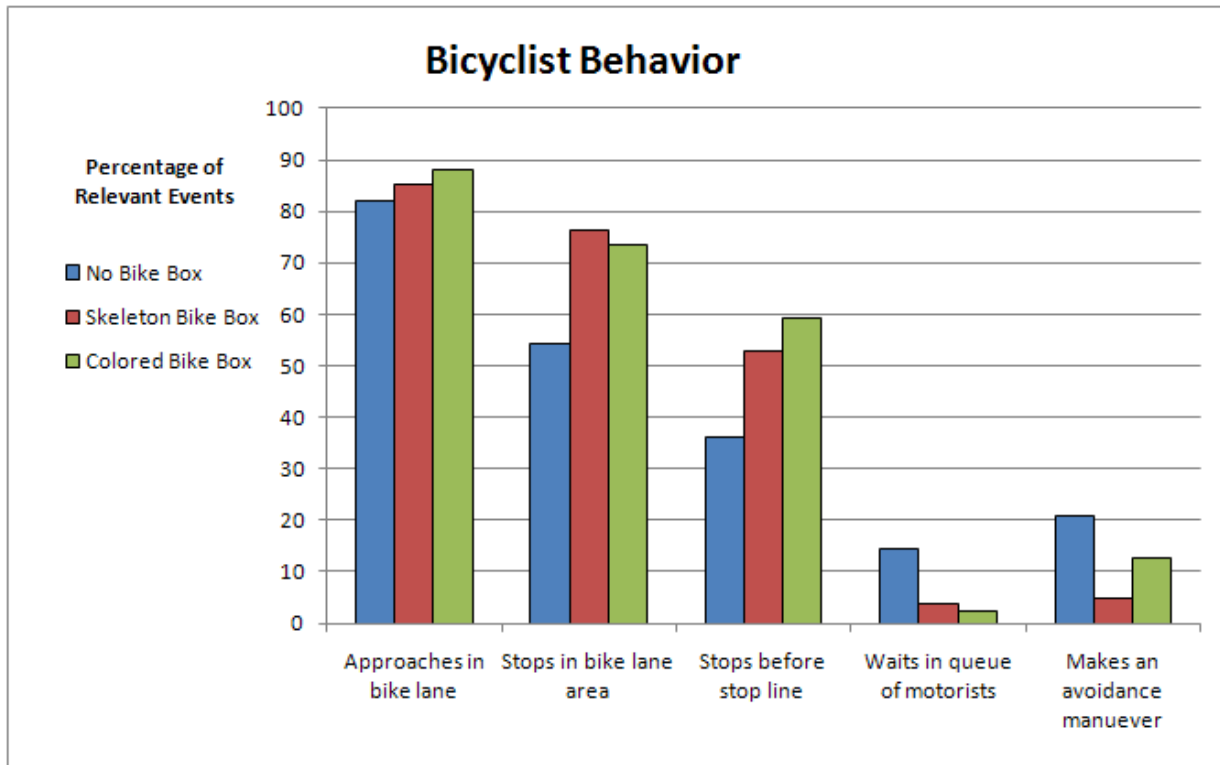
Figure 9 shows changes in bicyclist behavior before any bicycle box existed, after the skeleton bicycle box was installed, and after the chartreuse color was added. There was a steady increase in the number of bicyclists that use the bicycle lane on their approach to the intersection. This fact combined with the significant decrease in the percentage of bicyclists that waited in a queue of motorists ($p=0.007$) and the increase in the percentage of bicyclists that stopped before the stop line ($p=0.015$) after the skeleton bicycle box was installed suggests that bicyclists used the facilities at the intersection more appropriately. Also, a significant increase in the percentage of bicyclists that stopped in the bicycle lane area was observed. Since the bicycle lane continues on the other side of the intersection, bicyclists at this location might find it unnecessary to maneuver into the bicycle box area away from their straight line path. The main problem that resulted from bicyclists stopping in the bicycle lane area was that it hindered bicyclists who follow from entering the bicycle box. Often a queue of bicyclists would develop in the bicycle lane causing the bicyclists further back in the queue to be a greater risk or being right-hooked. Lastly, a significant decrease in the percentage of avoidance maneuvers ($p<0.001$) was observed when the skeleton bicycle box was installed, then this percentage increased slightly after the color was added. In general, the addition of the bicycle box and color led to safer and more predictable bicyclist actions.

Figure 9. Bicyclist behavior at 38th Street and Speedway

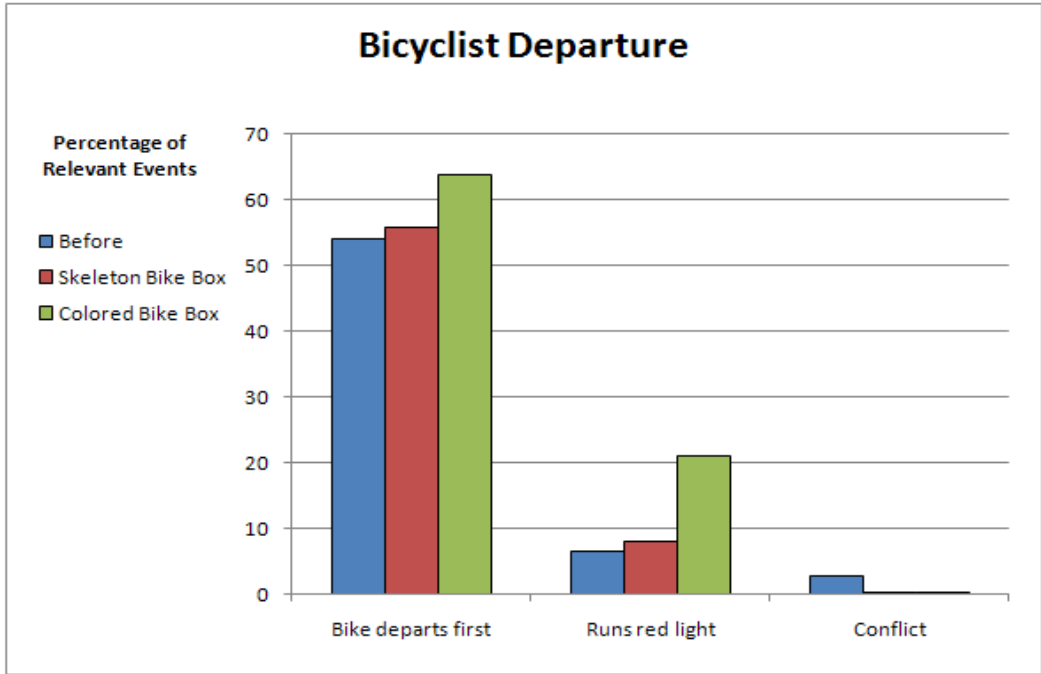
Safety was also quantified by how the bicyclist and motorist depart the intersection. Figure 10 shows an increase in the percentage of bicyclists that depart the intersection before a motorist after each stage of implementation, which may suggest that motorists are more aware of the presence of a bicyclist at the intersection and therefore more likely to yield to them when the light turns green. Unfortunately, a significant increase in the percentage of bicyclists that ran a red light was observed ($p < 0.001$), which could be due to the higher percentage of bicyclists positioning themselves in front of motorists.

Figure 10. Bicyclist departure movements at 38th Street and Speedway

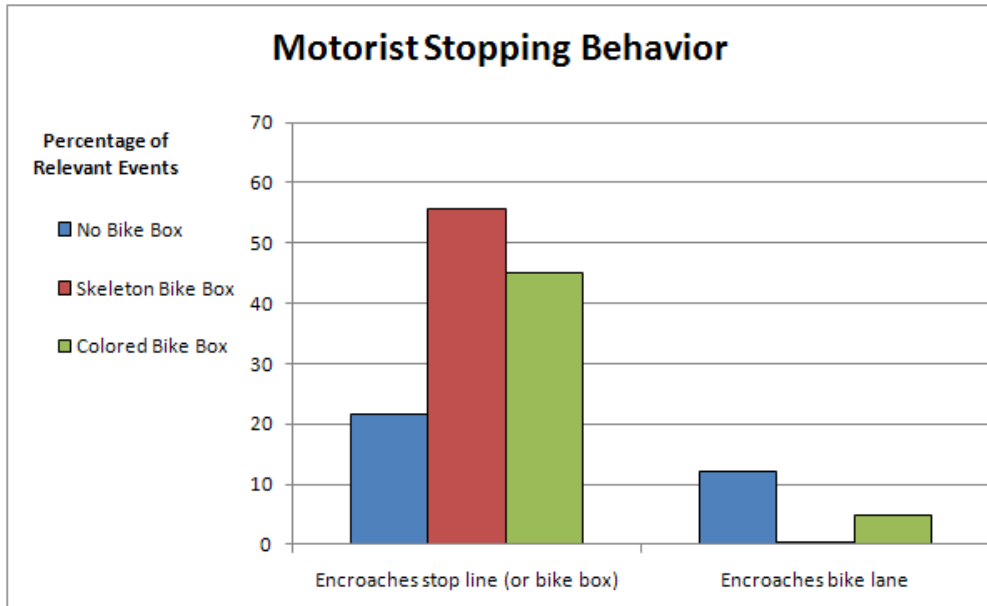
Additionally, motorist stopping position was recorded and is shown in Figure 11. Considerably more motorists encroach on their stop line after the skeleton bicycle box was installed, which could be due to motorists being unaware of the intention of the bicycle box. After the color was added, a significant change in the percentage of motorists stopped behind the bicycle box in the appropriate place was observed ($p=0.002$). Another positive result of the bicycle box was the decrease in the percentage of motorists that encroach on the bicycle lane after the installation of the skeleton bicycle box ($p=0.003$), which allows for bicyclists to safely bypass a queue of motorists and access the bicycle box. The small increase in motorists encroaching the bicycle lane after color was added could be partially attributed to some motorists exiting a driveway located just before the intersection. Lastly, the percentage of motorists making an illegal right turn on red was recorded. Contrary to Shoal Creek Boulevard, only 5.3% of motorists made an illegal right turn after the bicycle box was installed at this location. The low percentage of illegal right turns combined with the high volume of bicyclists makes this site well suited for a bicycle box. Also, the bicycle volume on this facility was much higher than on Shoal Creek Boulevard (20-60 bicyclists per hour as opposed to 0-30 bicyclists per hour), which likely contributes to the better motorist behavior since they know they are more likely to encounter a bicyclist.

Figure 11. Motorist stopping position when a bicyclist is present at Speedway and 38th Street

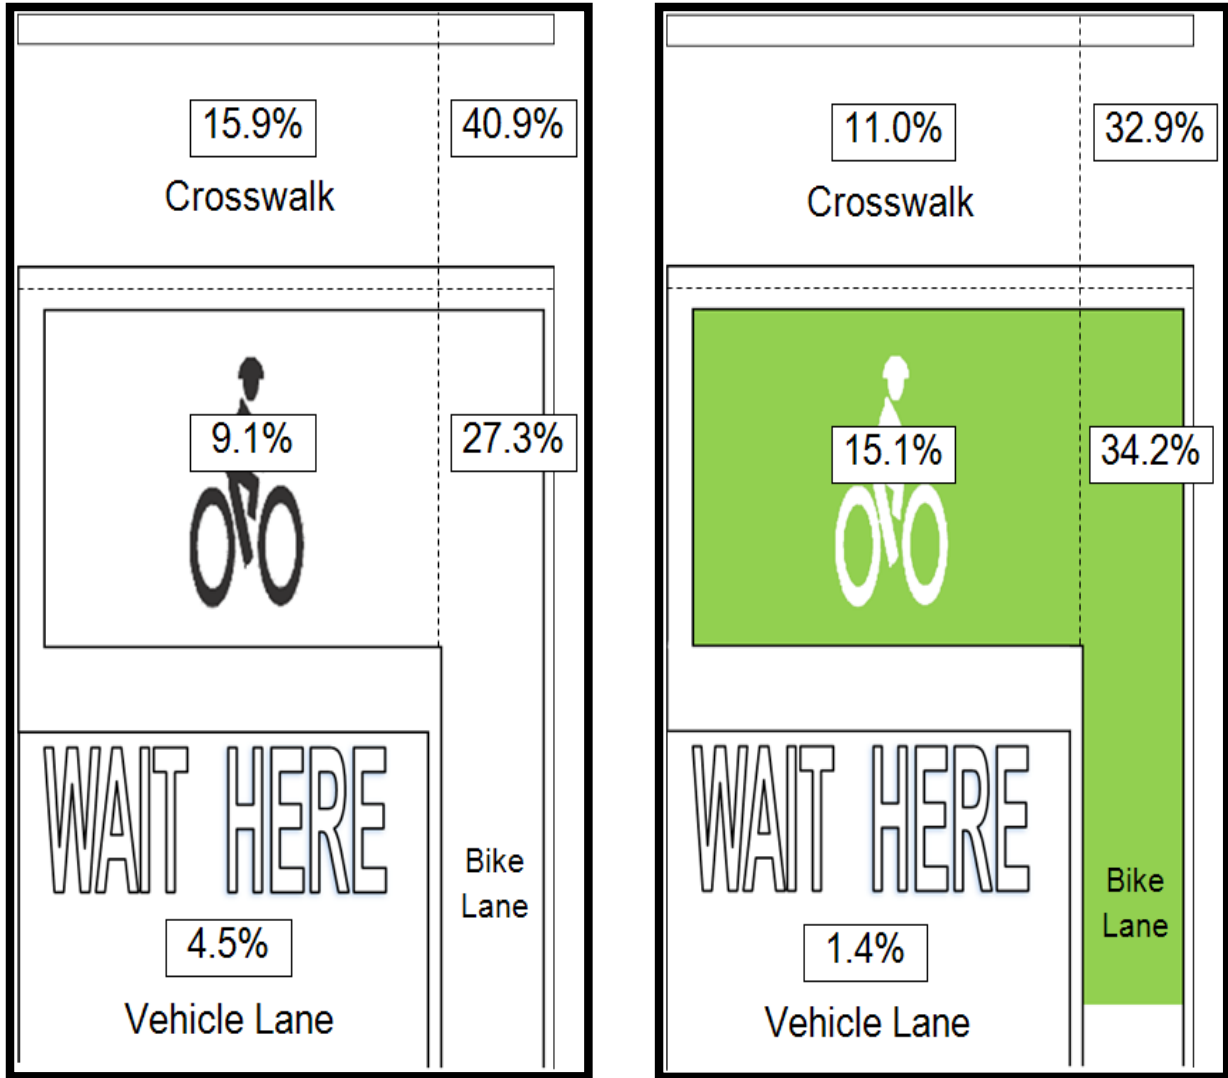
Figure 12 shows the percentage of bicyclists stopped in each location at Speedway and 38th Street before and after color was added to the bicycle box. Only events when a bicyclist was given the opportunity to access the bicycle box are shown. A bicyclist had the opportunity to access the bicycle box when a motorist did not encroach on the bicycle lane or stop line and there was no additional bicyclist blocking the bicycle box. After the chartreuse was added, bicyclists stayed within the colored area 13% more often, indicating a positive reaction to the color. A higher percentage of bicyclists began using the bicycle box correctly and did not encroach on the crosswalk. Additionally, a lower percentage of bicyclists waited in a queue of motorists, indicating that bicyclists are more confident using the bicycle lane to approach the front of the intersection and wait in front of motorists. Overall, 25% of bicyclists stopped in or in front of the bicycle box when only the skeleton was installed and 26.1% used the bicycle box after color was added. An ideal use of the bicycle box on southbound Speedway is shown below in Figure 13.

Figure 12. Bicyclist stopping position by percentage on Speedway before and after color is added to the bicycle box

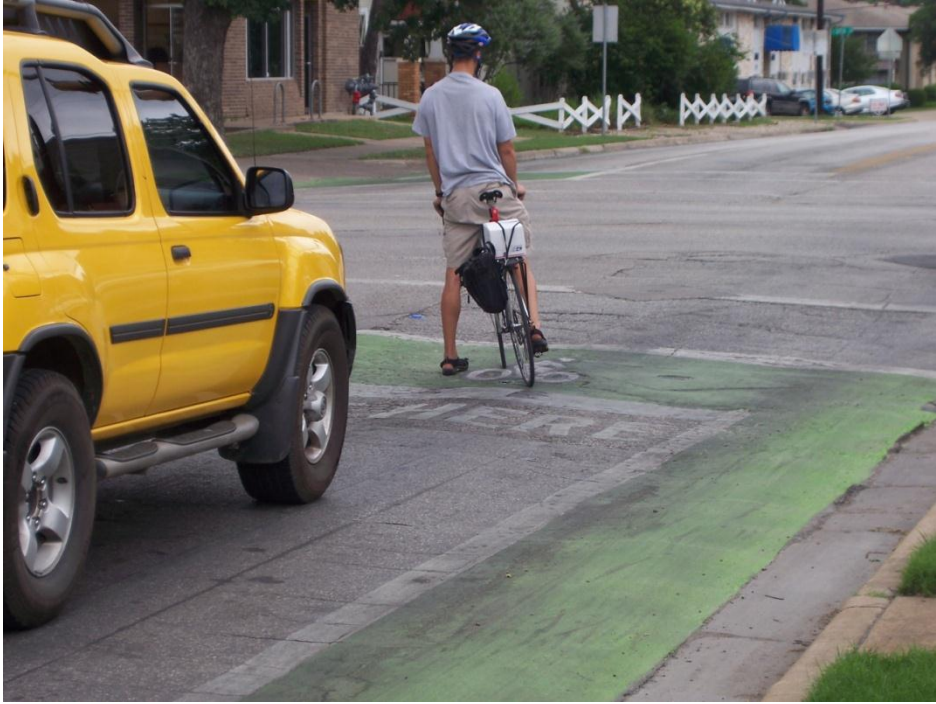
Figure 13. Bicyclist using bicycle box on southbound Speedway at 38th Street

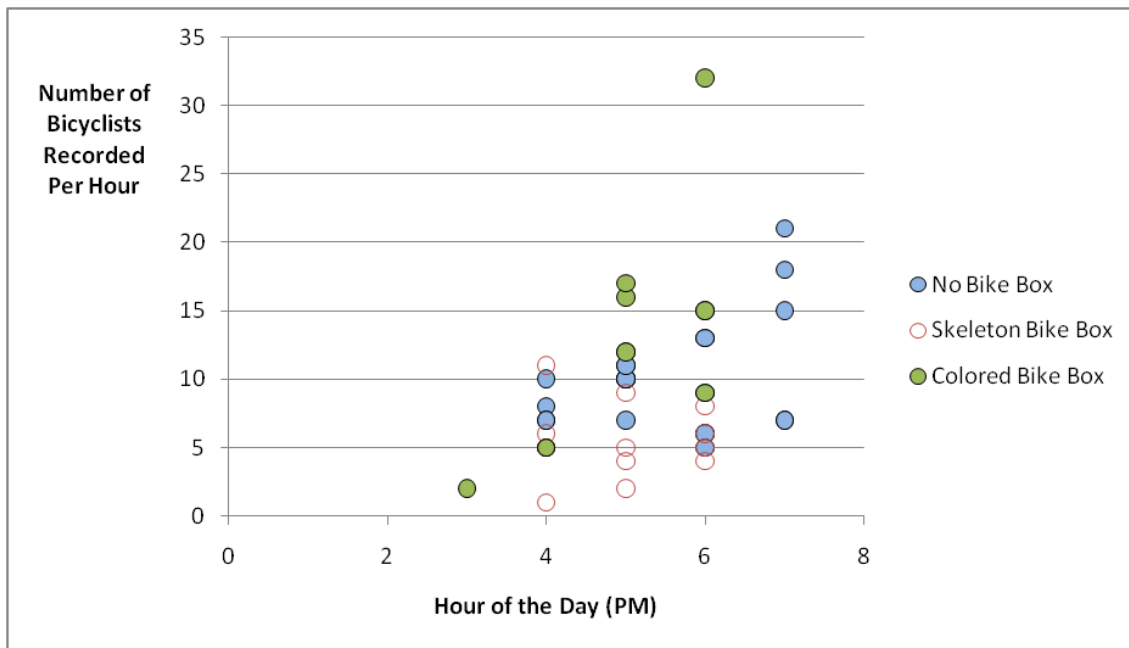
Figure 14 and Figure 15 show the total number of bicyclists observed by hour of the day at Shoal Creek Boulevard and Speedway, respectively. Shoal Creek Boulevard experienced an increasing number of bicyclists as the afternoon progressed for all three phases. Based on the high number of bicyclists between 5:00 PM and 7:00 PM, Shoal Creek Boulevard is most likely a commuter route with about 10 bicyclists an hour. Bicycle volumes on Speedway also increased as the afternoon progressed, but had a slightly more constant trend. This could be due to its proximity to The University of Texas since students tend to have more flexible schedules than typical commuters. On average, about 10 bicyclists per hour and 30 bicyclists per hour traveled along Shoal Creek Boulevard and along Speedway, respectively.

Figure 14. Number of bicyclists recorded each hour of the day on Shoal Creek Boulevard

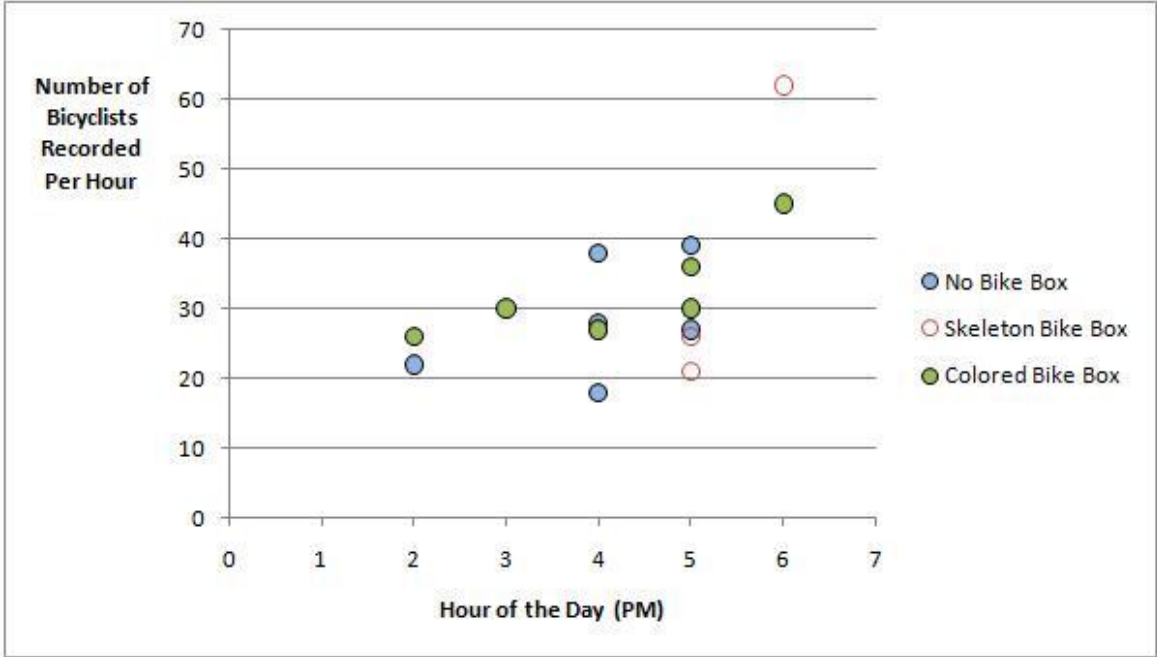
Figure 15. Number of bicyclists recorded each hour of the day on Speedway

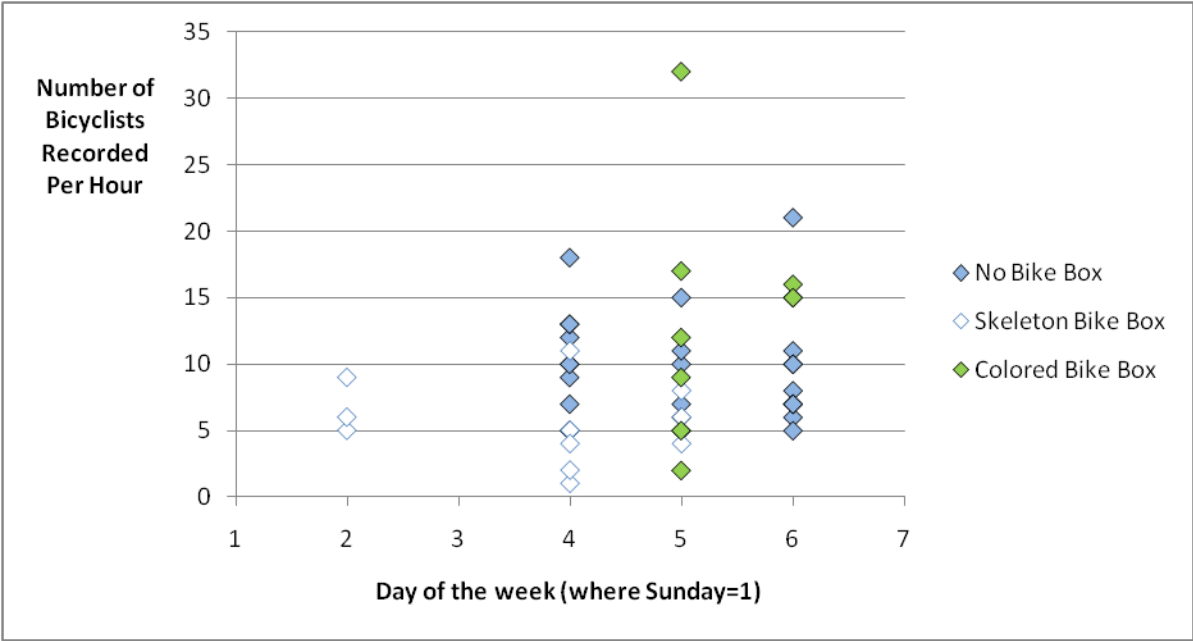
Figure 16 and Figure 17 show the total number of bicyclists observed each day of the week at Shoal Creek Boulevard and Speedway, respectively. Both sites show a varying number of bicyclists for each day of the week. Bicycle volumes on Shoal Creek Boulevard were observed to range from five to 10 bicyclists per hour, while they range from 20 to 40 bicyclists per hour on Speedway over the course of the week.

Figure 16. Number of bicyclists recorded each day of the week on Shoal Creek Boulevard

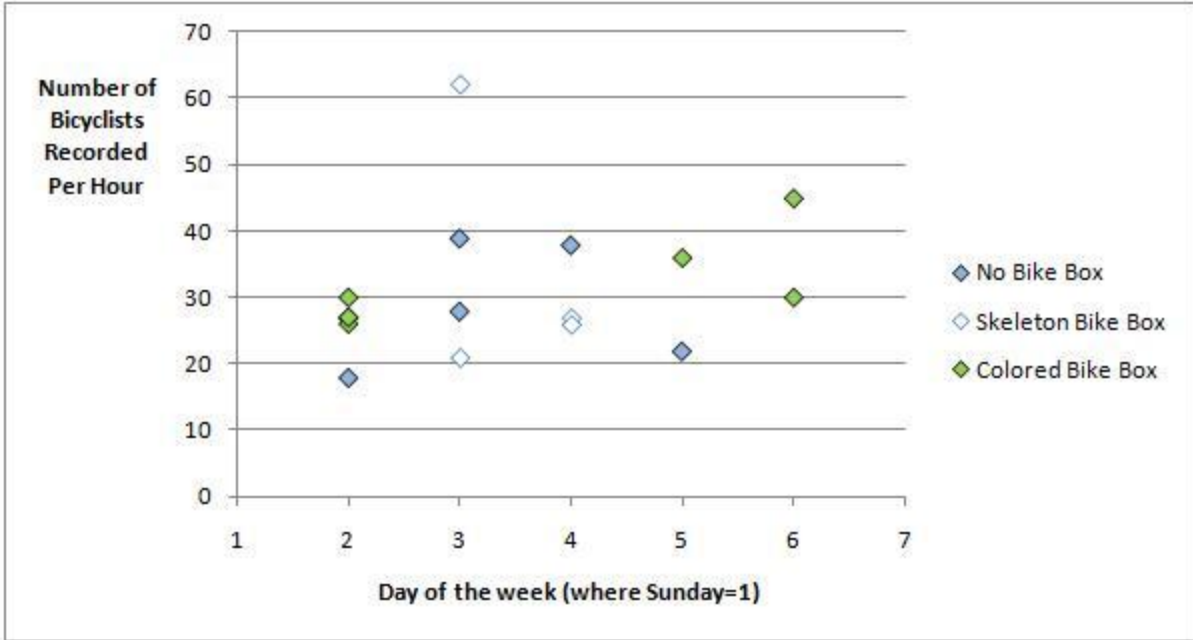
Figure 17. Number of bicyclists recorded each day of the week on Speedway
