1. Report No. FHWA/TX-0-1746-1		2. Government Accession No.		3. Recipient's Catalog No.	
4. Title and Subtitle Measurement-Based Evaluation of Noncomposite Steel Girder Bridges				5. Report Date February 2000

**MEASUREMENT-BASED EVALUATION OF NONCOMPOSITE
STEEL GIRDER BRIDGES**

Research Report 1746-1

*EFFECTS OF OVERLOADS
ON EXISTING STRUCTURES*

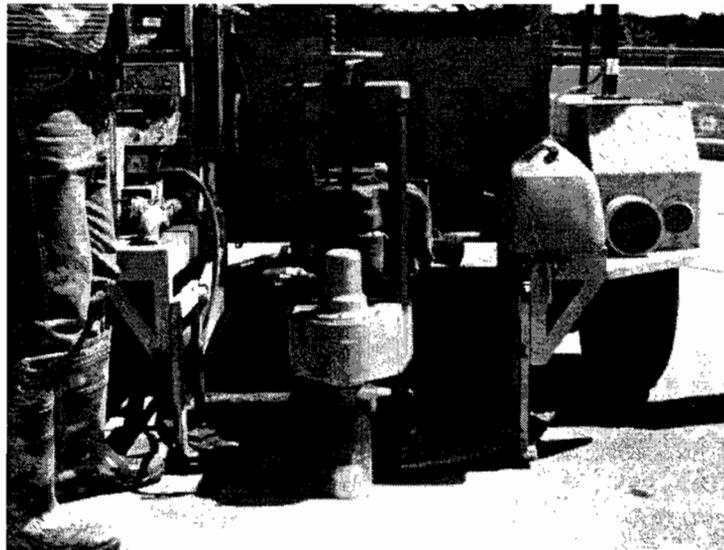
Figure 4.10 Drilling of Concrete Core in Progress.

Compressive tests were conducted on six 100 mm (4 in) diameter cores removed from the bridge deck to obtain an experimental estimate of the concrete strength and for comparison with the values given in the specifications. A total of six concrete cores were removed; three from both the north and south four-span units. On each unit, the specimens were taken from three separate spots; one alongside the east curb, one alongside the west curb, and one towards the center of the roadway. Before each core, the general area of the deck to be drilled was scanned with a rebar locator to find the reinforcement. Because the scan needed to pass through the asphalt overlay, a clear image of the reinforcement pattern could not be obtained which made it difficult to drill through the deck without hitting rebar. The close 180 mm (7 in) rebar spacing further complicated the removal of undisturbed samples. Figure 4.10 shows the coring rig and the 100 mm (4 in) drill bit used to remove the concrete samples.

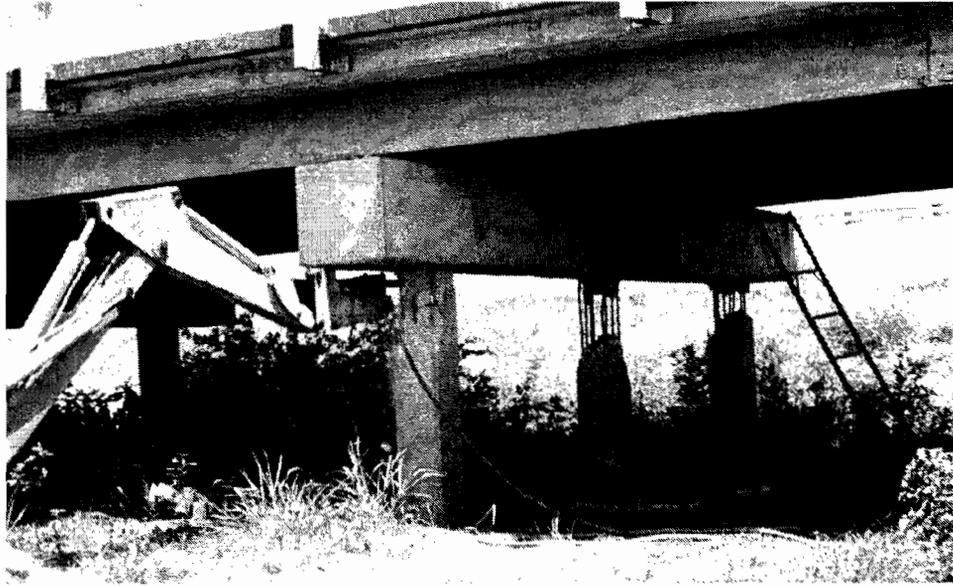
Figure 5.1 Removal of Bent Cap in Progress at Unit-N.

The same procedure was followed in removing both bent caps. First, the 25.4 mm (1 in) diameter bolts attaching the fixed bearing plates to the top of the cap were torch cut at the five girder locations. By severing the bolts, the girders were no longer affixed to the bent cap. Next, the concrete at the top of the three 410 mm (16 in) square piles was chipped away below the base of the bent cap to expose the rebar as shown in Figure 5.1. The exposed reinforcement was then torch cut and the bent cap removed. At Unit-S, deflection measurements were made using a theodolite to determine the amount of girder deflection caused by the bent cap removal. At a distance of 9.1 m (30 ft) from the abutment (i.e., mid-span of the longest span), the girder displacement averaged 49.3 mm (1.94 in).
