1. Report No. FHWA/TX-12/0-6668-1		2. Government Accession No.		3. Recipient's Catalog No.	
4. Title and Subtitle MICROSURFACING IN TEXAS				5. Report Date August 2011 Published: January 2012

MICROSURFACING IN TEXAS

Project Title: Synthesis of Microsurfacing Successes and Failures

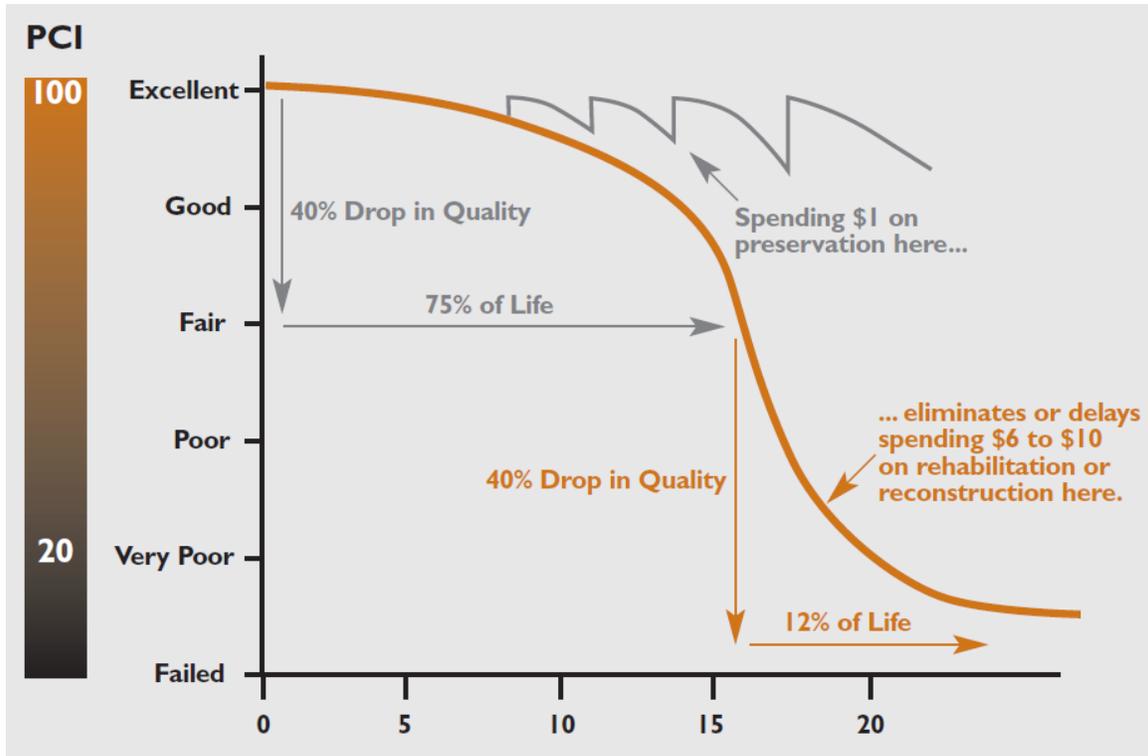
Figure 2-2. Relationship between Condition of Pavement when Treatments are Applied and Cost of Treatment. PCI = Pavement Condition Index, X-axis is in years (18)

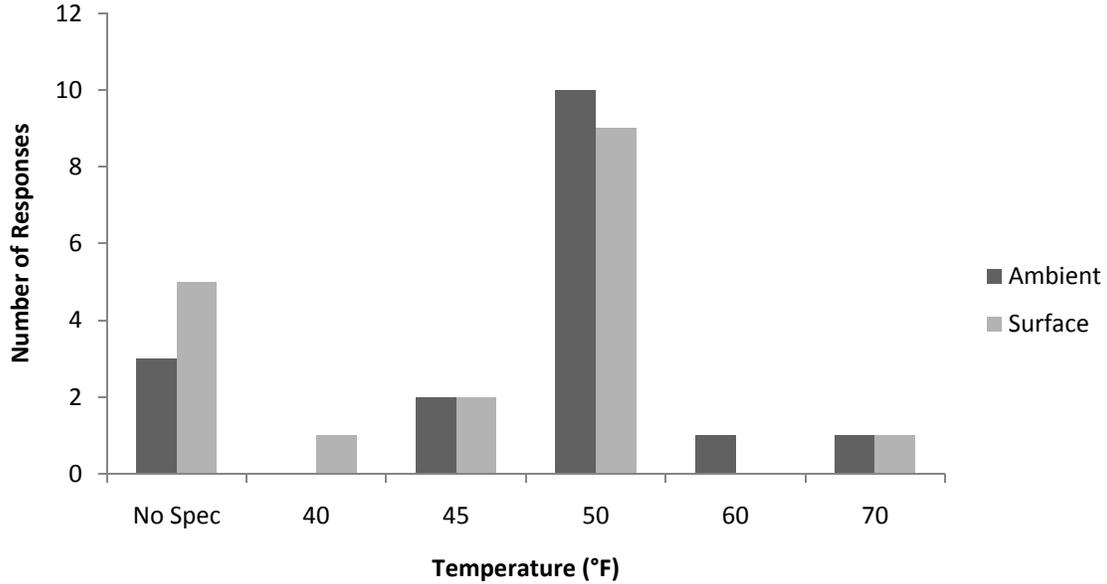
Figure 5-1. Summary of U.S. and Canadian Ambient Air and Surface Temperature Specifications.

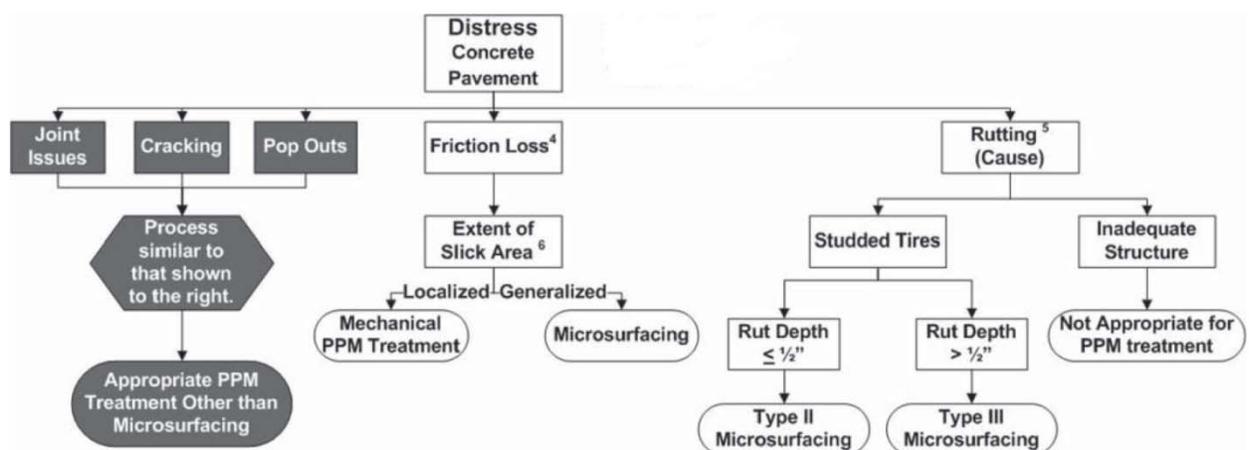
Figure 5-3. Conceptual Decision Tree for Concrete Pavement Preservation and Maintenance Treatment Selection (3, 6, 21)

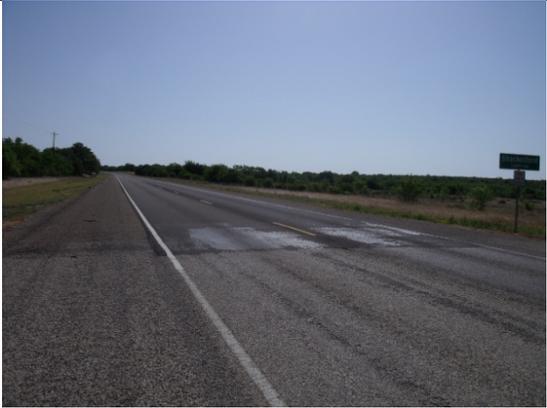
<p>Bleeding seen where transition occurs from microsurfacing (top) to existing road (bottom). Existing roadway can also be seen to be structurally sound, a major contributor to the success of this project.</p>

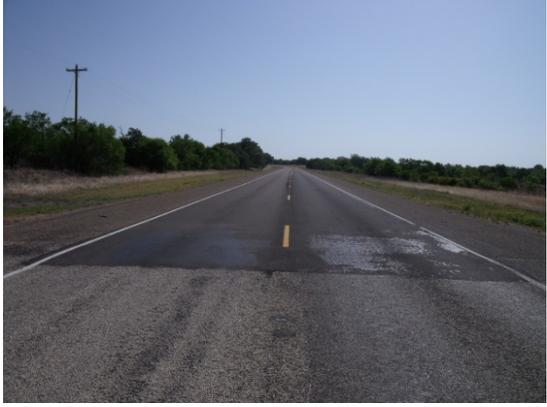
<p>Another view of the bleeding in the microsurfacing. Bleeding was not seen elsewhere on this project, attesting to the difficulties encountered in starting and stopping paving, the reason for continuous travel paving mills. Transverse joint was well constructed as can be seen from lack of cracking or height difference from existing road.</p>

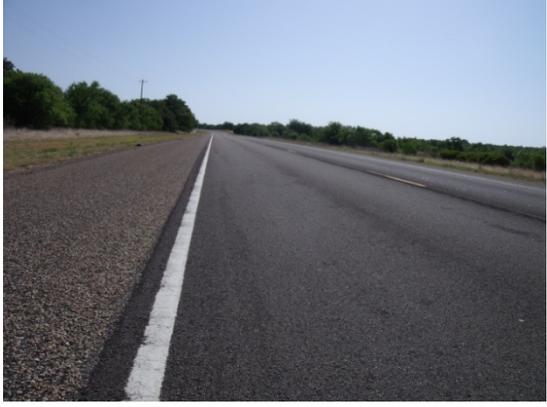
<p>Project had good joints, no rutting over 1/4" deep, some minor streaking and good texture.</p>

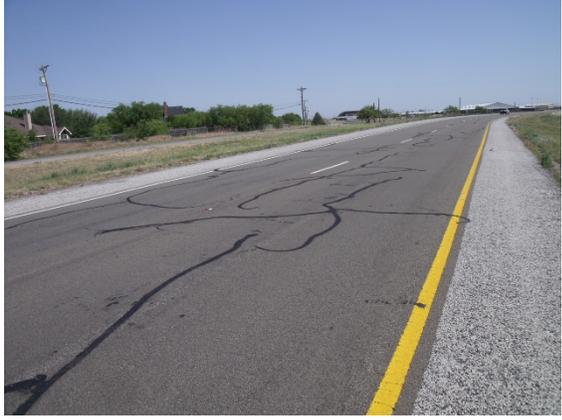
<p>Southbound lanes showing no rutting, good texture, well constructed edges and joints, with crack-sealing.</p>

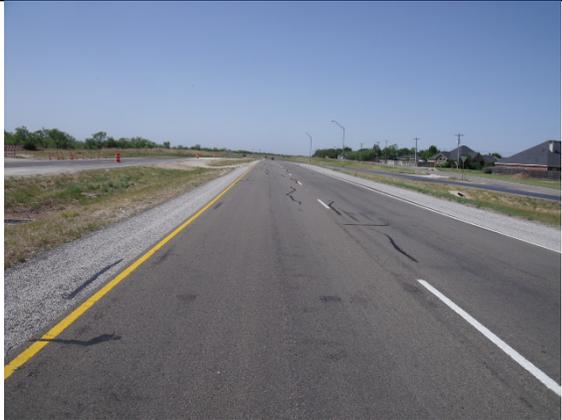
<p>Southbound lanes (right) had some crack sealing but no major distresses. Northbound lanes (left) can be seen under construction. Northbound lanes were reported to be under construction by the area engineer who stated “we are performing in place repairs on areas that cropped up right after the really bad ice and snow spell with 3 consecutive days with temps never getting to 20 degrees (F). I think the weather was the primary problem but it does demonstrate that the condition of the road was probably borderline for consideration of placement of the microsurfacing at the time the decision was made to do so.”</p>

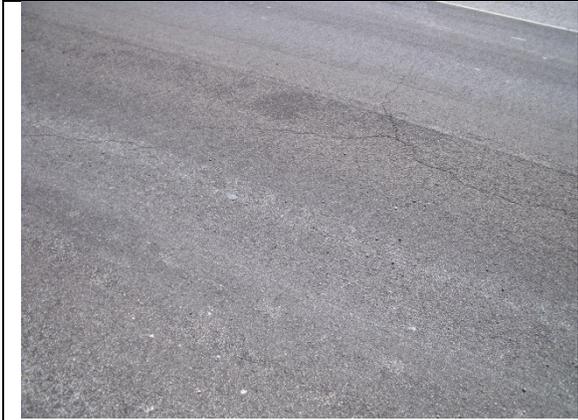
Minor unsealed crack in Northbound lane.

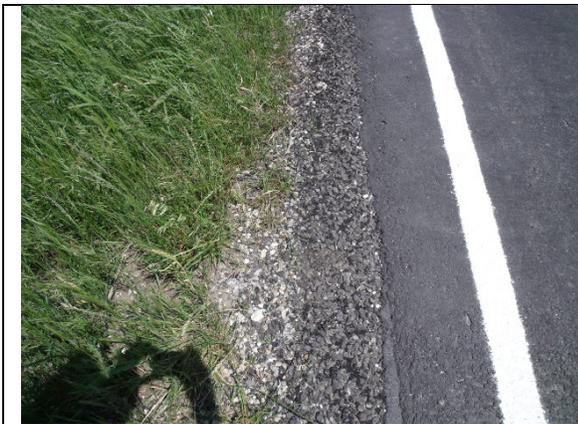
Well constructed edges on pavement with good macro-texture. Microsurfacing had good micro-texture.

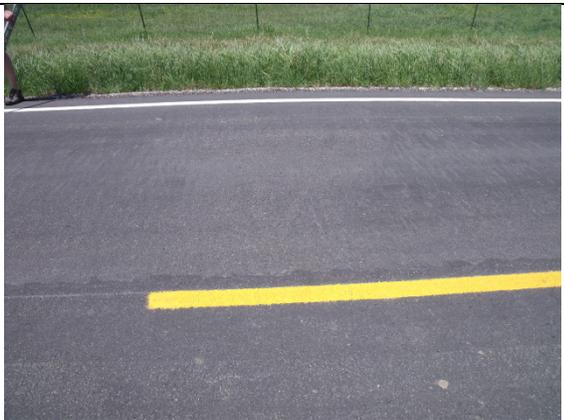
Also present in this project was high frequency, low amplitude corrugation as seen on the left of the top lane. Rough pavement underneath reflecting through or causing the rear strikeoff to “jump” is the most likely cause of this. Demonstrates importance of meeting the requirements in Table 4-1.

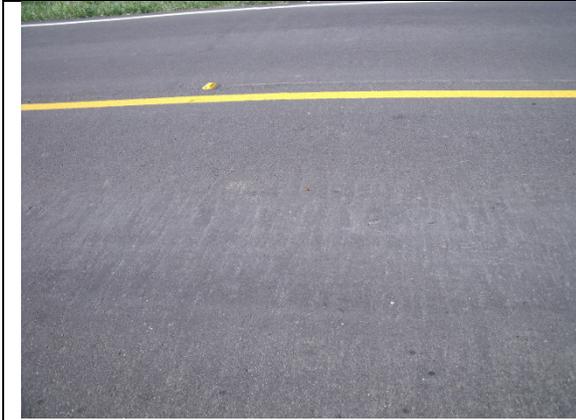
Another shot of the corrugation.

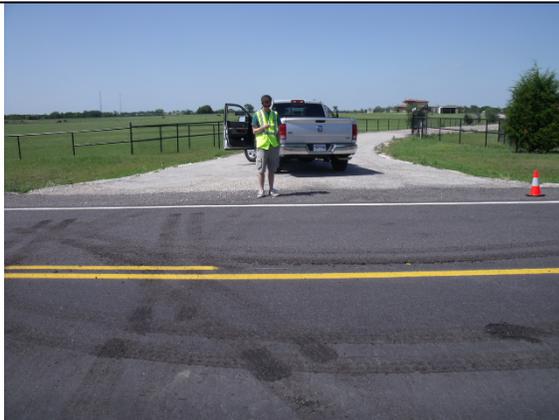
Damage to intersection most likely from early opening to traffic.

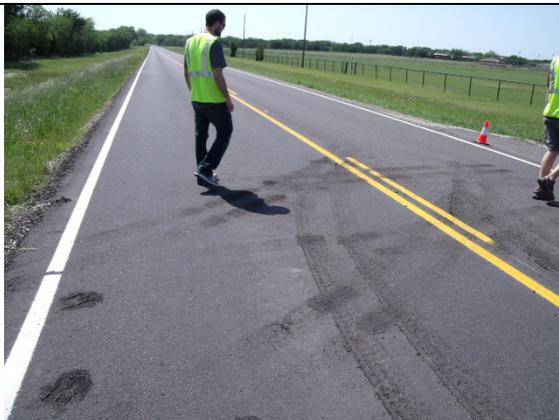
Tear marks (bottom left) from power to rear tires damaging the microsurfacing. The microsurfacing was still slightly soft when visited 5-6 months after construction. Demonstrates importance of creating an adequate mix design to ensure proper curing.

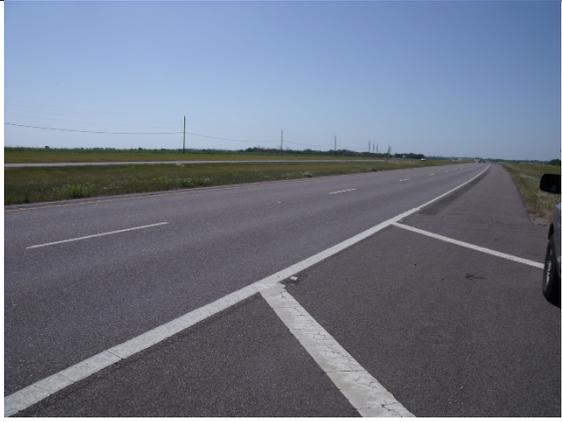
<p>No rutting over 1/4", good surface texture, almost no cracking, no bleeding, good color and ride. This project had a destroy date of 5/2011 and was still performing very well. Example of a well constructed project on an appropriate underlying road.</p>

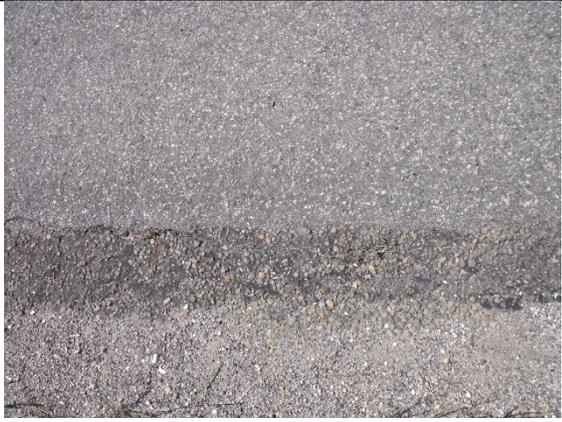
<p>Surface texture seen at edge of microsurfacing (top) and existing road (bottom).</p>

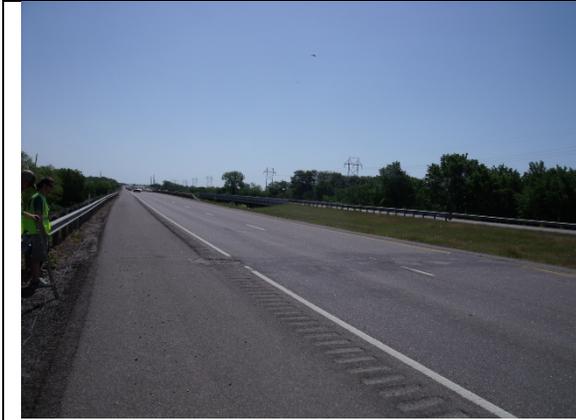
One of only two significant distresses in the microsurfacing. Occurred at the beginning of an embankment constructed for a bridge. Settlement of the fill was the obvious cause of failure of the base pavement which reflected through the microsurfacing.

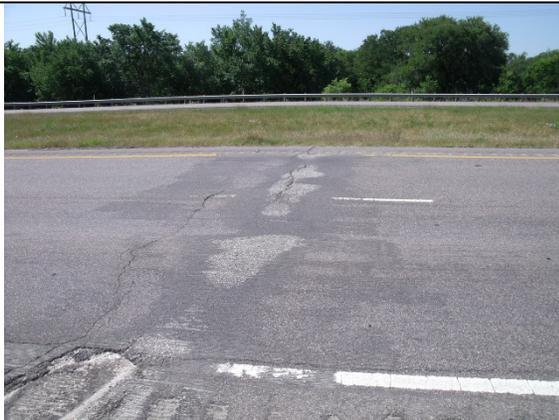
Another view of the reflective crack.

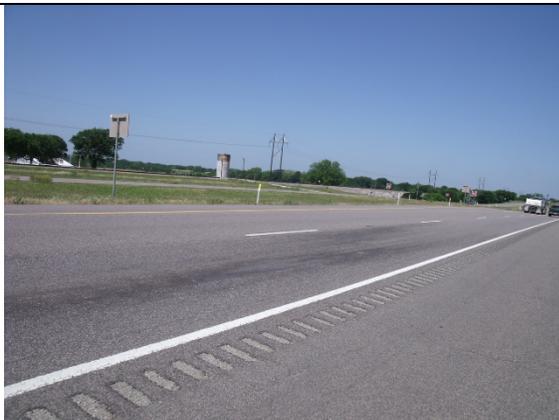
The second distress was an area of minor raveling and bleeding.

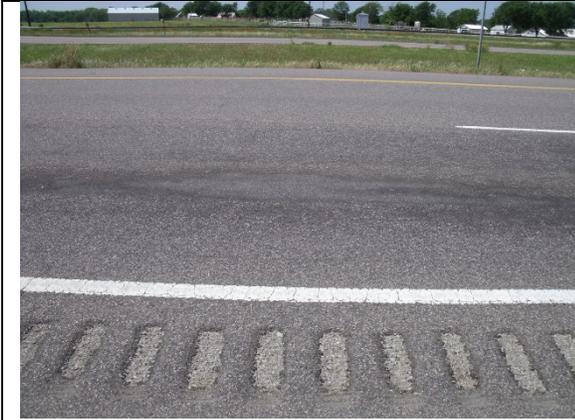
Cause is unknown but minor variation in the mix may have left a spot of softer binder allowing bleeding and raveling.
