## Investigation of Settlement at Bridge Approach Slab Expansion Joint: Bump at the End of Bridge

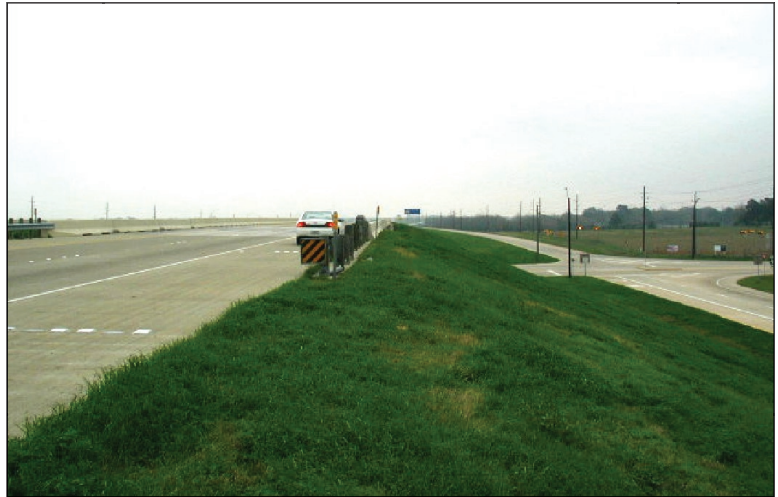
Figure 1. An Example of Bridge Approach Slab (US 290 at FM 362).

A number of recently constructed bridge approach slabs using an articulation at mid span and the wide-flange terminal anchorage system have experienced settlement at their expansion joints (see Figures 1 and 2). This problem is more commonly referred to as the bump at the end of the bridge. It is estimated that the Texas Department of Transportation (TxDOT) spends \$7 million each year for maintenance associated with the bump at the end of the bridge. This project investigated reasons for the bumps and recommended ways to improve the current situation. As part of the results, a new wide-flange terminal anchorage/bridge approach slab system that is less sensitive to weak embankments was designed and tested.

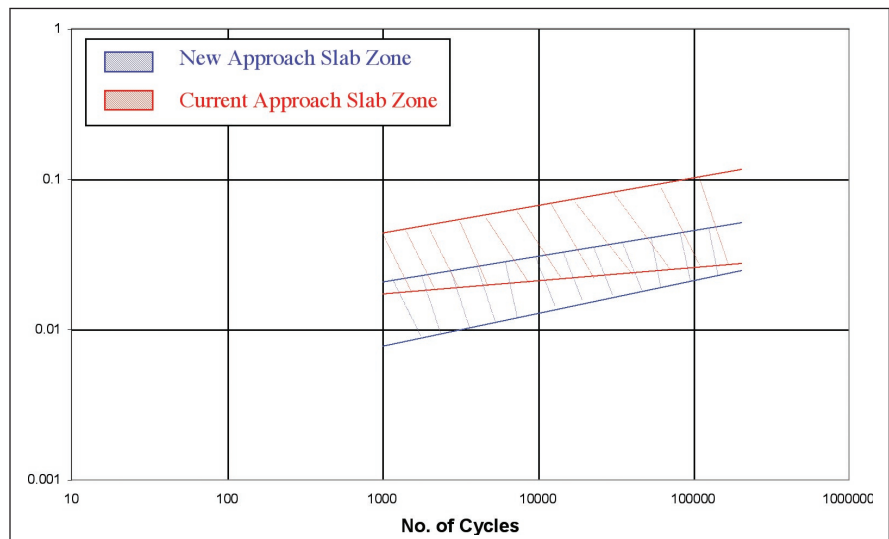
gives a smaller bump than the current two-span approach slab (Figure 5).

Figure 5. New Approach Slab versus Current Approach Slab: BEST Results.
