Project Summary Report O-4471-S

Project O-4471: Evaluation of Horizontal Signing Applications

Research Recommendations for Pavement Marking Words and Symbols

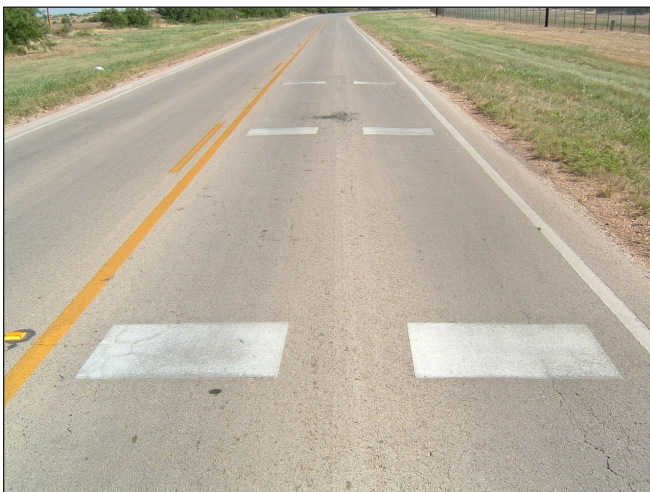
Figure 1. Transverse Line Treatment.

Transverse Lines: The northbound direction of FM 707

in the Abilene District received a treatment of simple transverse lines (see Figure 1). This treatment was selected to represent the lowest-cost minimal treatment. The treatments applied here attempted to provide a visual warning, a “visual rumble strip” of sorts, to alert drivers to some upcoming change or hazard.

Transverse Lines: The transverse line treatment at the study location did not appear to have a measurable effect on speed. The results indicate that the materials did not provide a sufficient cue to drivers that they should slow for the approaching curve.

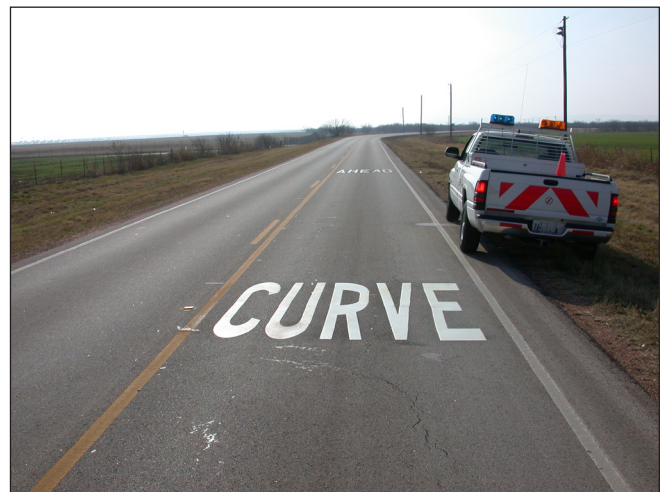
Figure 2. CURVE AHEAD Treatment.

CURVE AHEAD Text: The southbound direction of FM 707 received a treatment of the text message CURVE AHEAD. The text consisted of 8-ft letters as shown in Figure 2.

CURVE AHEAD Text: The CURVE AHEAD treatment at this location did not have the expected effect on speed selection. The number of observations for this site was smaller than the number for other sites, but still of

sufficient size to draw the conclusion that the CURVE AHEAD text treatment did not succeed in changing driver behavior.

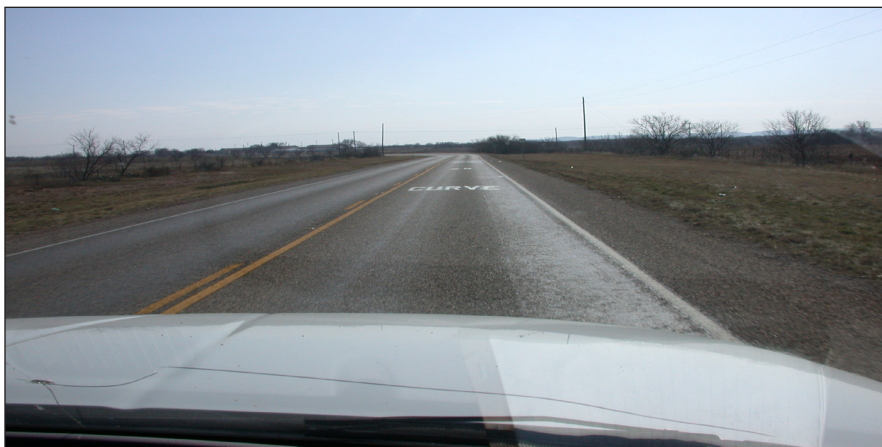
Figure 3. CURVE 55 MPH Treatment.

CURVE 55 MPH Text on Rural Curve: The treatment consisted of the words CURVE 55 MPH. The treatment began approximately 400 ft after the standard curve warning sign (see Figure 3).

CURVE 55 MPH Text on Rural Curve: With only a standard warning sign drivers slowed down approximately 8 mph, while after the installation of the text on the pavement they slowed down 12 mph. This difference was not statistically significant, but it does suggest a benefit of the horizontal signing treatment that is worthy of further exploration.

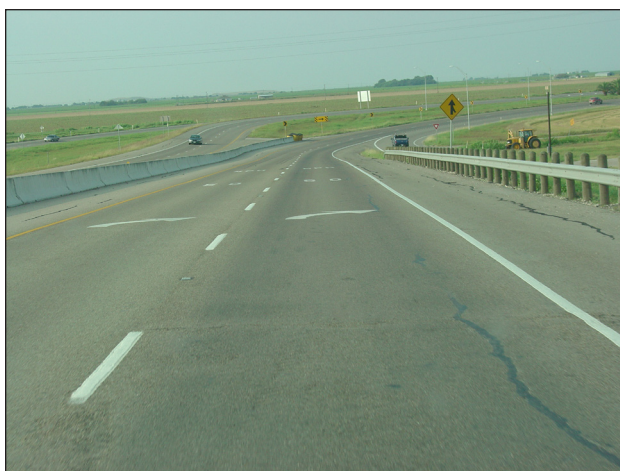
Figure 4. Curve Arrow and Advisory Speed Treatment.

CURVE 50 MPH Text on Urban Curve: An urban curve location was selected on US 77 near Robstown in the Corpus Christi District. This location, on a divided four-lane highway, was selected based on a high number of truck rollover accidents in the area as reported by the TxDOT district engineer. Directional curve arrows and a 50 mph advisory speed were placed on the pavement as shown in Figure 4.

CURVE 50 MPH Text on Urban Curve: The average speed data showed that because of the vertical crest between the control point and the warning sign, vehicles slowed down between the first and second counter locations. After passing the warning sign, vehicles in the before period accelerated as they went down the overpass. In the after condition, vehicles did not accelerate. The percentage of vehicles exceeding the speed limit revealed the effectiveness of this treatment.

of an upcoming curve through words and transverse lines. In addition, the use of the curve arrow provides drivers with information about the direction of the curve that can be particularly useful on a blind approach like the one created by the vertical crest of the overpass at our test location. Overall, the results of the rural location field studies of speed on horizontal curves were fairly inconclusive.

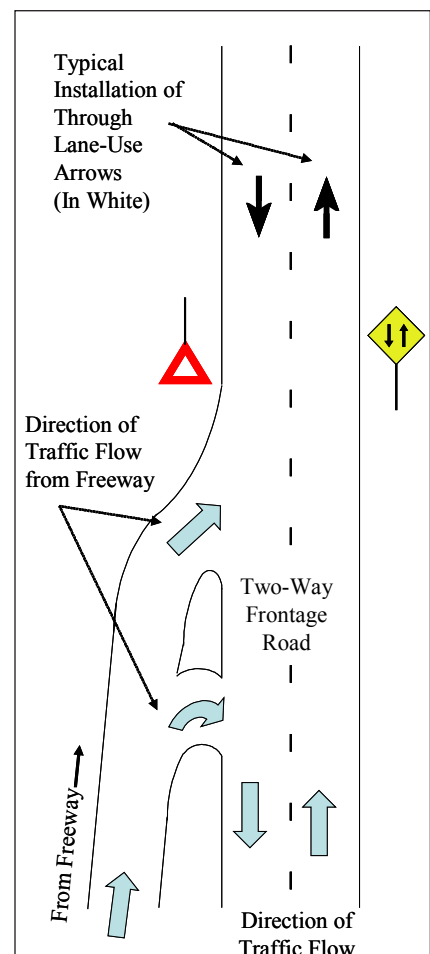
Figure 5. Typical Installation for Directional Arrows on Two-Way Frontage Road to Reduce Wrong-Way Movements.

one-way roadways, while rural areas tend to have two-way frontage roads. The presence of both one-way and two-way frontage roads in a given area may create increased potential for wrong-way movements. The location selected for the field evaluation was a short section of two-way frontage road on the fringe of the College Station, Texas, urban area. The diagram in Figure 5 shows the ramp configuration and adjoining frontage road.

The pavement marking treatment was a pair of standard 9-ft white retroreflective thermoplastic pavement marking arrows defined in the *Manual on Uniform Traffic Control Devices (MUTCD)* as a “Through Lane-Use Arrow.” Typical cost for such an installation is in the range of \$300.

Overall, incorrect maneuvers were reduced from 7.4 percent to 0.7 percent, a 90 percent reduction of the number of vehicles driving the wrong way. Stated another way, prior to the installation of the lane direction arrows about 1 out of every 13 vehicles that exited the freeway at this location ended up

driving in the wrong frontage road lane. After the installation of the arrows, this number dropped to about 1 out of every 150 vehicles.
