Project 0-4479: Develop a Methodology for Establishing
Bump Detection Using Inertial Profile Measurements
for Implementation with the Ride Specification

Develop a Methodology for Establishing Bump Detection Using Inertial Profile Measurements for Implementation with the Ride Specification: Summary Report

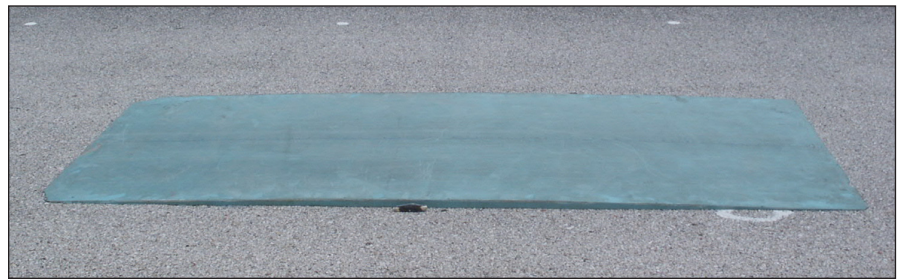
bump 5 of the set as the “golden” bump as it consistently showed one of the smoother transitions when inserted into the various profiles for study. Figure 1 shows a photograph of bump 5 on one of the test sections located at the Texas A&M University Riverside Campus. Having established the “golden” bump, research and development efforts proceeded according to the following work plan.

Figure 1. Photo of Bump 5 on Pavement Test Section.

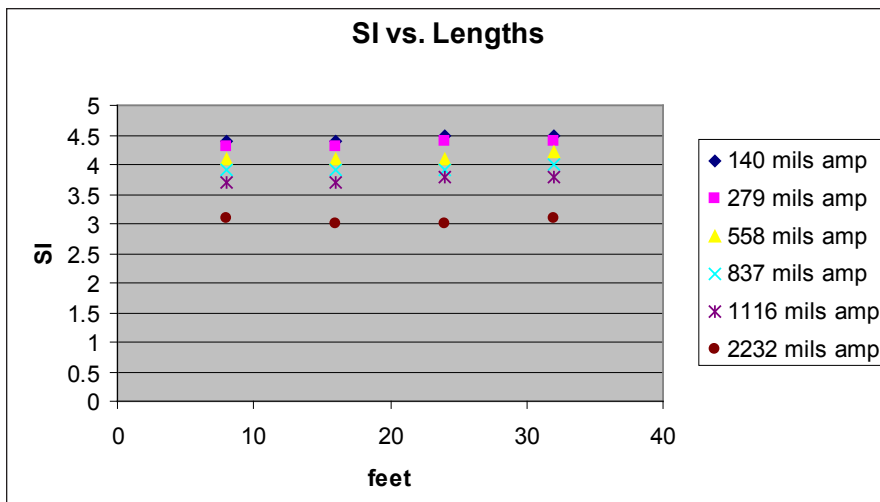
Figure 2. Sensitivity of Current SI to Simulated Bumps of Various Amplitudes and Wavelengths.

Application of the new ride equation to compute the SI on the Pearce Lane section demonstrated the sensitivity of the new SI to the presence of localized roughness. Further investigations of the effects of simulated bumps on various ride statistics revealed that the new SI is affected by both the amplitude and wavelength of a bump. In contrast, the current SI and IRI were found to be sensitive only to the bump amplitude for the range of simulated bumps considered in the analysis. These findings are illustrated in Figures 2 and 3.

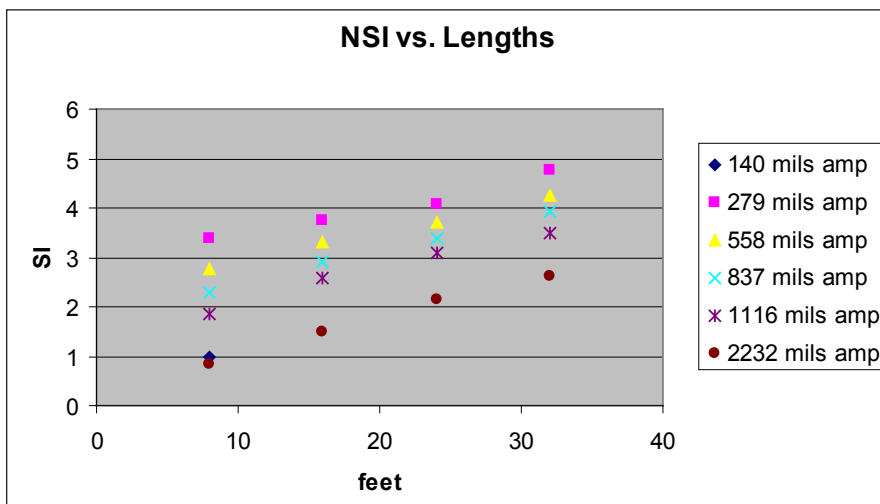
Figure 3. Sensitivity of New SI to Simulated Bumps of Various Amplitudes and Wavelengths.
