Project Summary

Texas Department of Transportation

5-4124-01: Bridge Strengthening Through the Use of Post-Installed Shear Connectors - Phase 1

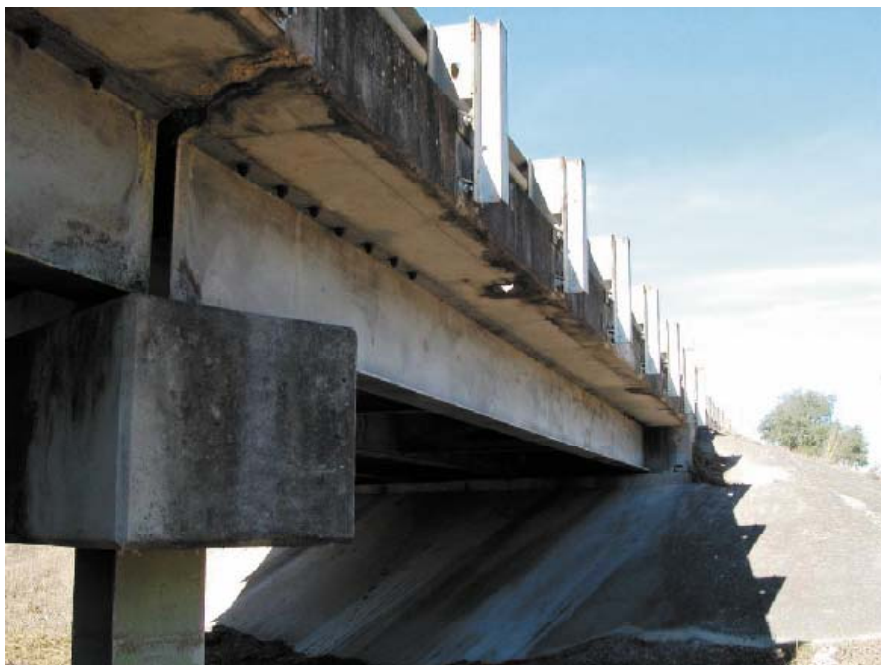
Post-Installed Shear Connectors in Bridge Located Near Hondo, Texas.

In this implementation study (phase 1), an existing non-composite bridge in the San Antonio District was retrofitted with these three types of post-installed shear connectors to increase the load rating of the bridge. The bridge, built in 1950, is located on FM 462 over Live Oak Creek in Medina County near the town of Hondo, Texas, and is referred to in this study as the Hondo Bridge.

A complete detailed design process to strengthen the Hondo Bridge using post-installed shear connectors was developed in this study, and can be used as a model for future strengthening projects. The Hondo Bridge consists of three identical simple spans and each span was retrofitted with a different type of post-installed shear connector, in order to gain experience with each type of connector. The design process resulted in a recommendation to install 28 shear connectors per girder for the DBLNB and HTFGGB connectors, and 52 shear connectors per girder for the HASAA connector. A larger number of HASAA connectors were needed due to the lower fatigue strength of this connector. The shear connectors were then installed in the bridge by TxDOT personnel. A load rating was conducted for the bridge, both before and after installation of the shear connectors. Field live load tests were also conducted on the bridge, before and after the installation of the shear connectors, to assess the effectiveness of the connectors in developing composite action. Finite element studies of the bridge were conducted to assist in the design process and to improve understanding of the behavior of the bridge before and after strengthening.
