Final report 0-7084-1

Develop Improved Methods for Eliminating Striping on Roadway Surfaces: Final Report

Dr. Maurizio Manzo, University of North Texas
Zhenhua Huang

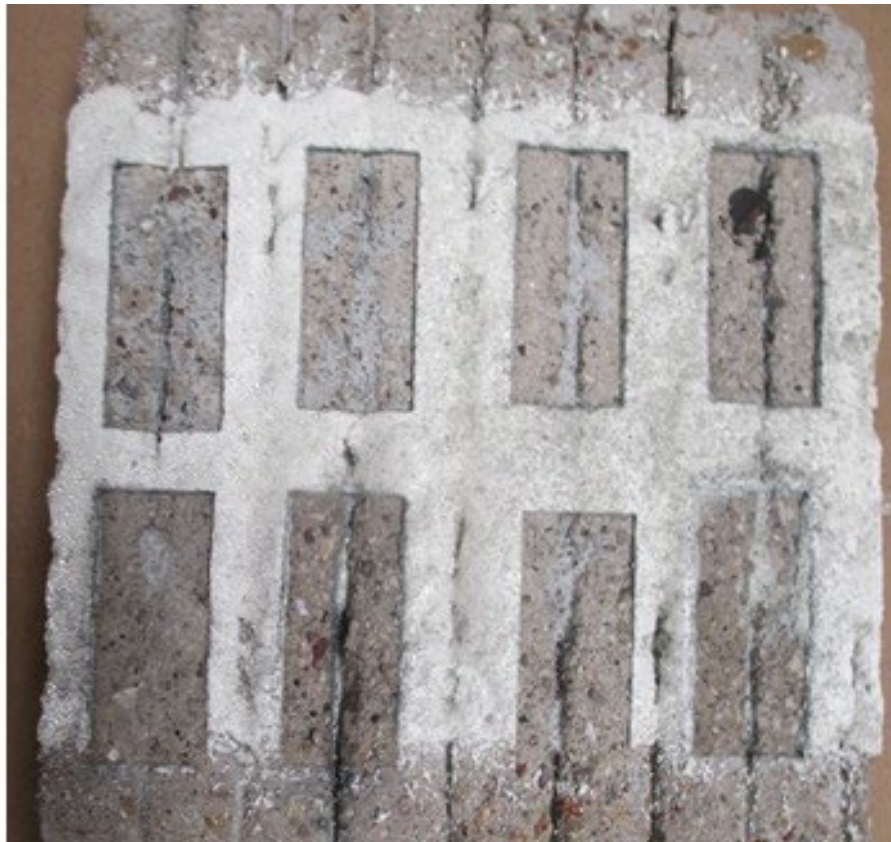
Figure 4: Photograph of a white thermo (by truck) stripe on concrete specimen with different ablated regions.

Figure 4 shows a concrete specimen with different laser ablated regions of a white thermo (by truck) stripe. Different laser parameters were tested. The highest average laser power of 200 W with a pulse width of 60 ns and pulse frequency of 20 - 30 kHz was utilized during the removal of the thermo (by truck) stripes. The galvo-mirror, which scans the laser beam used for removing the stripes, was set to 2000 mm/sec. The laser beam was positioned perpendicular to the sample's surface.

The thickness of the tested white thermo (by truck) stripe was about 100 mil (2.54 mm). An area of 0.8×2 in (20×50 mm) was removed from the specimen by the laser. It was found that the

shortest scanning time of 2.33 – 4 s (with the average errors smaller than 0.13) can be achieved with the following laser parameters showed in table 2:

Using the optimal time, for a 4-inch stripe (100 mile in thickness), the speed removal is 1.7 ft/min (0.0193182 miles/hr.).

Fig. 4 shows different ablated regions of the thermo (by truck) stripe specimen.

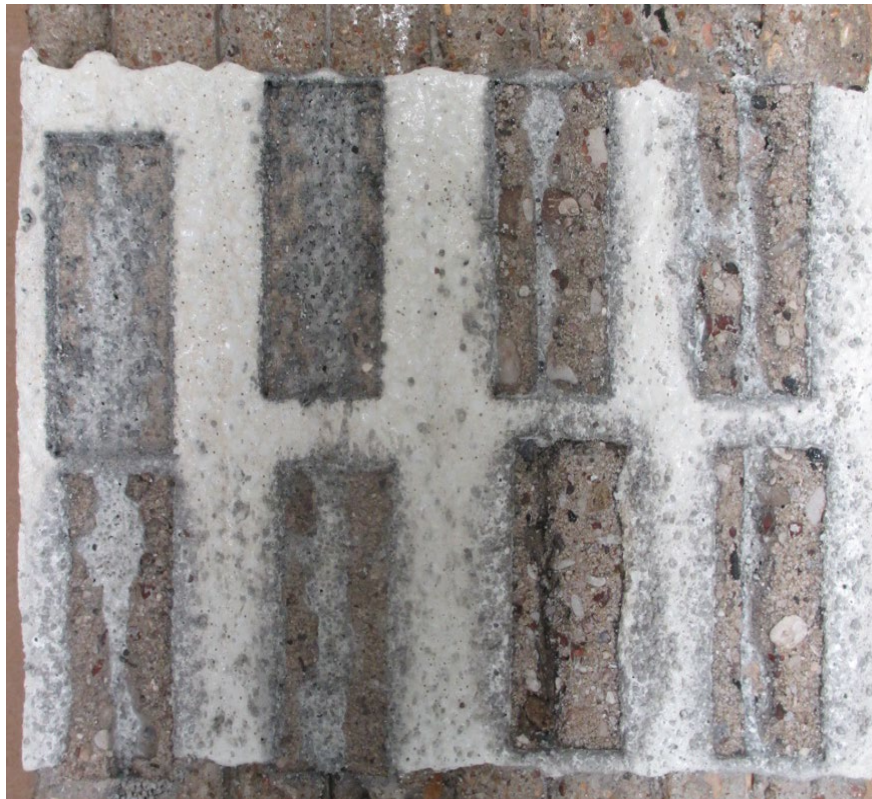
Figure 5: Photograph of a white hot tape stripe on concrete specimen with different ablated regions.

Similarly, areas of size 0.8×2 in (20×50 mm) were removed from a hot tape stripe as shown in Fig. 5. It was found that the shortest scanning time of 62 – 90 s (with the average errors smaller than 0.15) can be achieved with the following laser parameters showed in table 3:

Using the optimal time, for a 4-inch stripe (140 mile in thickness), the speed removal is 0.065 ft/min (0.0007386 miles/hr). This can be improved with the current system based on the cleanness values desired and evaluated at a driving distance.

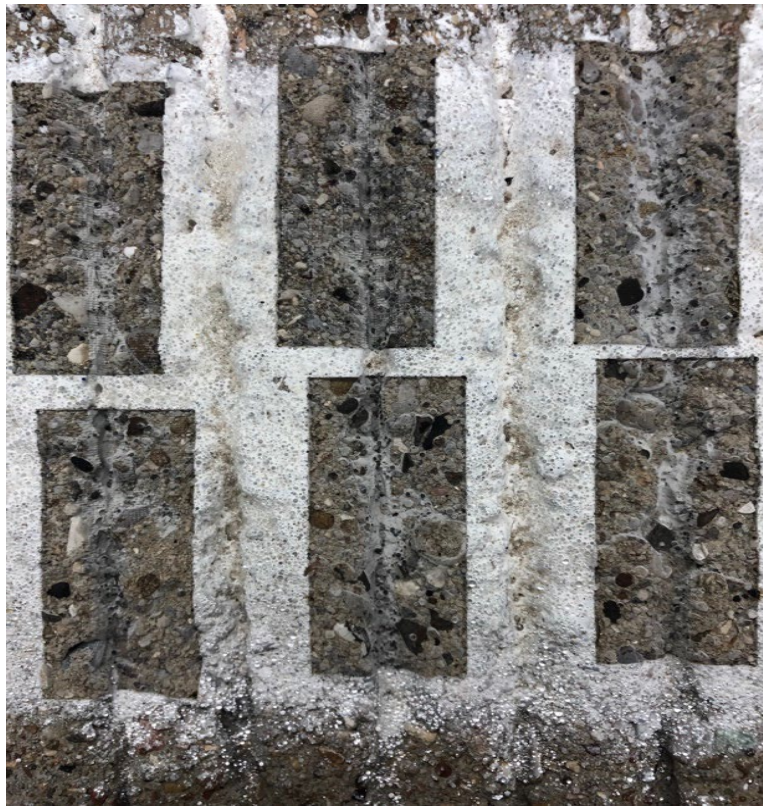
Figure 6: Photograph of a white paint stripe on concrete specimen with different ablated regions.

Also, for the paint stripe, areas of size 0.8×2 in (20×50 mm) were removed using laser ablation and it was found that the shortest scanning time of 13-36 s (with the average errors smaller than 0.13) can be achieved with the following laser parameters:

The speed of removing the 4-in tape stripe was 0.31 ft/min (0.0035227 miles/hr). Tests were also made on asphalt cores received from the TxDOT Fort Worth Material Science Lab. The cores were covered by white paint stripe with a thickness of less than 40 mil (<1 mm).

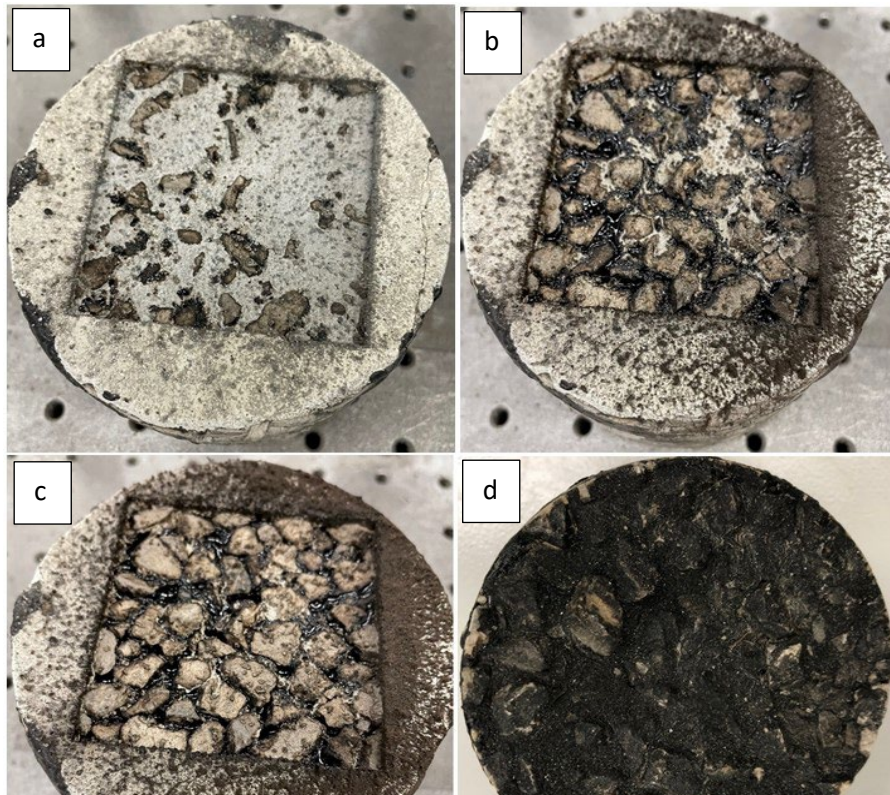
Figure 7: Removal of paint stripe from asphalt by multiple scans: a) first scan; b) second scan; c) third scan; d) control.

The laser parameter selected were the same as the paint stripe removal test of the concrete specimen. The first scan only removed a small portion of the white stripe as shown in Fig. 7a. The second scan removed most of the stripe as shown in Fig. 7b. The third scan removed the whole

white stripe but melted the superficial layer of the asphalt, showing coarse aggregates (see Fig. 7c). Fig. 7d shows the control sample before the laser removal process.

Fig. 6 shows the removal process of paint stripe of 2.5” × 2.5” square from asphalt by multiple scans.

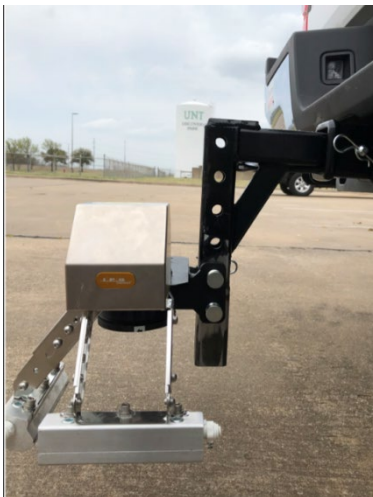
Figure 9: Scanner connected to the hitch of the pick-up truck.

The laser scanner was mounted on the back of the pick-up truck using a custom-made adapter for the hitch. The laser scanner was used to move the laser beam at high speed within an area of about 160x160 mm.

The scanner was connected to the hitch of the truck and was placed at 254mm from the surfacer road (focal length of the lens).

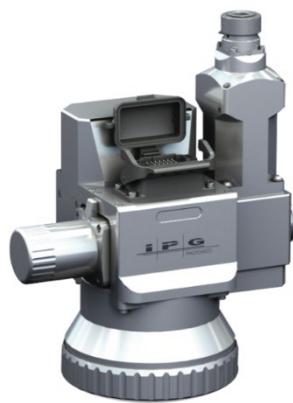
Figure 14: 2D Laser scanner for a high-power laser.

Figure 14 shows the laser scanner for a high-power laser. External interfaces are available for easy integration with automation. The scanner can be mounted on a robotic arm and can include a camera. The system can be programmed to recognize the type of stripe, pavement, and estimate

The scanner can be selected with a lens of 410mm generating a scanning field size of 200x200 mm. The current system has a lens of 254mm with a much smaller scanning field area.

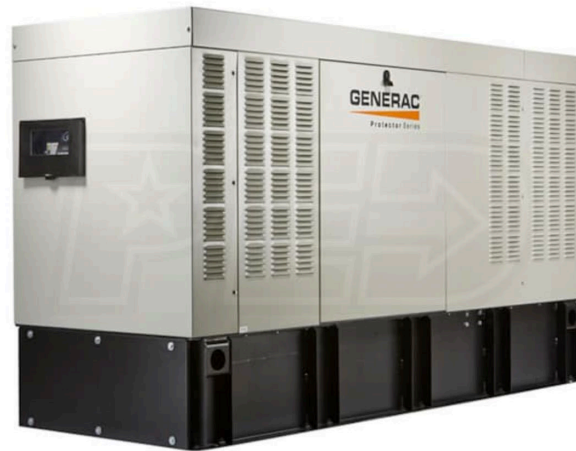
Figure 15: 3-phase generator.

The system (laser and chiller) requires a 3-phase generator of few KWatts to be powered, such as the one showed in Figure 15.
