## TEST AND EVALUATION OF RURAL MAILBOX SUPPORTS

TEST AND EVALUATION OF RURAL MAILBOX SUPPORTS

Research Report 0969-1

October 1980

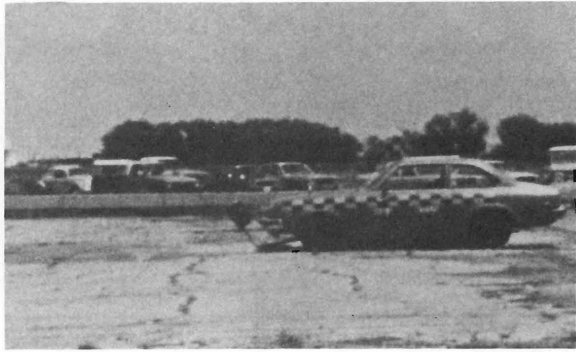
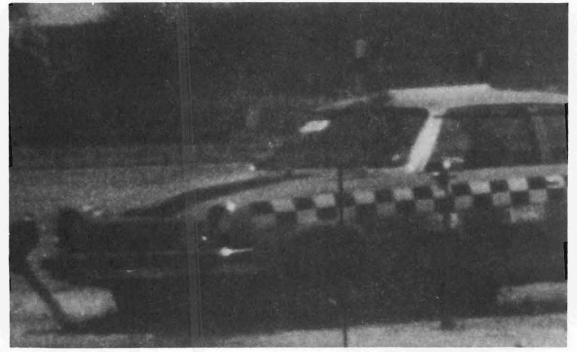
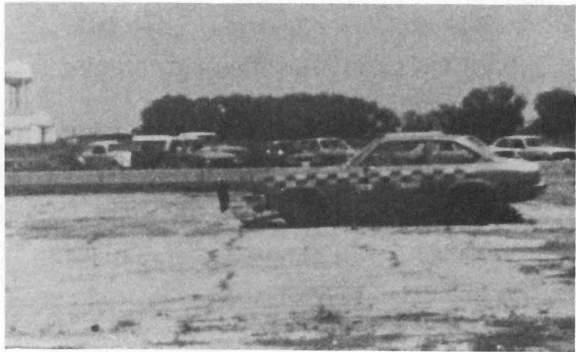
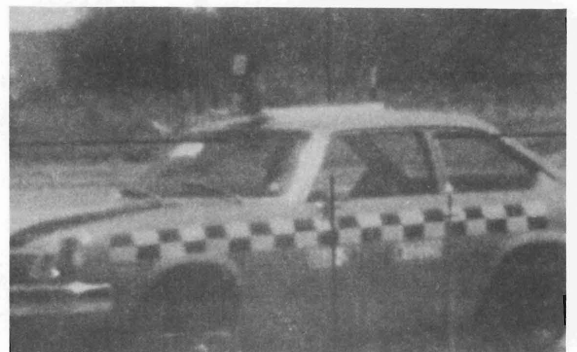
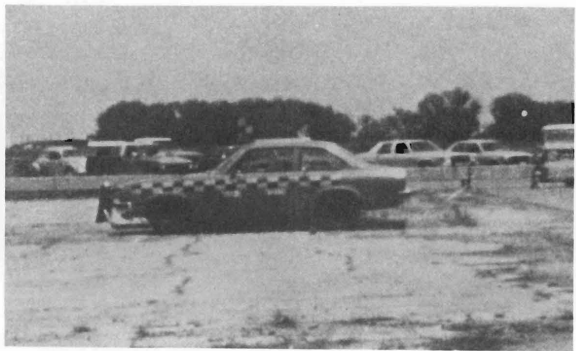
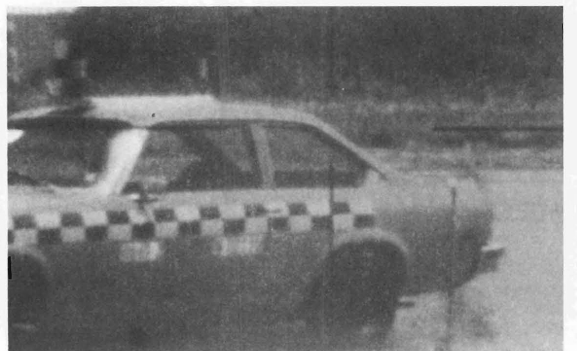
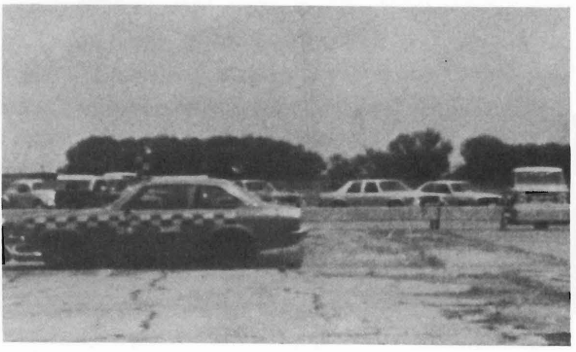
Figure 14. Sequential Photographs for Test 2.

Figure 14. Sequential Photographs for Test 2. (Cont.)

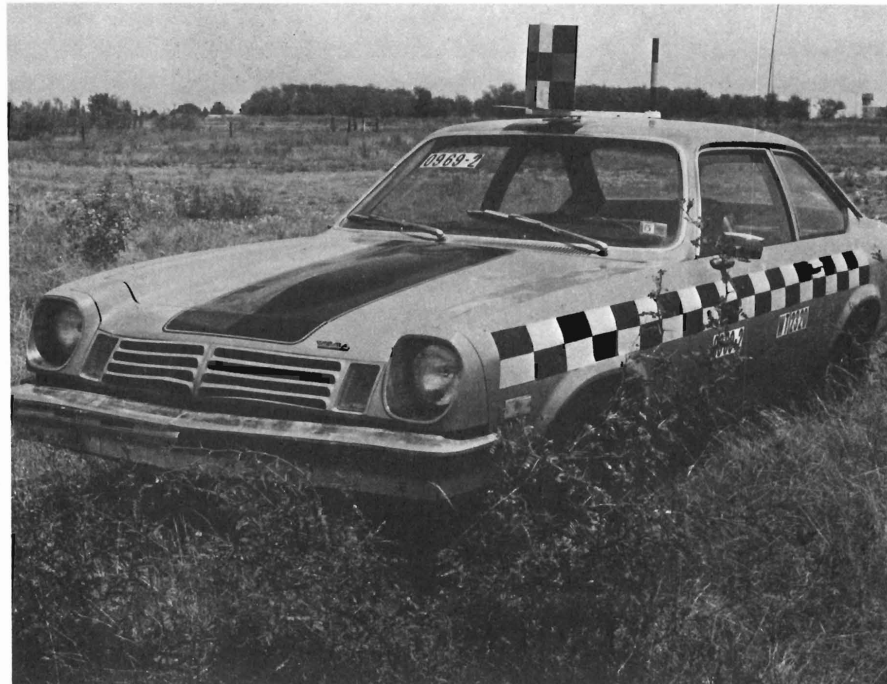
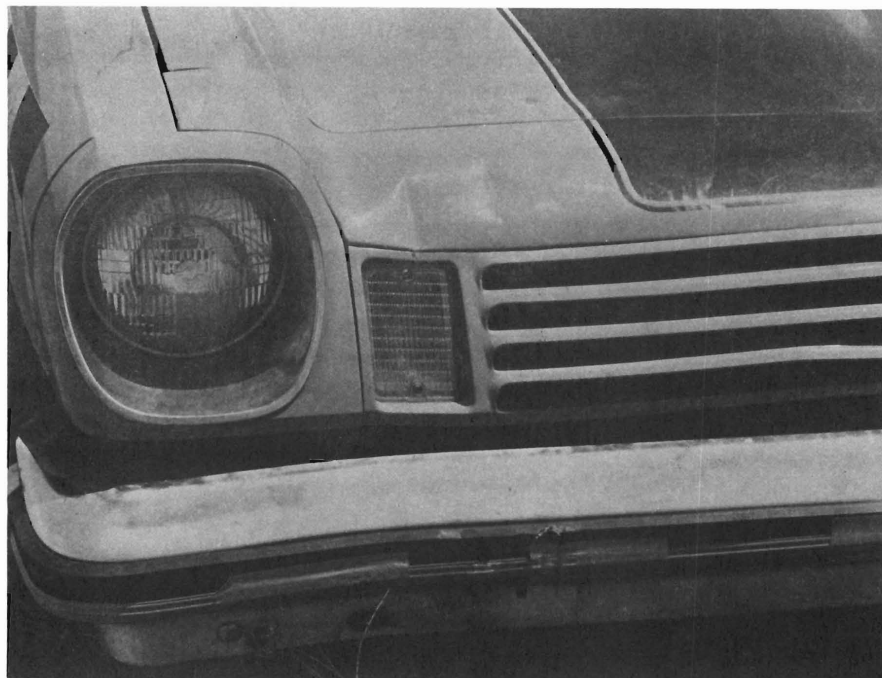
Figure 16. Vehicle After Test 2.

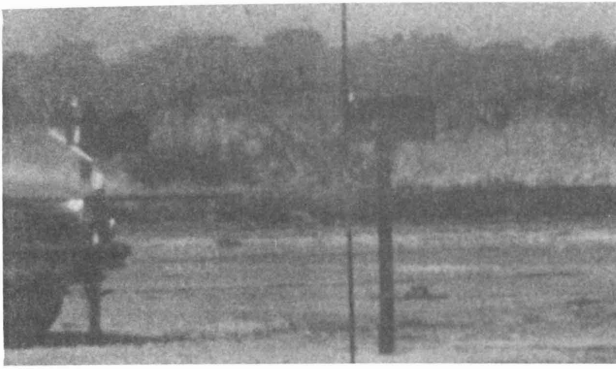
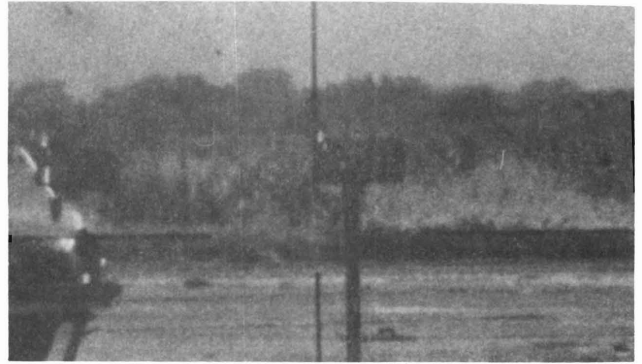
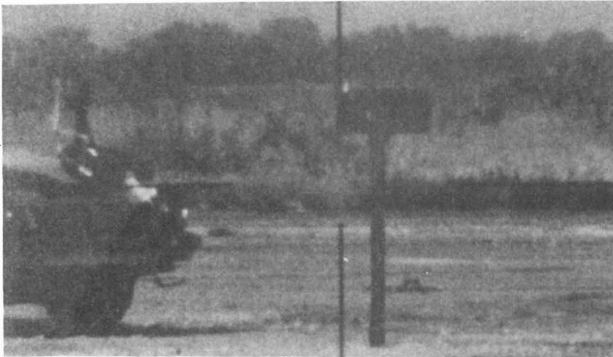
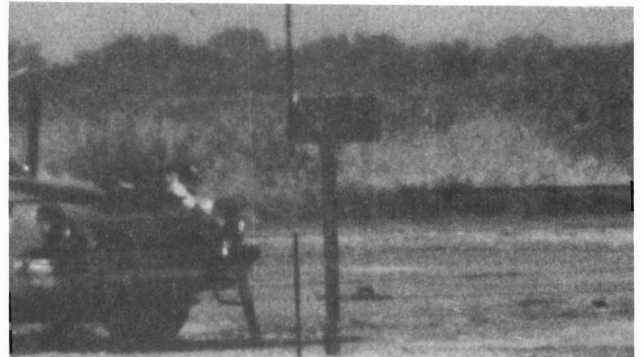
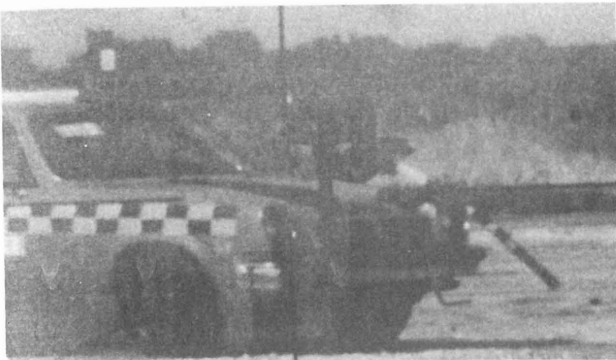
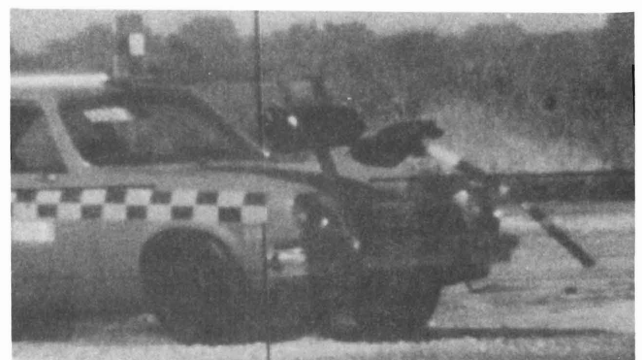
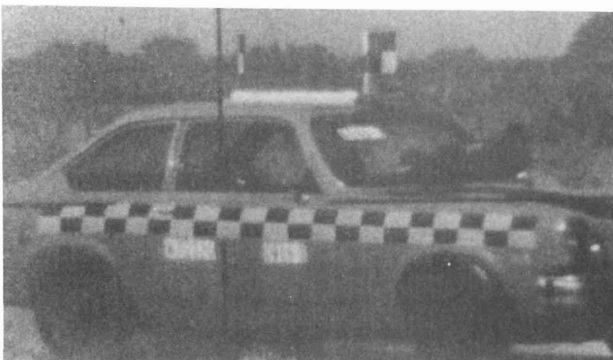
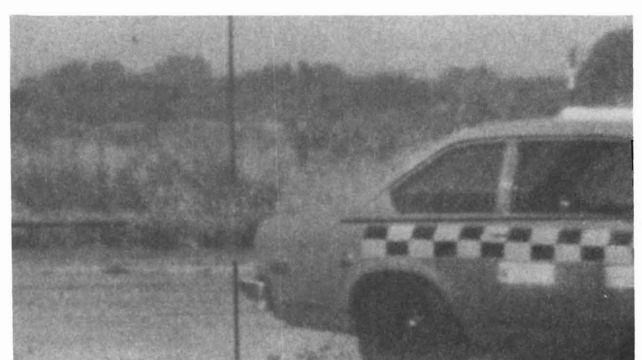
Figure 22. Sequential Photographs for Tests 3-1 and 3-2 - Close-up View.

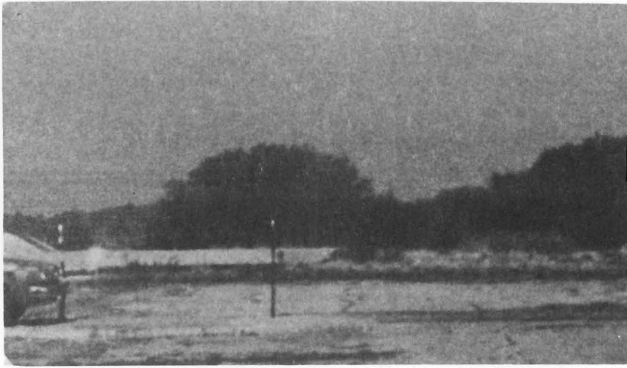
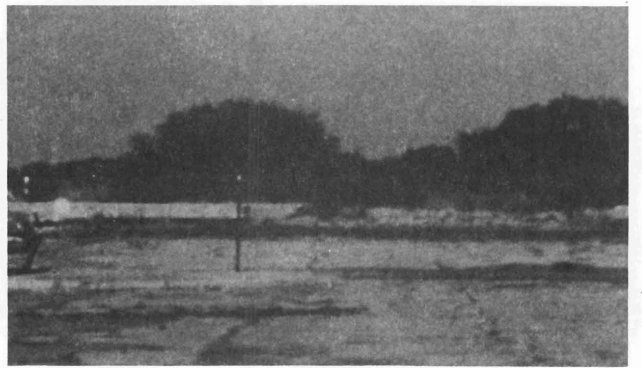
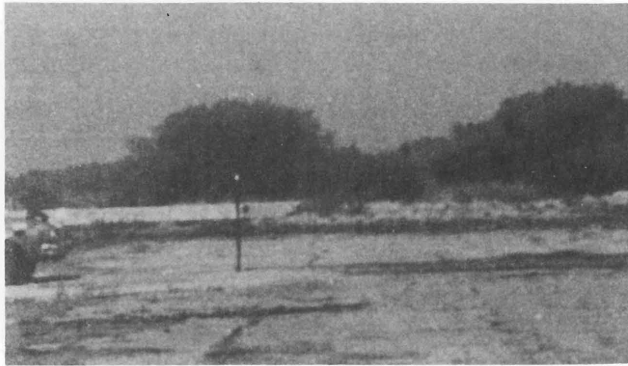
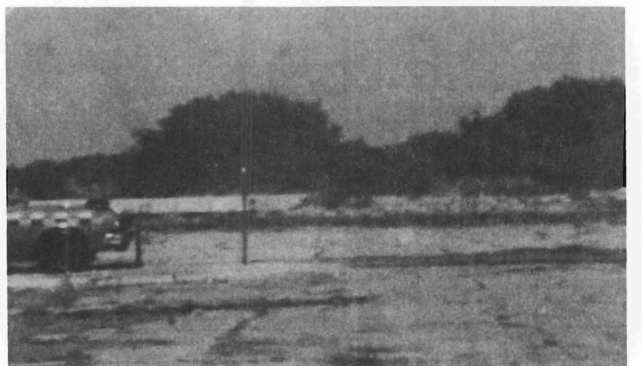
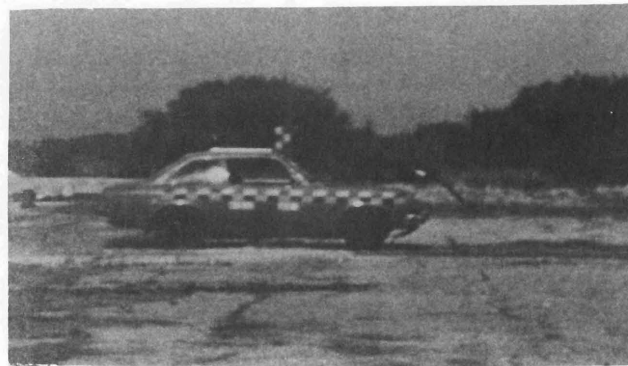
Figure 23. Sequential Photographs for Tests 3-1 and 3-2 - Side Veiw.

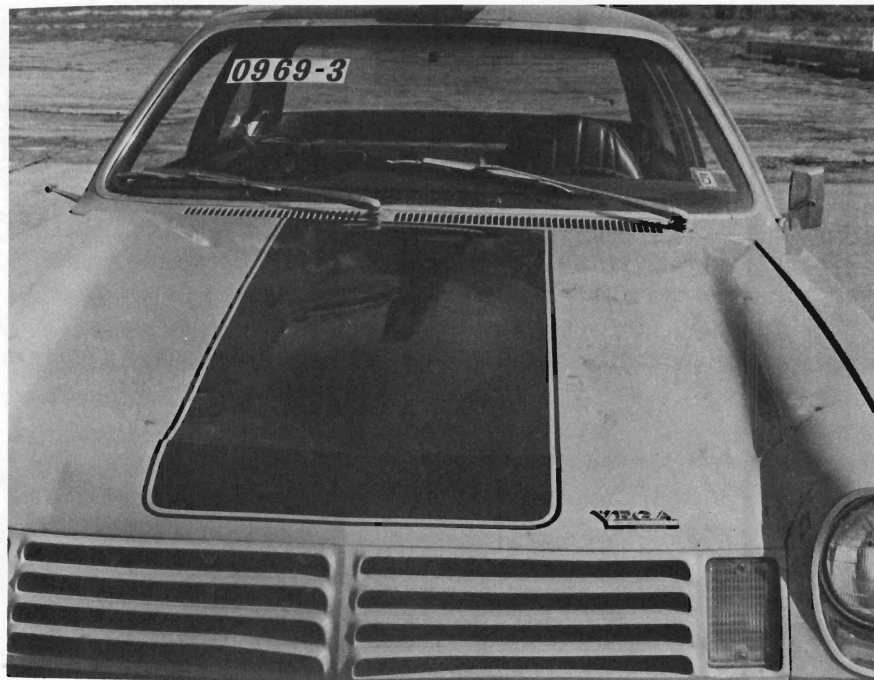
Figure 26. Vehicle After Tests 3-1 and 3-2.
