1. Report No. FHWA/TX-11/0-6590-1		2. Government Accession No.		3. Recipient's Catalog No.	
4. Title and Subtitle Materials Selection for Concrete Overlays: Information Survey Review and Evaluation of Existing Concrete Overlays in Texas				5. Report Date October 2010; Revision April 2011

Materials Selection for Concrete Overlays: Information Survey Review and Evaluation of Existing Concrete Overlays in Texas

This technical report is divided into two parts: Information Survey Review and Condition Surveys/Evaluation of the Existing Overlays in Texas. These two topics were the first two tasks performed for CTR Project 0-6590: Materials Selection for Concrete Overlays.

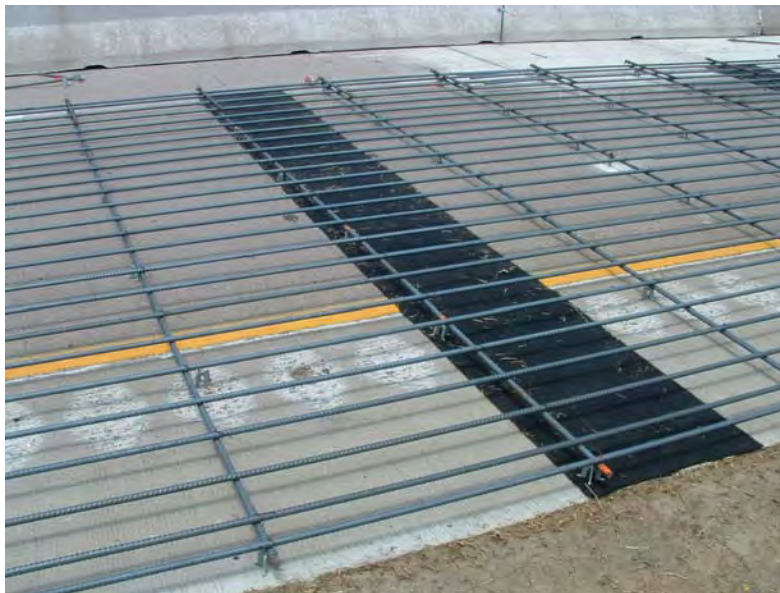
Figure 8.4: Prepared surface prior to the yellow stripe removal

The surface was roughened up and cleaned before the BCO placement. However, the survey team noticed that the yellow pavement stripe was still intact, which raised a concern for the possibility of the stripe acting as a debonder. Therefore, the contractor was asked to remove the yellow stripe and thoroughly clean the surface again before the construction began. Figure 8.4 shows the pavement before the yellow strip was removed, and Figure 8.5 shows it after removal.

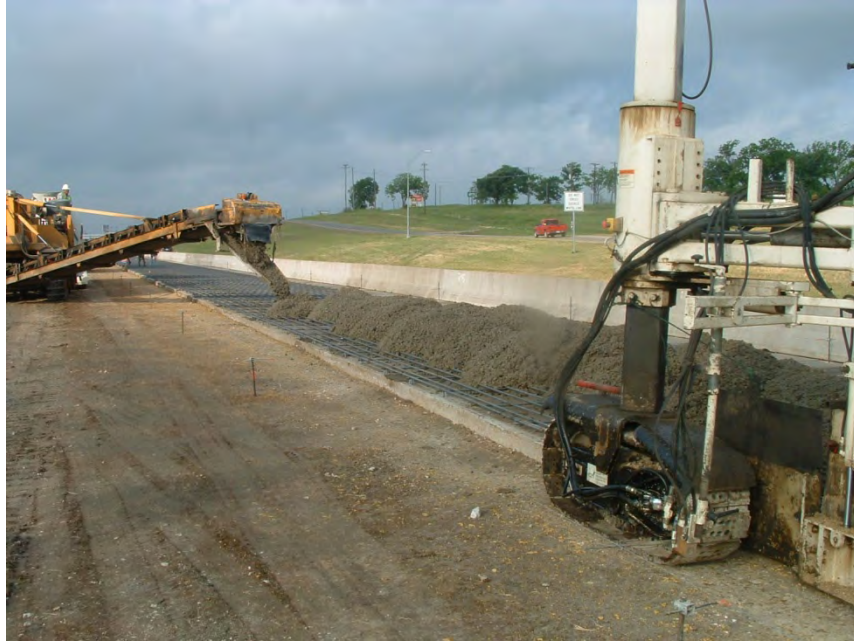
Figure 8.10: Concrete too far ahead of the paving machine

There were instances when concrete was placed too far ahead of the paving machine and there were possible risks of concrete setting even before the paving machine reached those areas. Also, the pavement surface around the concrete dried. Figure 8.10 shows the concrete waiting on the paving machine to catch up, and Figure 8.11 shows the dried surface around the concrete. The contractor was asked to slow the placing of concrete ahead of the paving machine.

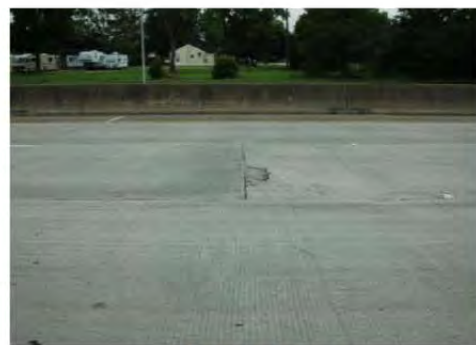
Patch with Failure

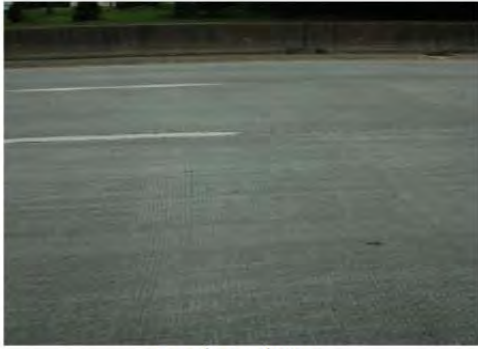
Good condition

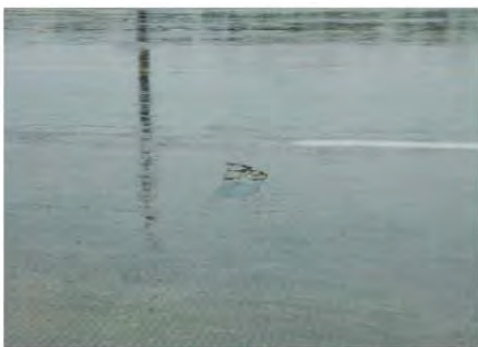
Punchout
Rain during survey

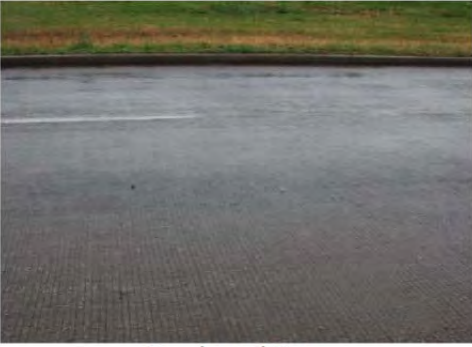
Good condition

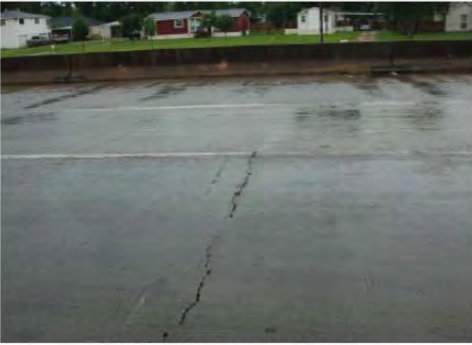
Wide transverse crack

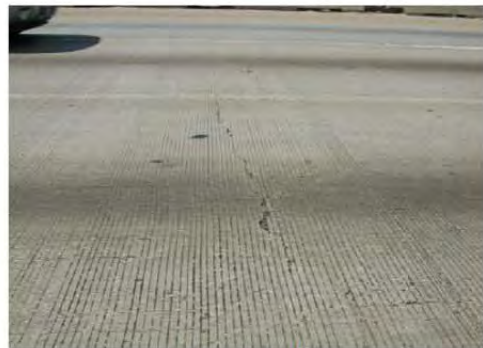
Minor spall

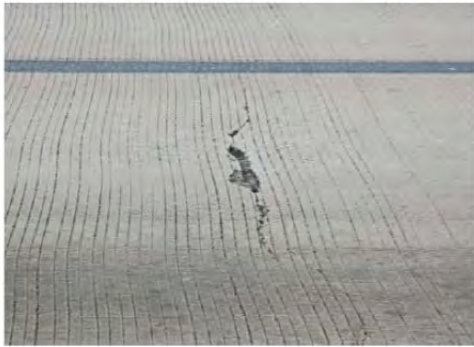
Spall

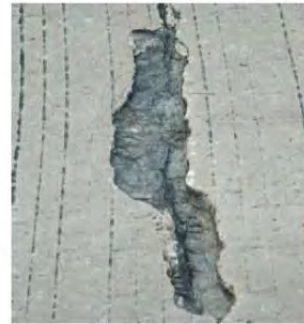
Fibers seen in spall

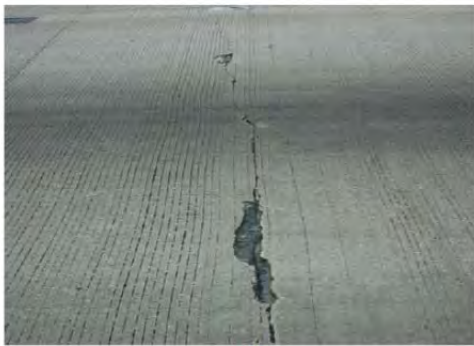
Spall

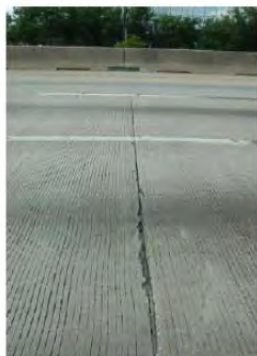
Joint damage

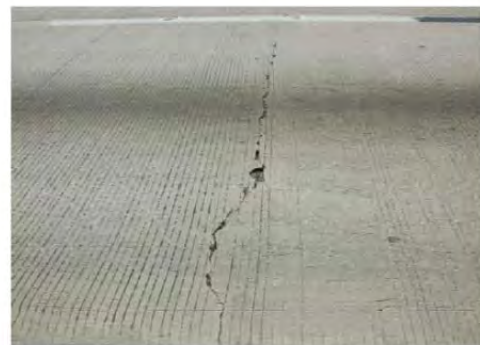
Longitudinal crack

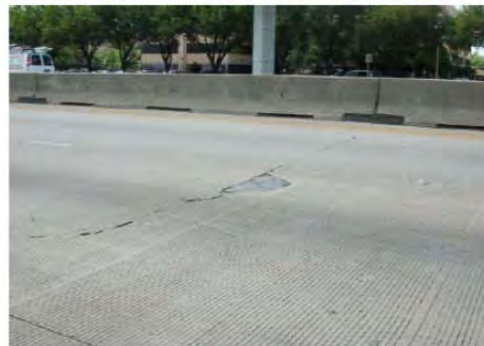
Start of EB BCO at Greenspoint Dr.

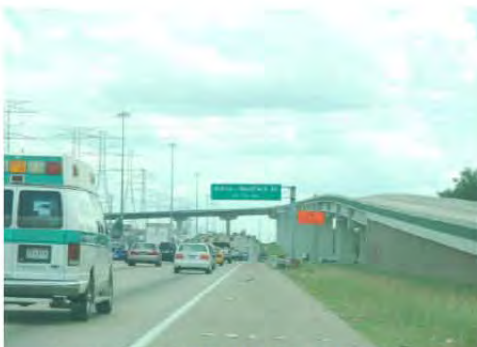
Excellent condition

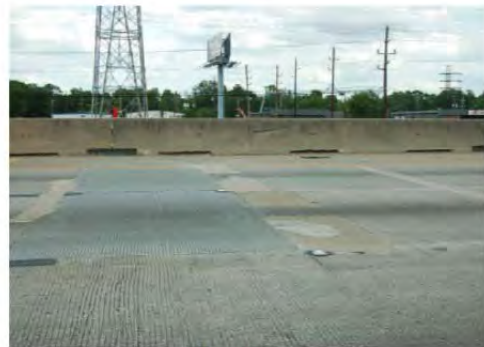
Open joints

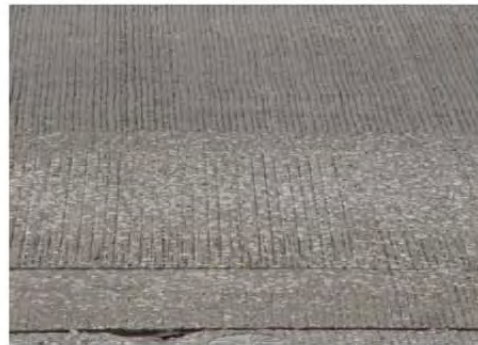
Spall

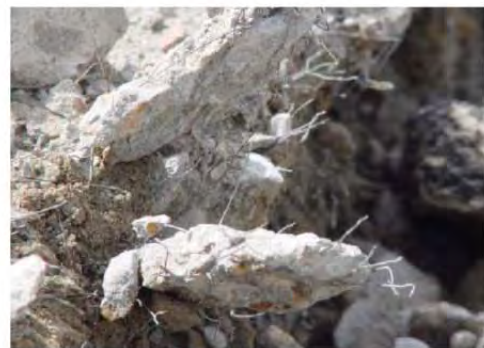
Steel fibers

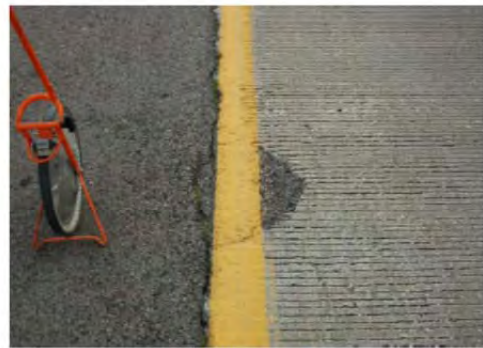
Punchout
1989-1990 Experimental sections (EB)

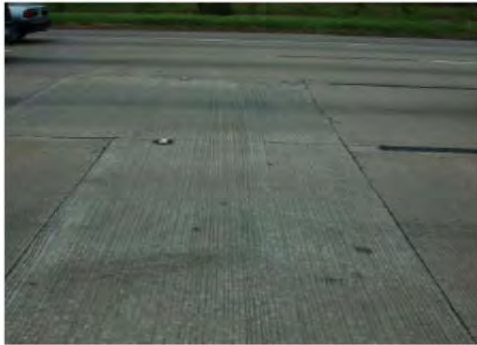
View east of MLK Blvd.
1989-1990 Experimental sections (EB)

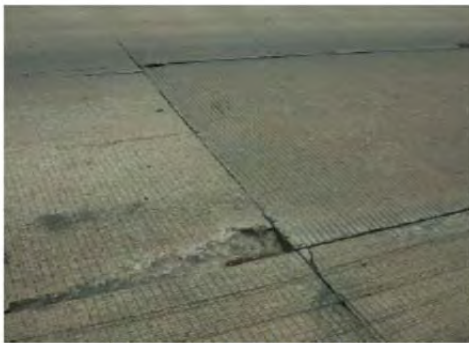
Large spall and patch

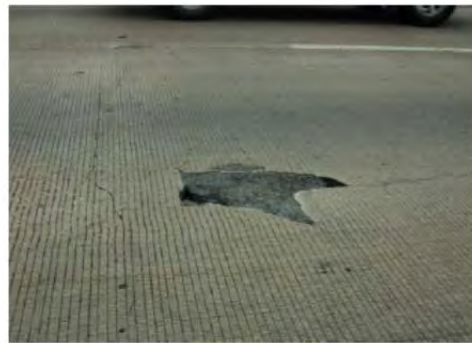
AC patch, longitudinal and transverse cracks

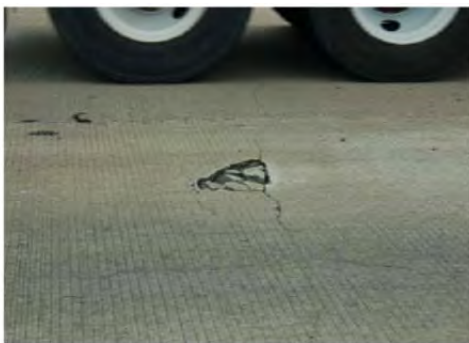
Punchout

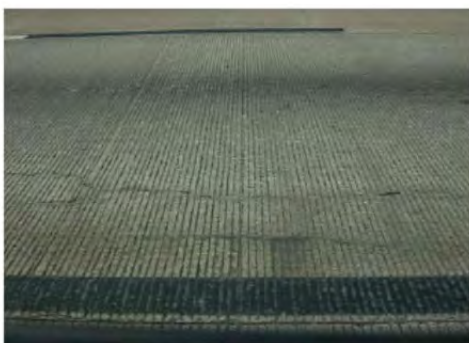
Longitudinal cracks
Westbound

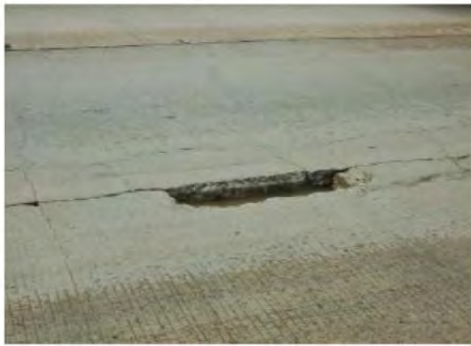
Punchout

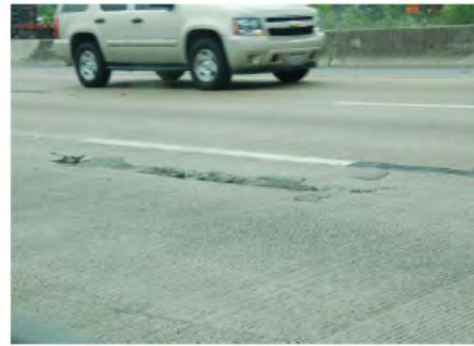
AC Patch, longitudinal cracks

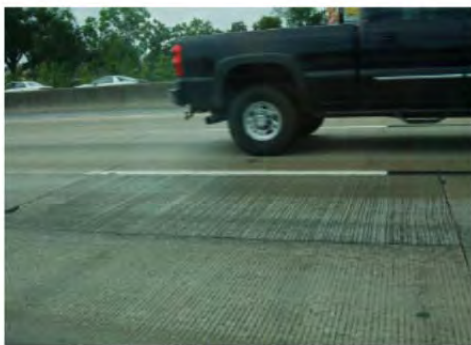
PCC patch with spall

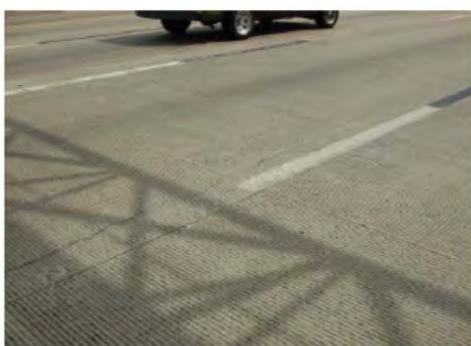
Longitudinal crack
1983 Experimental sections

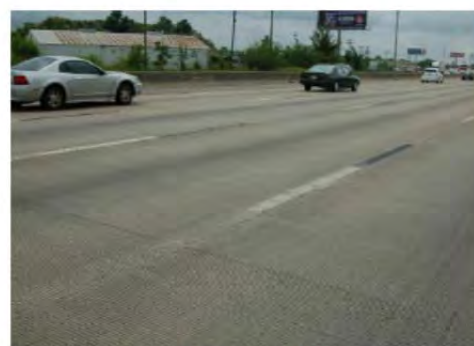
Excellent condition
1983 Experimental sections

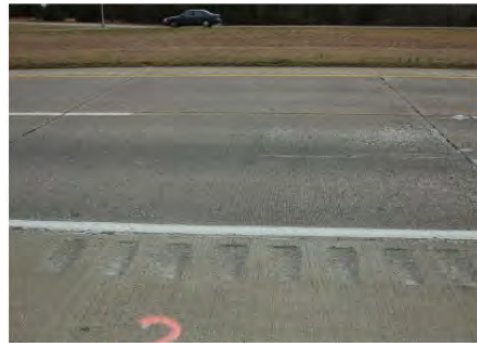
JCP slab in good condition

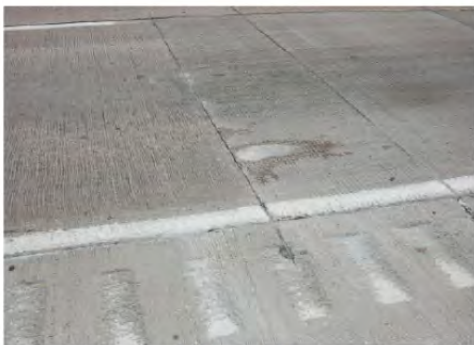
PCC patch

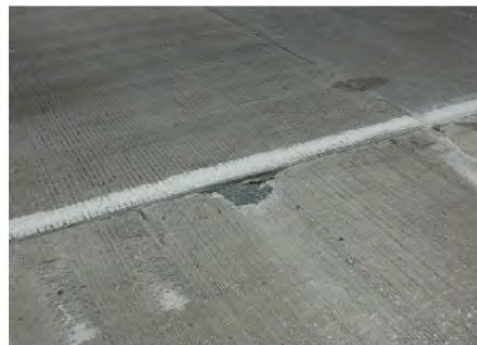
Shoulder joint damage

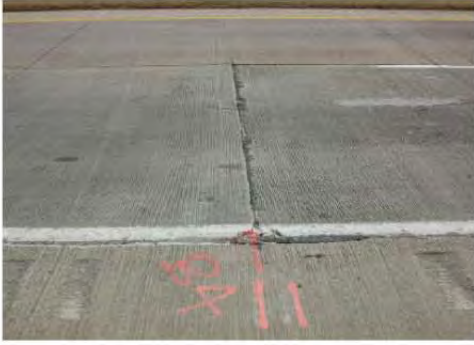
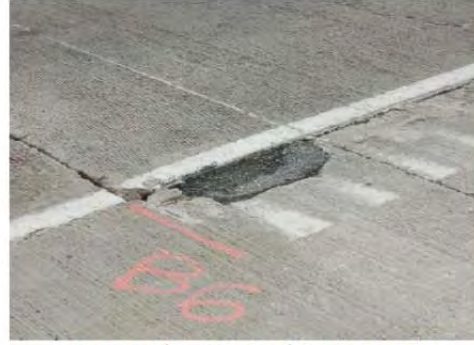
Areas to be repaired prior to BCO placement marked with spray paint

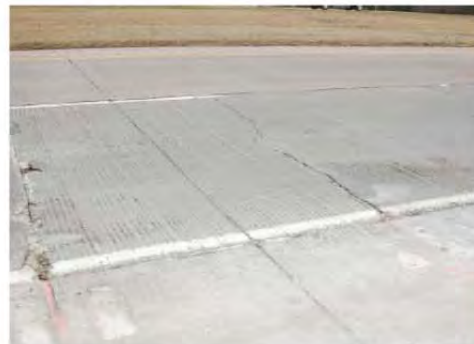
Wide crack and punchout

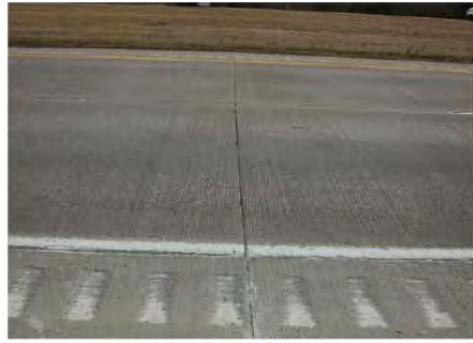
Good condition

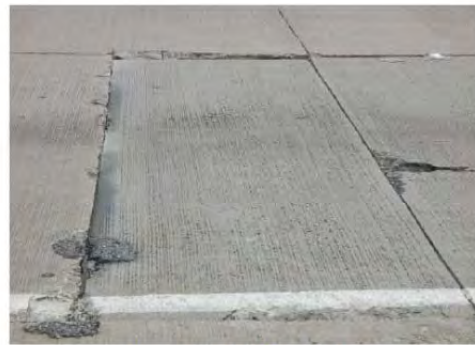
Damaged PCC patch

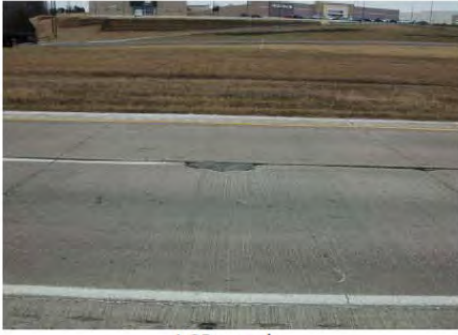
ACP patch

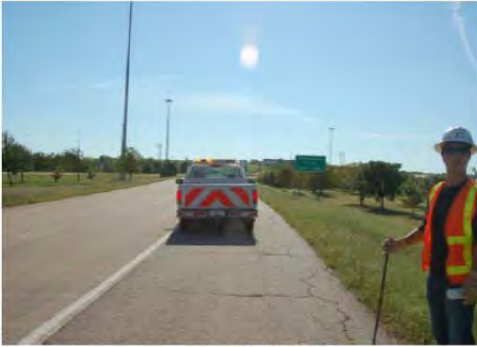
Start of BCO (SB)
at Holliday Creek

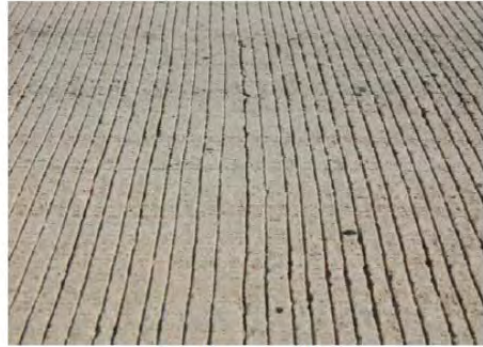
Excellent condition

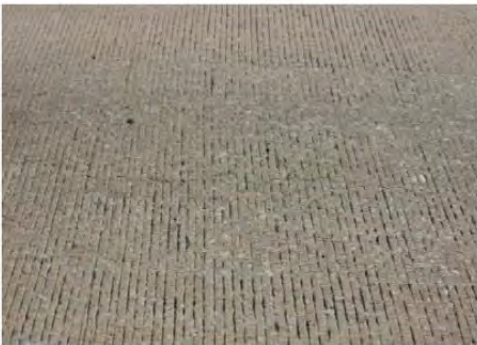
Narrow longitudinal crack

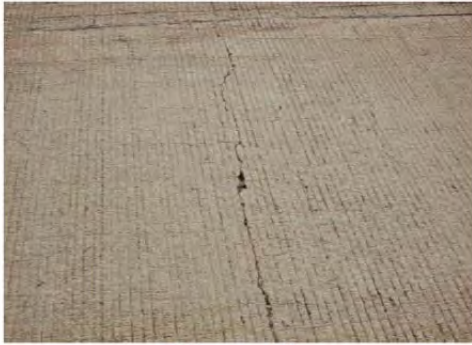
Minor spall

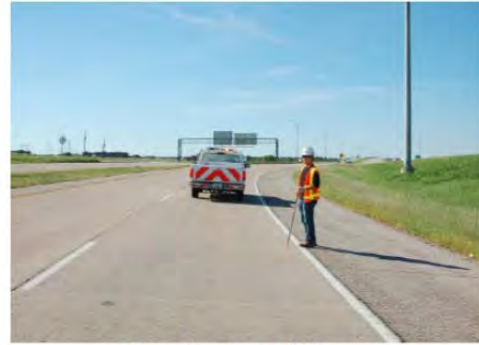
Excellent condition

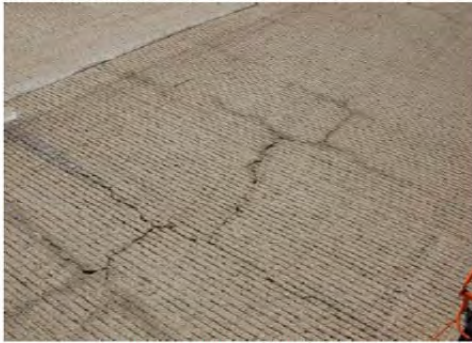
Transverse and longitudinal cracks
(area of potential punchout)

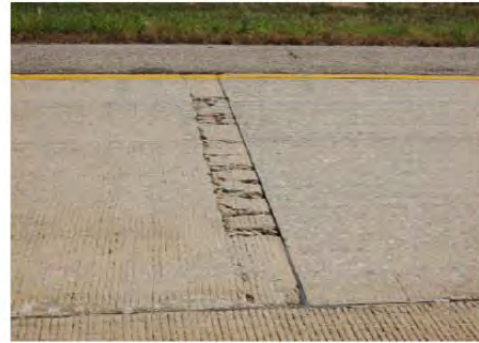
Punchout at joint (SB inside lane)

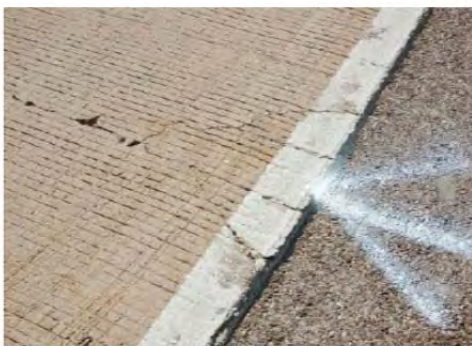
Delaminated area

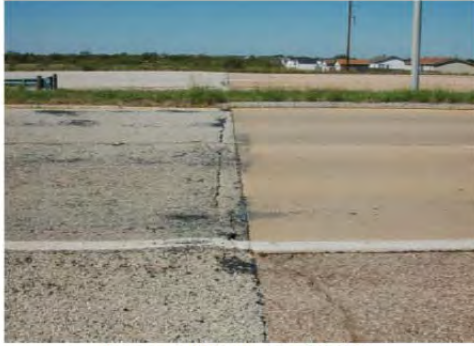
Joint at NB start of BCO

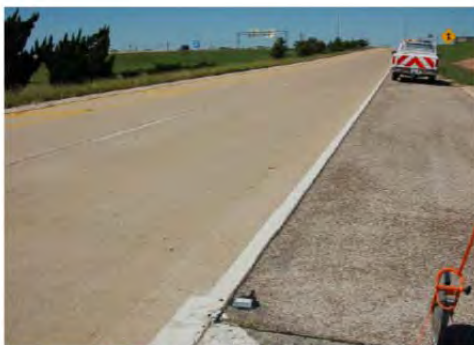
End of NB BCO at Holliday Creek bridge

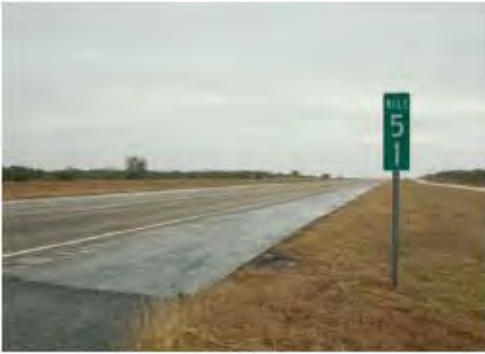
Picture 1
Beginning of the Laredo Whitetopping section, RM 51

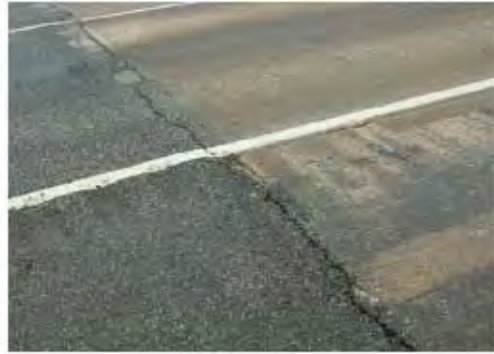
Picture 2
RM 51. Joint between ACP and whitetopping overlay

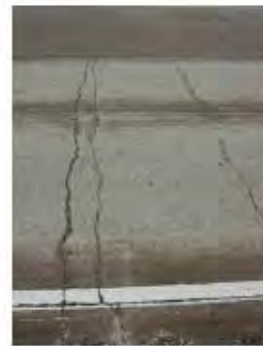
Picture 4
Area of potential punchout (RM 51 + 214 ft)

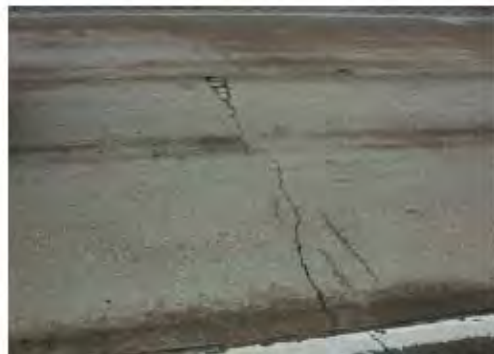
Picture 6
Punchout (RM 51 + 413)

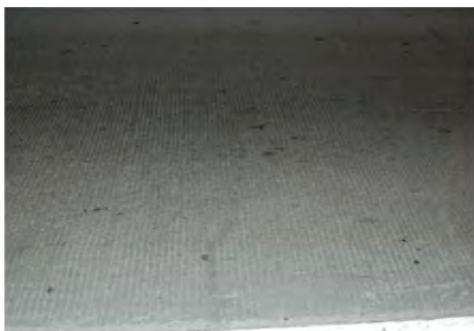
Good condition

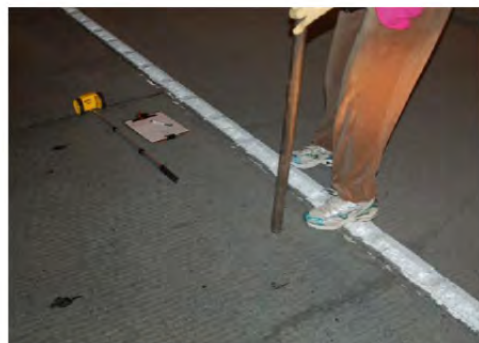
Sounding of delaminated area with no
superficial distresses

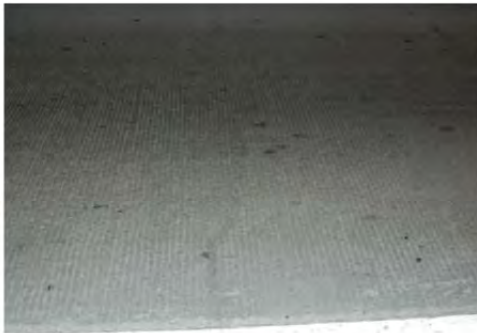
Excellent condition

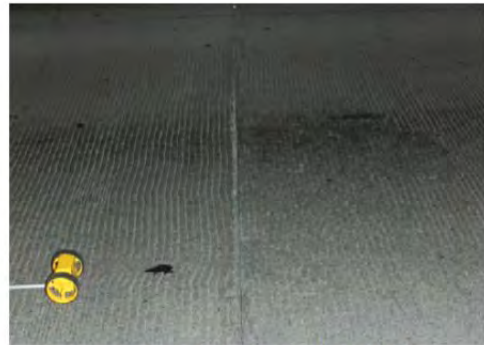
Transverse joint at end of BCO
(Westbound direction)

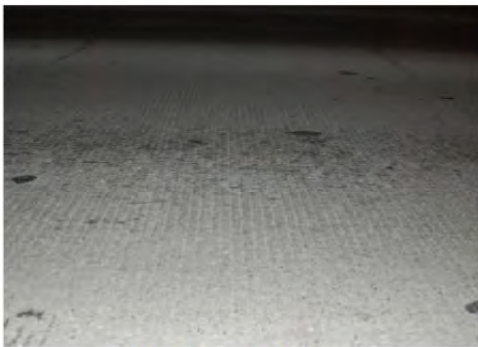
Excellent condition

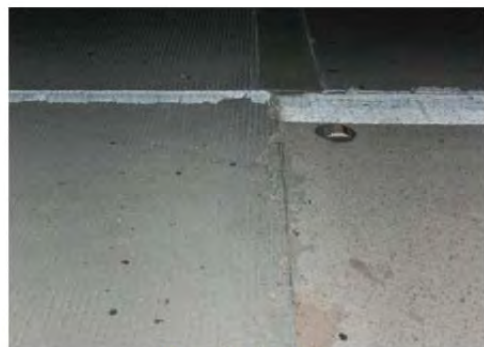
EB end of BCO
