TECHNICAL REPORT 0-6804-3
TxDOT PROJECT NUMBER 0-6804

Traffic Noise Barrier Analysis for SH 190 in Rowlett, Texas

August 2019; Published September 2020

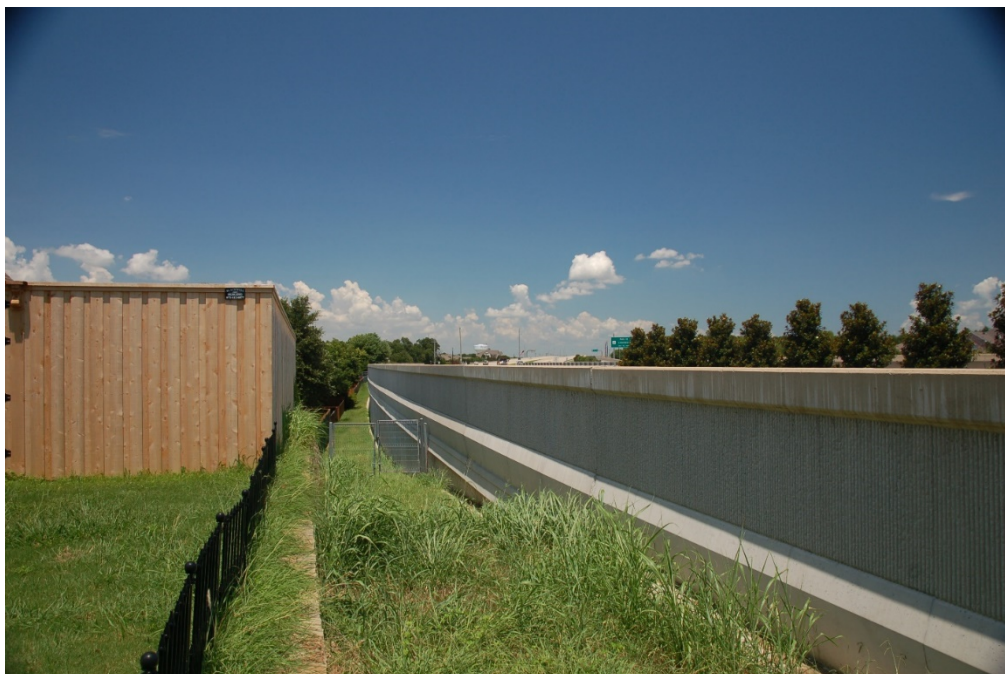
Figure 2.32: View of SH 190 and noise wall from Site #8: 4509 Meadowcove Dr.

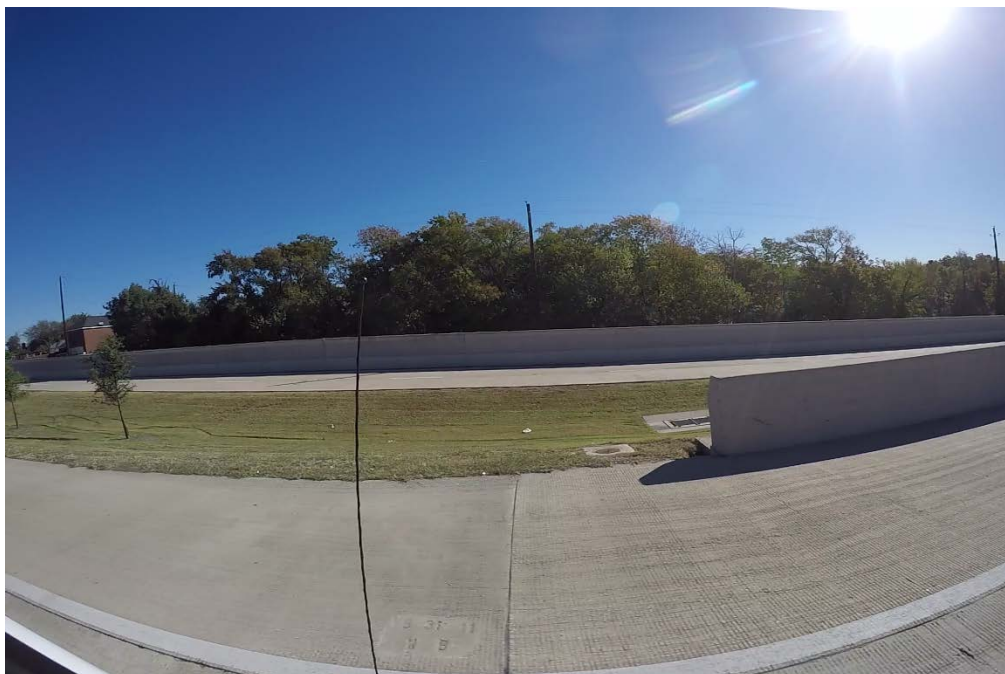
Figure 3.3: SH 190 Northbound main lane. Pavement cast on 8/31/2011 as indicated by inscription on the shoulder as recorded by video

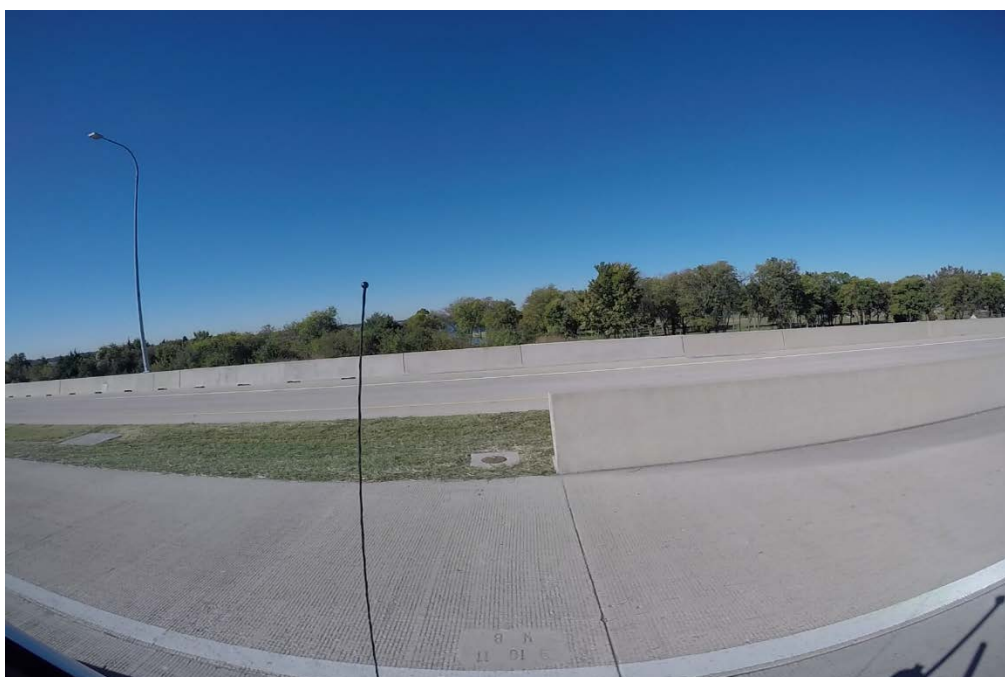
Figure 3.4: SH 190 Southbound main lane. Pavement cast on 9/10/2011 as indicated by inscription on the shoulder as recorded by video

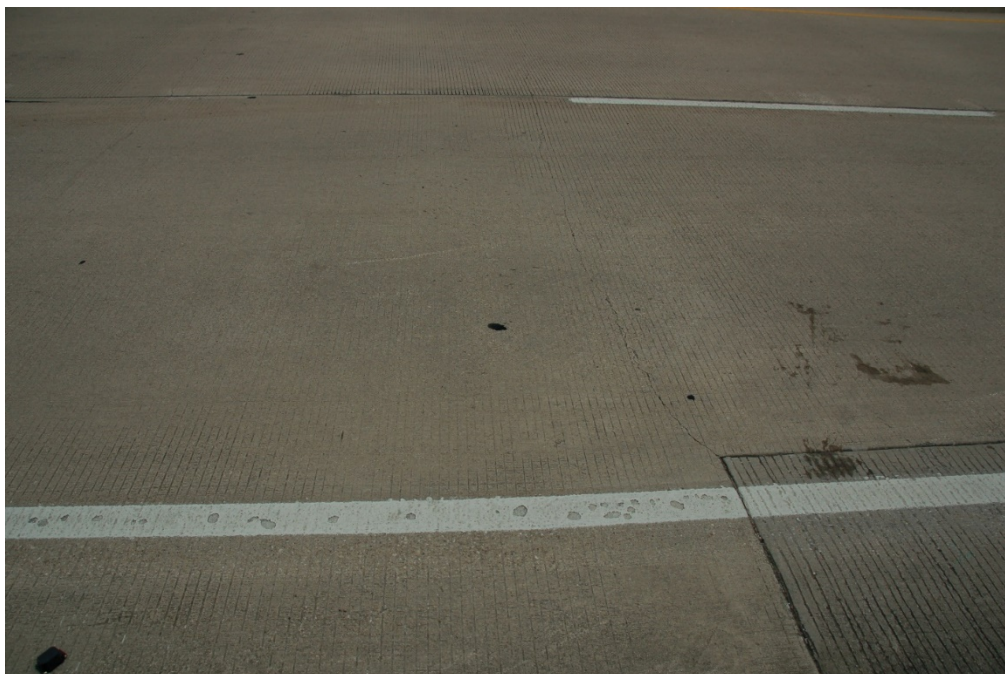
Figure 3.6: Northbound frontage road

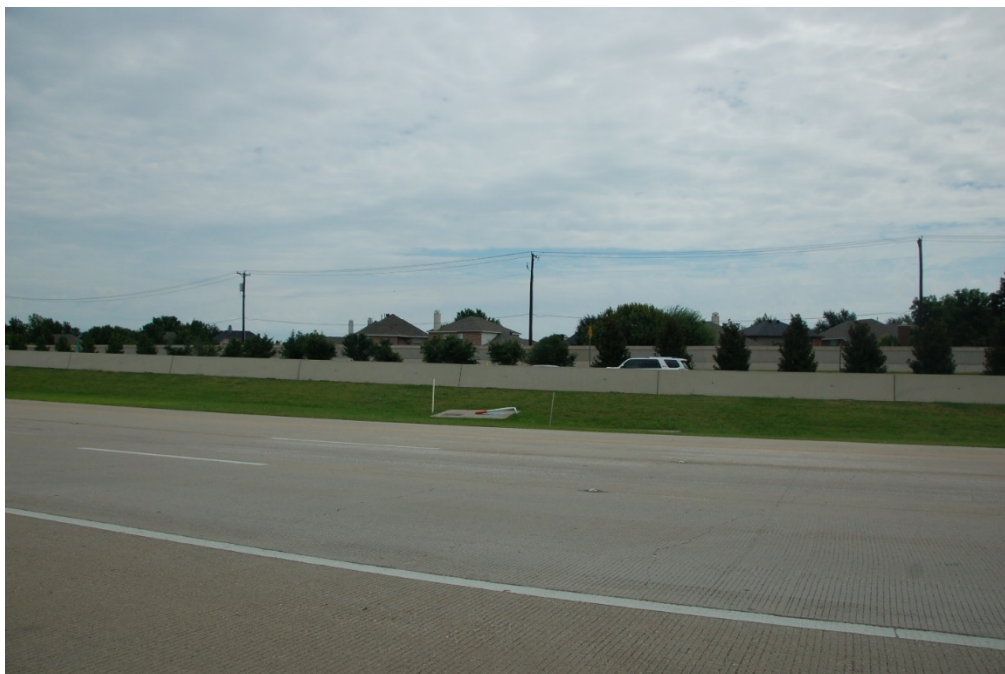
Figure 3.8: Southbound main lanes

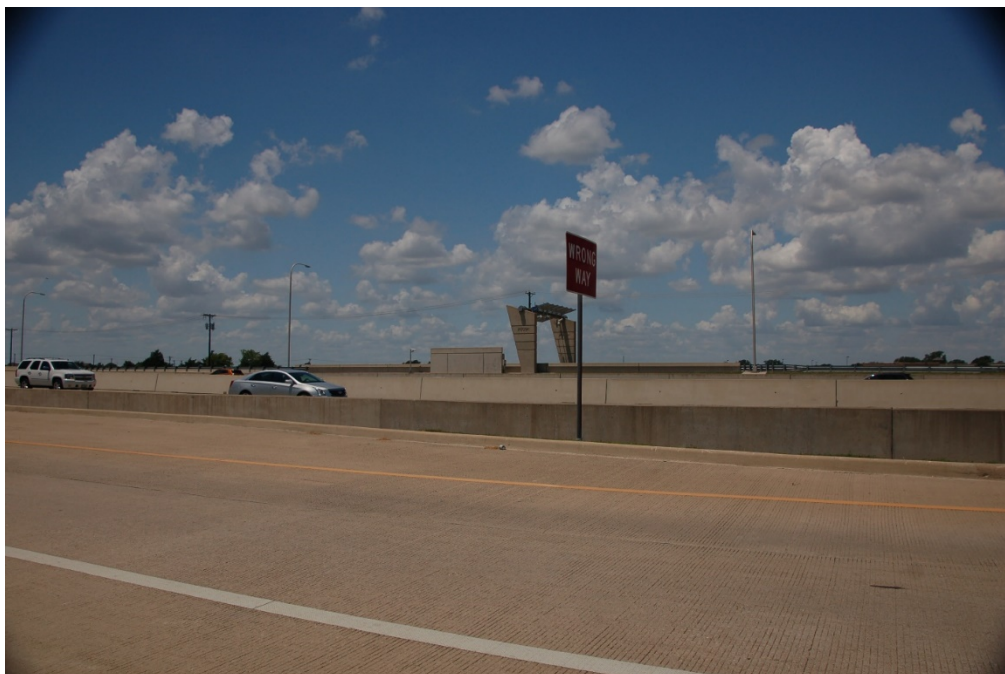
Figure 3.10: Northbound exit ramp
